NUREG-1841

U.S. Operating Experience With Thermally Treated Alloy 690 Steam Generator Tubes

**U.S. Nuclear Regulatory Commission
Office of Nuclear Reactor Regulation
Washington, DC 20555-0001**

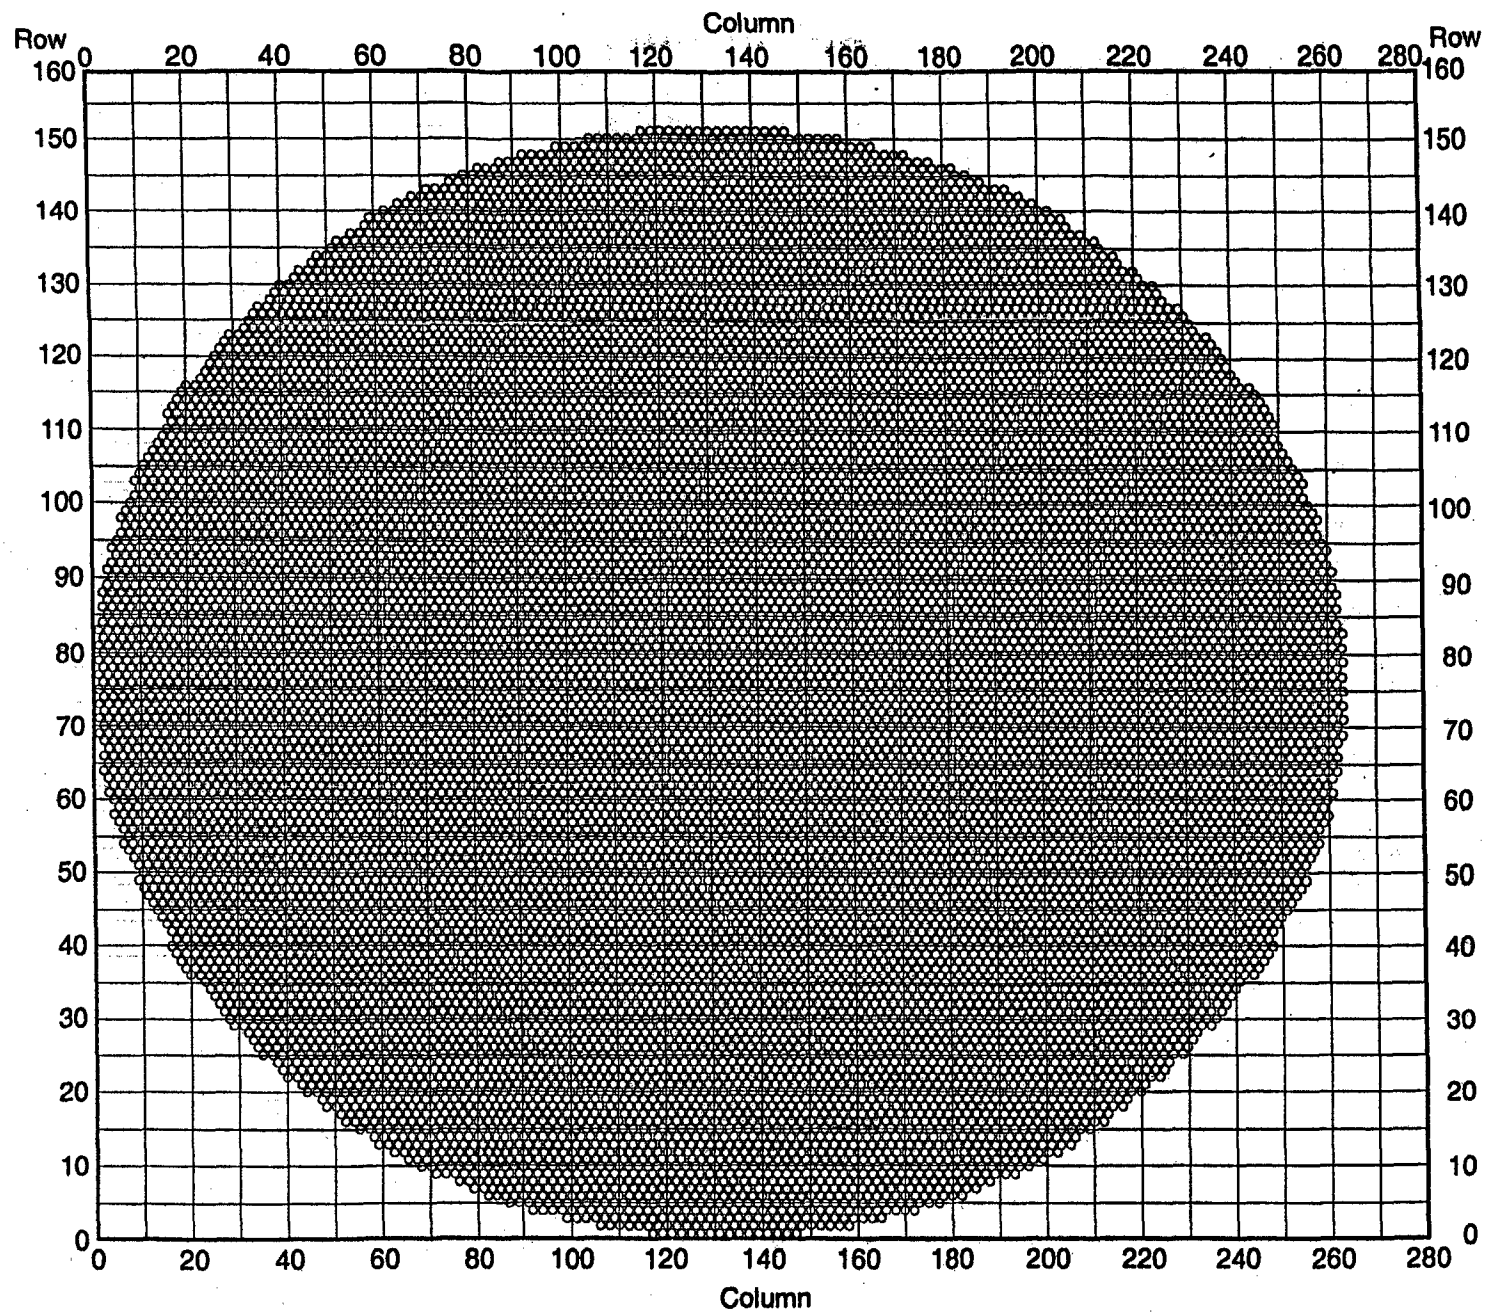
Figure 2-37: Tubesheet Map for Oconee Units 1, 2, and 3

Each steam generator has 15,631 thermally treated Alloy 690 tubes that have an outside diameter of 0.625 inch and a nominal wall thickness of 0.038 inch. The tubes were manufactured by Sumitomo and are arranged in a triangular pattern as illustrated in Figure 2-37 with a spacing of approximately 0.875 inch. The heat transfer surface area is 134,600 ft². The total length of a tube is 56.2 feet, with a heated length of 52.4 feet.

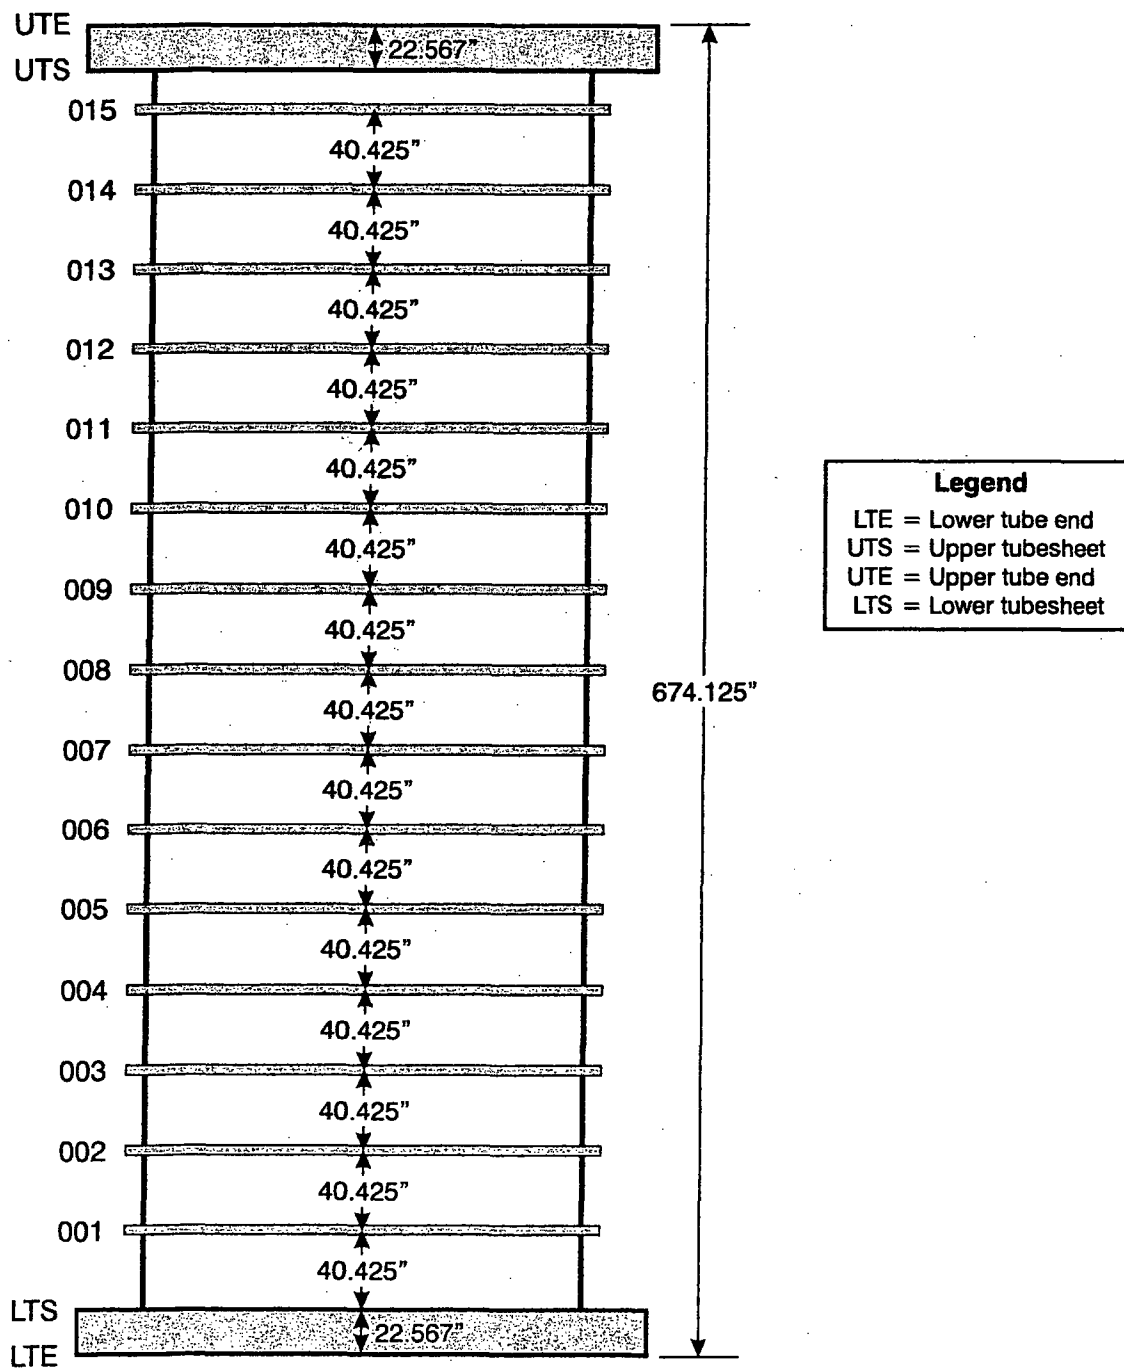
Figure 2-38: Tube Support Naming Convention at Oconee Unit 1, 2, and 3

The tubes were hydraulically expanded into the tubesheet for 13 inches from the tube end. The tubesheet is 22 inches thick. The tubes are supported by tube support plates constructed from 410 stainless steel, with trifoil-shaped holes through which the tubes pass. The trifoils have an hour-glass profile to improve hydraulic resistance (i.e., reduce the pressure drop across the plate), provide a flat contact surface for the tube, facilitate tubing of the steam generator, and provides better accessibility for water lancing and chemical cleaning. Figure 2-38 illustrates the tube support configuration and numbering.

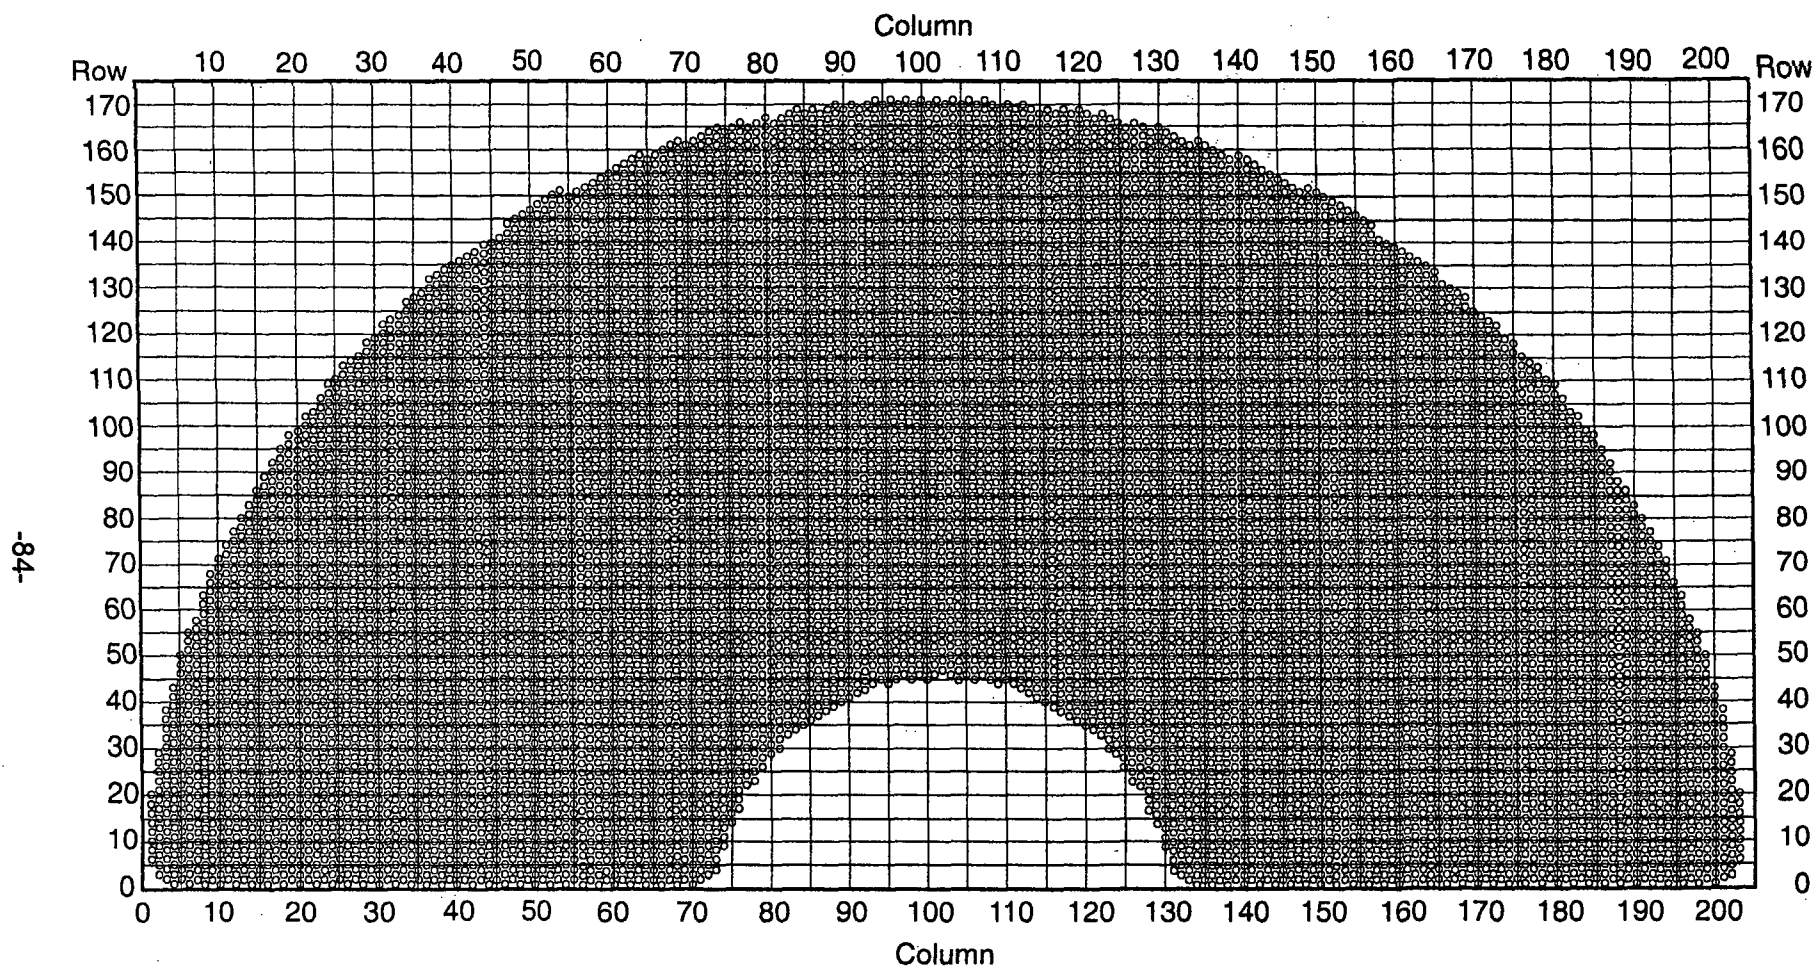
Figure 2-39: Tubesheet Map for Palo Verde Unit 2

manufactured by Sandvik and are arranged in a triangular pattern as illustrated in Figure 2-39 with a spacing of approximately 0.866 inch.

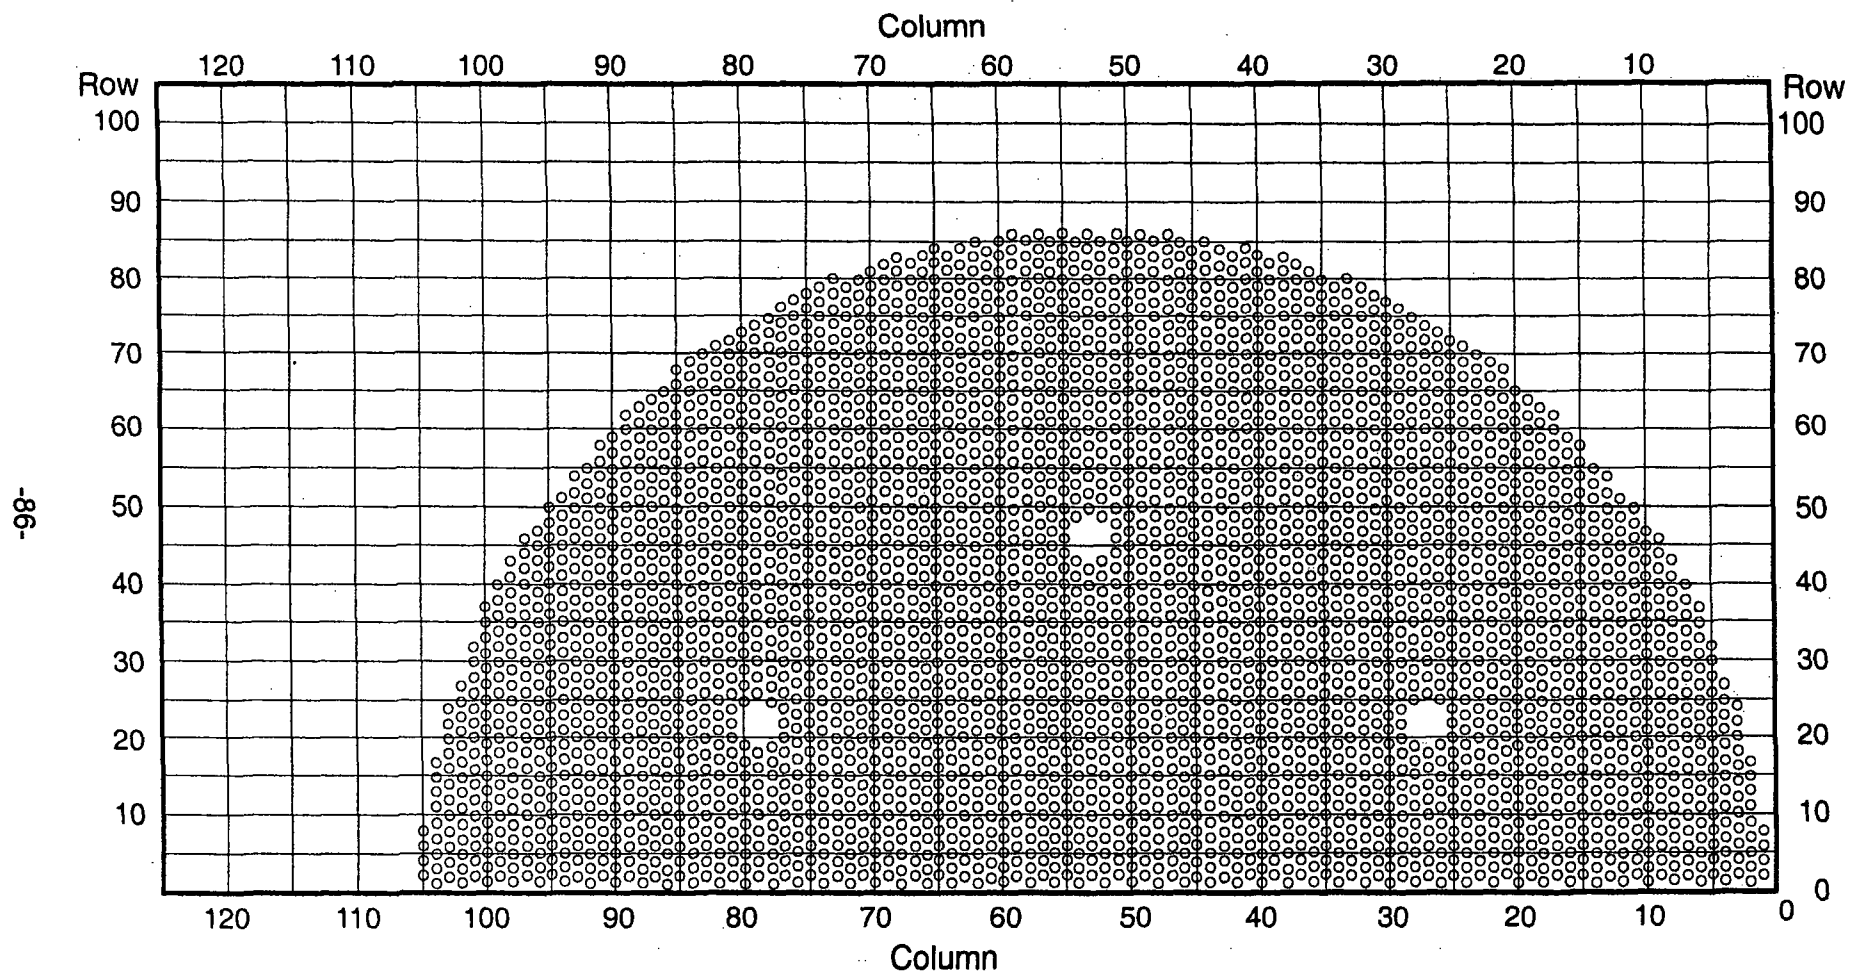
Figure 2-40: Tube Support Naming Convention at Palo Verde Unit 2

Palo Verde 2 has two recirculating steam generators designed by Combustion Engineering and fabricated by Ansaldo. The steam generators were put into service in 2003 during RFO 11. The licensee numbers its tube supports as depicted in Figure 2-40.

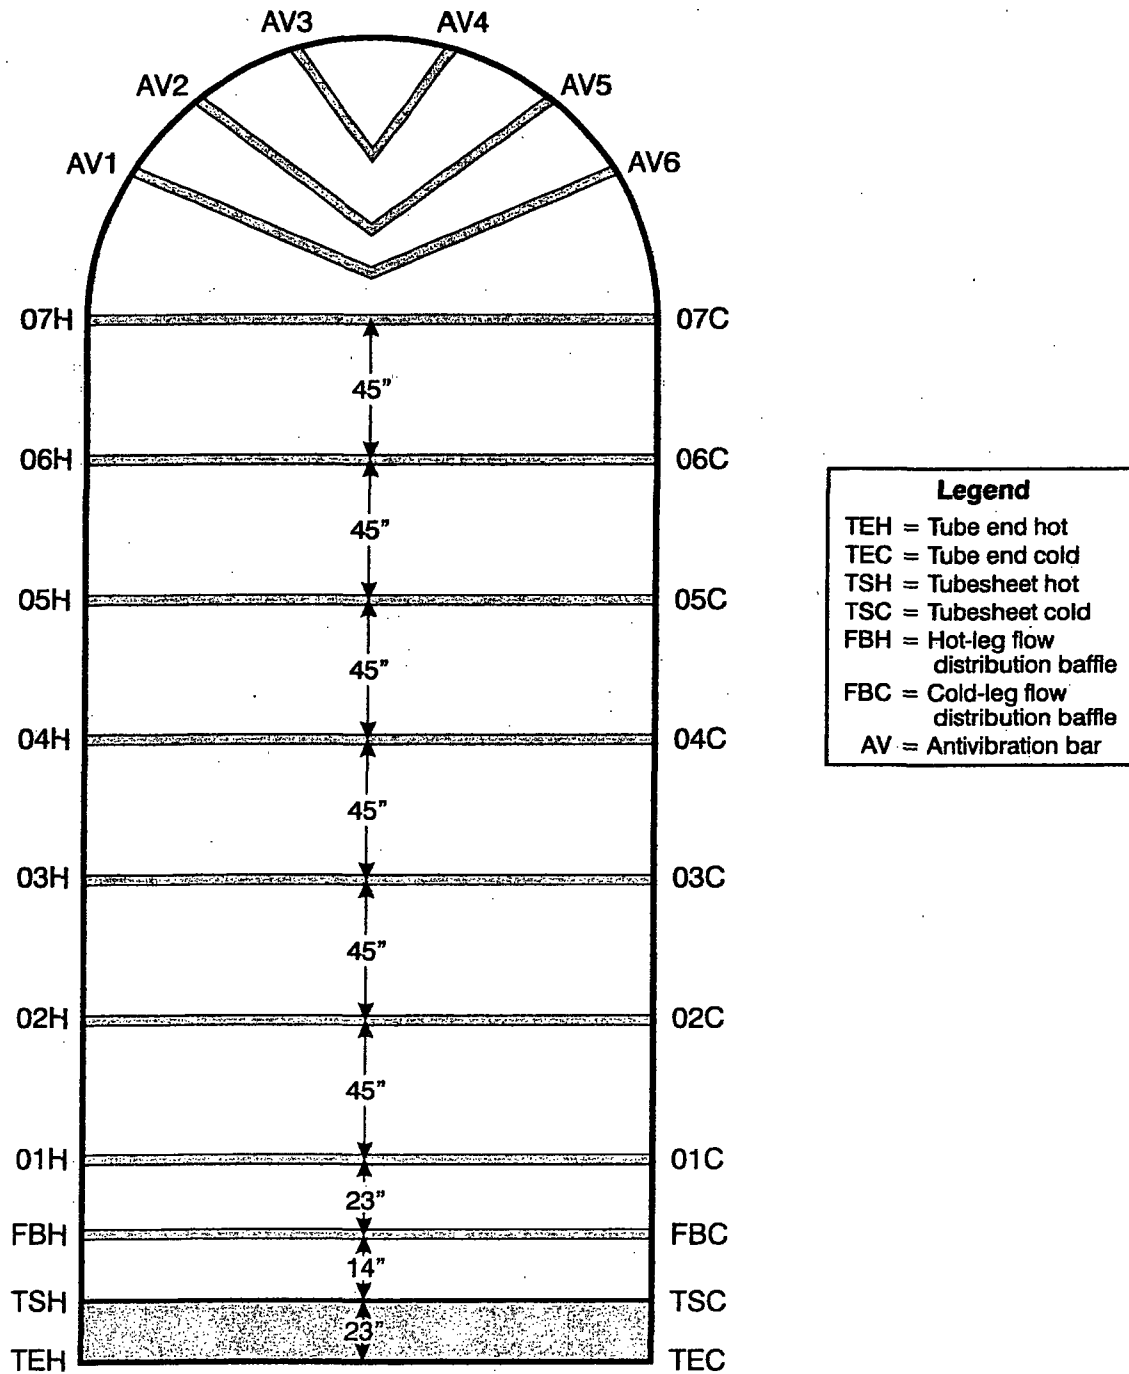
Figure 2-41: Tubesheet Map for Point Beach Unit 2

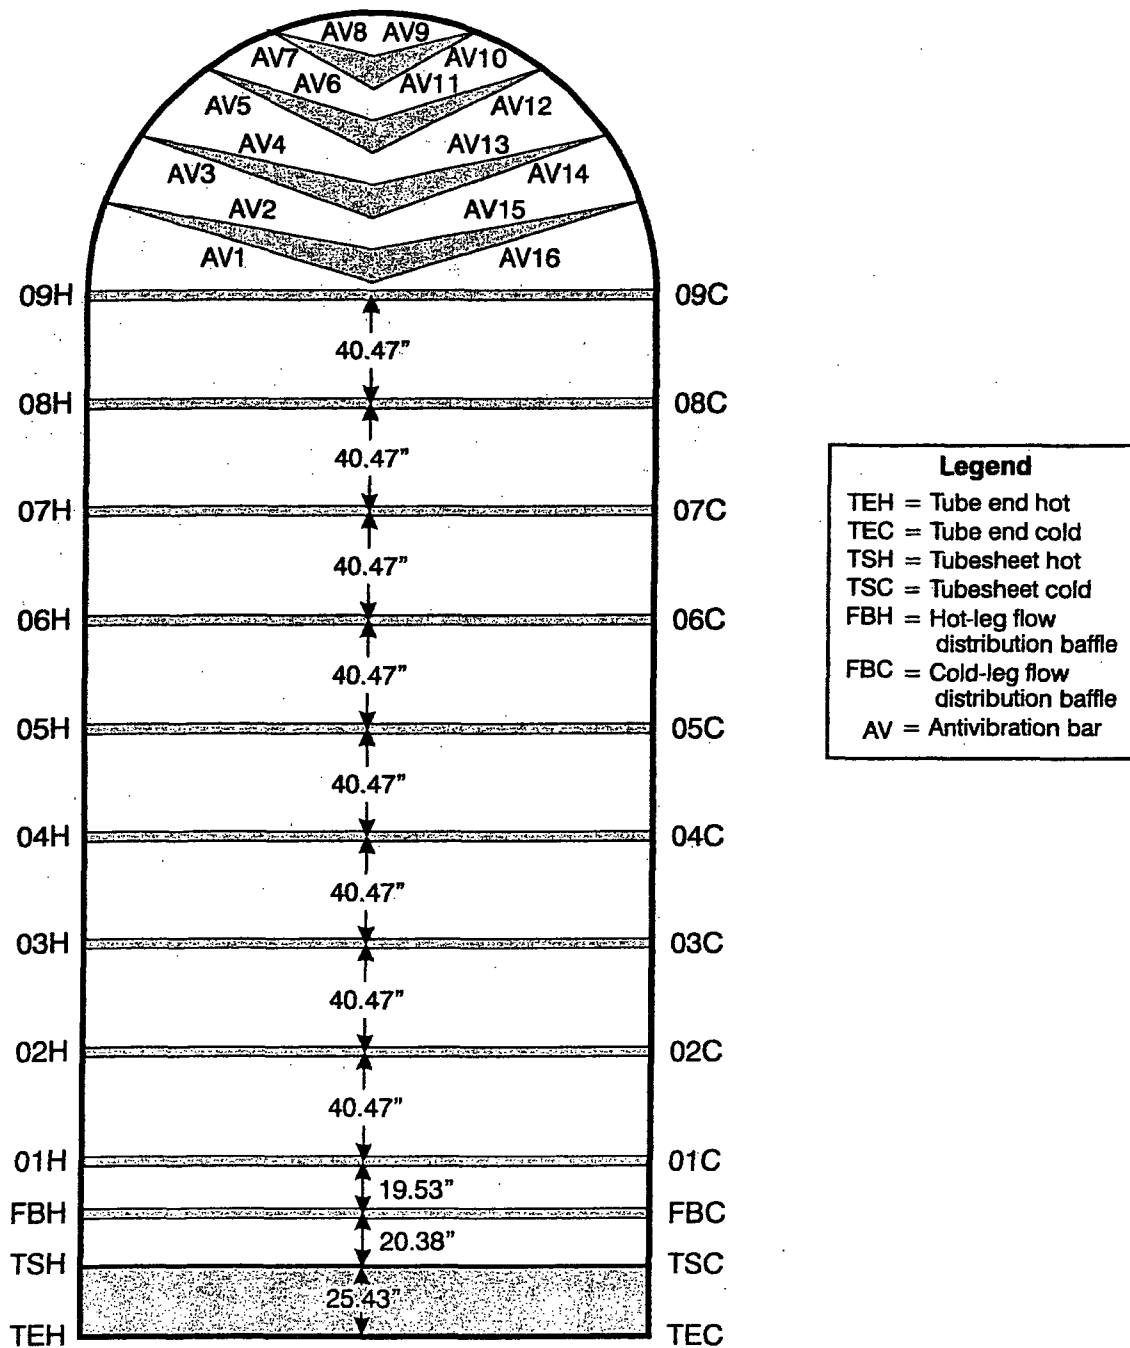
Figure 2-42: Tube Support Naming Convention at Point Beach Unit 2

Point Beach 2 has two recirculating steam generators designed and fabricated by Westinghouse. The model Delta 47 steam generators were put into service in 1997 during RFO 22. The licensee numbers its tube supports as depicted in Figure 2-42.

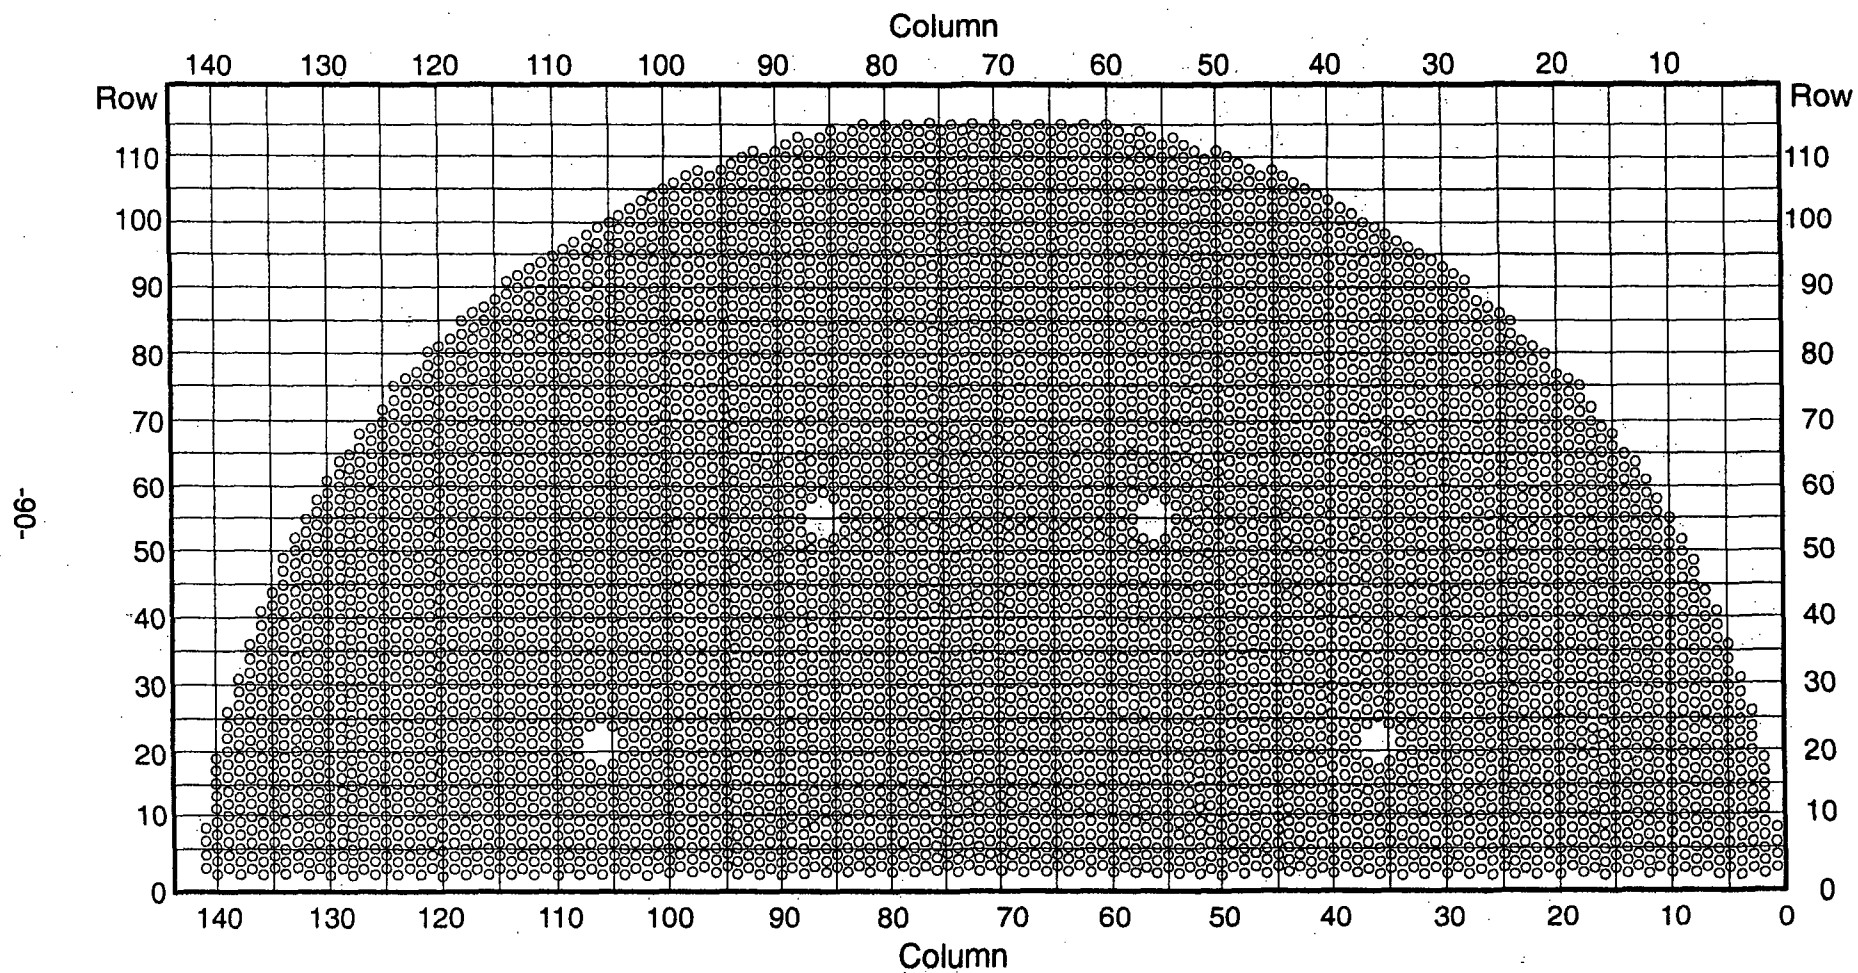
Figure 2-44: Tube Support Naming Convention at South Texas Project Units 1 and 2

The tubes were hydraulically expanded at each end for the full depth of the tubesheet. The tubesheet is 25.43 inches thick. The tubes are supported by a flow distribution baffle, support plates, and AVBs. All supports are constructed from Type 405 stainless steel. The flow distribution baffle has nonafoil shaped holes through which the tubes pass. The tube support plates have trifoil shaped holes through which the tubes pass. The AVBs are arranged in a "V" shape and are 0.480 inch thick. Figure 2-44 illustrates the tube support configuration and numbering.

South Texas Project 1 has four recirculating steam generators designed and fabricated by Westinghouse. The model D94 steam generators were put into service in 2000 during RFO 9. The licensee numbers its tube supports as depicted in Figure 2-44.

South Texas Project 2 has four recirculating steam generators designed by Westinghouse and fabricated by ENSA in Spain. The model D94 steam generators were put into service in 2002 during RFO 9. The licensee numbers its tube supports as depicted in Figure 2-44.

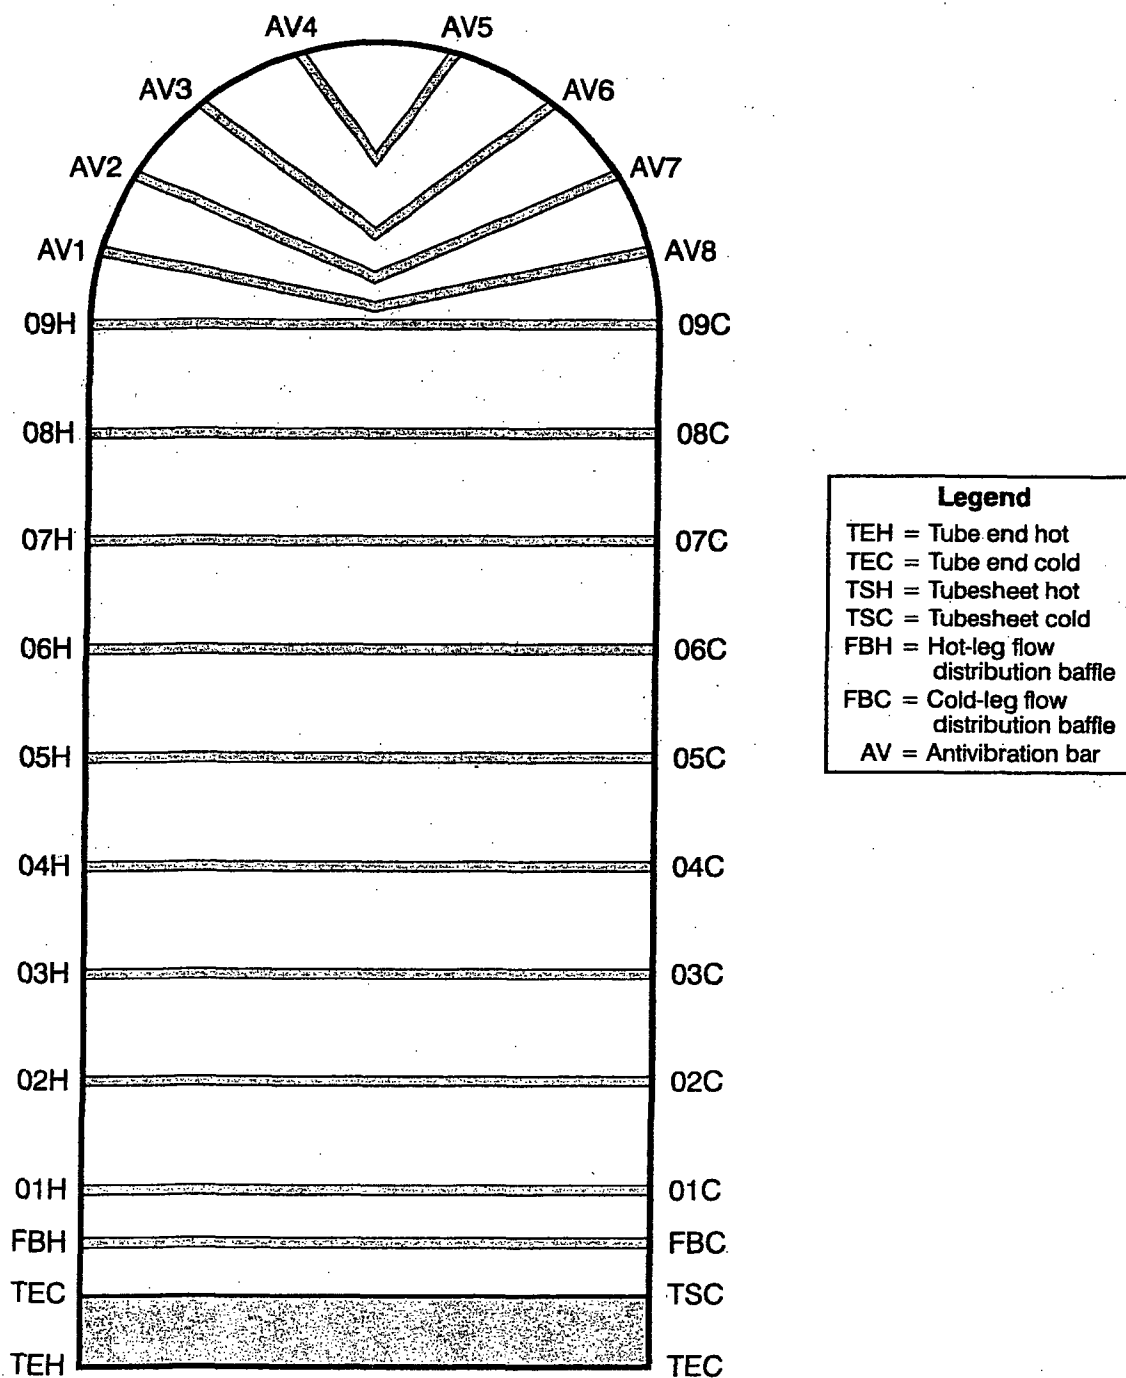
Figure 2-45: Tubesheet Map for Summer

Each steam generator has 6307 thermally treated Alloy 690 tubes that have an outside diameter of 0.6875 inch and a 0.040-inch nominal wall thickness. The tubes were manufactured by Sandvik and are arranged in a triangular pattern as illustrated in Figure 2-45 with a spacing of approximately 0.980 inch.

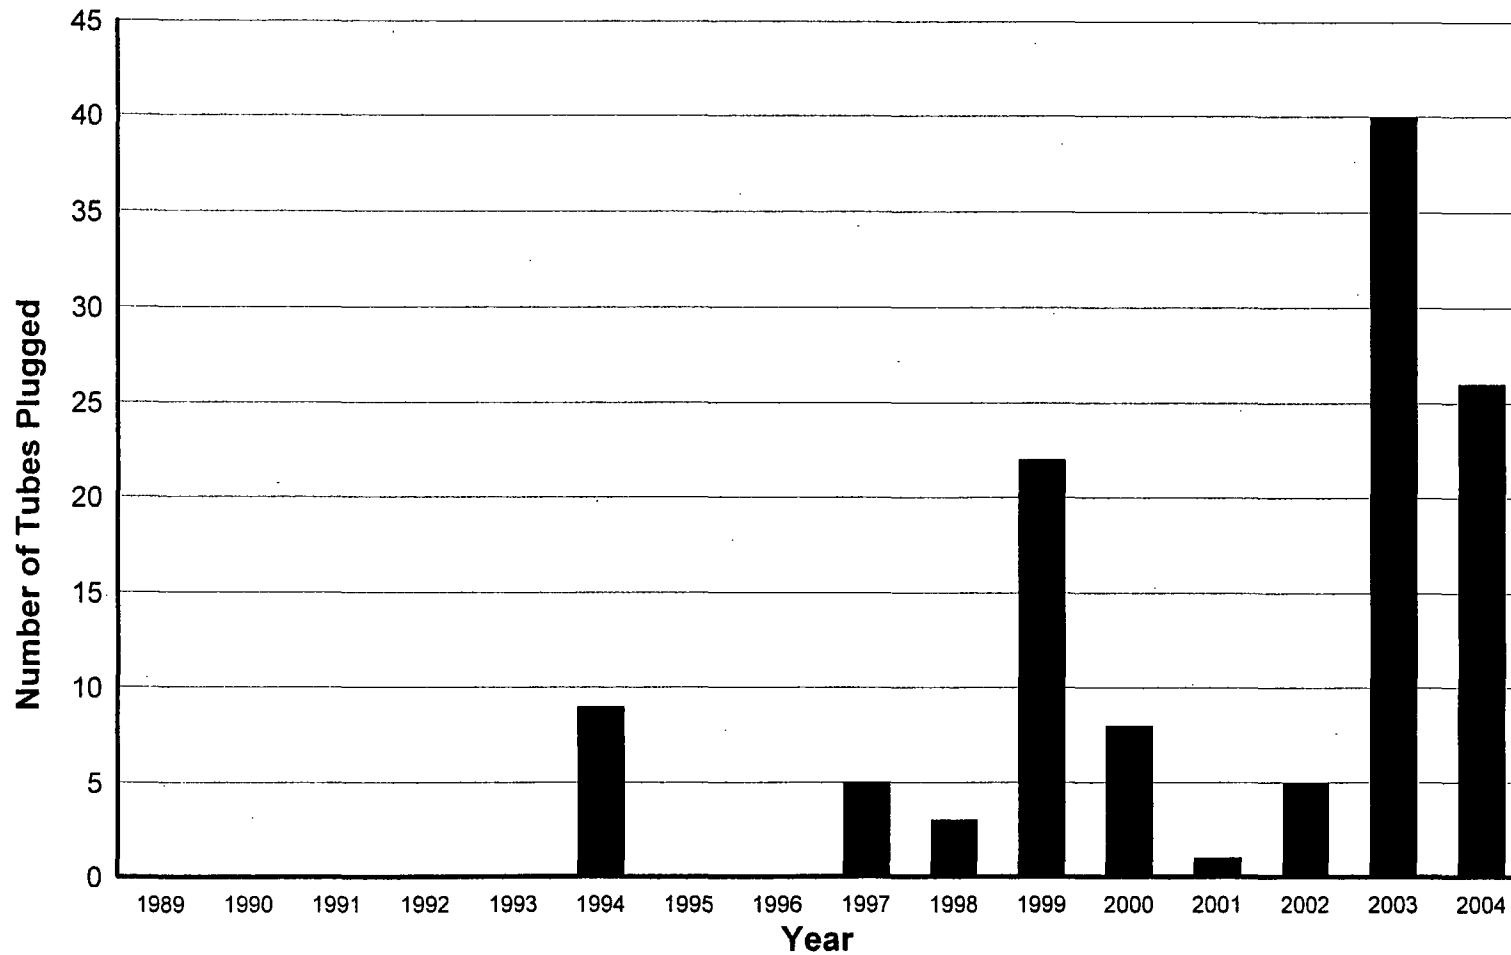
**Figure 4-1: Number of Tubes Plugged per Year
Preoperational Plugging Not Included**

As depicted in Figure 2-2, 577,070 thermally treated Alloy 690 tubes were placed in service at 30 units between 1989 and 2004. Cumulatively, these 30 units have operated for approximately 173 calendar years and for an average of 6 calendar years each (as of December 2004). Of the 577,070 tubes in these units, only 333 tubes (0.06 percent) have been plugged. Table 4-1 summarizes the number and percentage of tubes plugged at the 30 units with thermally treated Alloy 690 tubes. Figures 4-1 and 4-2 depict the total number and percentage, respectively, of tubes plugged in units with thermally treated Alloy 690 tubes as a function of year. These figures were developed from the data provided in Tables 4-2 and 4-3.

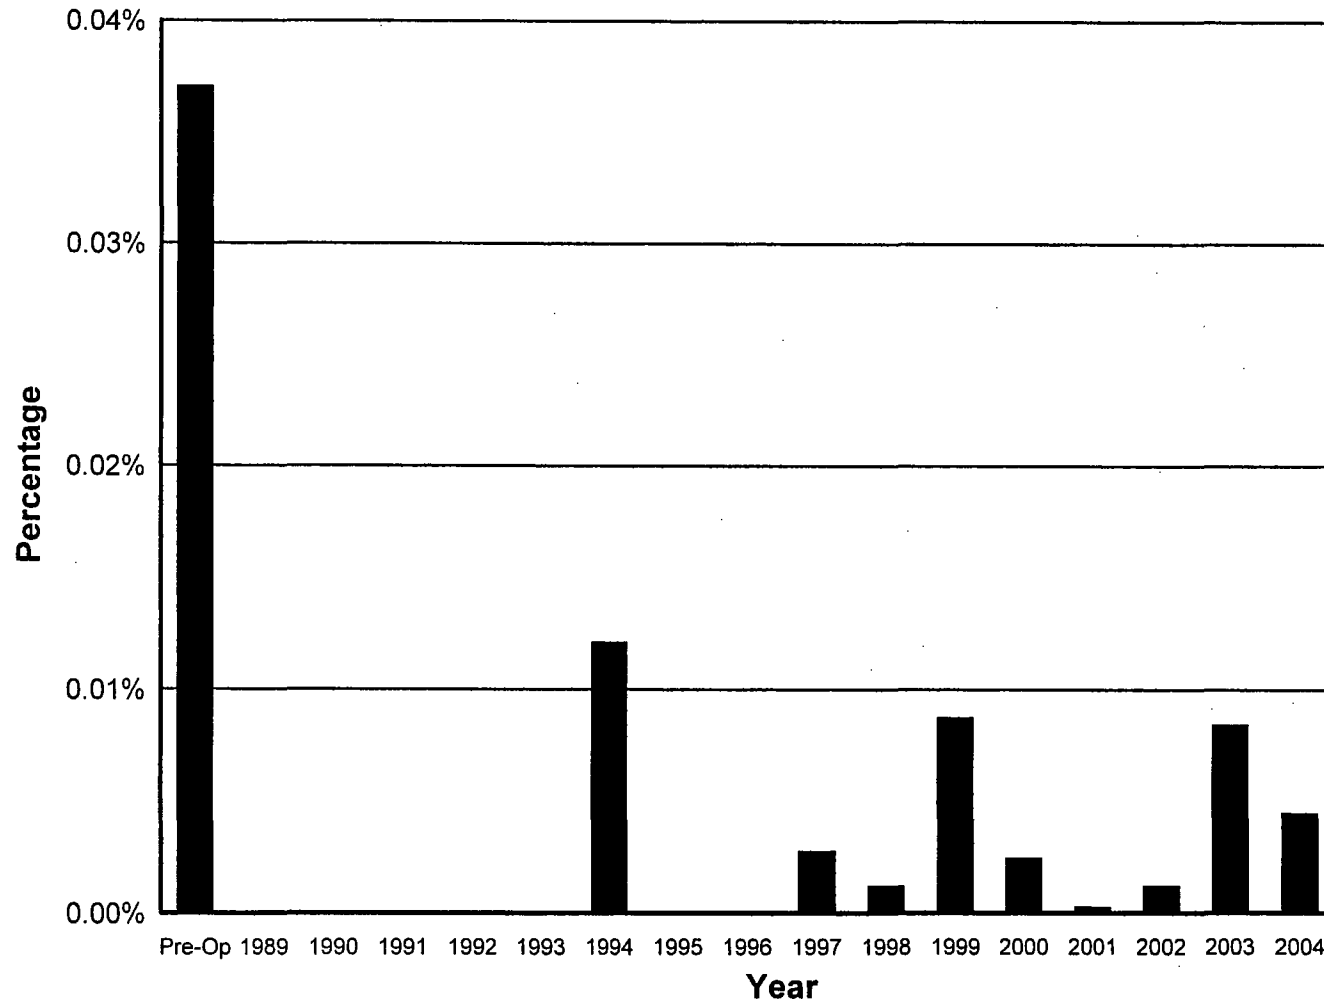
Figure 4-2: Percentage of Tubes Plugged per Year

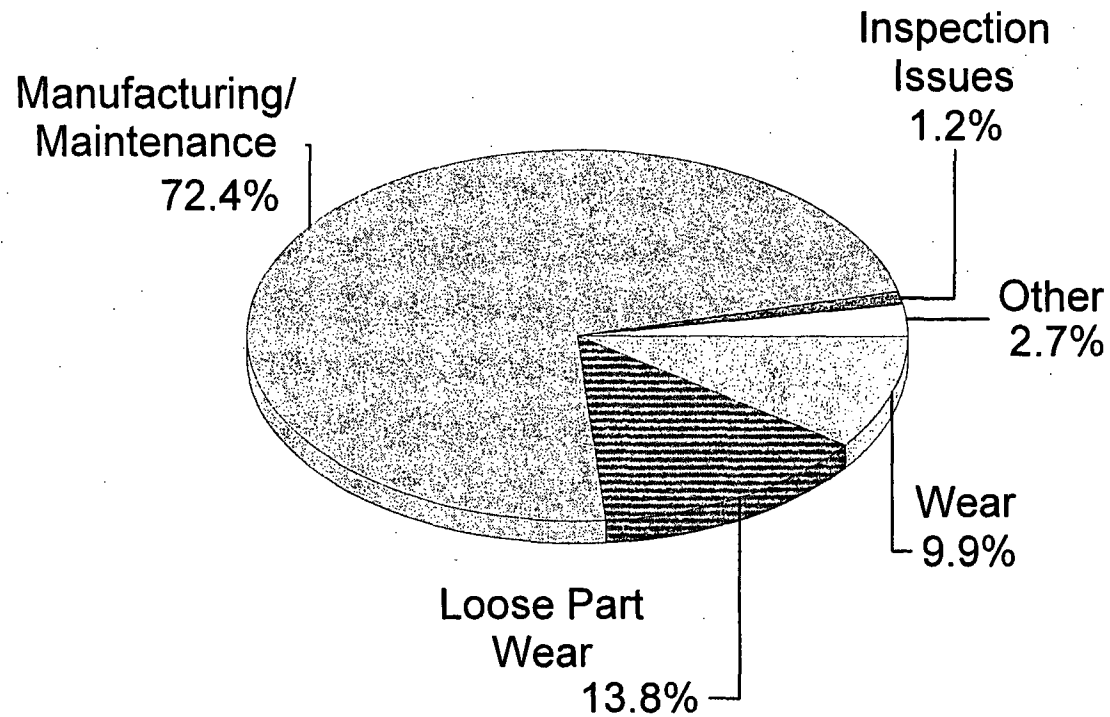
Figure 4-3: Causes of Tube Plugging

Table 4-4 summarizes the number of tubes plugged as a function of the degradation mechanism. Figure 4-3 graphically depicts the information in this table. As this table and figure show, the dominant degradation mode (excluding manufacturing and maintenance reasons) of thermally treated Alloy 690 tubes is wear. Of the 333 tubes plugged, approximately 24 percent were plugged as a result of tube wear. Tube wear occurs as a result of contact between the tube and a support structure (e.g., an antivibration bar (AVB)) or a foreign object (e.g., a loose

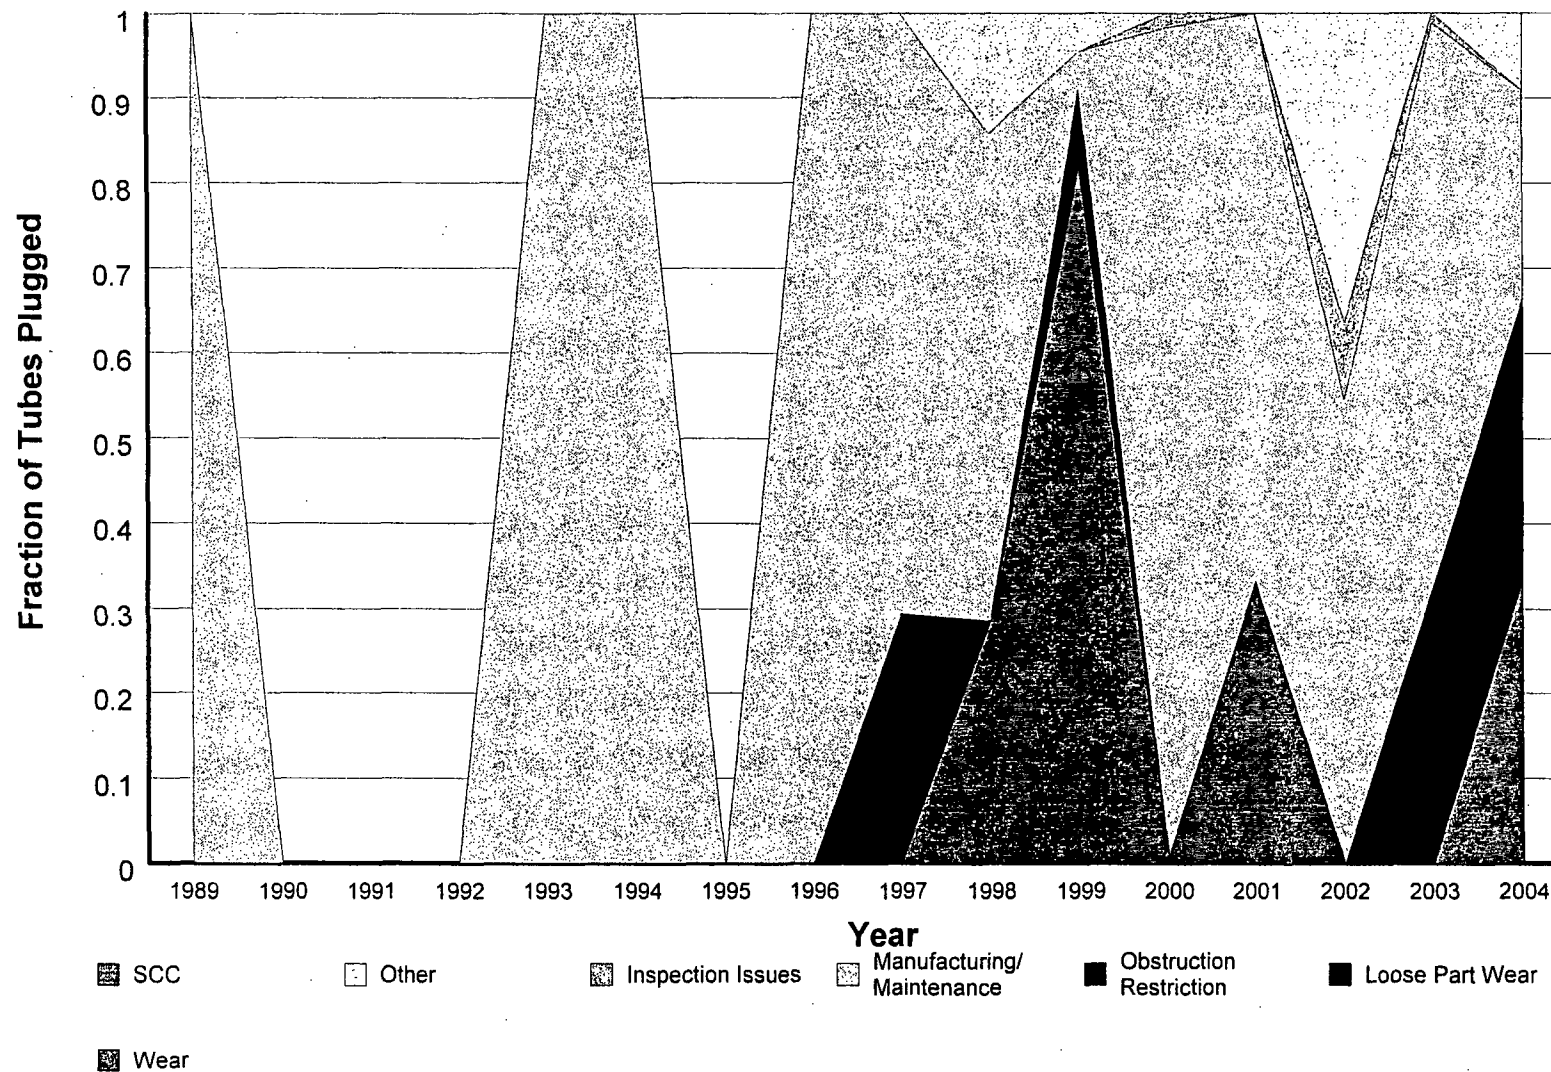
Figure 4-4: Causes of Tube Plugging per Year

Developed from data in Tables 4-5, 4-6, and 4-7, Figure 4-4 depicts the fraction of tubes plugged for a specific mechanism as a function of year. In this figure, tubes plugged before the steam generators went into commercial operation were treated as being plugged during the year the steam generator began commercial operation (in previous tables and figures in this report, these tubes were treated as a distinct group independent of the actual year/outage in which they were plugged).
