Invensys Response to Request for Additional Information (RAI)

Ref: Letter dated December 8, 2010, NRC to Invensys

RAI No. 1: RXM Safety/Non-safety Interface versus Interim Staff Guidance (ISG)-4

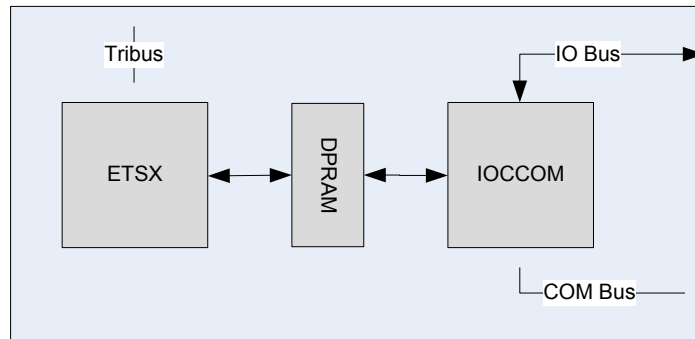
The 3008N Main Processor module consists of three main subsystems as shown in the figure below:

Each subsystem consists of a microprocessor and memory subsystem. The ETSX (Enhanced Triconex System Executive) is responsible for running the user defined application program on the Application Processor. The IOCCOM Processor is responsible for communications with the I/O modules in the system and the Tricon communications modules (TCM). The DPRAM provides the interface between the ETSX and IOCCOM. The DPRAM is divided into several sections:
