Subject: **COLUMBIA GENERATING STATION, DOCKET NO. 50-397
RESPONSE TO REQUEST FOR ADDITIONAL INFORMATION
LICENSE RENEWAL APPLICATION**

Transmitted herewith in the Attachment is the Energy Northwest response to the Request for Additional Information (RAI) contained in Reference 2. Enclosure 1 contains Amendment 42 to the Columbia License Renewal Application. One revised commitment is included in this response.

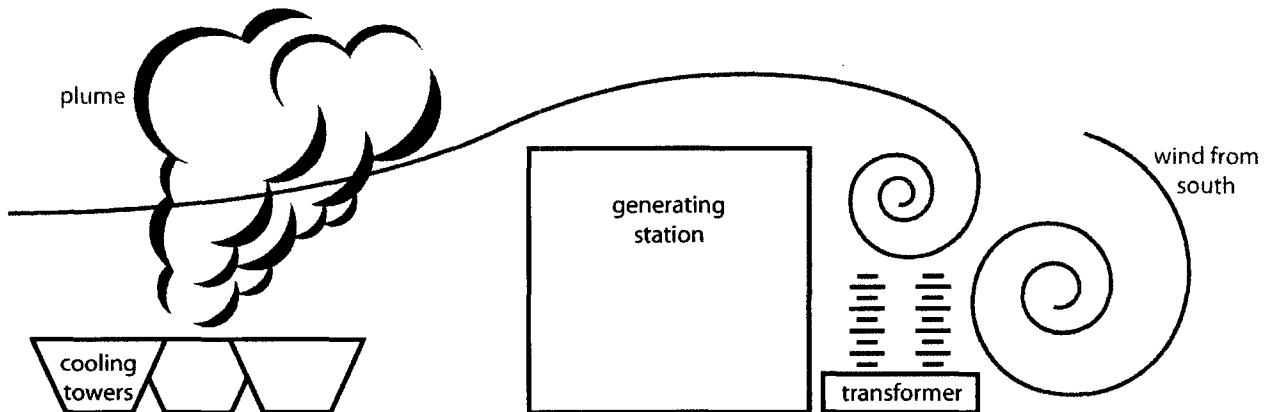
quarter mile north of the main plant. As the drift droplets move northward towards the plant, wind dynamics experienced, as the droplets are carried over the generating station, force much of the droplets down onto the transformer yard, thus making this area the most vulnerable to scintillation. Figure 1 illustrates the effect.

Figure 1: Droplet fallout settling on transformer yard

Under worst-case conditions, the drifting droplets created conditions conducive to arcing in the station's transformer yard. This arcing occurred when a sufficient layer of conductive substances built up on the insulators, became wetted, and formed an electrical track. Columbia Generating Station collects its cooling water from the Columbia River, which it then buffers with various chemicals to temper the water for use in the plant. Thus, the substances found in the drift droplets of the cooling tower are chemical species found naturally in the river, those added to buffer the water, those that form from decomposition of original buffers, and trace minerals and metals from the cooling system. The result is a layer of anions and cations that once settled on the surface of insulators present a prime opportunity for insulator failure.
