SEABROOK STATION UPDATED FINAL SAFETY ANALYSIS REPORT	Containment Structure Mat Reinforcing [2 Sheets]	
		Figure 3.8-1 Sh. 1 of 2

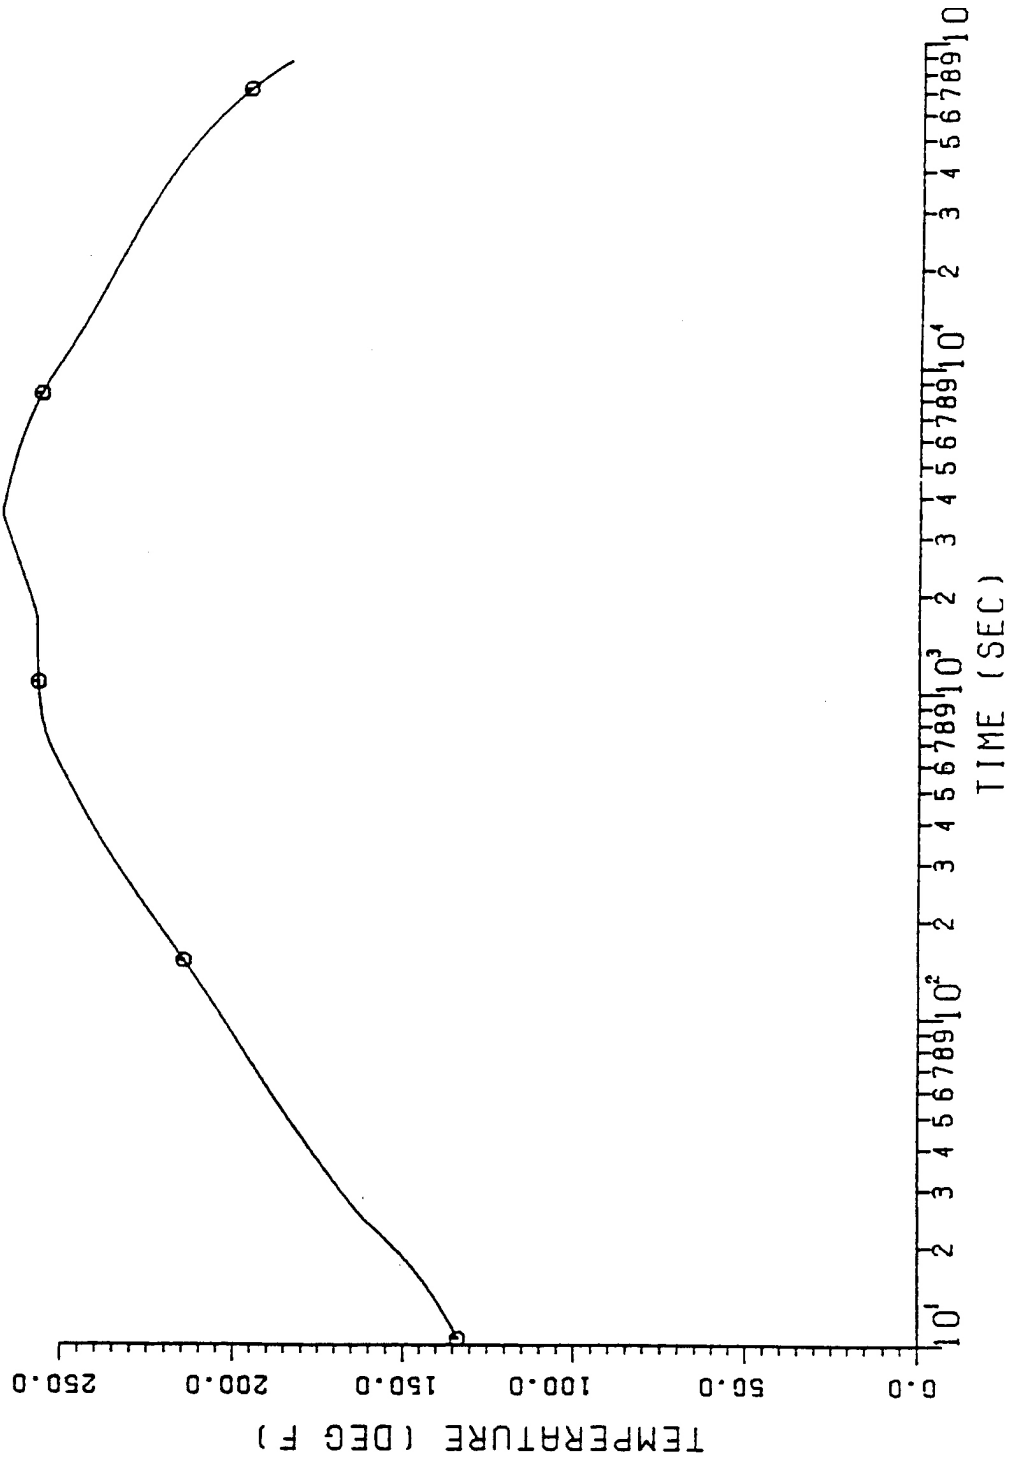
SEABROOK STATION UPDATED FINAL SAFETY ANALYSIS REPORT	Containment Dome Liner Temperature Transients Curve	
		Figure 3.8-11

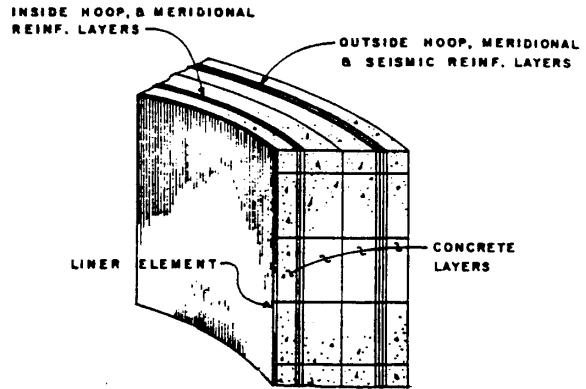
TYPICAL SECTION THROUGH
REINFORCED CONCRETE WALL

EQUIVALENT LAMINATED
CONTAINMENT WALL

IDEALIZED MATERIAL MODEL

CONCRETE CRACKING PLANES AND
ASSOCIATED COORDINATE DIRECTIONS

SEABROOK STATION UPDATED FINAL SAFETY ANALYSIS REPORT	Reinforced Concrete Idealization	
		Figure 3.8-13

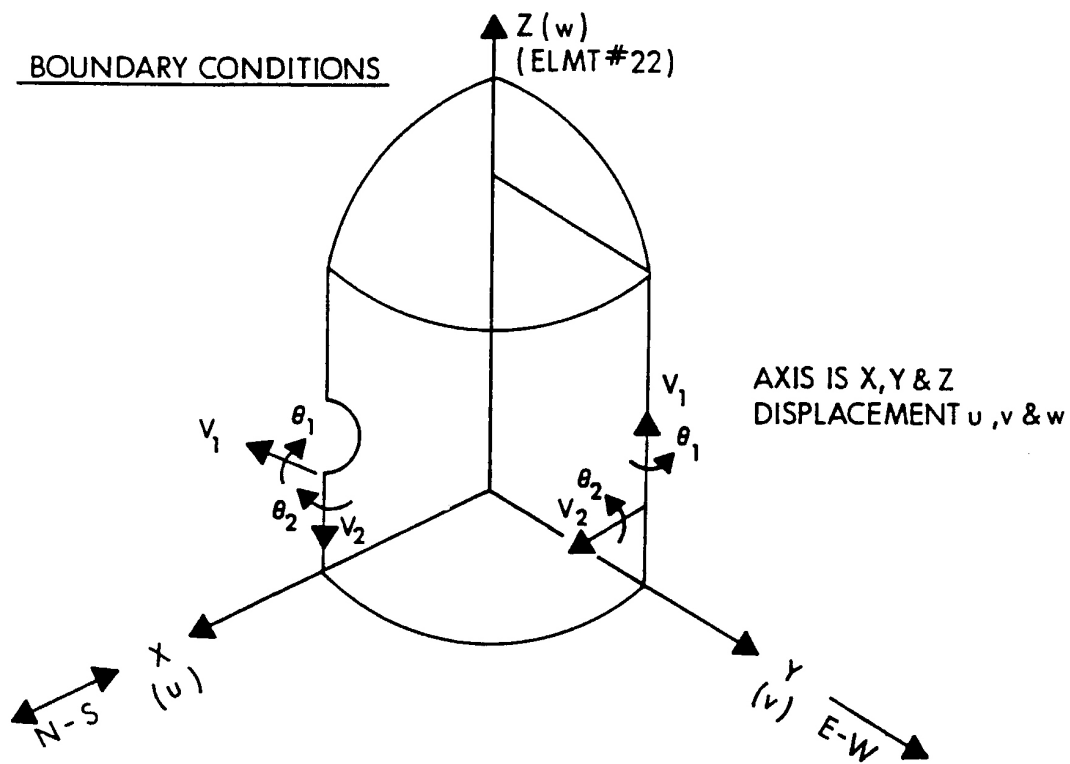
SEABROOK STATION UPDATED FINAL SAFETY ANALYSIS REPORT	Boundary Conditions for Equipment Hatch Analysis - Model Sketch	
		Figure 3.8-14

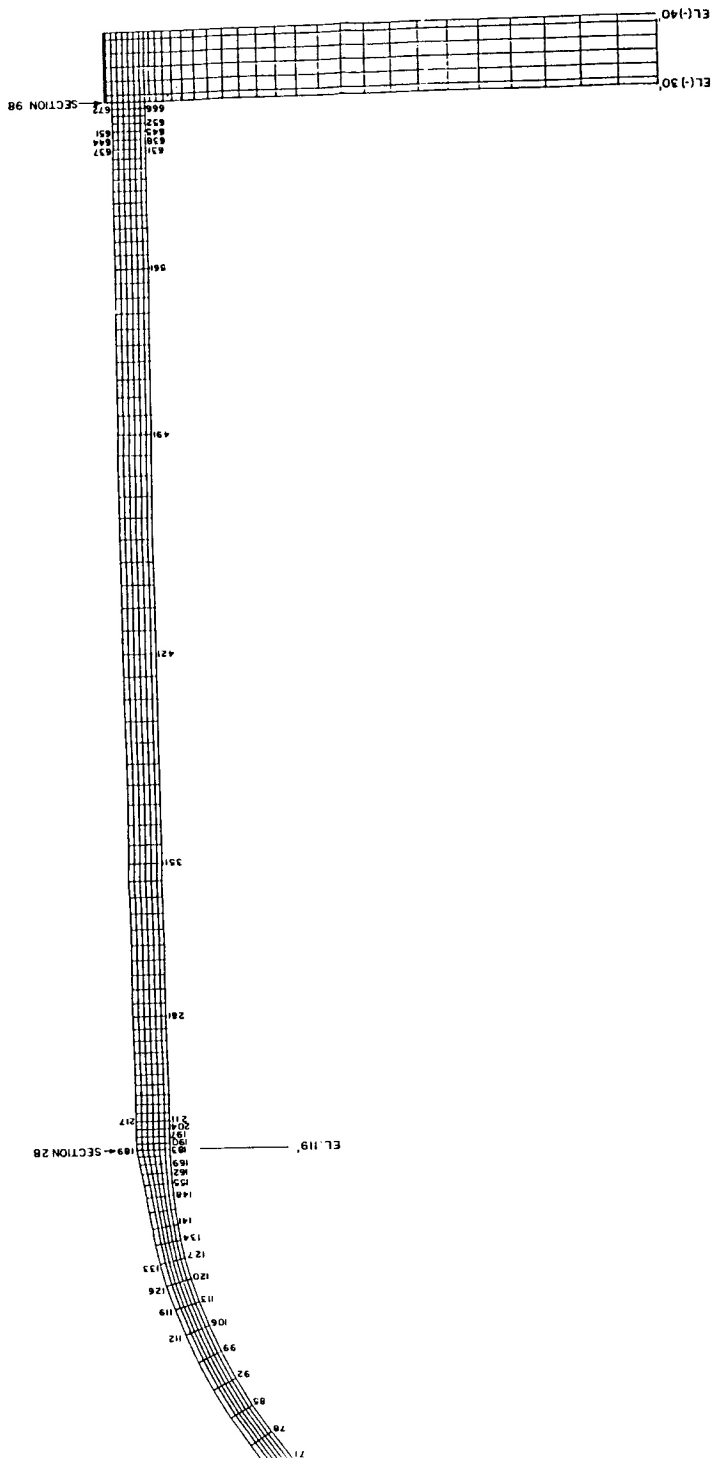
SEABROOK STATION UPDATED FINAL SAFETY ANALYSIS REPORT	Containment Axisymmetric Model	
		Figure 3.8-16

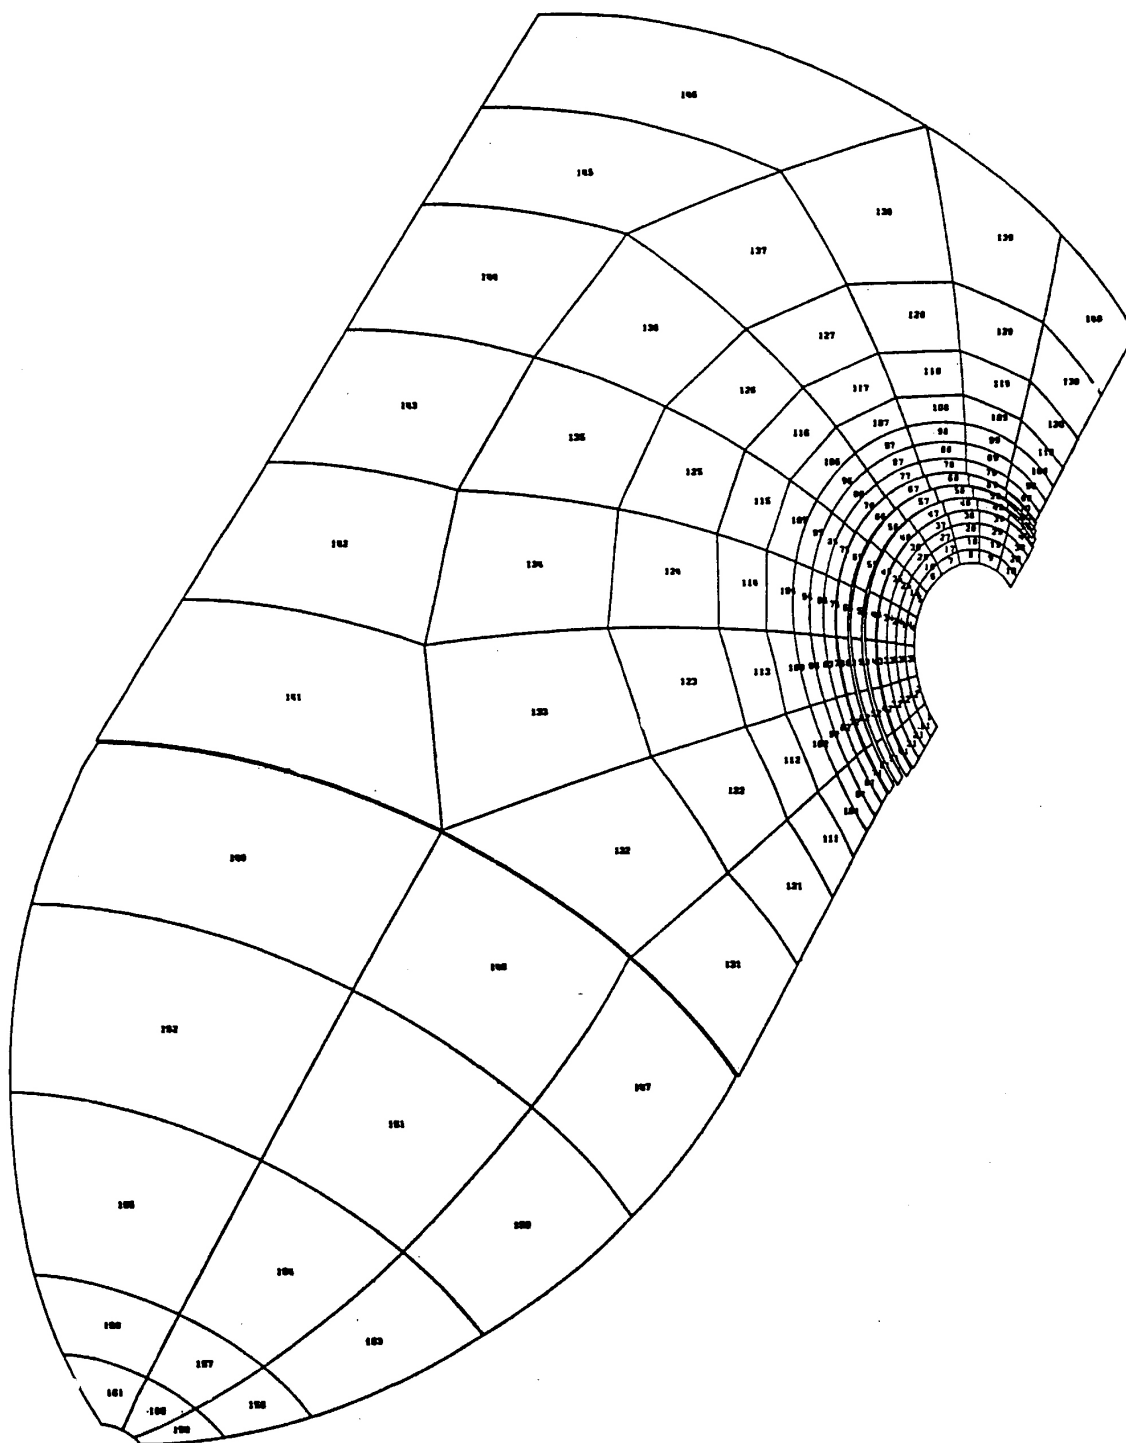
SEABROOK STATION UPDATED FINAL SAFETY ANALYSIS REPORT	Three-Dimensional Finite Element Model for Equipment Hatch Analysis	
		Figure 3.8-17

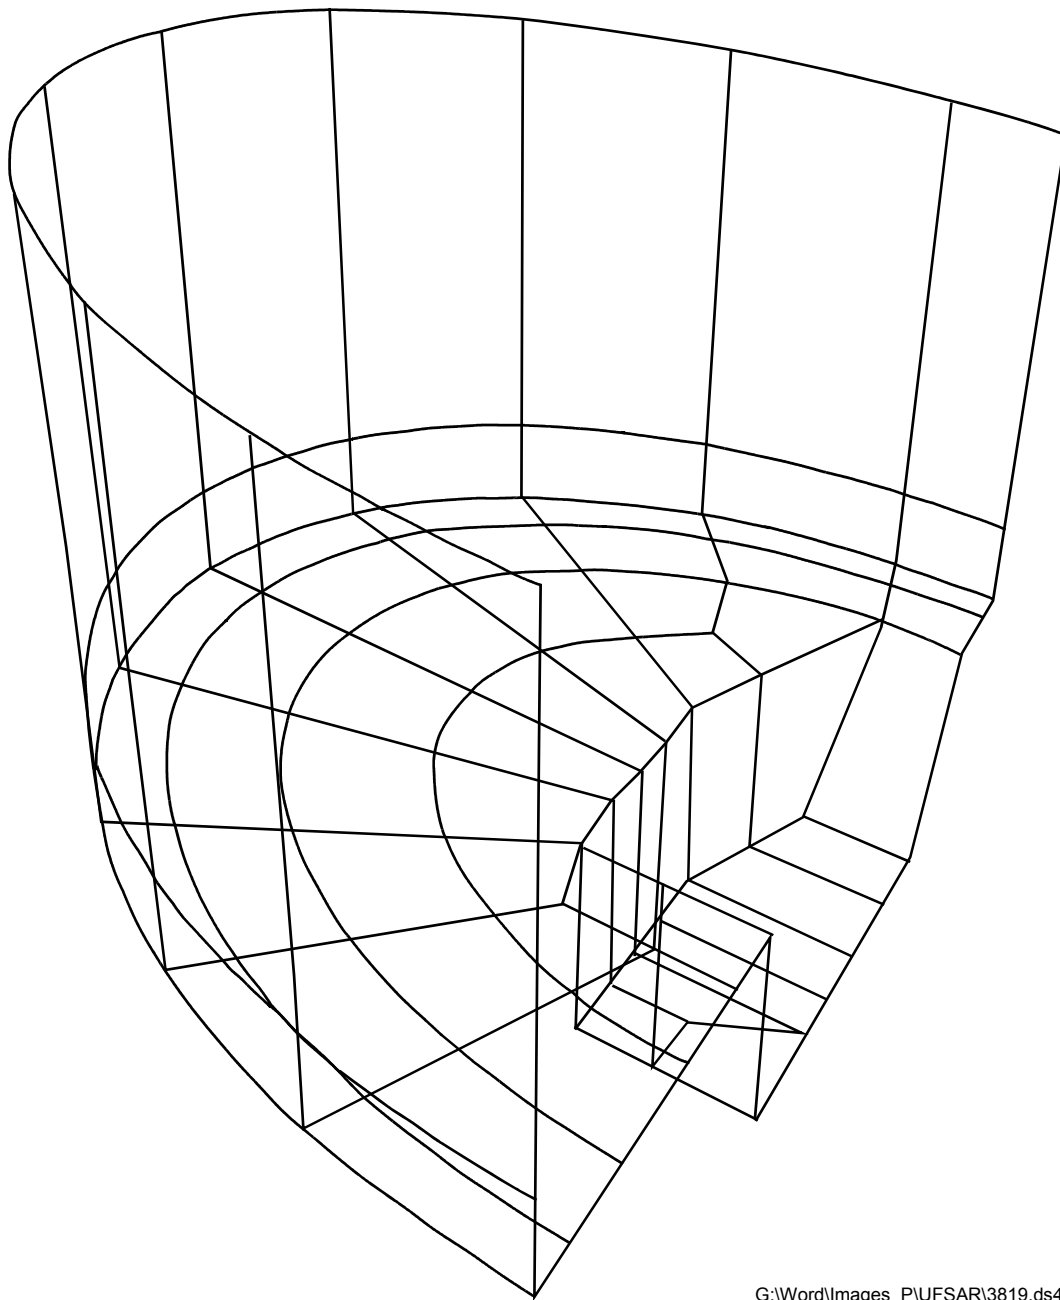
SEABROOK STATION UPDATED FINAL SAFETY ANALYSIS REPORT	Finite Element Model of Containment Mat	
		Figure 3.8-19

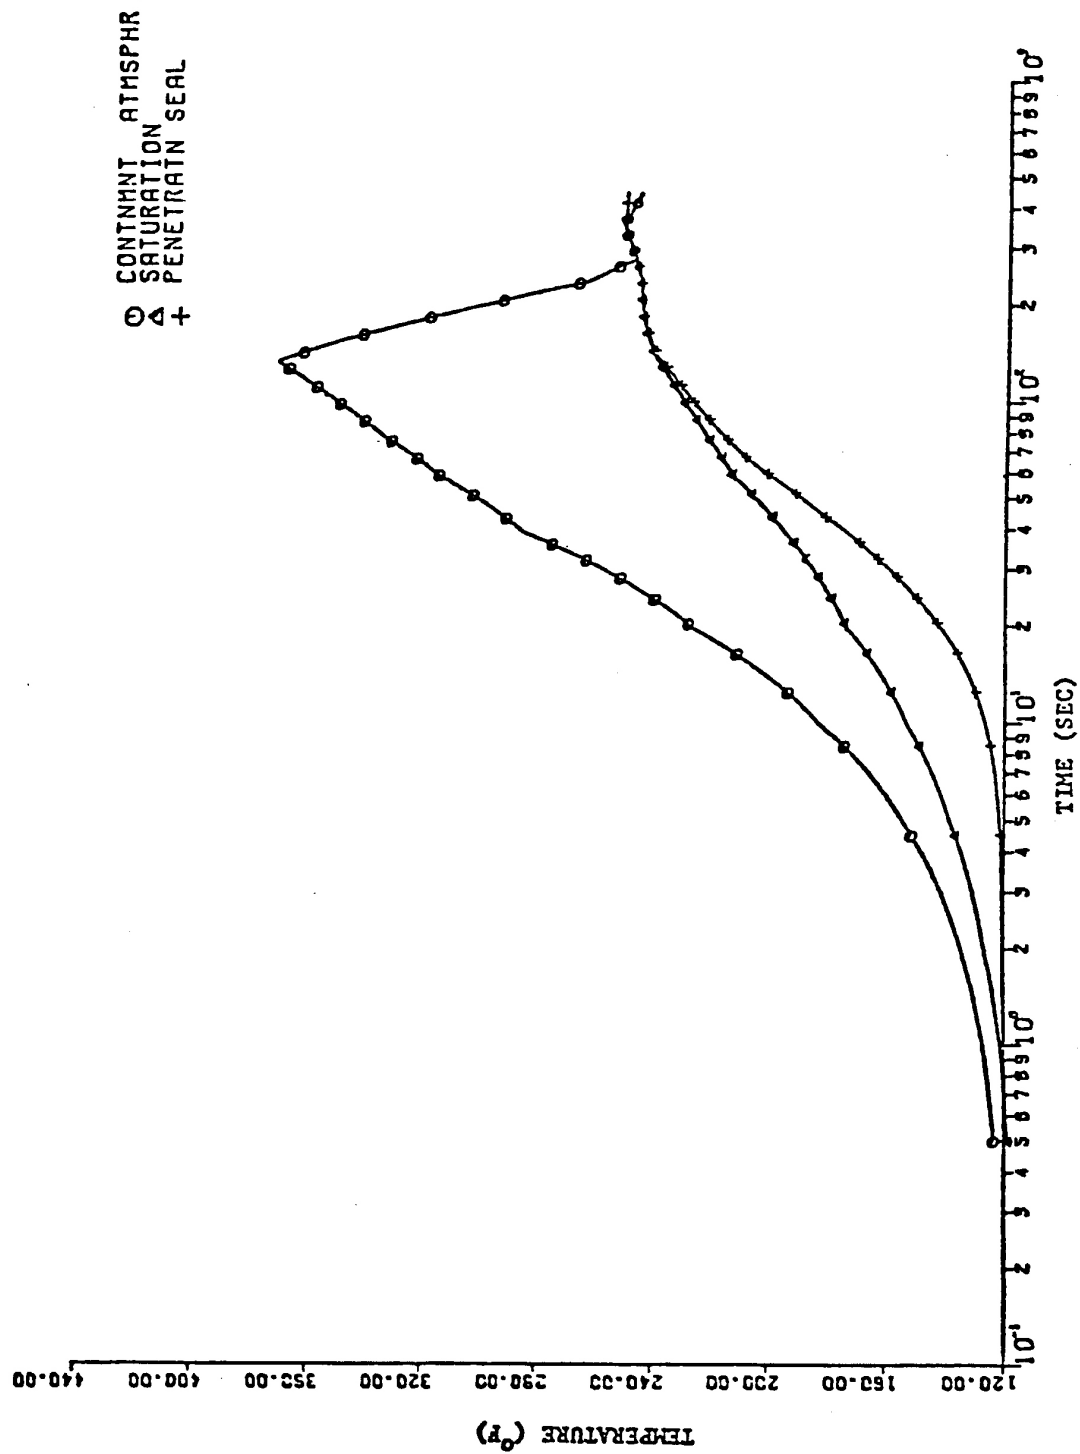
SEABROOK STATION UPDATED FINAL SAFETY ANALYSIS REPORT	Electrical Penetration Seal Temperature Response Following 0.84 ft ² Split Rupture at 75% Power	
	Figure	3.8-27

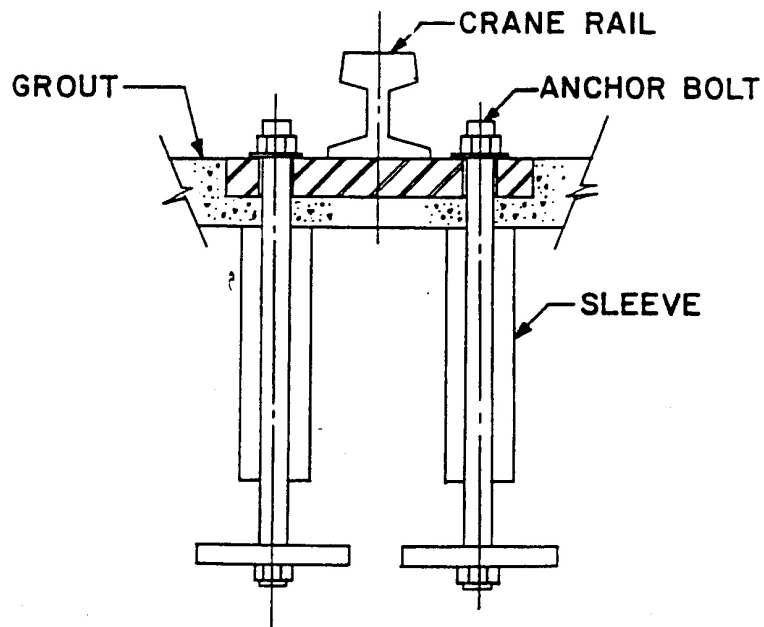
SECTION THROUGH CLAMP PLATES

SECTION THROUGH ANCHOR BOLTS

NOTE: CLAMP PLATES AND KICK-BACK PLATES ARE ALTERNATELY SPACED 9" CENTER TO CENTER.

SEABROOK STATION UPDATED FINAL SAFETY ANALYSIS REPORT	Design of Kick-Back Plate, Clamp Plate, Base Plate and Anchor Bolts for Polar Crane	
		Figure 3.8-30
