NUCLEAR REGULATORY COMMISSION

Title: Advisory Committee on Reactor Safeguards
595th Meeting

Date: Thursday, June 7, 2012

H.B. Robinson – Automatic Reactor Trip and Safety Injection with Fires

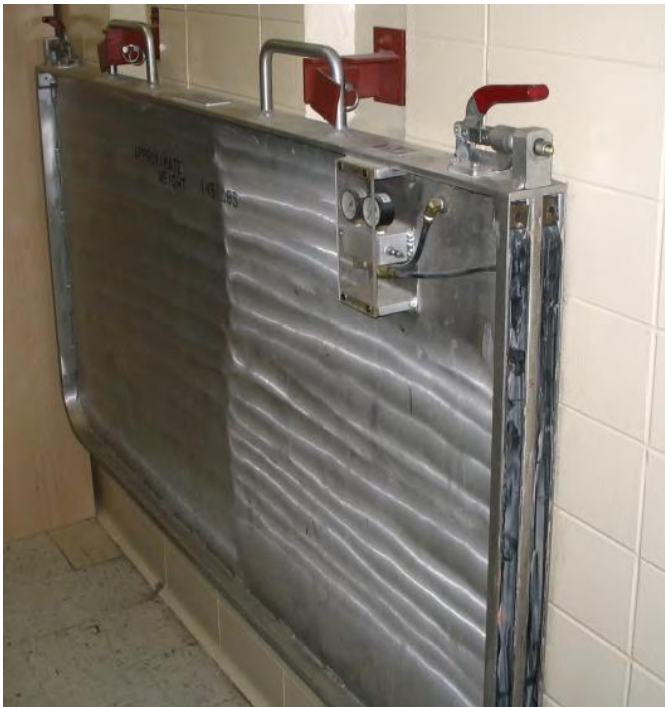
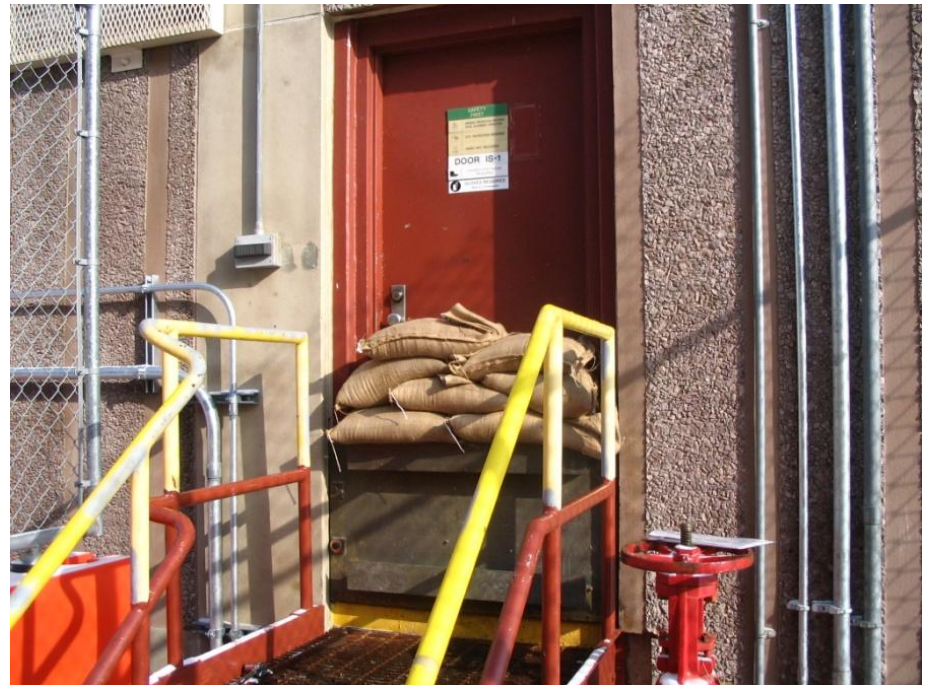
Yellow finding during 2009 FCS Component Design Basis Inspection (CDBI)

- Deficiencies protecting structures above 1,008 ft msl
- Buildings not adequately sealed
- Sandbagging equipment and procedures inadequate

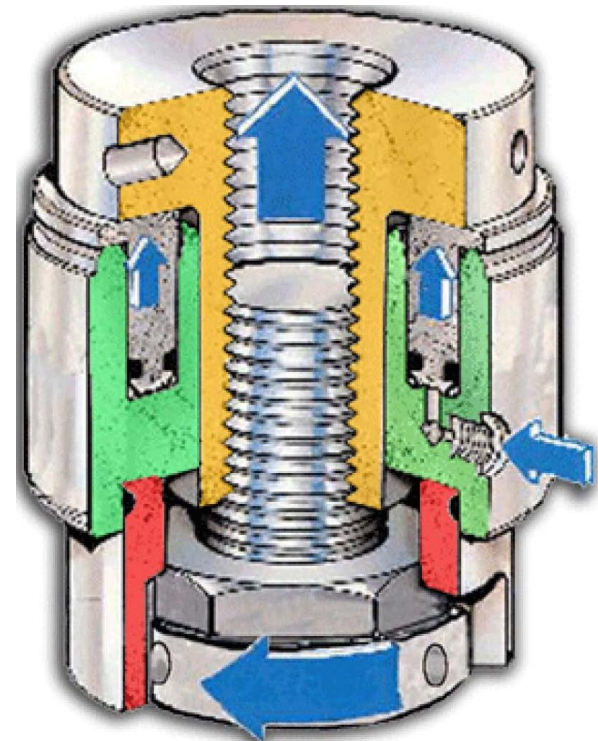
Hydraulic Tensioning - Overview

- Initial stud length measured to provide a reference
- Hydraulic tensioning
- Final stud elongation measured
 - 0.045 ± 0.004 inches
(41-49 mils)

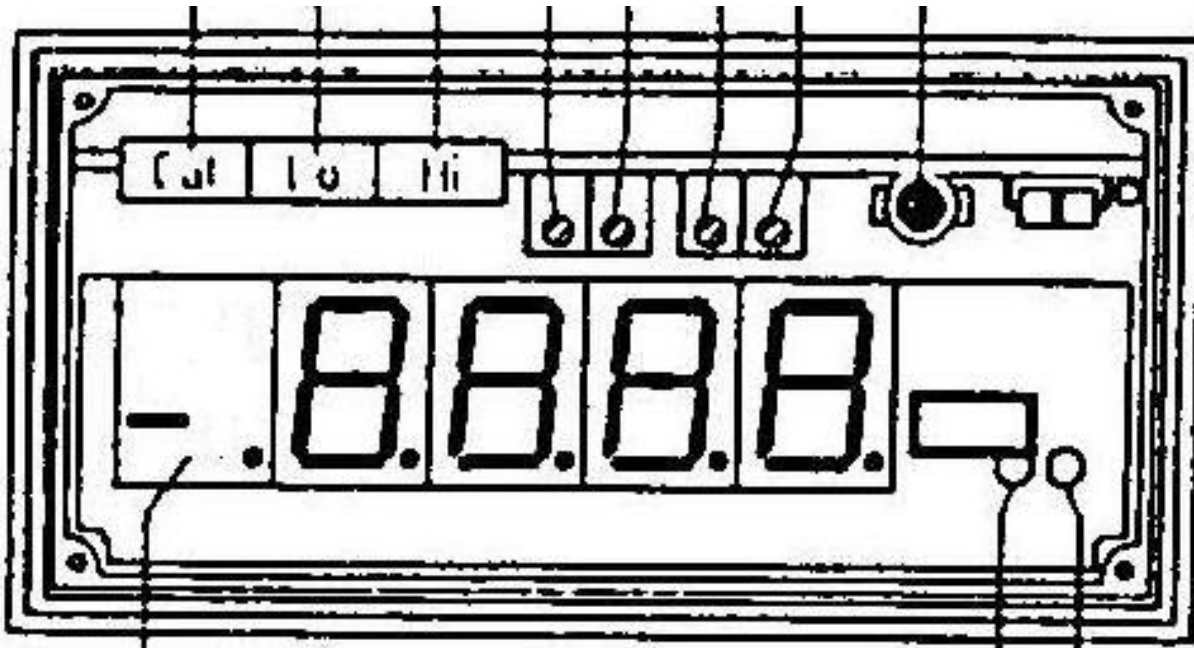
Hydraulic Tensioner Display

- Personnel misinterpreted the readings on the hydraulic tensioner
 - Instead of applying the required 13,000 psi, the operators only applied 1,300 psi

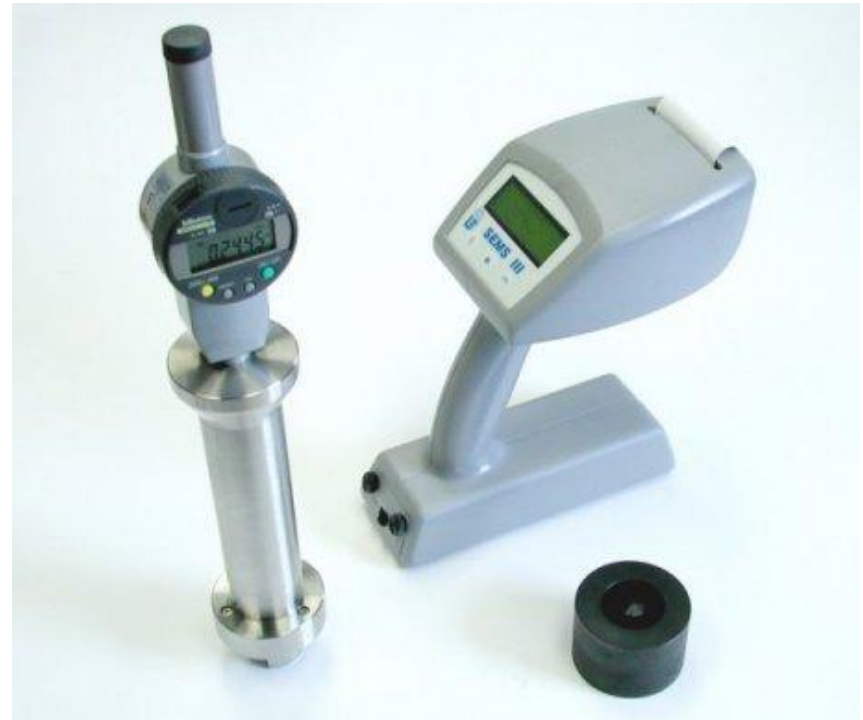
Stud Elongation Measurement

- Personnel misunderstood the readings on the SEMS III
 - Elongations were documented to be ≤ 0.004 inches (4 mils)
 - Personnel rationalized unexpected readings
