PSEG Power, LLC

PSEG Site ESPA
Part 2, Site Safety Analysis Report

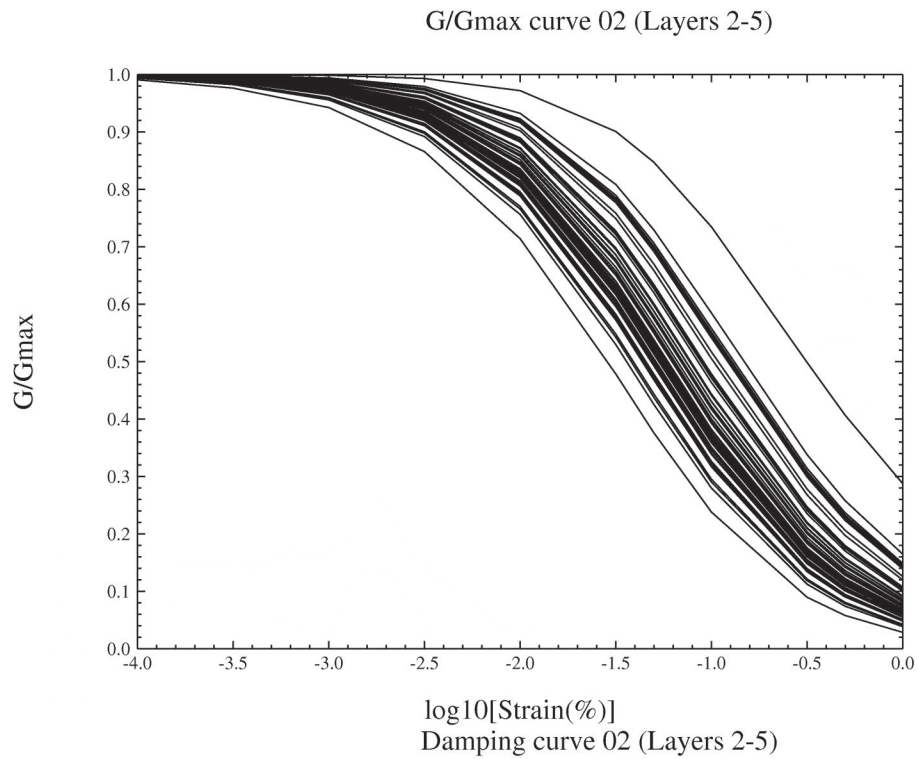
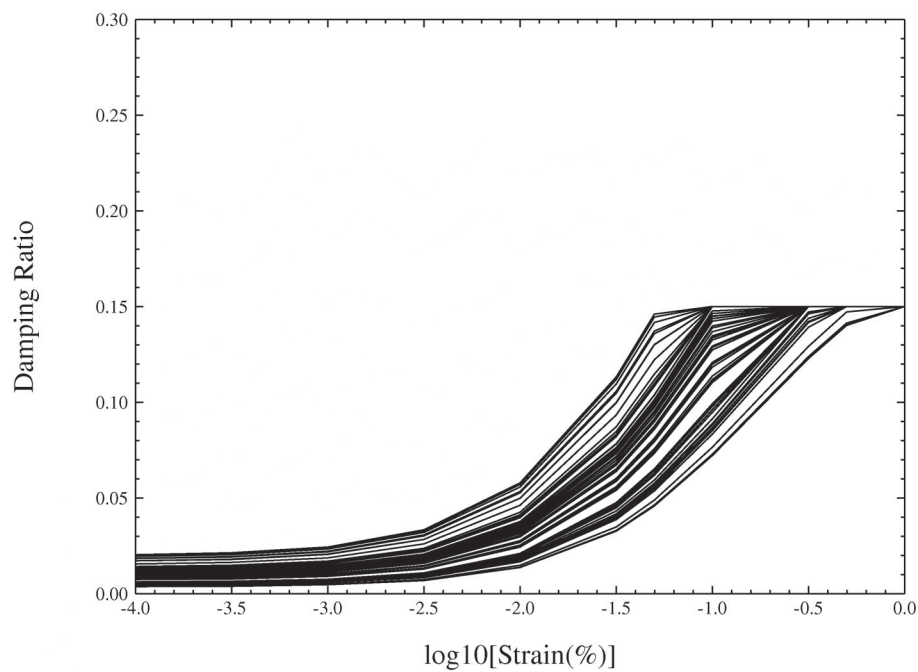
FIGURE 2.5.2-38

Synthetic Modulus and Damping
Degradation Curves for Soil
Layers 2 through 5
