**FENOC’S ANSWER OPPOSING INTERVENORS’ THIRD AND FOURTH MOTIONS
TO AMEND AND/OR SUPPLEMENT PROPOSED CONTENTION NO. 5 (SHIELD
BUILDING CRACKING)**

Shield Building Crack Investigation and Root Cause Presentation

Davis-Besse Nuclear Power Station

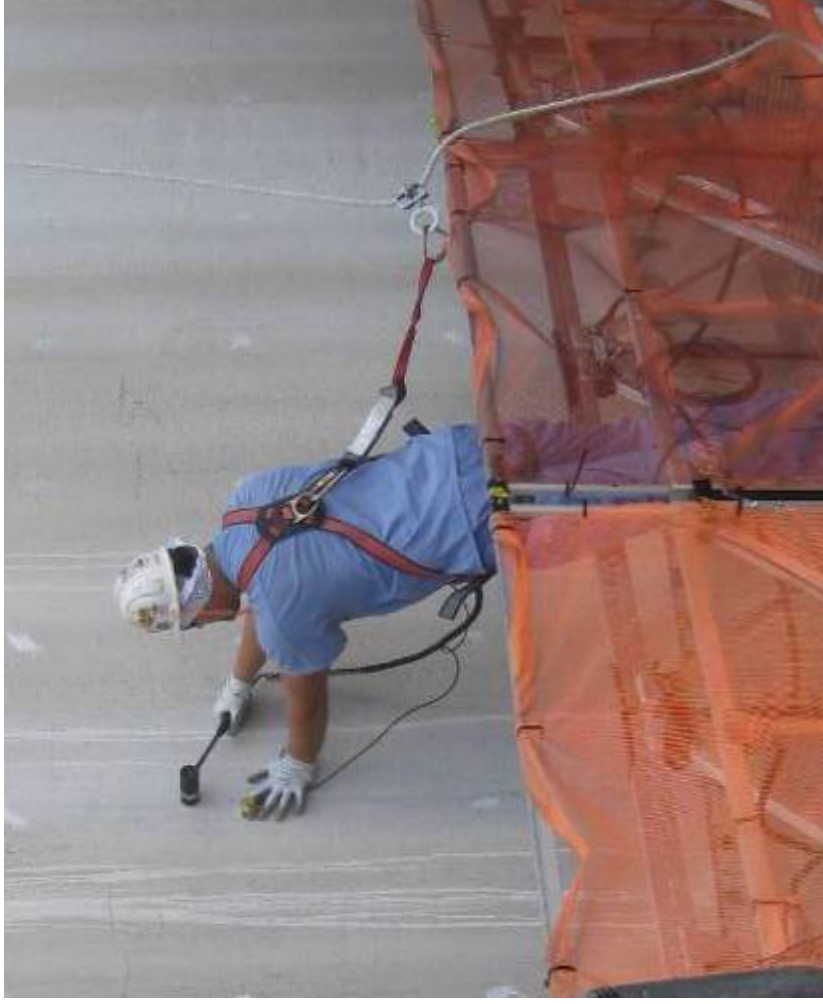
- Impulse Response (IR) testing methodology used to investigate extent of crack

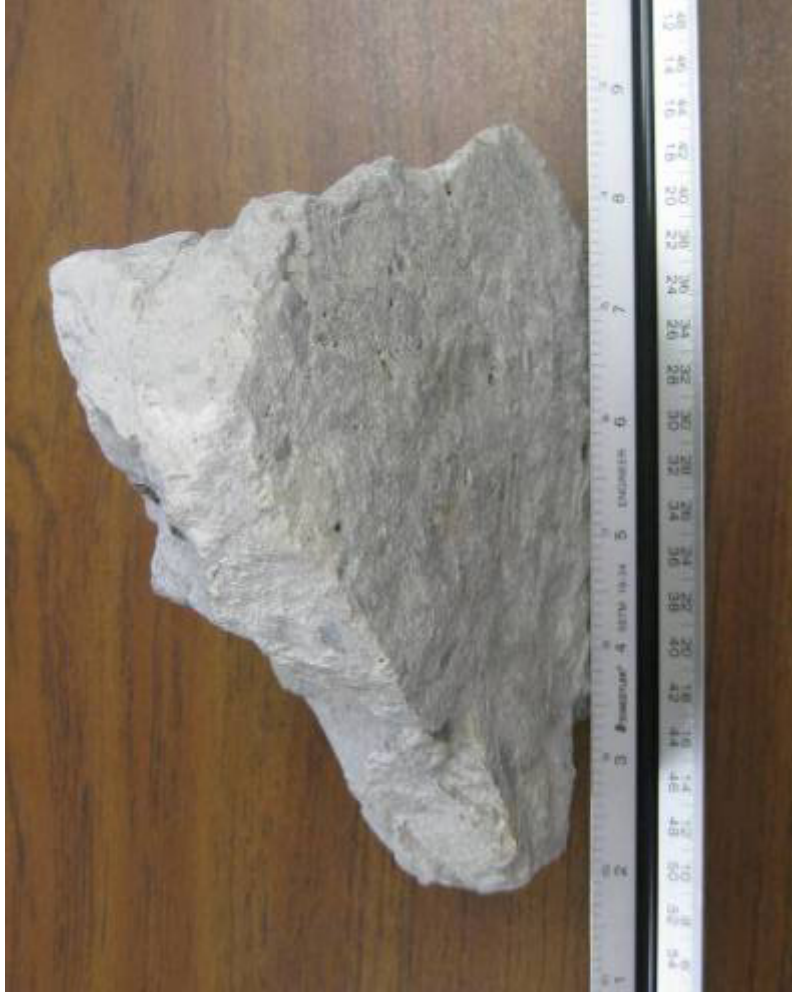
- Typical concrete sample showing the laminar crack sheared the coarse aggregate
- Therefore, laminar crack occurred after the concrete achieved its strength

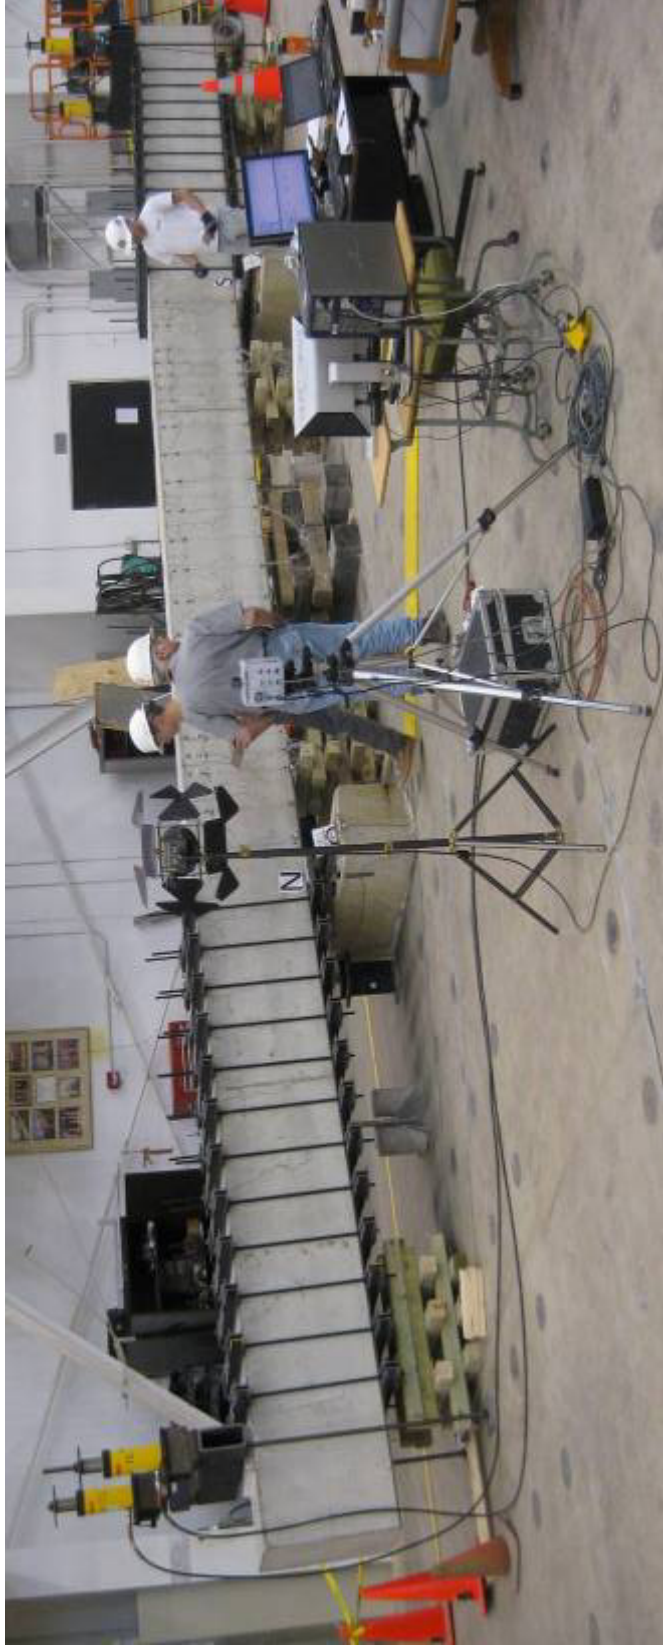
Additional Actions – Testing

- Tests were developed and conducted at two nationally recognized universities
- Professors are industry experts and are American Concrete Institute (ACI) Committee members

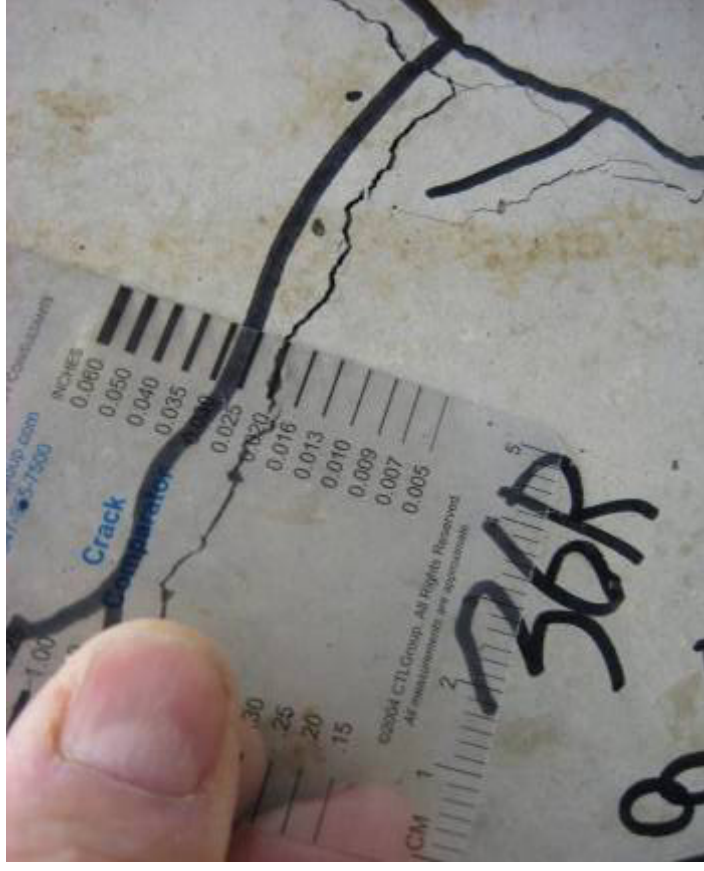
Additional Actions – Testing, *continued*

- Two different methods were used to create laminar cracks in the samples to be tested
- Results were independently verified
