SUBJECT: IOEB ANALYSIS TEAM STUDY ON COMPONENT AGING -  
INSIGHTS FROM INSPECTION FINDINGS AND REPORTABLE  
EVENTS

Enclosed is the study on component aging with insights from inspection findings and reportable events. The study was briefed to the Office of Nuclear Reactor Regulation Executive Team on November 8, 2012.

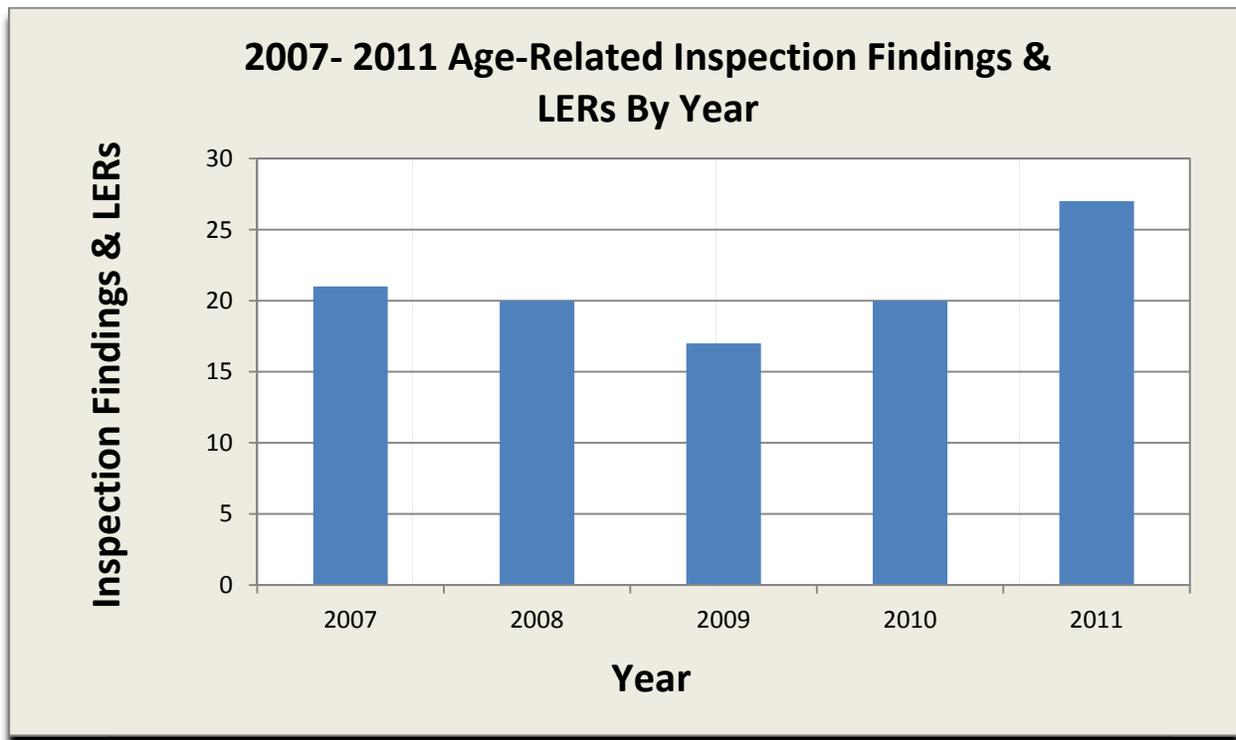
**Figure 1: 2007-2011 Inspection Findings/LERs for Age-Related Failures of Safety-Related and Important-to-Safety Equipment**

**[Note: No overall trend in the number of findings involving age-related failures of important-to-safety SSCs, but the number of findings involving failures of SSCs that has been in service for greater than 15 years since 2009 are increasing.]**

Many of the failure reports in the industry data do not reach the threshold of NRC reportability and do not involve performance deficiencies that rise to a level that would be documented in an inspection report. This study focused only on those inspection findings and LERs that met the criteria either for reportability or for a more than minor performance deficiency. IOEB determined that the majority of these failures occurred with components that typically are within the scope of the Maintenance Rule (see Figure 1 below).

One hundred and five (105) inspection findings and LERs were identified for the years 2007-2011 that involved age-related degradation of SSCs associated with safety-related and important-to-safety equipment (see the Appendix). Although the data set may not be statistically significant, the number of findings involving failures of SSCs that have been in service for 15-20 years or greater has been gradually increasing since 2009. About 50 percent of the 105 inspection findings and LERs involved SSCs that were known to have been in service for at least 15 years, with a majority in service for greater than 20 years, and some with in-service times approaching 40 years (see Figure 2 below). Although in-service time could not be determined for approximately 30 percent of the failures, it is probable that since the failures were all age-related, most of the components involved were in service for greater than 15 years.
