FIGURE 49
 Zone 1 pH Over Time
 United Nuclear Corporation, Church Rock Site, Church Rock, New Mexico

United Nuclear Corporation Church Rock Site,
Church Rock, New Mexico

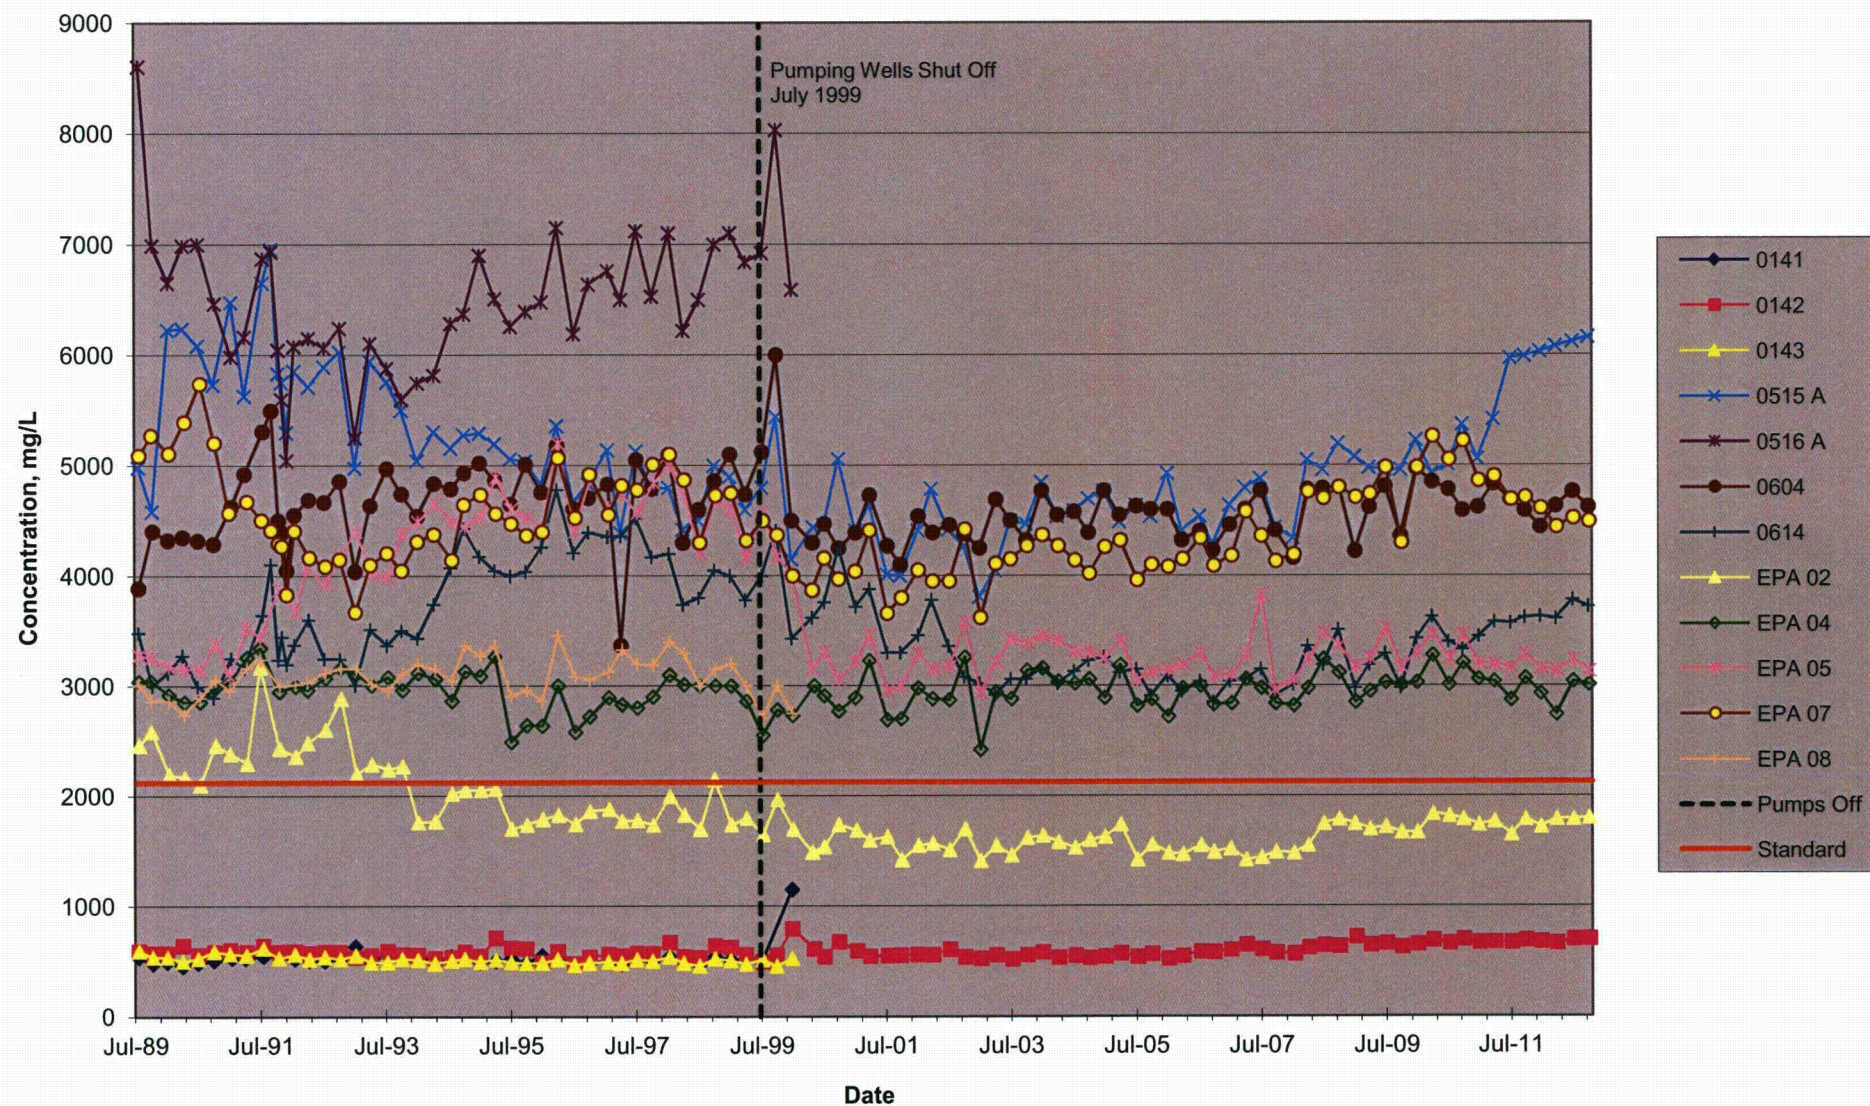
FIGURE 50
 Zone 1 Sulfate Concentrations Over Time
 United Nuclear Corporation, Church Rock Site, Church Rock, New Mexico

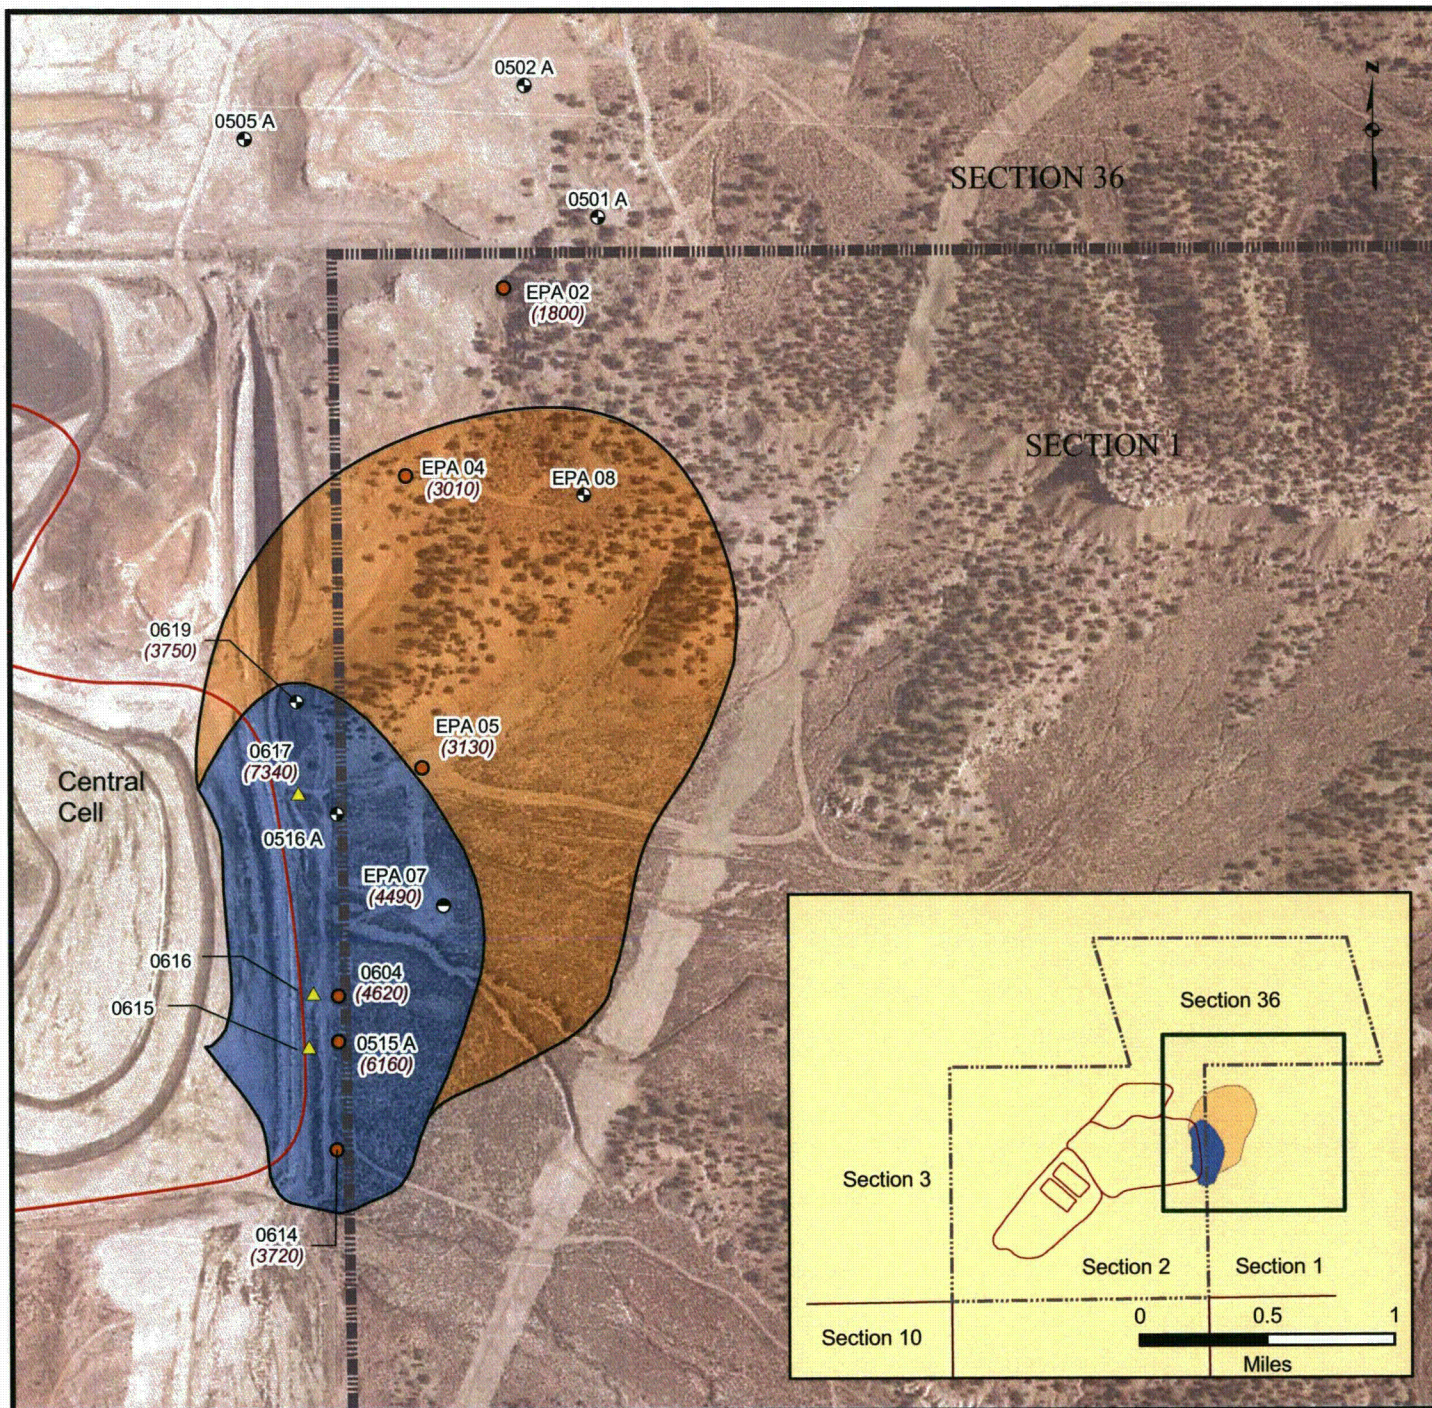
FIGURE 51

1. Seepage impacts delineated by Chloride detections greater than 50 mg/L.
2. Well names are displayed with black text.
3. Aerial photo taken on August 1, 1996.

Zone 1 Approximate Extent of
Sulfate Exceeding 2,125 mg/L,
October 2012

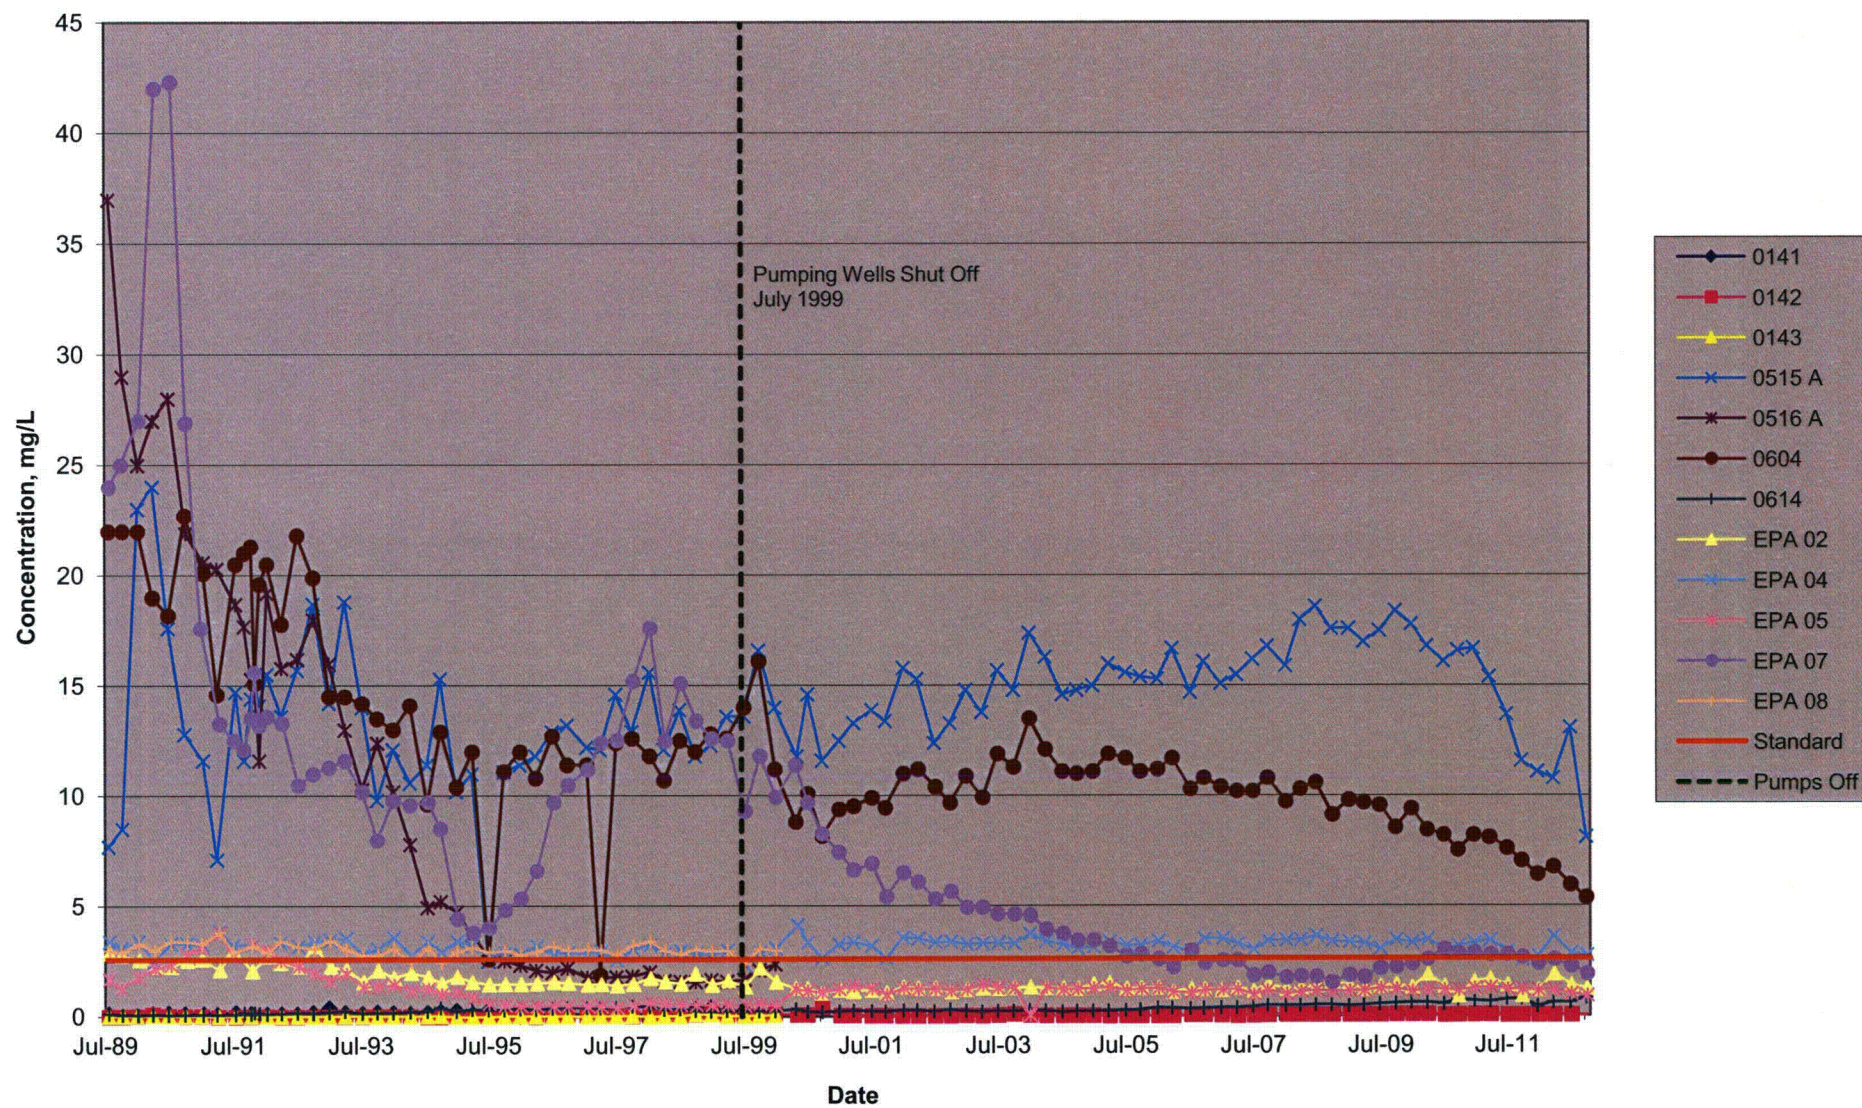
FIGURE 52
Zone 1 Manganese Concentrations Over Time
 United Nuclear Corporation, Church Rock Site, Church Rock, New Mexico

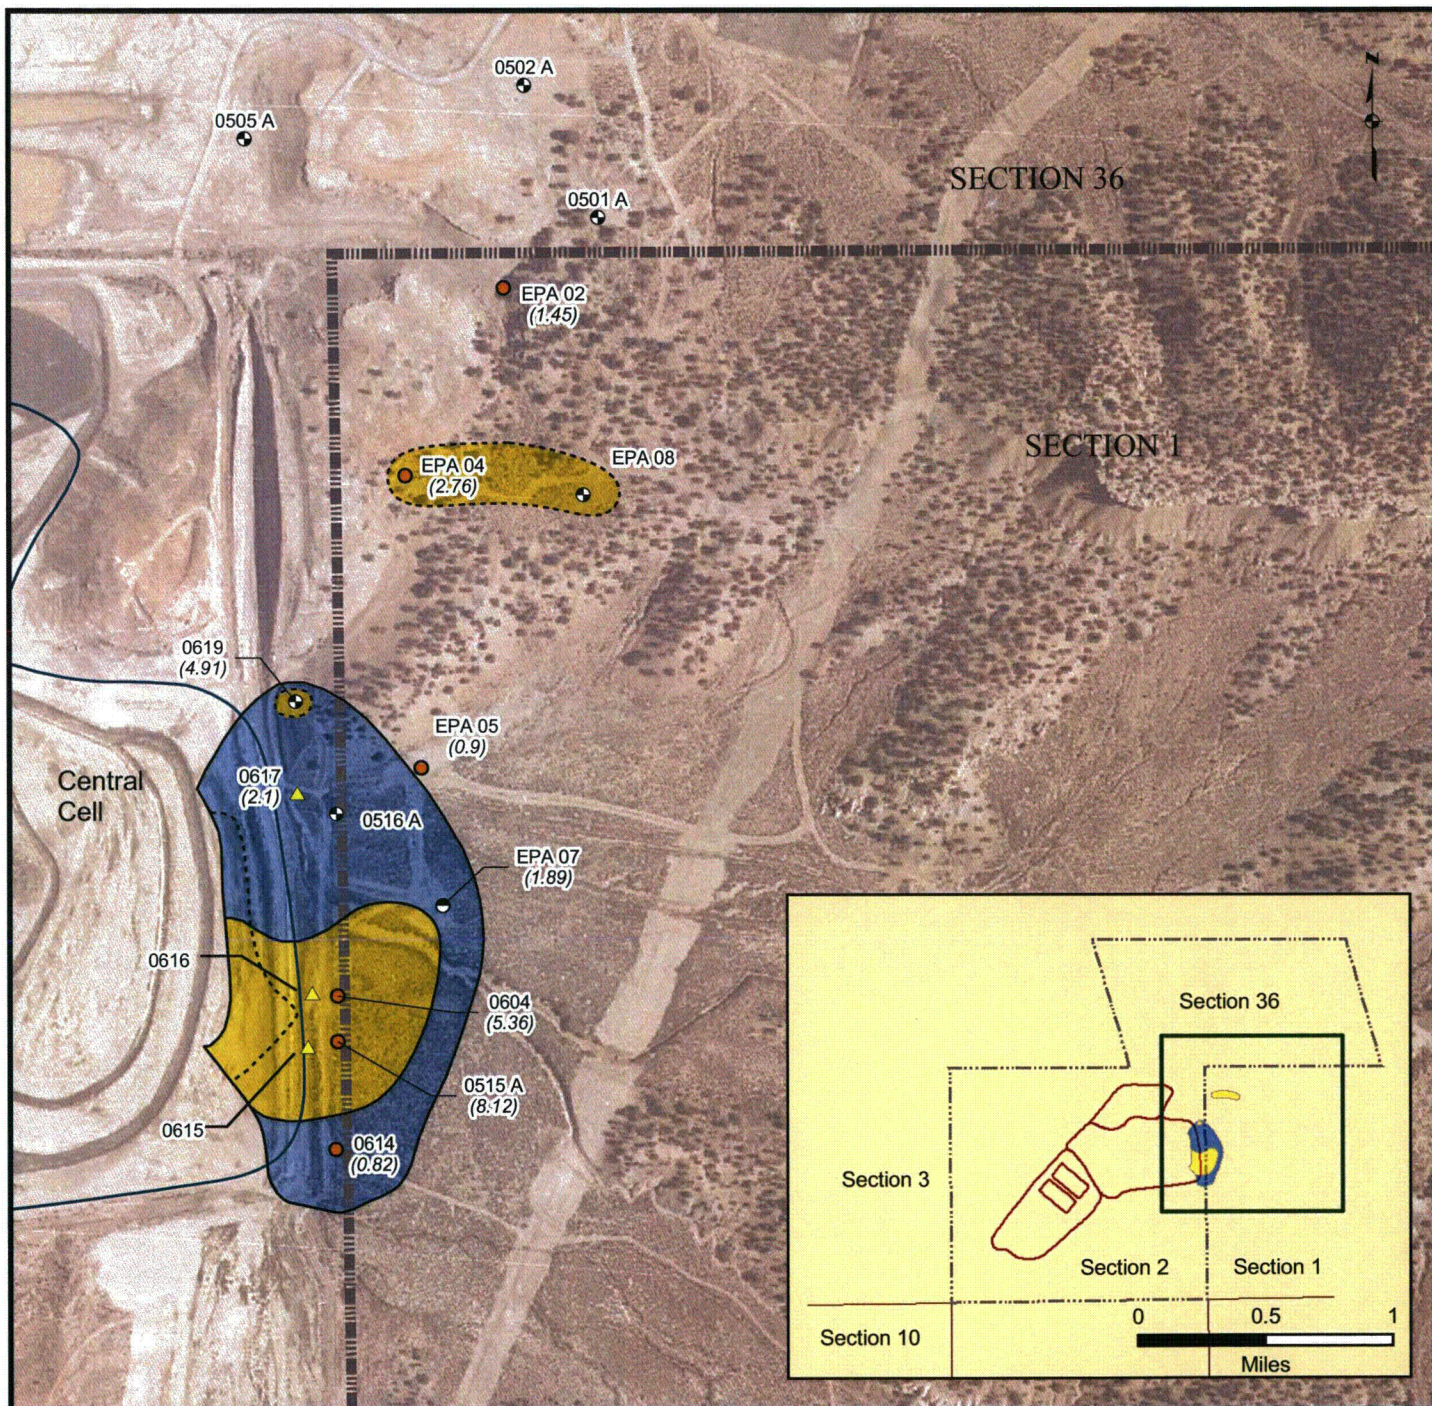
FIGURE 53

1. Seepage impacts delineated by chloride detections greater than 50 mg/L.
2. Aerial photo taken on August 1, 1996.

Zone 1 Approximate Extent of Manganese Exceeding 2.6 mg/L, October 2012

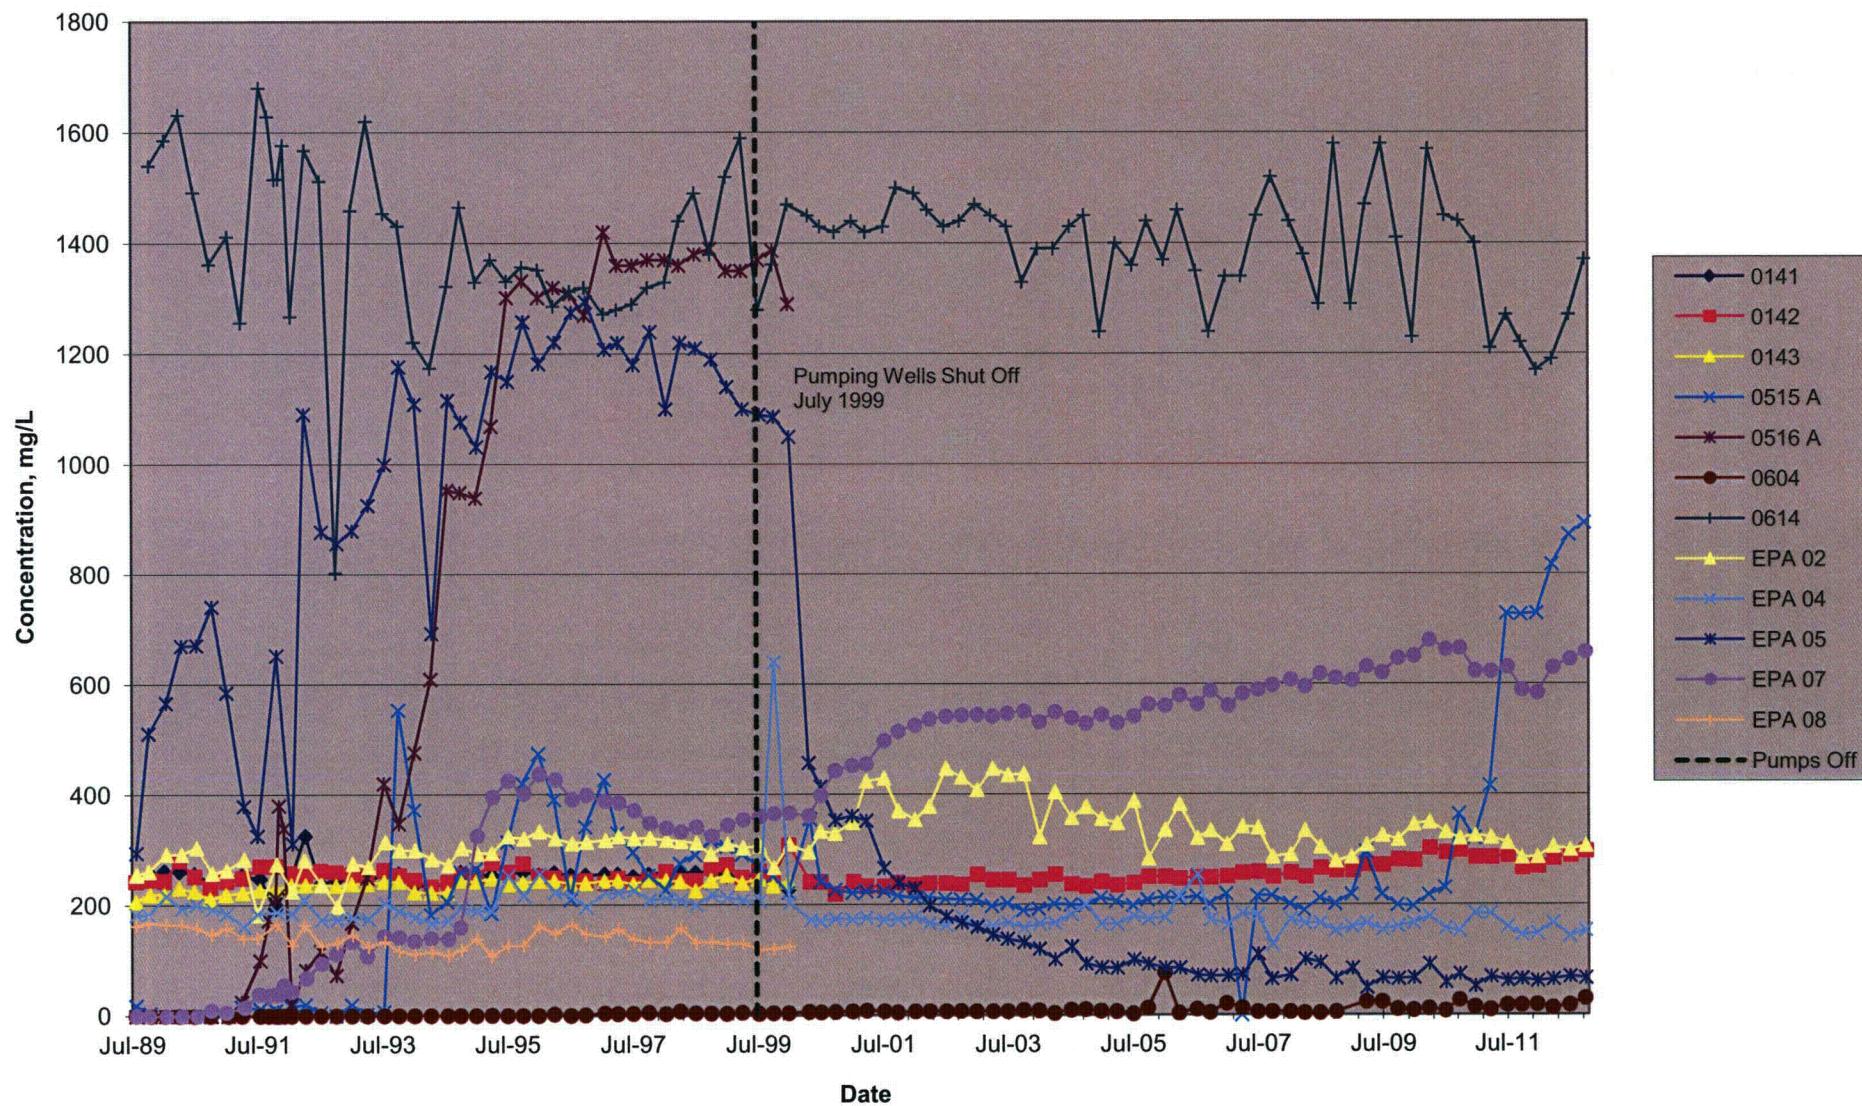
FIGURE 54
 Zone 1 Bicarbonate Concentrations Over Time
 United Nuclear Corporation, Church Rock Site, Church Rock, New Mexico

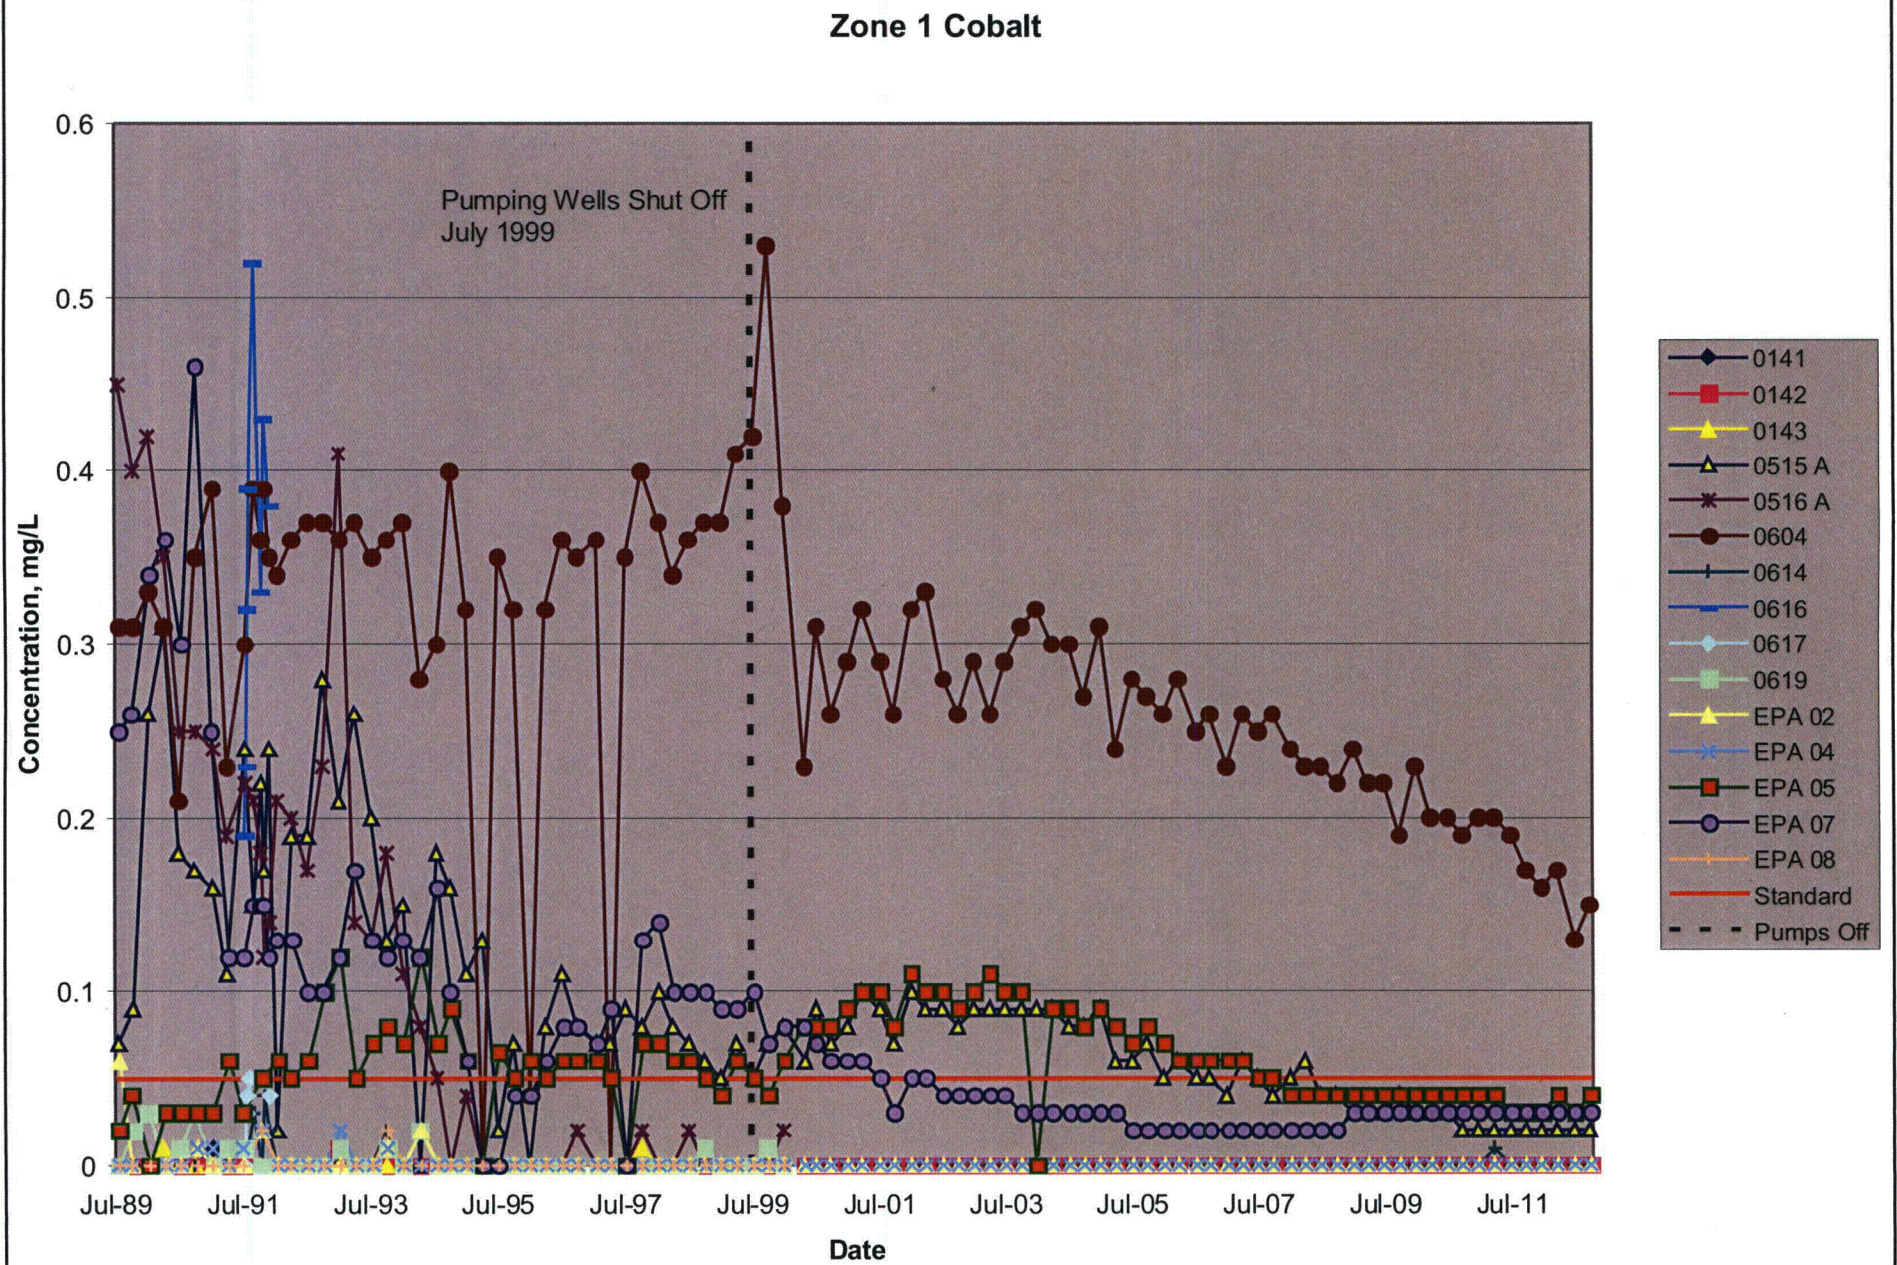
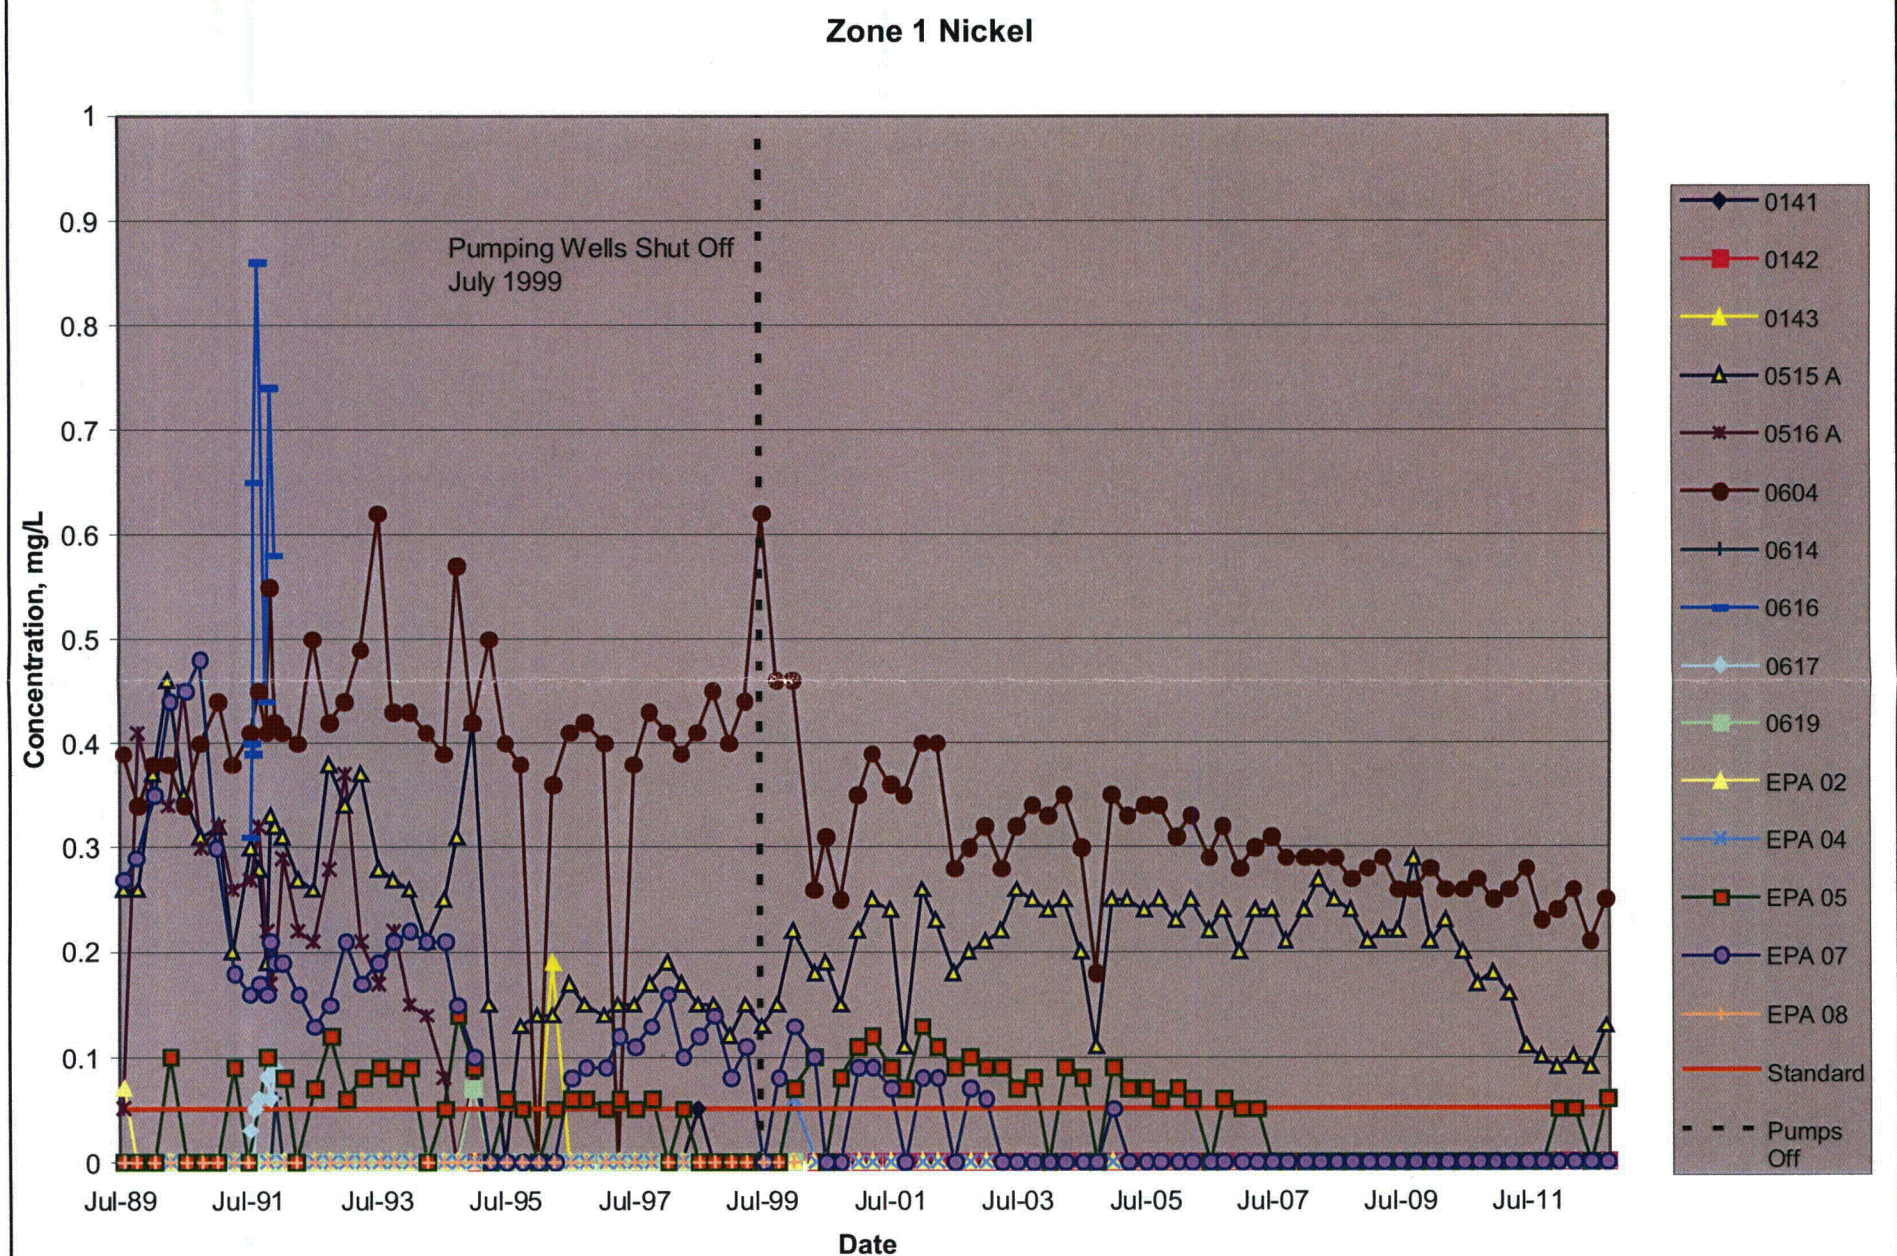
FIGURE 55
Zone 1 Cobalt and Nickel Concentrations over Time
 United Nuclear Corporation Church Rock Site, Church Rock, New Mexico

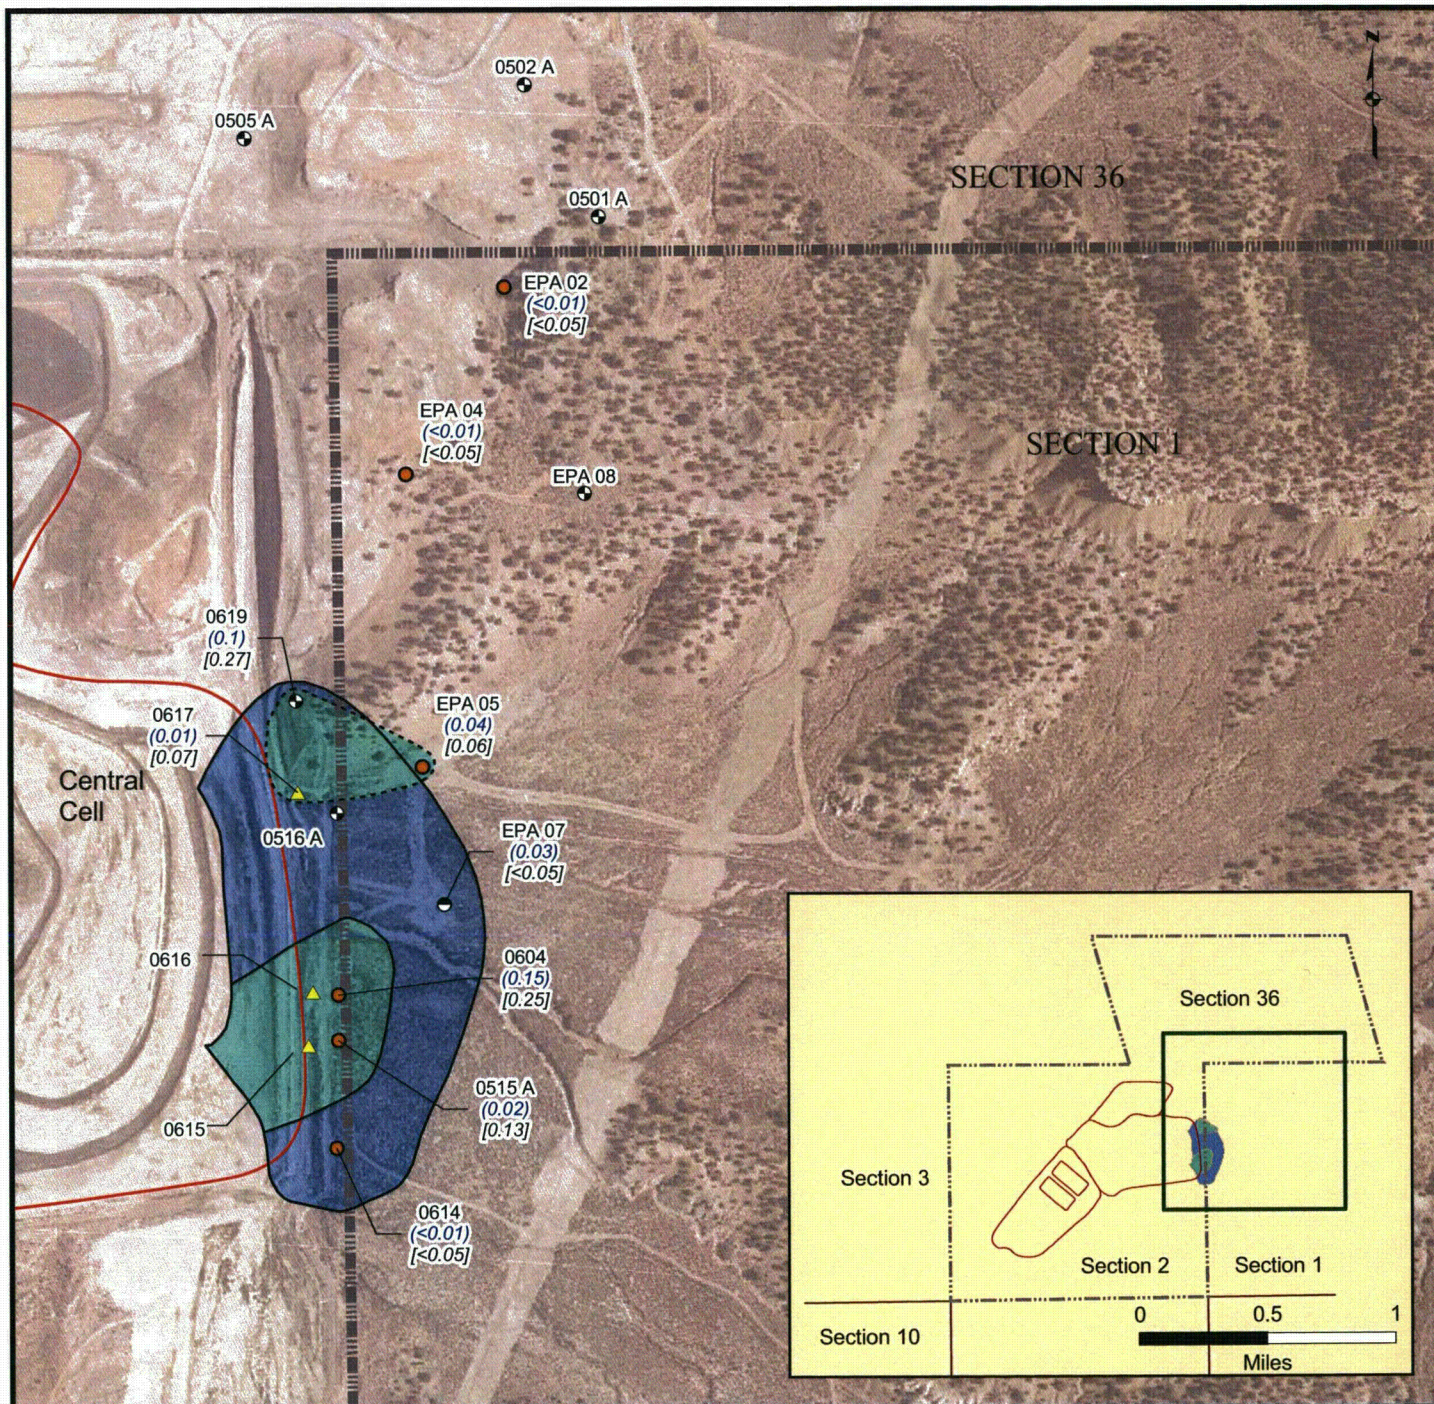
FIGURE 56

1. Seepage impacts delineated by chloride detections greater than 50 mg/L.
2. Well names are displayed with black text.
3. Aerial photo taken on August 1, 1996.

Zone 1 Extent of Cobalt and Nickel Exceeding 0.05 mg/L, October 2012

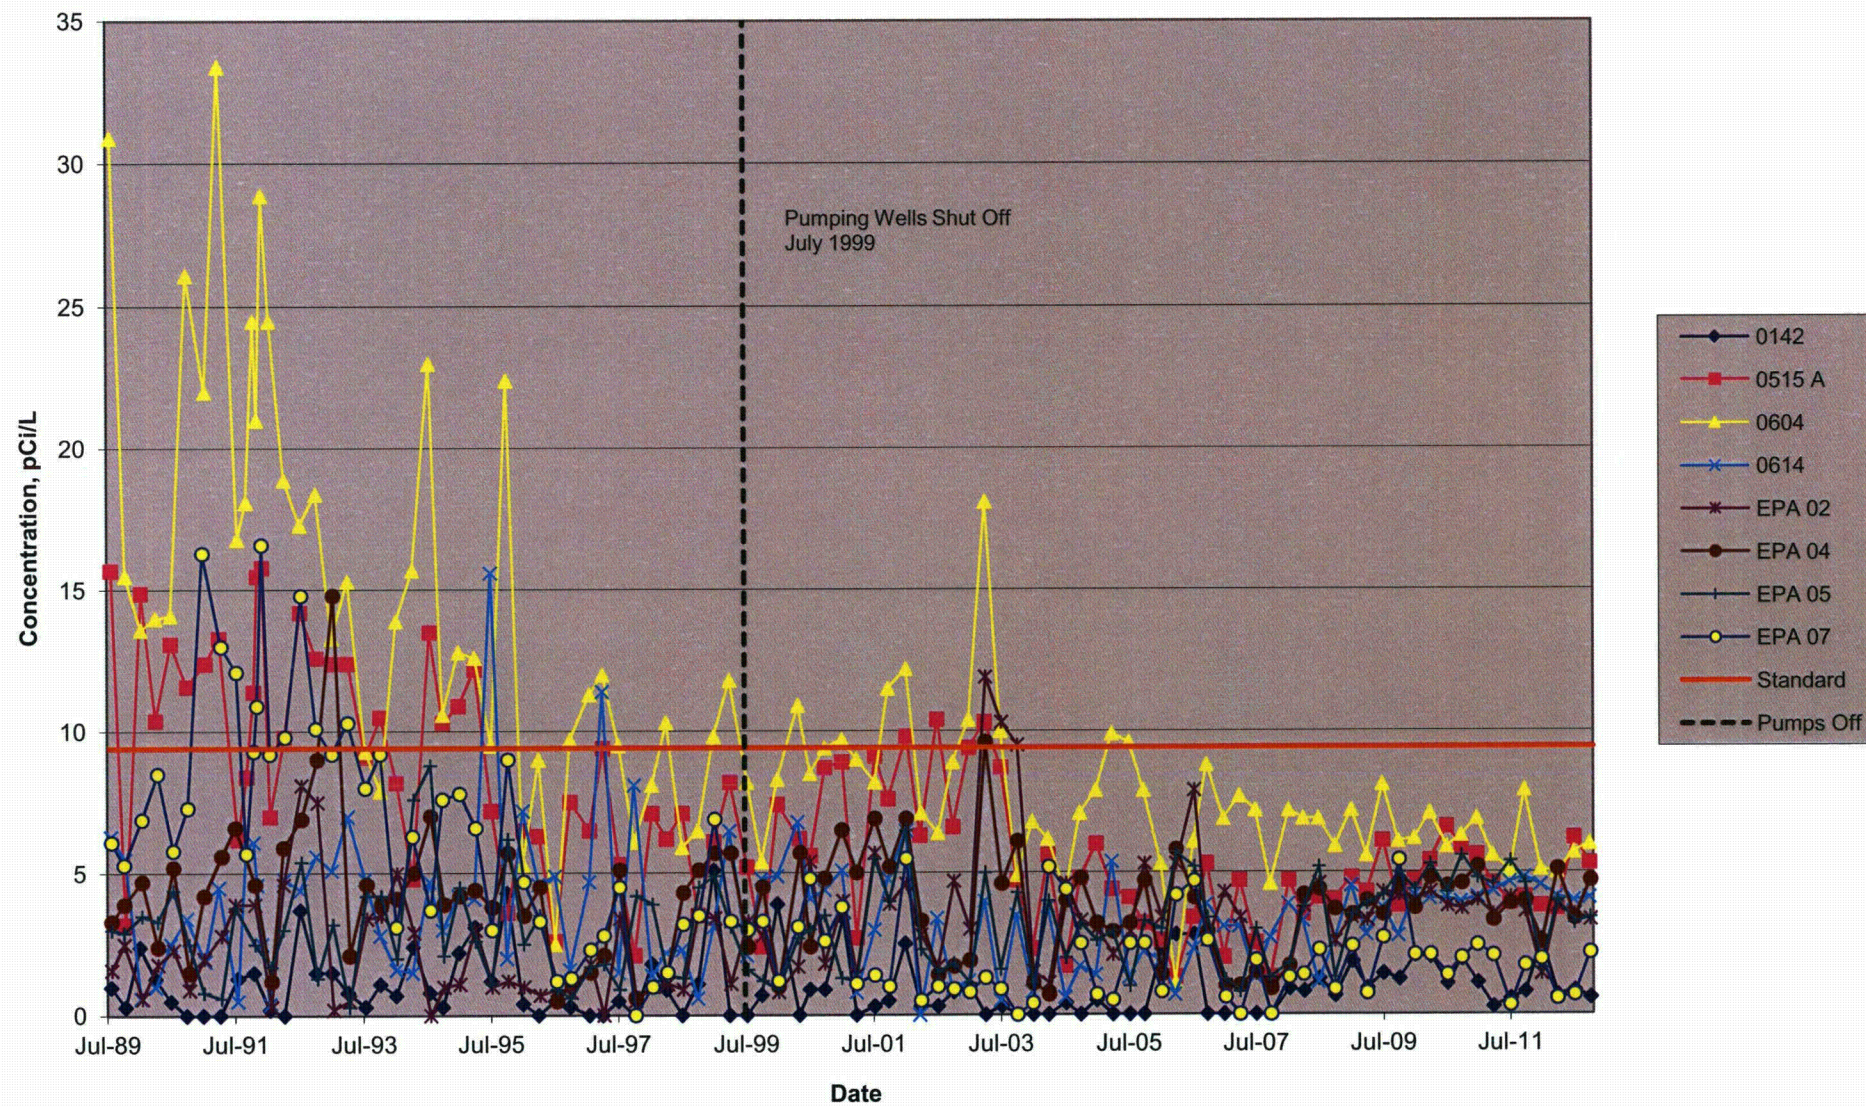
FIGURE 57
 Zone 1 Combined Radium-226 and Radium-228 Over Time
 United Nuclear Corporation, Church Rock Site, Church Rock, New Mexico
