# **D**

## **Area Walk-By Checklists (AWCs)**

**Table D-1. Summary of Area Walk-By Checklists**

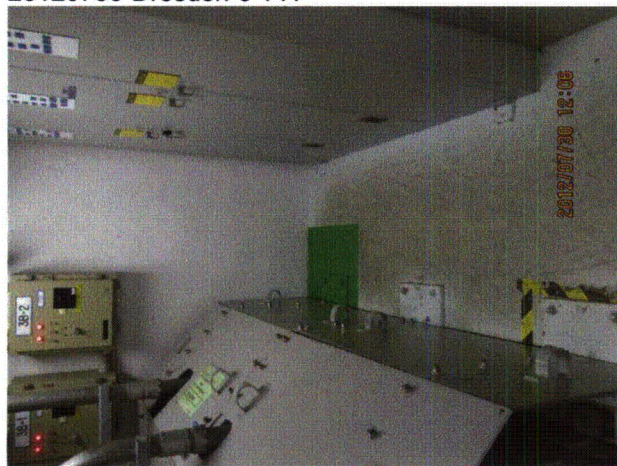
Location (Bldg, Elev, Room/Area): AWC-U3-01

*While performing NRC required NTTF (near term task force) seismic walkdowns, Panels 903-28 and 902-28 were found unlatched per IRs 01394831 & 01395481 respectively.*

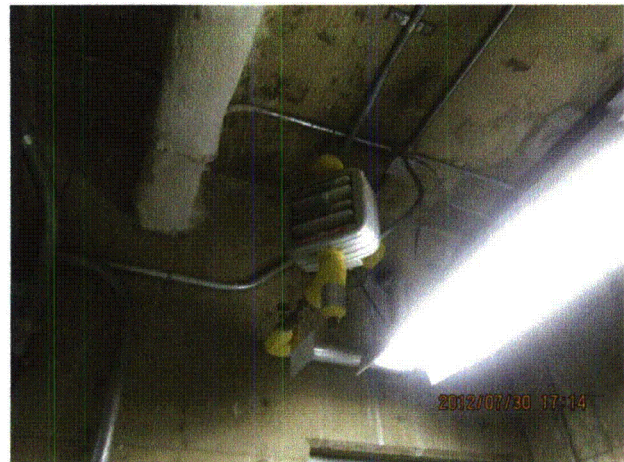
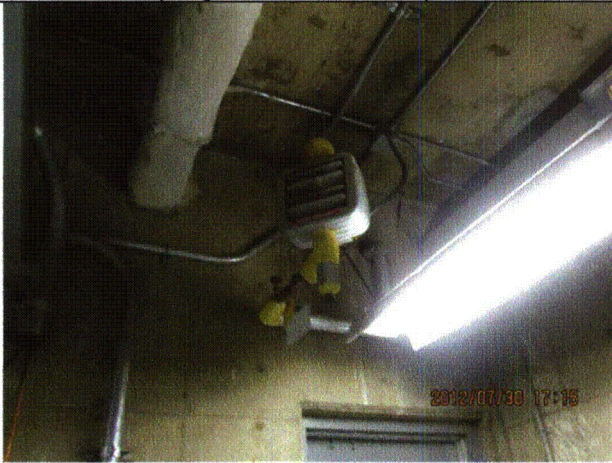
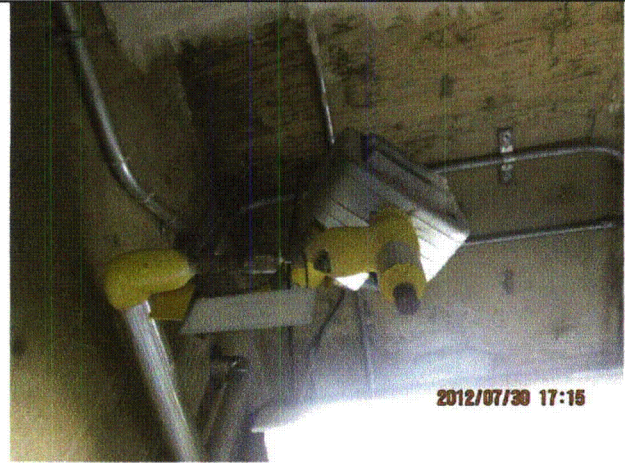
Location (Bldg, Elev, Room/Area): AWC-U3-03

| 5. Does it appear that the area is free of potentially adverse seismic interactions that could cause flooding or spray in the area?<br><i>Room heater and associated piping judged to be adequately supported.</i> | Yes |

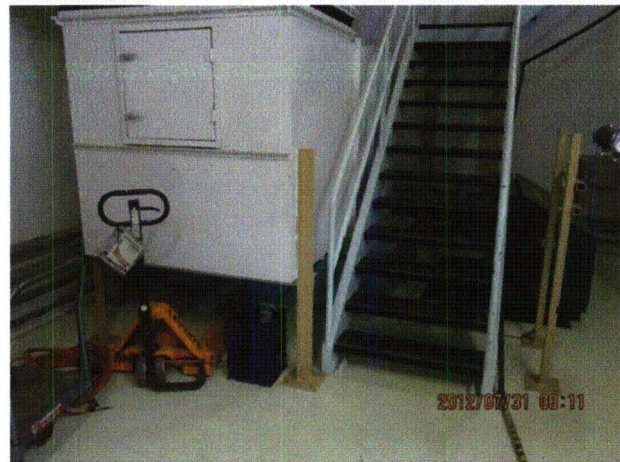
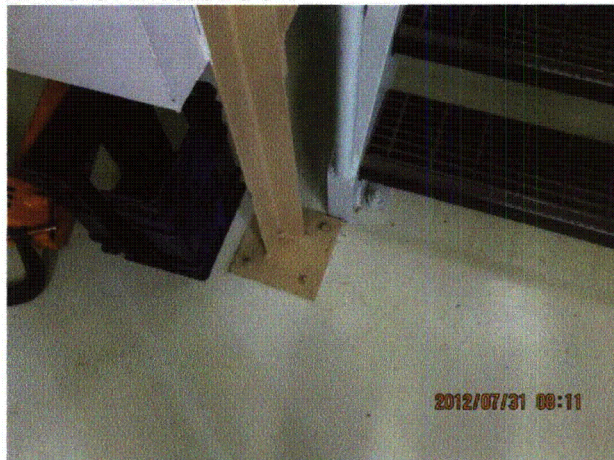
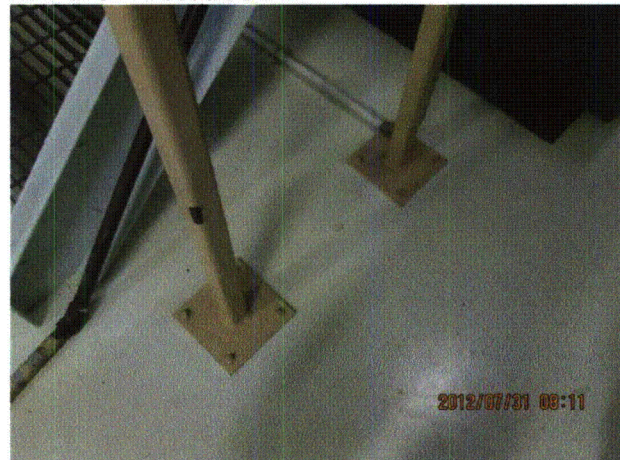
Location (Bldg, Elev, Room/Area): AWC-U3-04

| 5. Does it appear that the area is free of potentially adverse seismic interactions that could cause flooding or spray in the area?<br><i>Threaded fire pipe is well-supported and judged to be acceptable.</i> | Yes |
| 6. Does it appear that the area is free of potentially adverse seismic interactions that could cause a fire in the area?<br><i>Gas bottle is well-restrained and judged to be acceptable.</i> | Yes |
