SEABROOK STATION UPDATED FINAL SAFETY ANALYSIS REPORT	Containment Structure Mat Reinforcing [2 Sheets]	
		Figure 3.8-1 Sh. 1 of 2

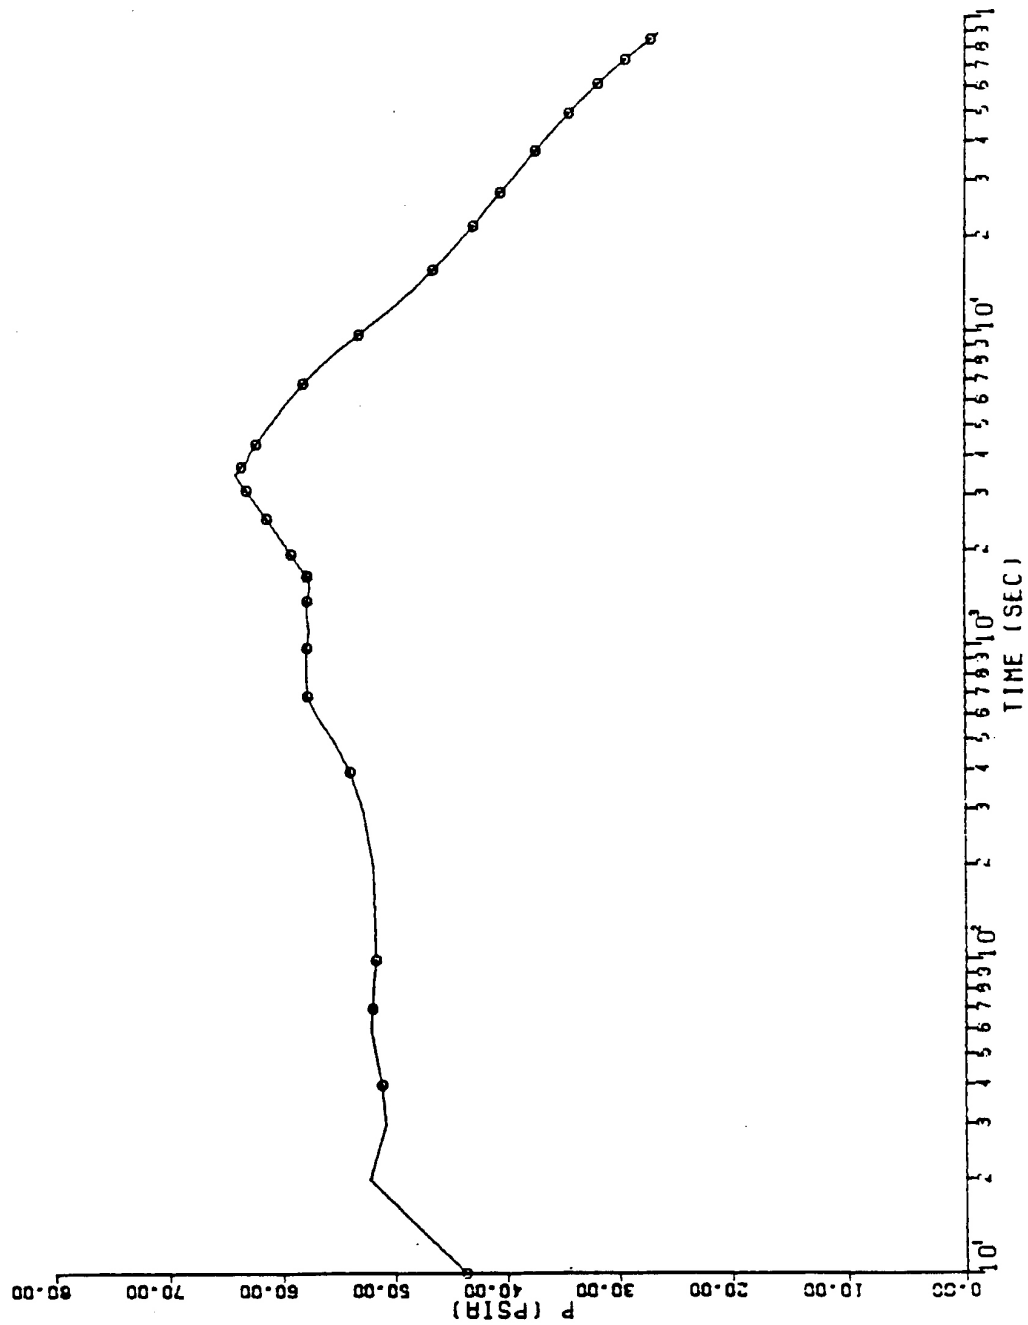
SEABROOK STATION UPDATED FINAL SAFETY ANALYSIS REPORT	Containment Pressure Transients Following a LOCA	
		Figure 3.8-9

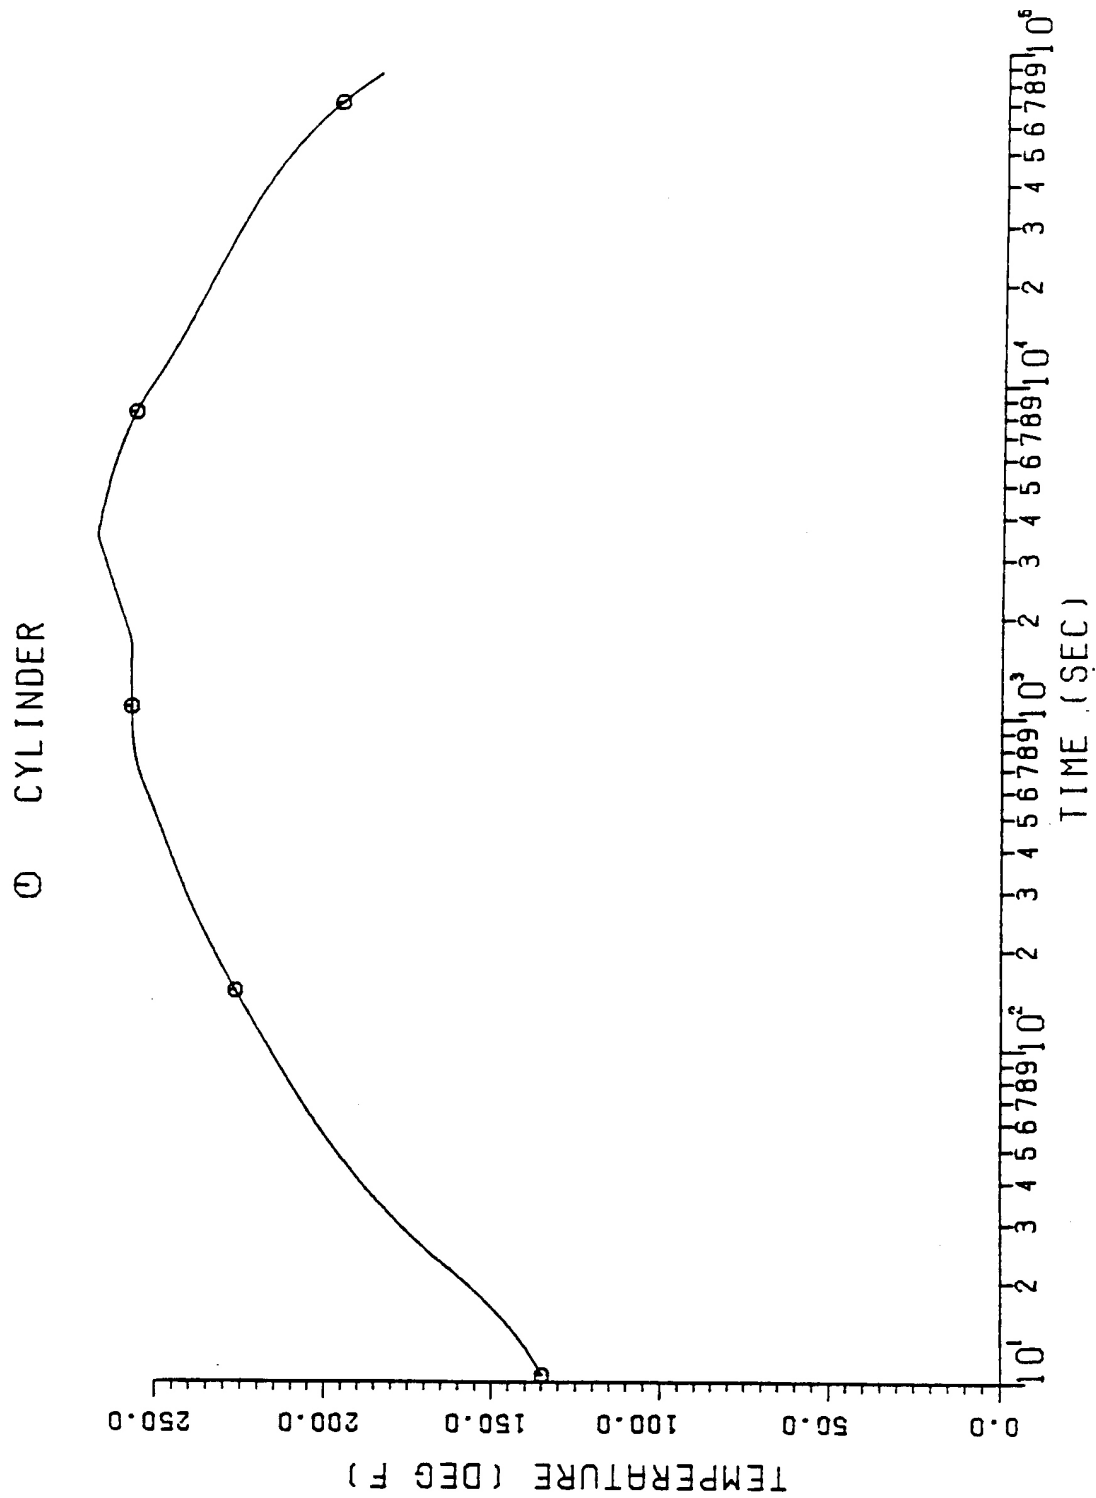
Figure 3.8-10

Containment Cylinder Liner Temperature Transients Curve

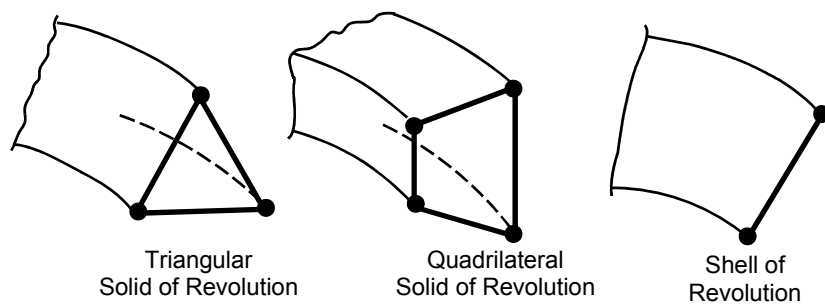
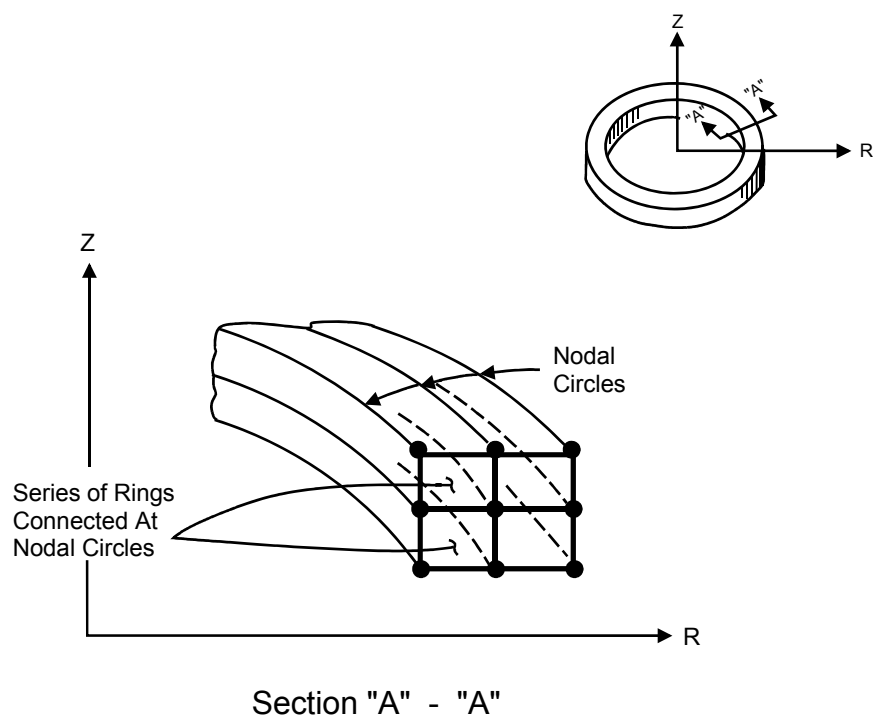
SEABROOK STATION UPDATED FINAL SAFETY ANALYSIS REPORT	Axisymmetric Modeling Elements	
		Figure 3.8-12

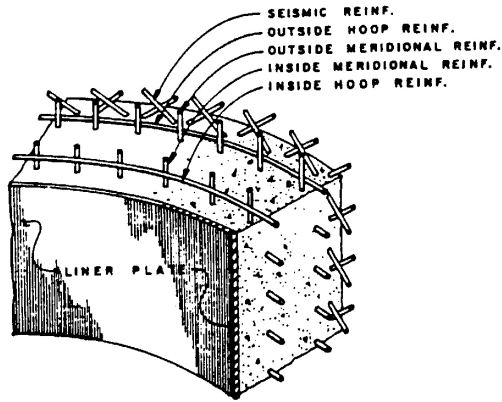
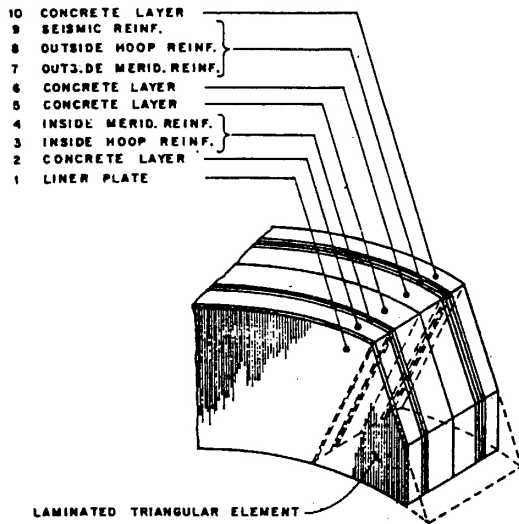
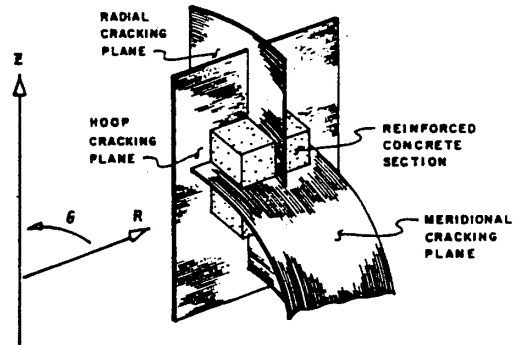
TYPICAL SECTION THROUGH
REINFORCED CONCRETE WALL

EQUIVALENT LAMINATED
CONTAINMENT WALL

IDEALIZED MATERIAL MODEL

CONCRETE CRACKING PLANES AND
ASSOCIATED COORDINATE DIRECTIONS

SEABROOK STATION UPDATED FINAL SAFETY ANALYSIS REPORT	Reinforced Concrete Idealization	
		Figure 3.8-13

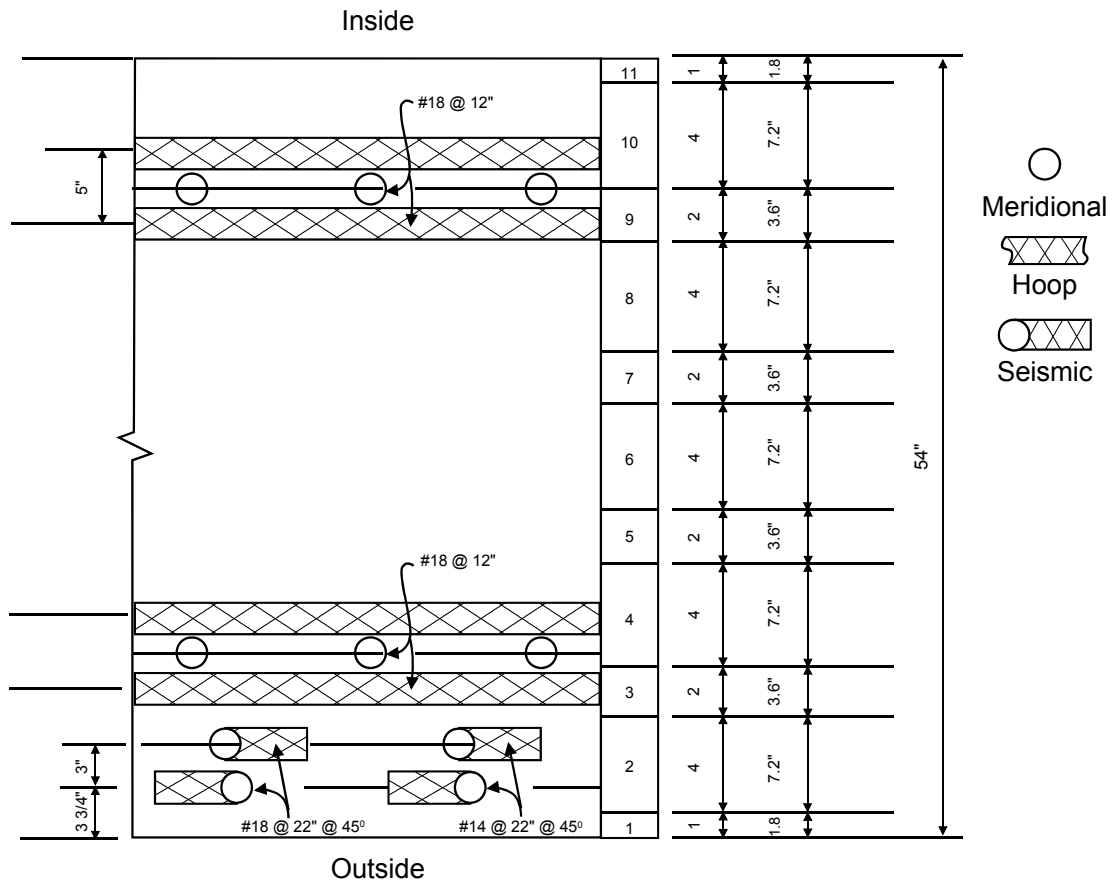
Rebar in Membrane Region From
El. 80' - 0" To El. 119' - 0"

SEABROOK STATION UPDATED FINAL SAFETY ANALYSIS REPORT	Layered Cross Section Model for MARC-CDC Element 22	
		Figure 3.8-18

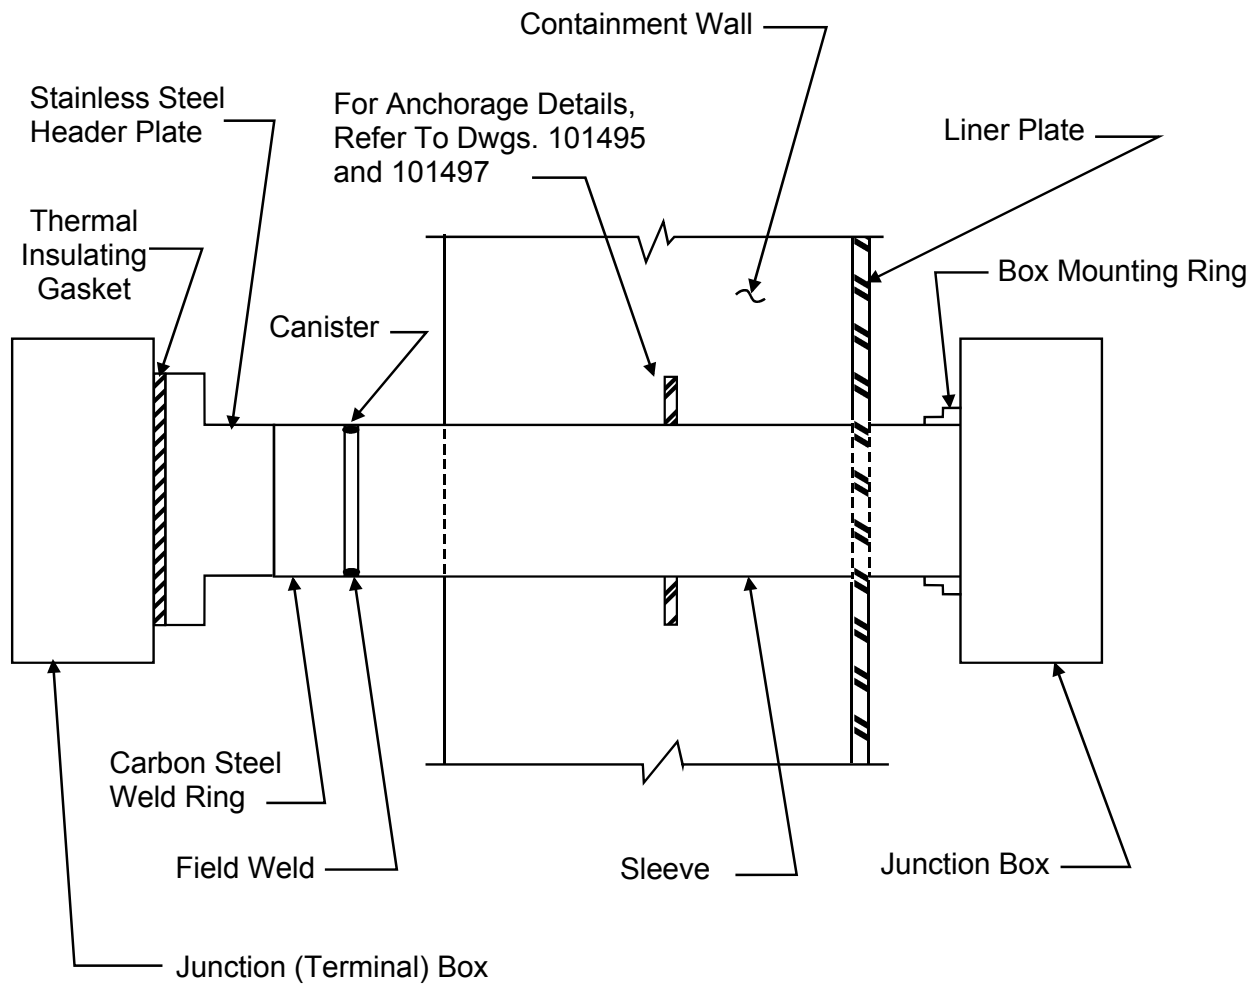
SEABROOK STATION UPDATED FINAL SAFETY ANALYSIS REPORT	Typical Electrical Penetration	
		Figure 3.8-24

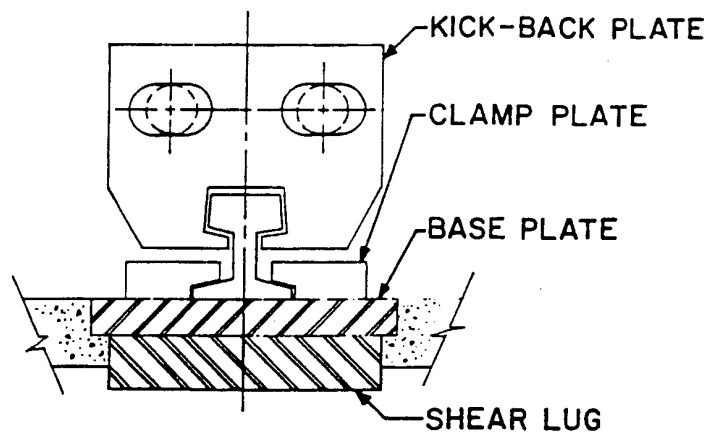
SECTION THROUGH CLAMP PLATES

SECTION THROUGH ANCHOR BOLTS

NOTE: CLAMP PLATES AND KICK-BACK PLATES ARE ALTERNATELY SPACED 9" CENTER TO CENTER.

SEABROOK STATION UPDATED FINAL SAFETY ANALYSIS REPORT	Design of Kick-Back Plate, Clamp Plate, Base Plate and Anchor Bolts for Polar Crane	
		Figure 3.8-30

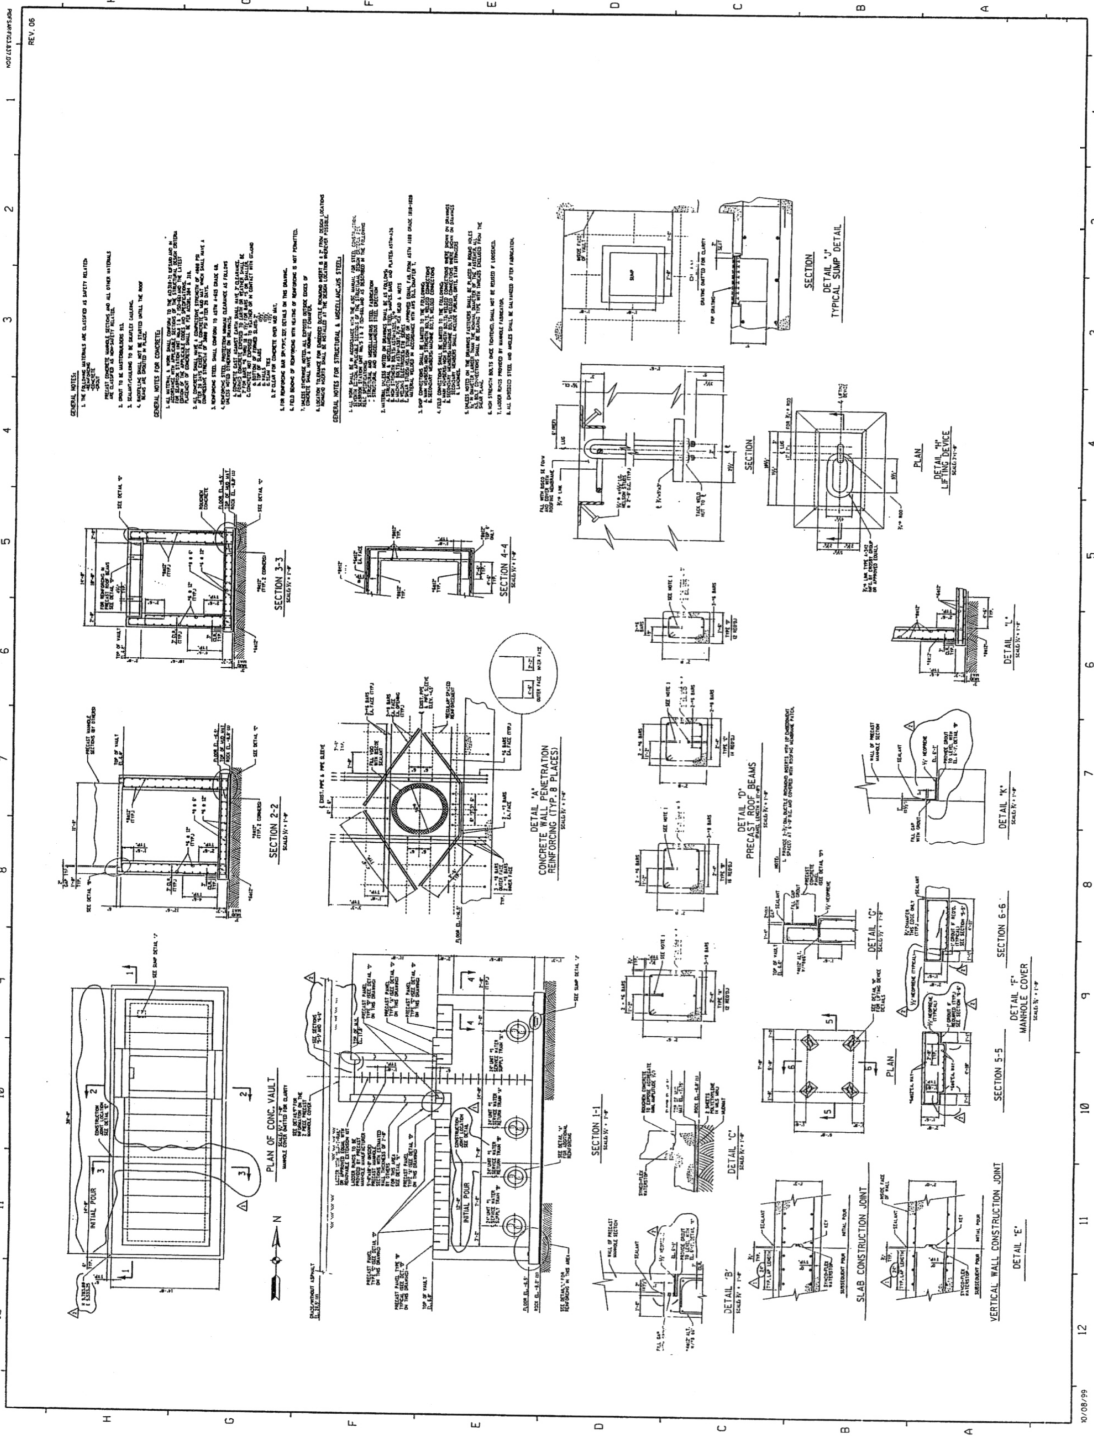
<p>SEABROOK STATION UPDATED FINAL SAFETY ANALYSIS REPORT</p>	<p>Service Water Pipe Access Vault Concrete Plan & Sections Precast Roof Option</p>
	<p>Figure 3.8-37</p>

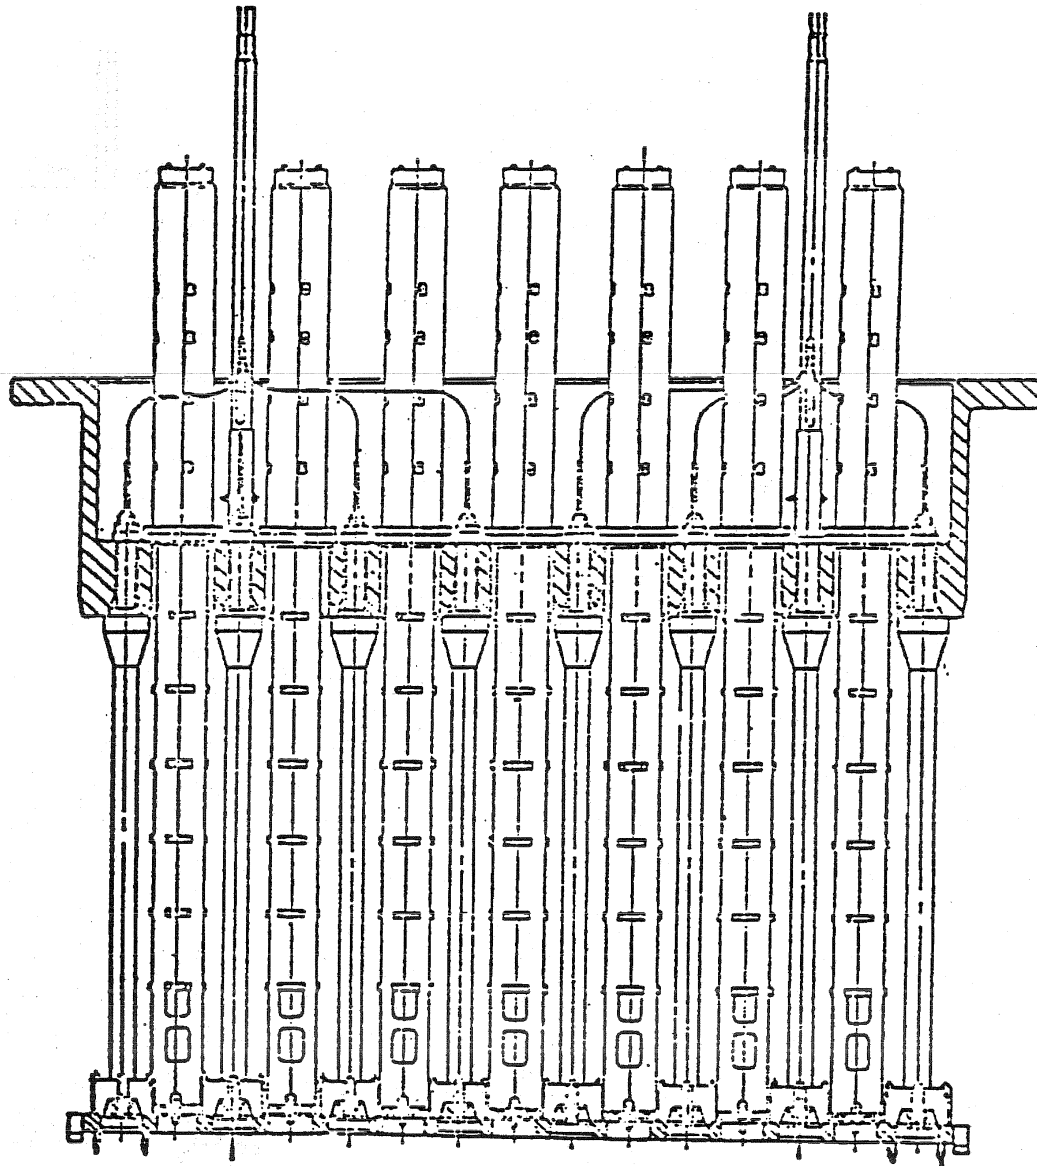
SEABROOK STATION UPDATED FINAL SAFETY ANALYSIS REPORT	Upper Core Support Structure	
		Figure 3.9(N)-8

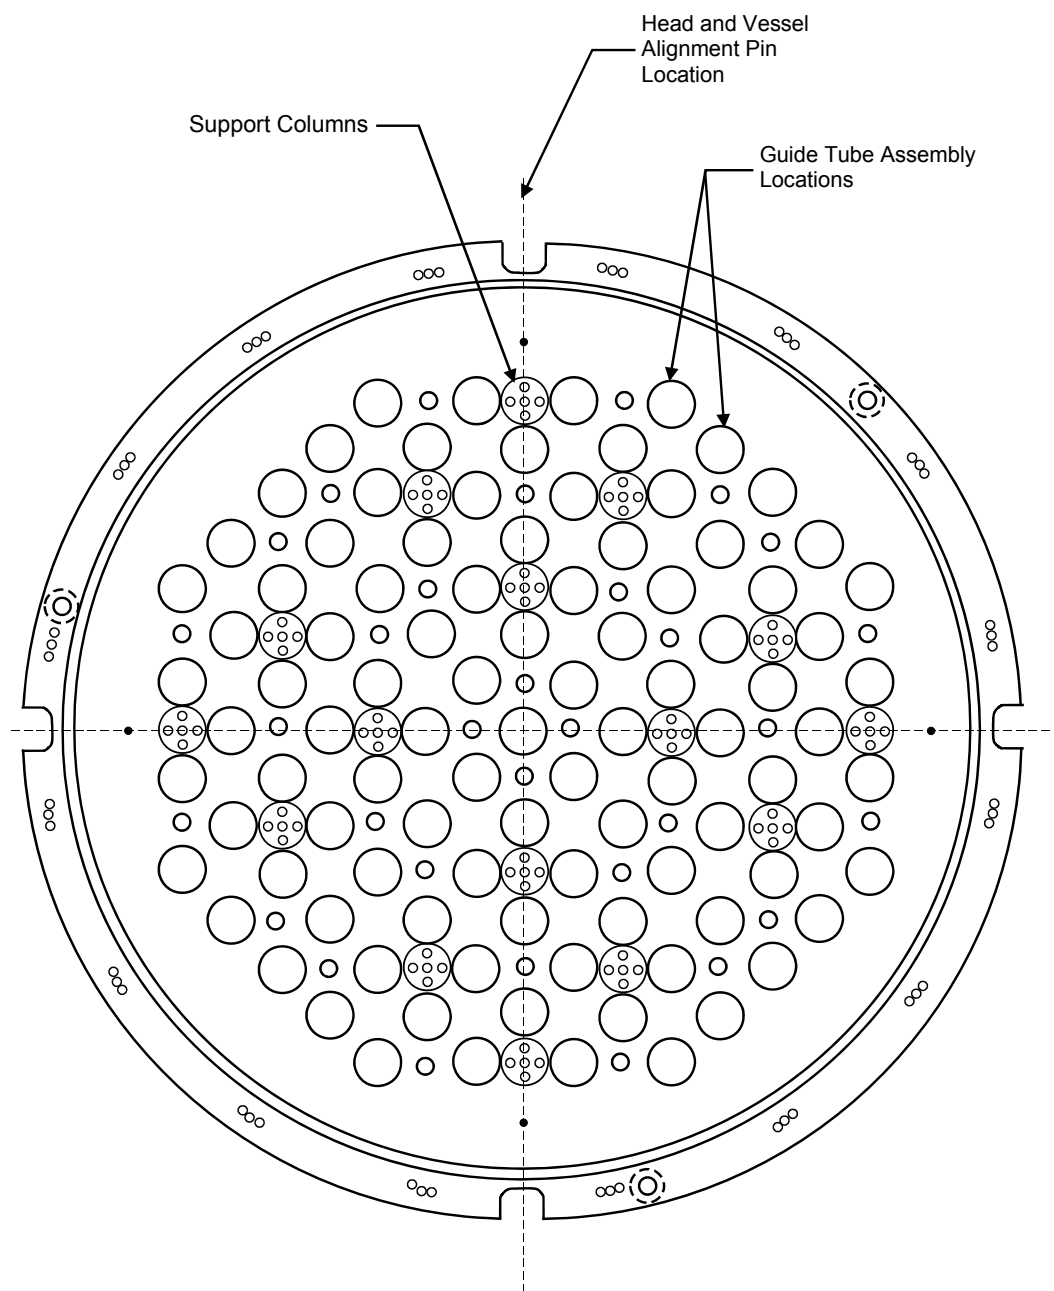
SEABROOK STATION UPDATED FINAL SAFETY ANALYSIS REPORT	Plan View of Upper Core Support Structure	
		Figure 3.9(N)-9
