Subject: 10CFR21 Reporting of Defects and Non-Compliance -
Engine Systems, Inc. Report No. 10CFR21-0109, Rev. 0

EMD Fuel Injectors, P/N 40084720 & 40099335

Report No. 10CFR21-0109

10CFR21 REPORTING OF DEFECTS AND NON-COMPLIANCE

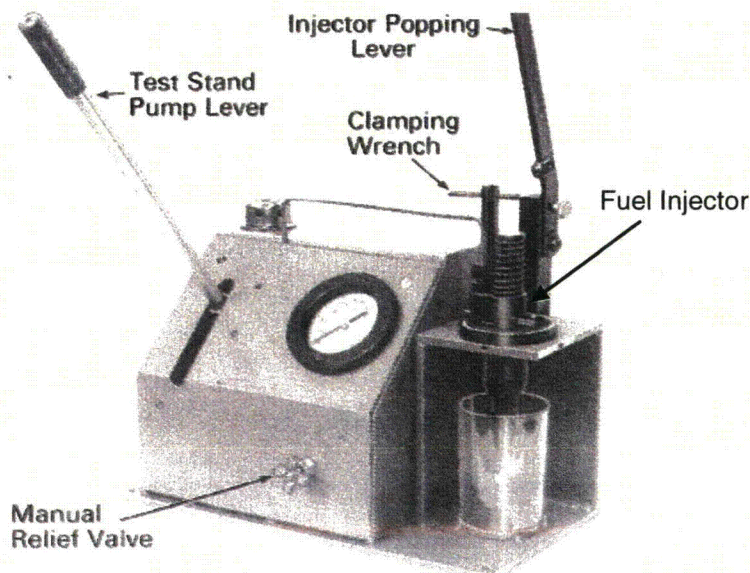
The standard holding pressure and leakage test specified for the EMD fuel injectors requires applying 2000 psi to the fuel injector and verifying the pressure does not fall below 1500 psi after 30 seconds. This test is performed on an Injector Tester designed specifically for this purpose. See Figure 1 below.

Figure 1: EMD Fuel Injector Tester

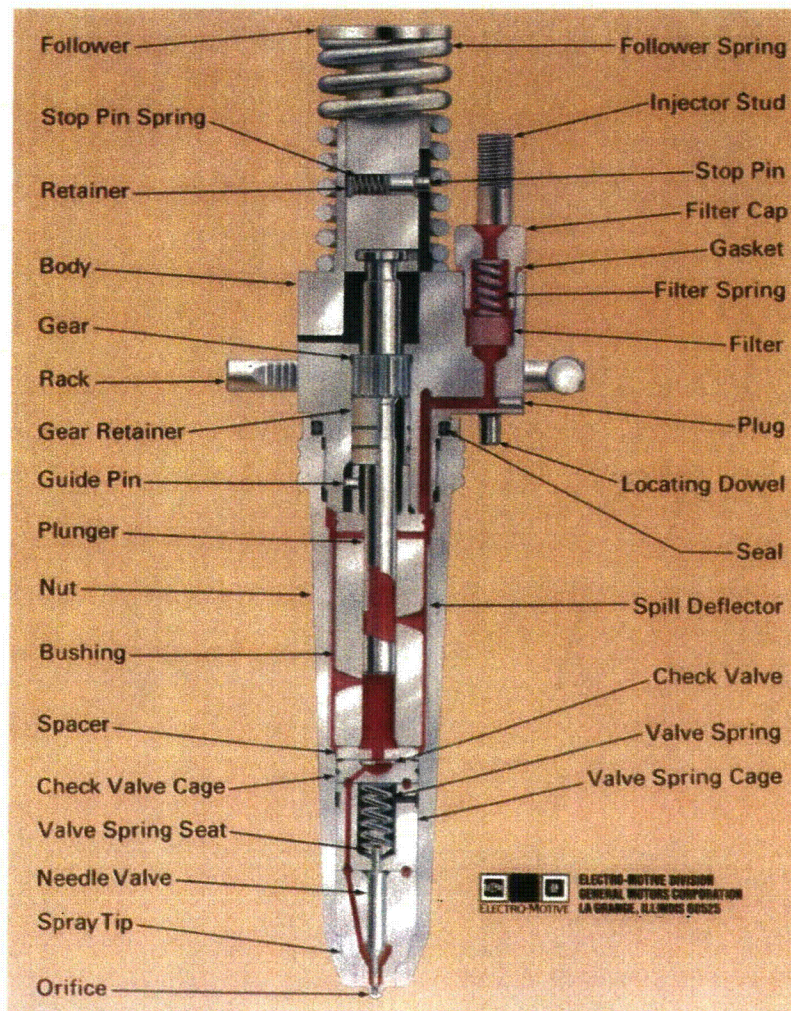
Cut-away of EMD Fuel Injector

All of the fuel injectors were subjected to a disassembly inspection (either at I-M or ESI). Two P/N 40084720 fuel injectors (12K20404 & 13A23943) from a non-nuclear customer were also subjected to a disassembly inspection; these would not build up pressure during the pressure test (similar to the Davis-Besse injector). A typical cutaway view of the fuel injector is provided below for reference. A summary of the inspection findings are provided on the following page.
