SUBJECT: Application for amends to Licenses NPF-10 & NPF-15,  
 clarifying requirements for determining content of inservice  
 insp tube sample by deleting tubes in batwing area based on  
 performance of corrective action program. Fee paid.

**Southern California Edison Company**

January 26, 1988

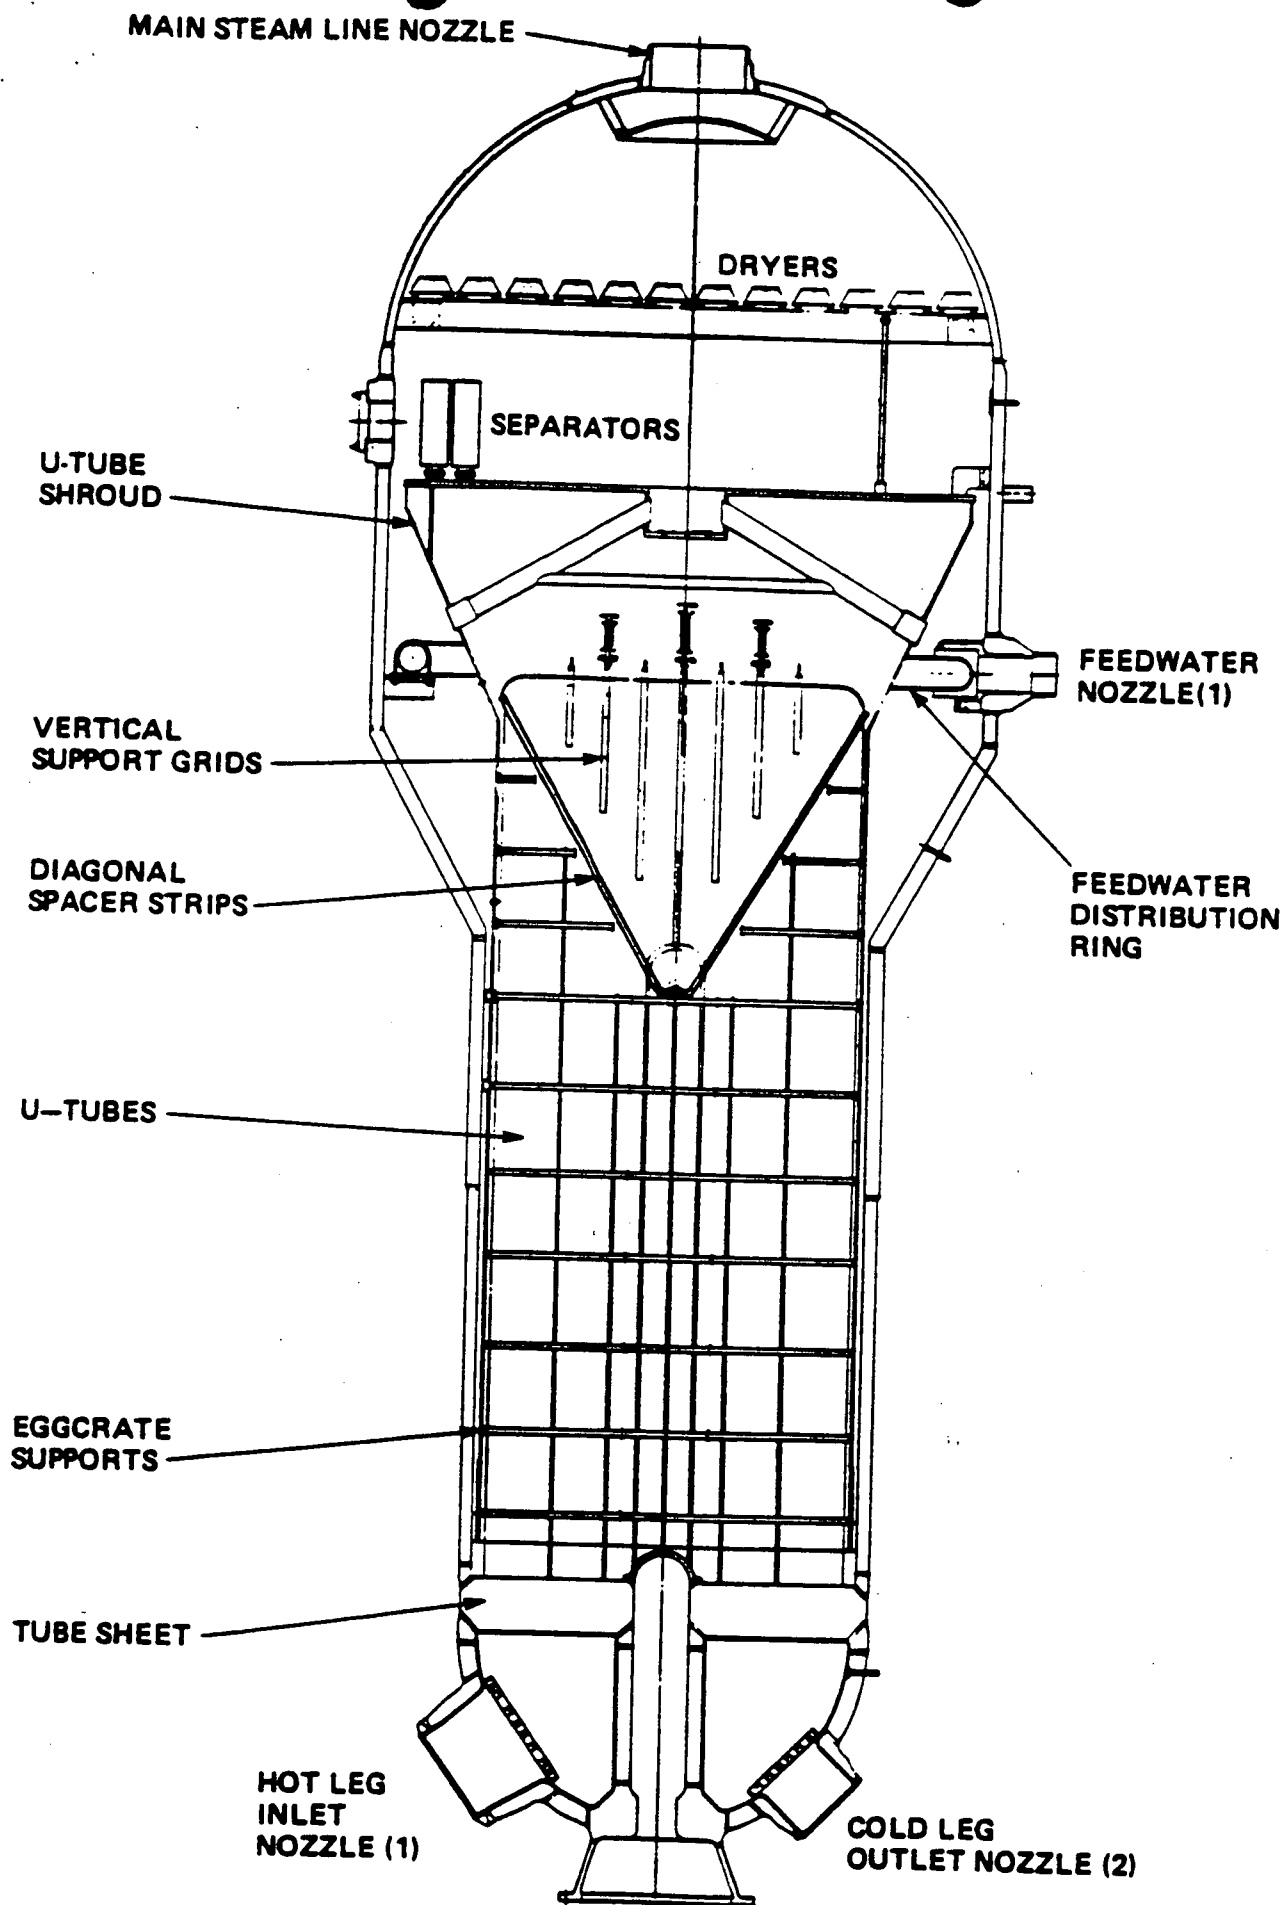
FIGURE 1 SONGS-2 STEAM GENERATOR ARRANGEMENT

Each steam generator contains 9350 mill annealed inconel 600 tubes arrayed in a triangular pitch U bundle. These tubes are supported along their vertical lengths by seven full diameter eggcrate supports and three partial diameter eggcrate supports (see Figure 1). The bend and horizontal lengths of the tubes are supported by diagonal ("batwing") straps, which cross the tubes just below the start of the bend, and as many as seven vertical support straps, depending on the horizontal length of the tube (see Figure 2). The vertical straps are connected in the out-of-plane dimension by horizontal straps. A stay cylinder is installed at the central portion of the tubesheet to permit reduction of tubesheet thickness. The region above the stay cylinder cannot be tubed, and forms a hollow cavity at the center of the tube bundle.

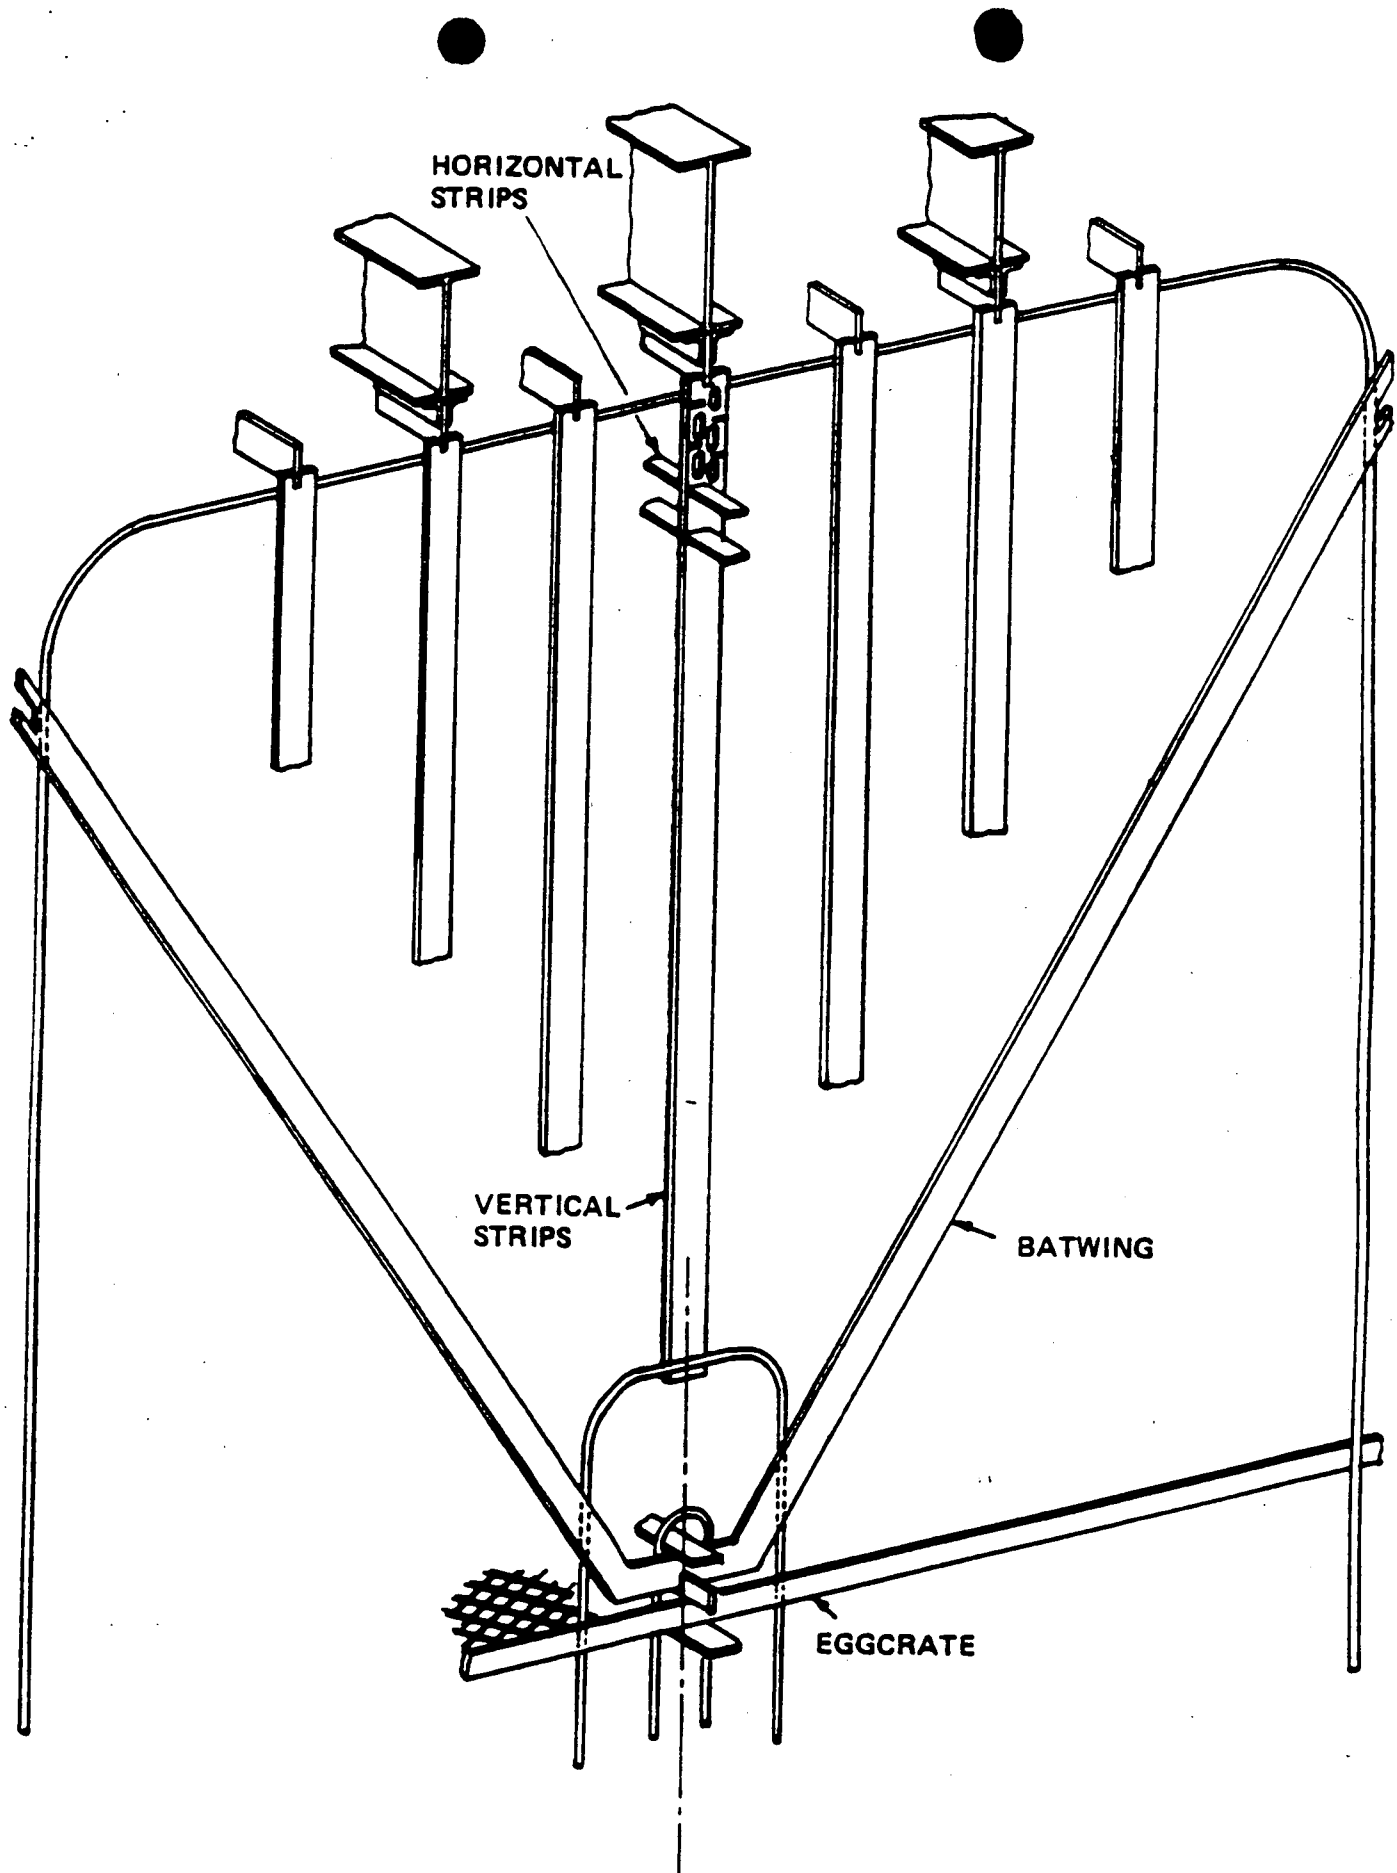
FIGURE 2  
SONGS-2 STEAM GENERATOR BEND REGION TUBE SUPPORTS
