Braidwood Station, Units 1 and 2  
Facility Operating License Nos. NPF-72 and NPF-77  
NRC Docket Nos. STN 50-456 and STN 50-457

Byron Station, Units 1 and 2  
Facility Operating License Nos. NPF-37 and NPF-66  
NRC Docket Nos. STN 50-454 and STN 50-455

**Subject:** Responses to NRC Requests for Additional Information, Set 3, dated November 25, 2013, related to the Braidwood Station, Units 1 and 2, and Byron Station, Units 1 and 2 License Renewal Application

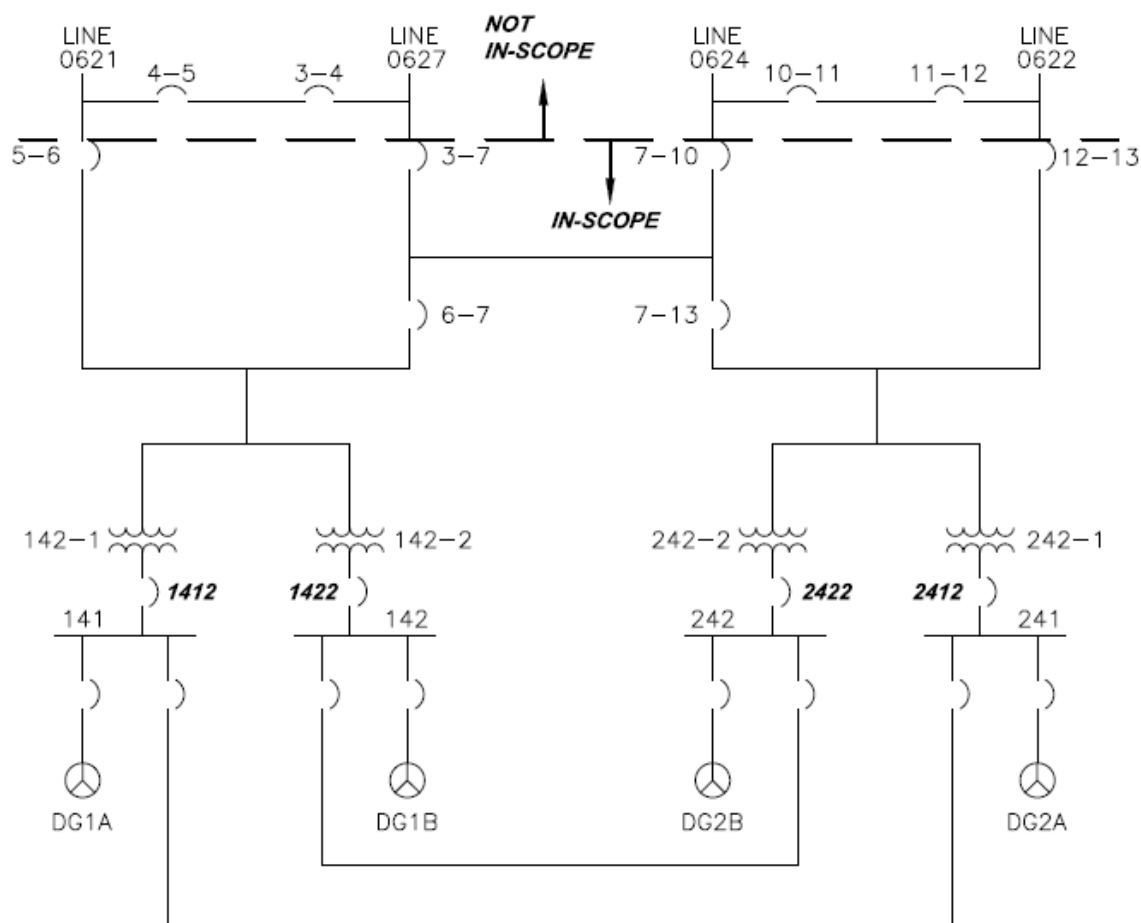
**Figure 2.1-2**

BYRON SBO RECOVERY BOUNDARY

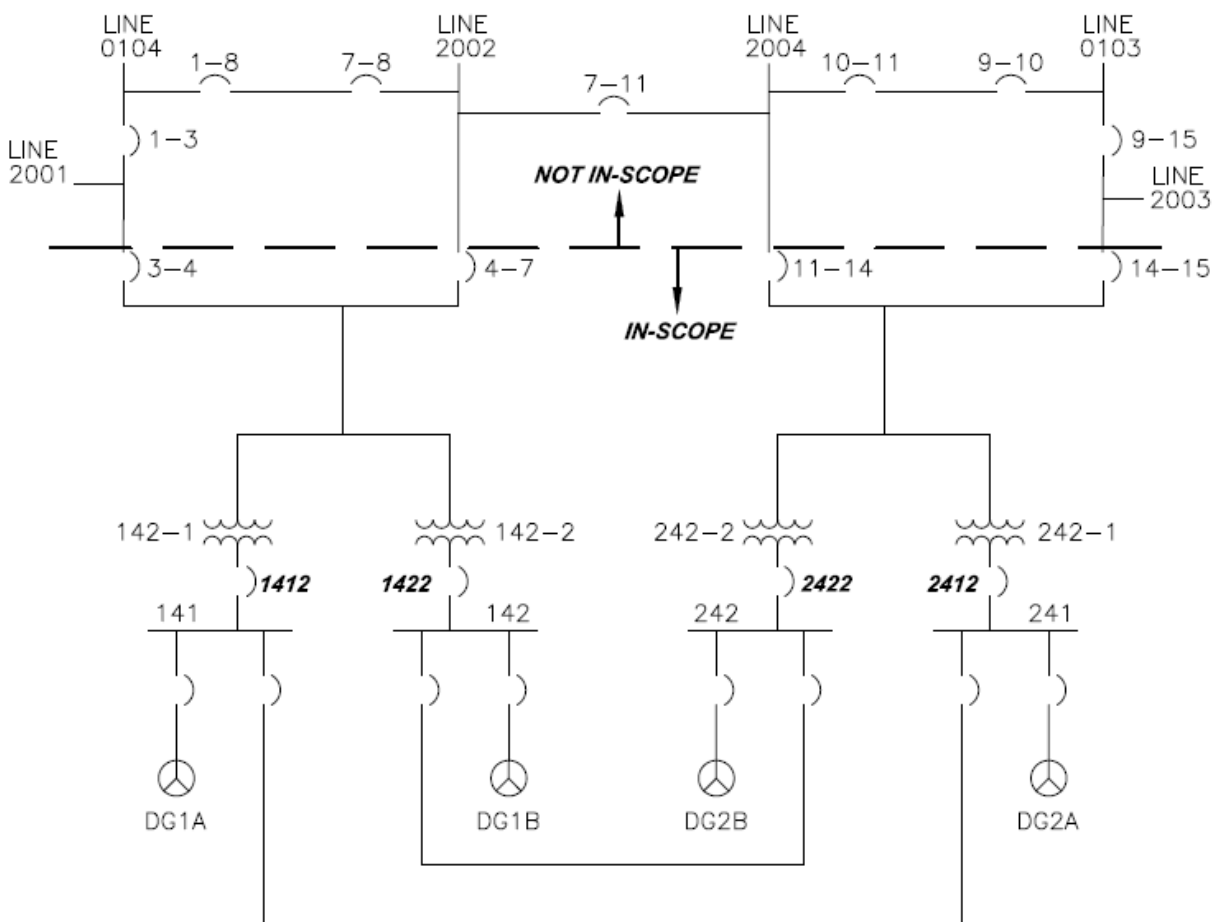
**Figure 2.1-3**

As a result of the responses to RAI 2.1.3.4-3 and 2.1.3.4-4 provided in Enclosure A of this letter, LRA Figure 2.1-3, page 2.1-15, "Braidwood SBO Recovery Boundary," is revised as shown below:

BRAIDWOOD SBO RECOVERY BOUNDARY
