SRR Annual Radioactive Waste Tank Inspection Program—CY2012
(SRR-STI-2013-00321)

**SRR Annual Radioactive Waste Tank Inspection Program–CY2012
(SRR-STI-2013-00321)**

Annual Radioactive Waste Tank Inspection Program - 2012

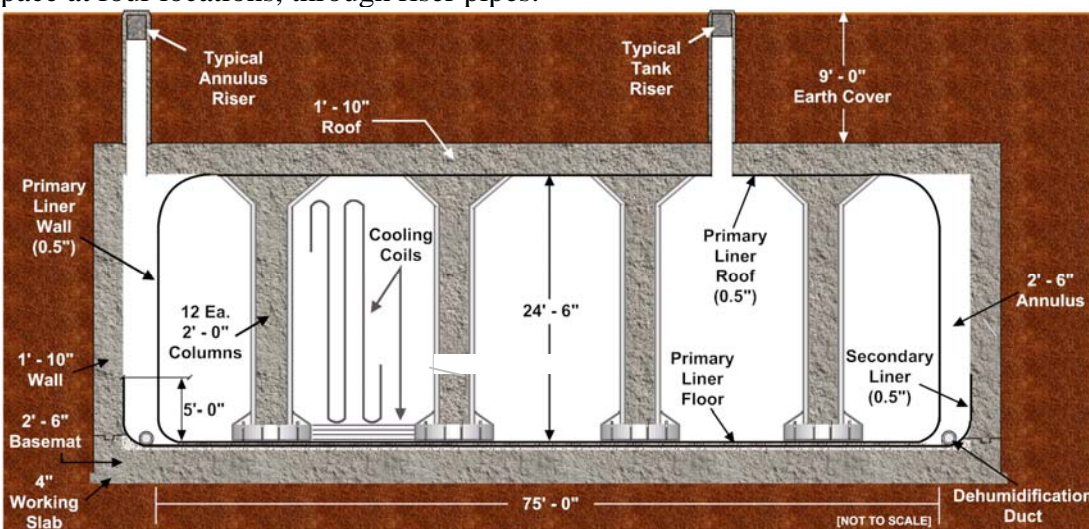
Figure 1. Cooled Waste Storage Tank, Type I (Original 750,000 Gallons).

The 12 original storage tanks constructed between 1951 and 1953 are designated Type I tanks. Tanks 1 through 8 are in F Area and Tanks 9 through 12 are in H Area. Each primary tank has a capacity of 750,000 gallons. Figure 1 shows the general features of Type I tanks, including the primary tank, the secondary pan, and the concrete support structure.

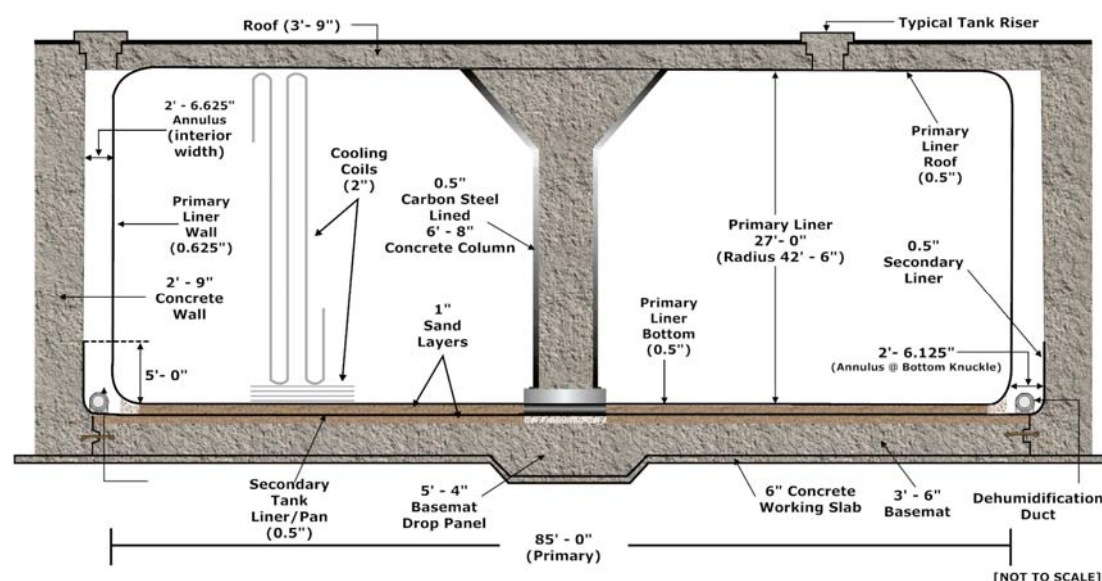
Figure 2. Cooled Waste Storage Tank, Type II (Original 1,030,000 Gallons).

Tanks 13 through 16, constructed in H Area in 1955 and 1956, are designated Type II tanks. Figure 2 is a cross section of this type of tank. Each primary tank has a capacity of 1,030,000 gallons.

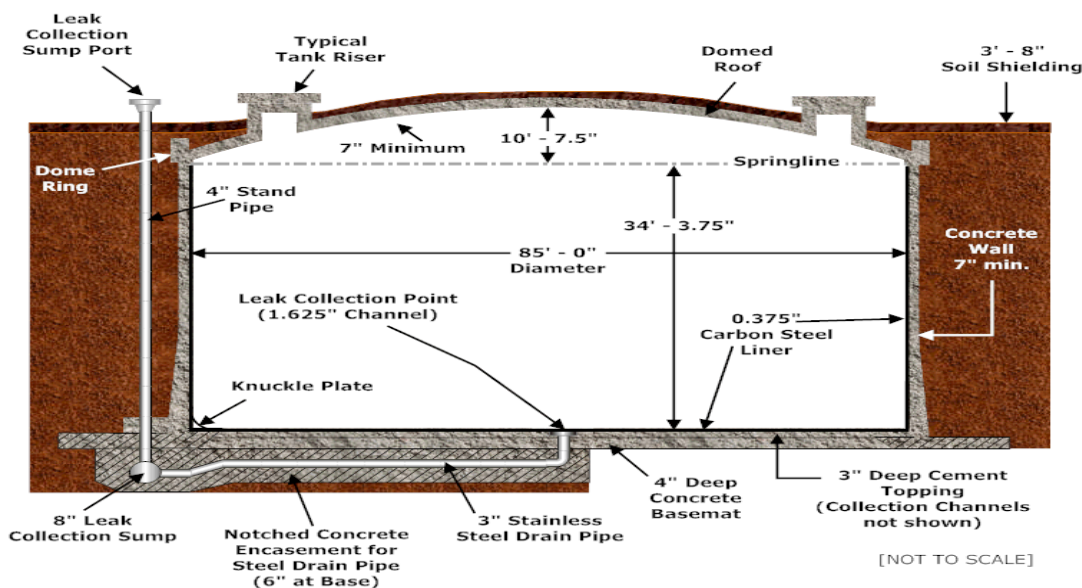
Figure 3. Uncooled Waste Storage Tank, Type IV (Prestressed Concrete Walls, 1,300,000 Gallons).

Area in 1960. Each tank has a capacity of 1,300,000 gallons. Figure 3 shows the general features of Type IV tanks. Each Type IV tank is basically a steel-lined, prestressed-concrete tank in the form of a vertical cylinder with a domed roof. Carbon steel plates were used to form the cylindrical sides and flat bottom portion of the steel liners. Concrete was built up around the steel vessel by the "shotcrete" technique.

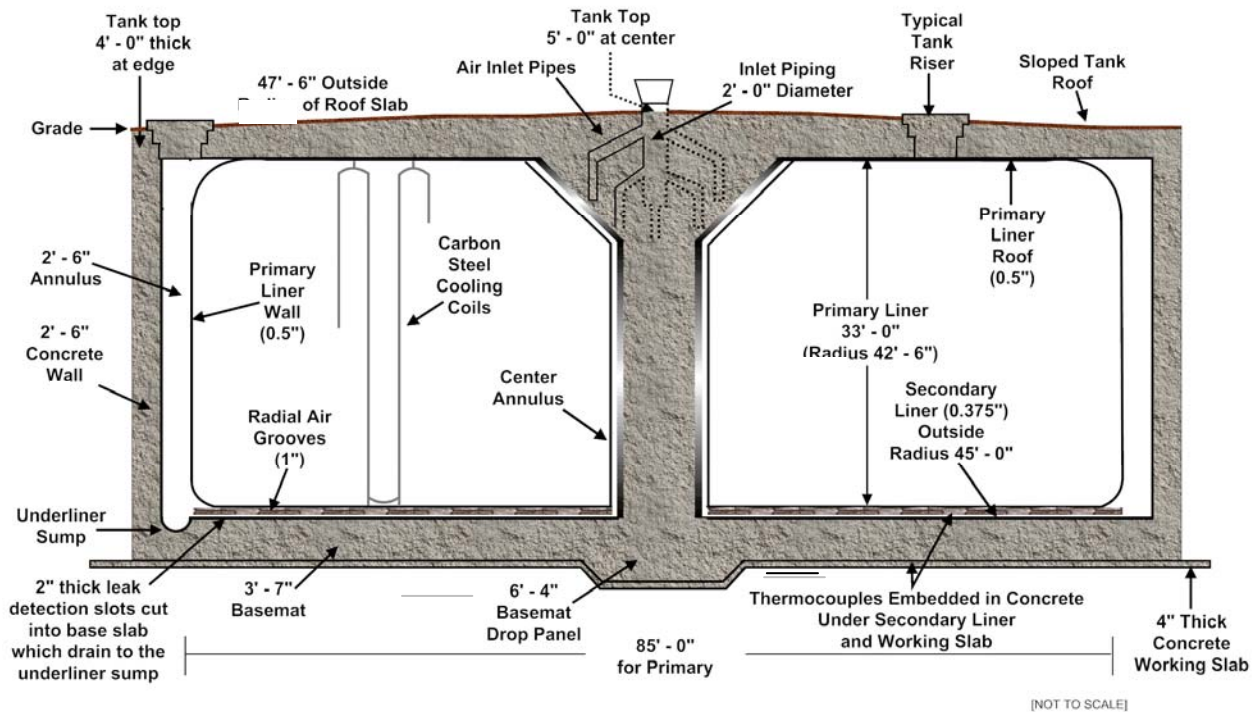
Figure 4. Cooled Waste Storage Tank, Type III (Stress Relieved Primary Liner, 1,300,000 Gallons).

The most recently constructed tanks are designated as Type III tanks (Figure 4). Twenty-seven tanks were built between 1966 and 1981. Figure 4 shows the general features of the Type III tanks. Type III tanks are designated as compliant. The Type III tank design was developed after an investigation into the causes of the leaks from the primary vessel of the Type I and Type II tanks. The study concluded that the leak-producing mechanism was nitrate-induced, stress-corrosion cracking at sites in or near the weld seams, and that stress relieving after fabrication should eliminate the cracking. For the Type III tanks, means were provided for heating each finished tank to relieve the stresses generated during fabrication. In addition, some stress patterns were avoided, or minimized, by mounting the roof supporting column on the
