Seismic Walkdown Report In Response To The 50.54(f) Information Request Regarding
Fukushima Near-Term Task Force Recommendation 2.3: Seismic, Updated
Transmittal #1 (Annex A) for the Three Mile Island Nuclear Station, Unit 1,
Report No. RS-14-032

SEISMIC WALKDOWN REPORT

UPDATED TRANSMITTAL # 1 (ANNEX A)

THREE MILE ISLAND GENERATING STATION UNIT 1
ROUTE 441S P.O. BOX 480, MIDDLETON PA 17057
Renewed Facility Operating License No. DPR-50
NRC Docket No. 50-289
Correspondence No.: RS-14-032

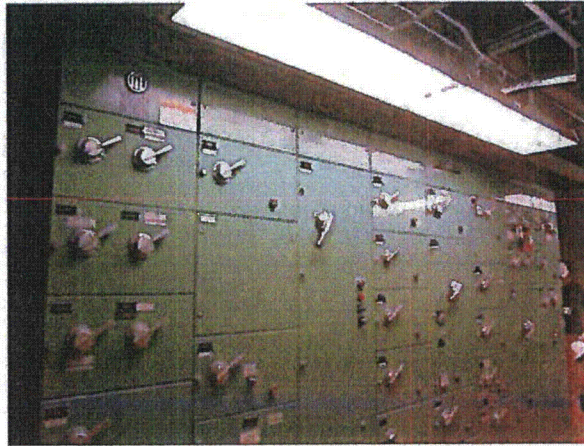
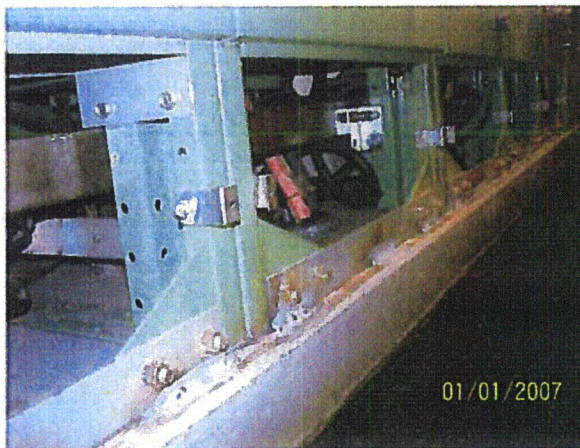
Equipment Description: 480V ENGINEERED SAFEGUARDS MCC 1B

Loose/Felt bolt found inside MCC. Bolt had no structural function. considered Foreign Material, not operability concern. IR 1584220

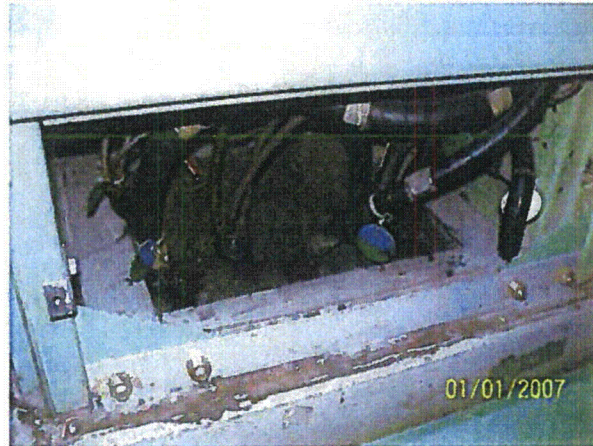
Equipment Description: 480V ENGINEERED SAFEGUARDS MCC 1B

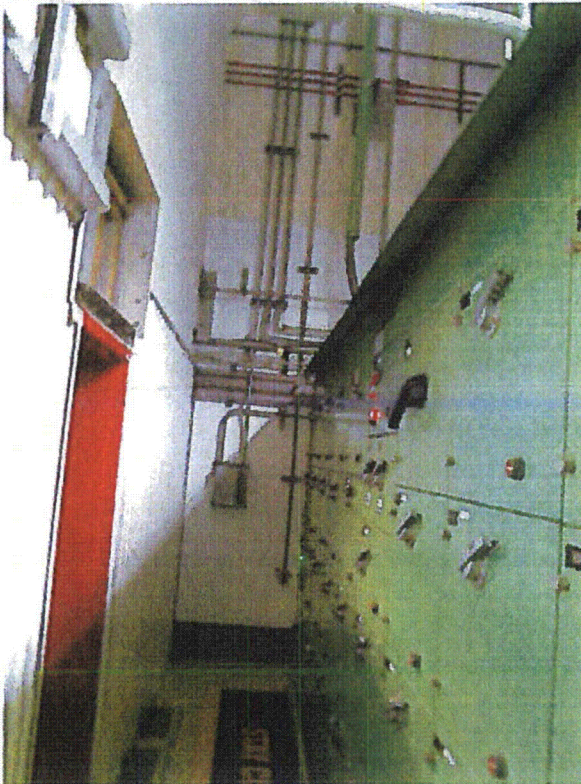
Equipment Description: 1B ENGINEERED SAFEGUARDS VALVES & HEATING CONTROL CENTR

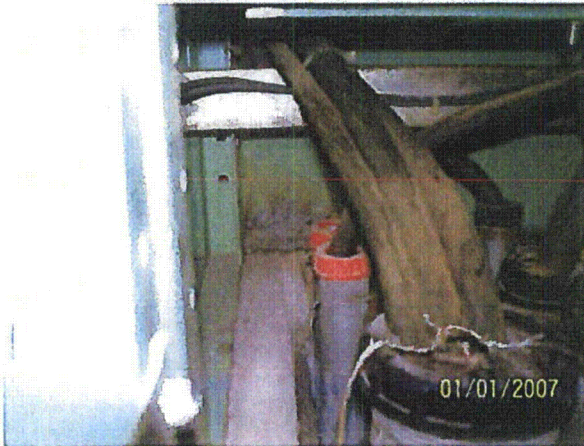
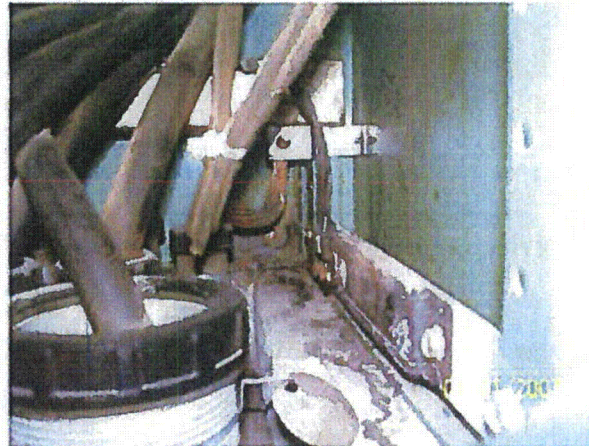
Equipment Description: 1B ENGINEERED SAFEGUARDS VALVES & HEATING CONTROL CENTR

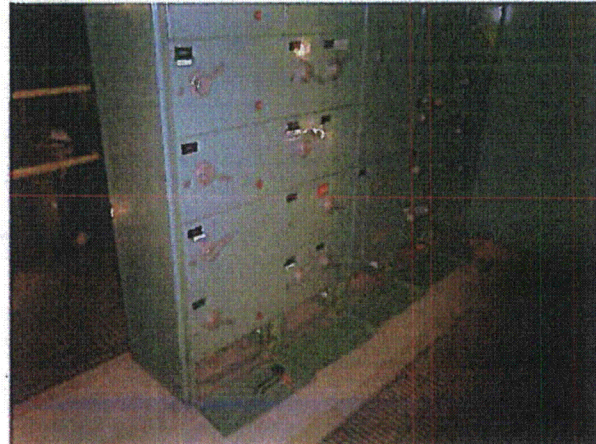
Equipment Description: 480V SCREEN HOUSE ENGINEERED SAFEGUARDS MCC 1B

9. Do attached lines have adequate flexibility to avoid damage? ☒ Y ☐ N ☐ U ☐ N/A
some rigid conduit adequate per comment ①

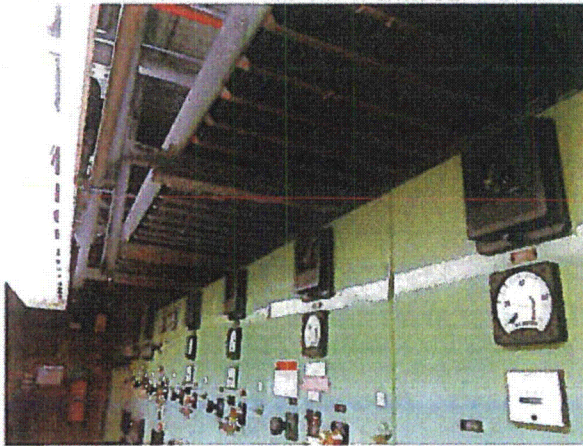
Equipment Description: 4160V ENGINEERED SAFEGUARDS BUS 1E

11. Have you looked for and found no adverse seismic conditions that could adversely affect the safety functions of the equipment? Yes
- Performed internal inspection and did not find any Other Adverse Conditions. Partial inspection was performed by opening two cubicles. The other Cubicles would not be opened by Operations due to the fact that they were energized. Internals and anchorage at the back of the cabinet was inspected through grating. There were no issues found in the areas. Therefore, the intent of no other adverse conditions is met.*

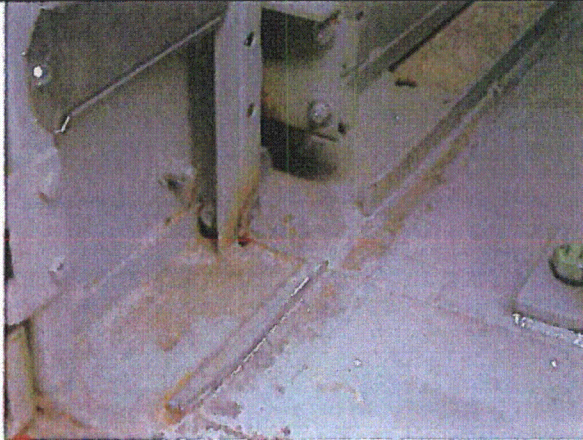
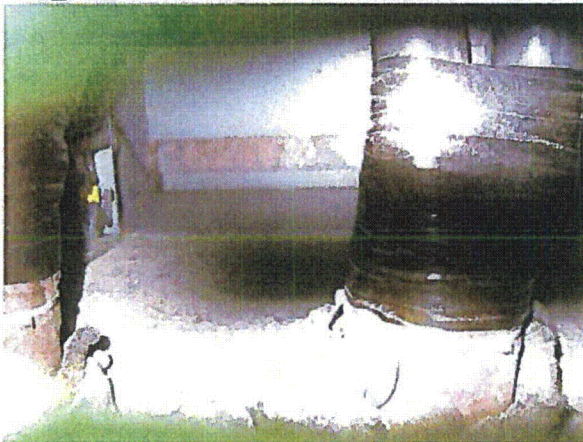
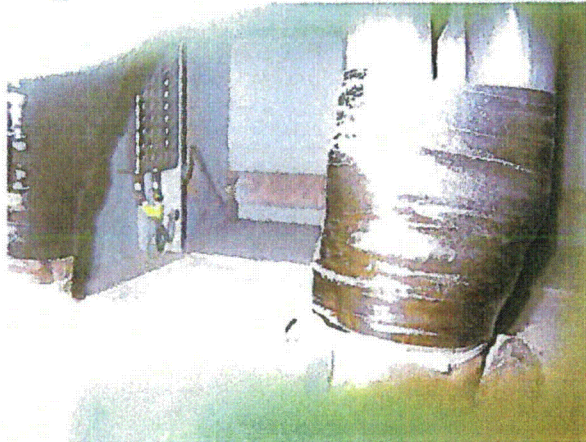
Equipment Class: (3) Medium Voltage Switchgear

Equipment Description: 4160V ENGINEERED SAFEGUARDS BUS 1E

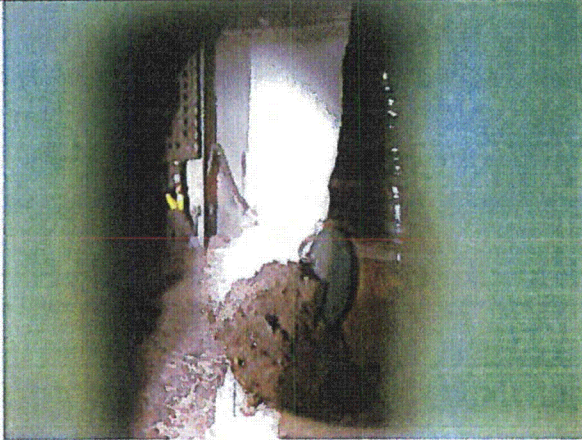
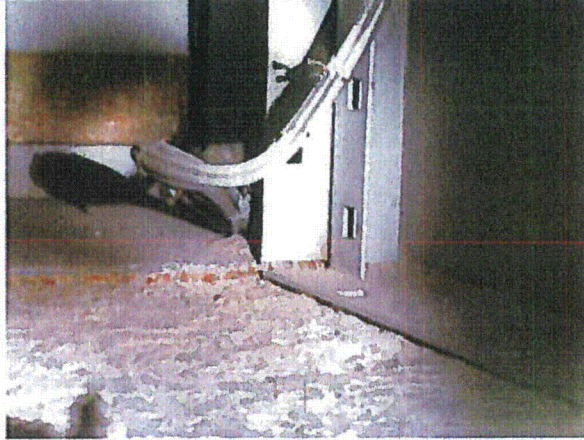
Equipment Class: (3) Medium Voltage Switchgear

Equipment Description: 4160V ENGINEERED SAFEGUARDS BUS 1E

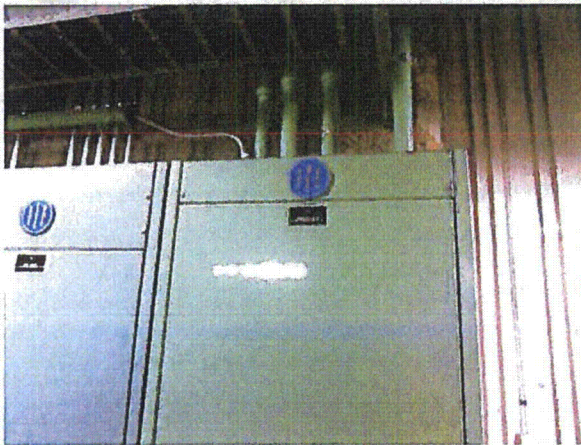
Equipment Description: 125/250V DC ES DIST PANEL 1F

Panel 1J adjacent to 1F-DC has taped door due to broken latch. No sensitive equipment, therefore OK.
