SUBJECT: Submits addl info re TS change re turbine overspeed protection valve testing frequency.

10 CFR 50.90

**Carolina Power & Light Company**

Serial: RNP-RA/95-0041

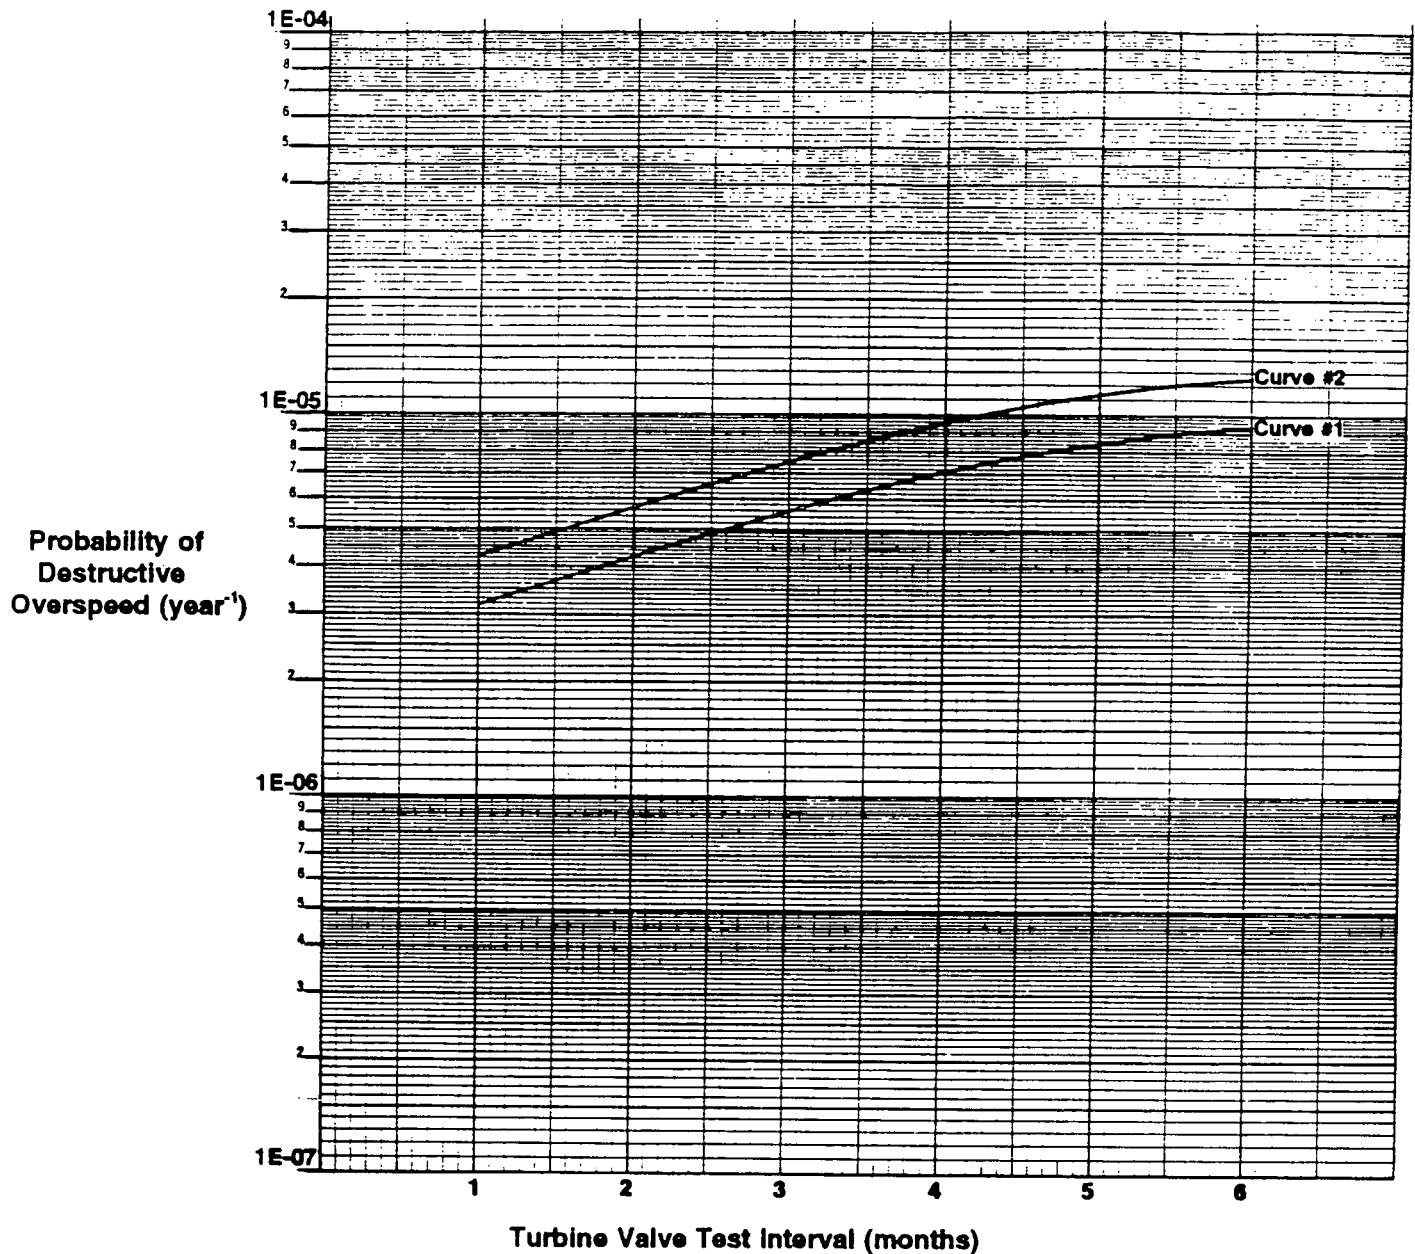
**ANNUAL FREQUENCY OF DESTRUCTIVE OVERSPEED  
FOR VARIOUS BB-95/96 TURBINE VALVE TEST INTERVAL**  
(1-on-1 SV-CV Turbine / 1 out of 4 Steam Paths)

Initial Case

**Curve #1:** Surveillance of stop valve discs occurs every 18 months. Testing of valve freedom of movement occurs at intervals of 1 to 6 months (horizontal axis).

**Curve #2:** Surveillance of stop valve discs occurs every 24 months. Testing of valve freedom of movement occurs at intervals of 1 to 6 months (horizontal axis).

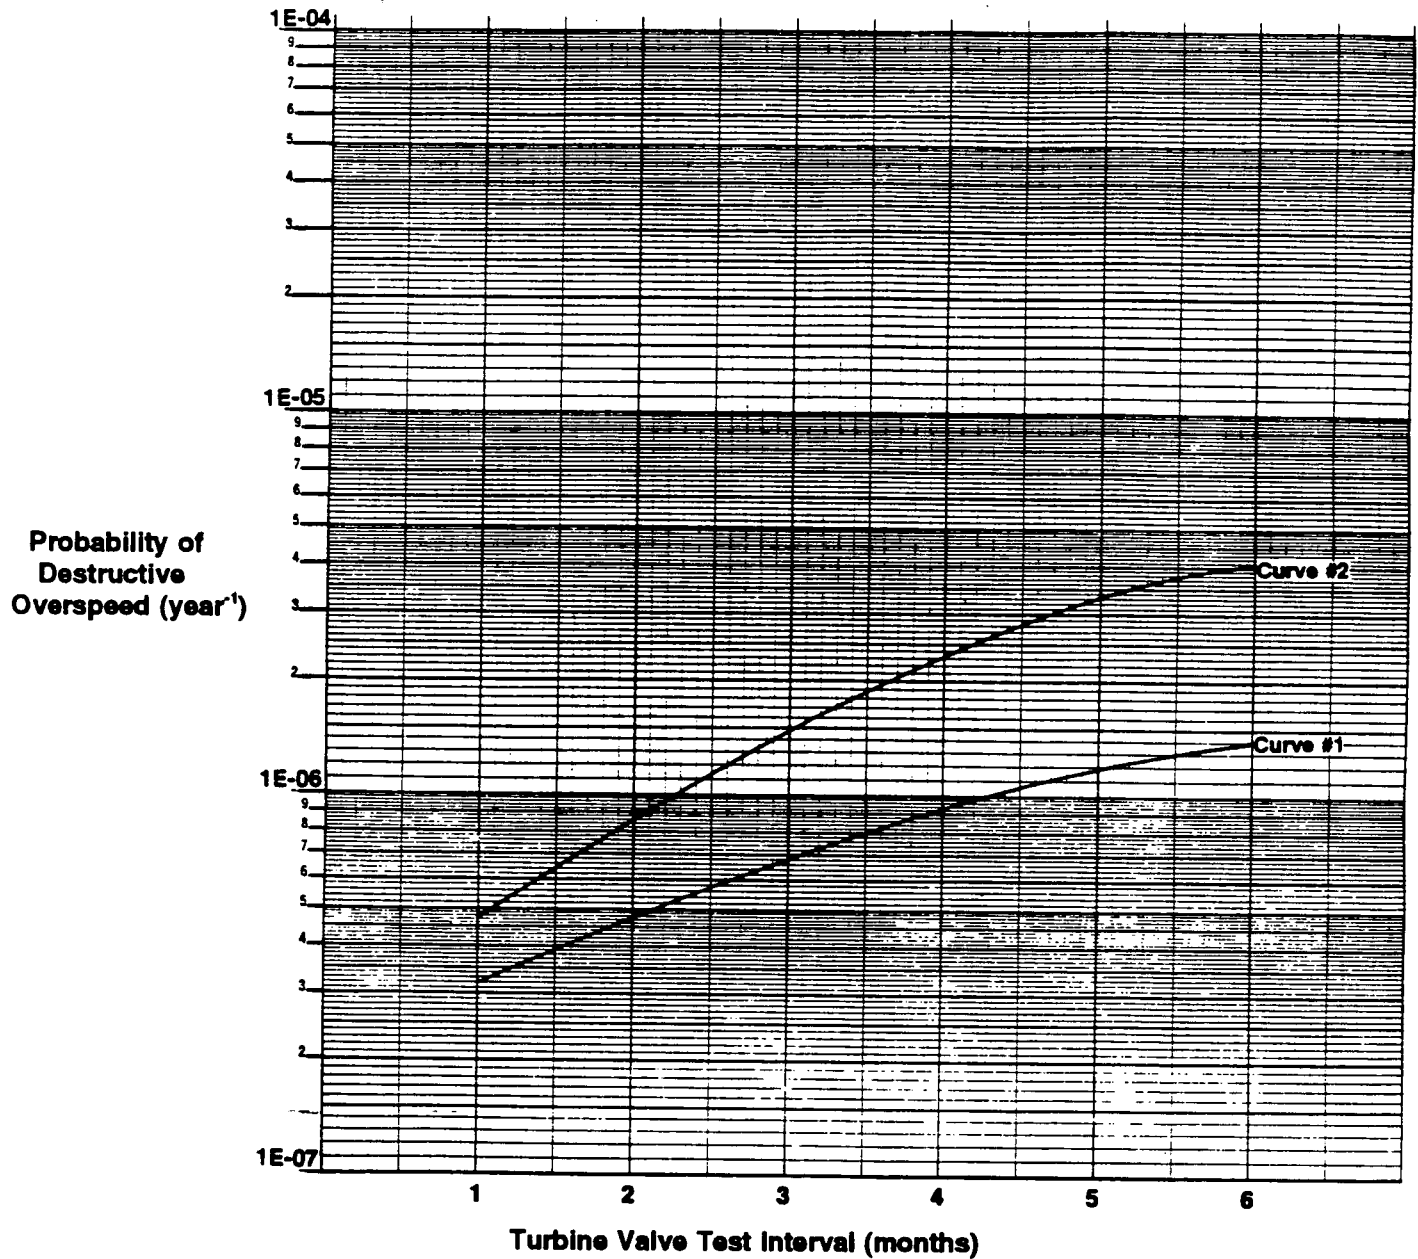
**ANNUAL FREQUENCY OF DESTRUCTIVE OVERSPEED  
FOR VARIOUS BB-95/96 TURBINE VALVE TEST INTERVAL**  
(1-on-1 SV-CV Turbine / 1 out of 4 Steam Paths)

Revised Case: 18-mo Refueling Interval

- Curve #1:** Surveillance of stop valve discs occurs once a day. Testing of valve freedom of movement occurs at intervals of 1 to 6 months (horizontal axis).
- Curve #2:** Surveillance of stop valve discs and testing of valve freedom of movement occur concurrently at intervals of 1 to 6 months (horizontal axis).
