SUBJECT: Forwards info re potential for steam generator water hammer  
 at PWRs w/ feedrings that discharge from bottom, in response  
 to NRC 790918 request.

H. B. ROBINSON STEAM ELECTRIC PLANT, UNIT NO. 2

DOCKET NO. 50-261

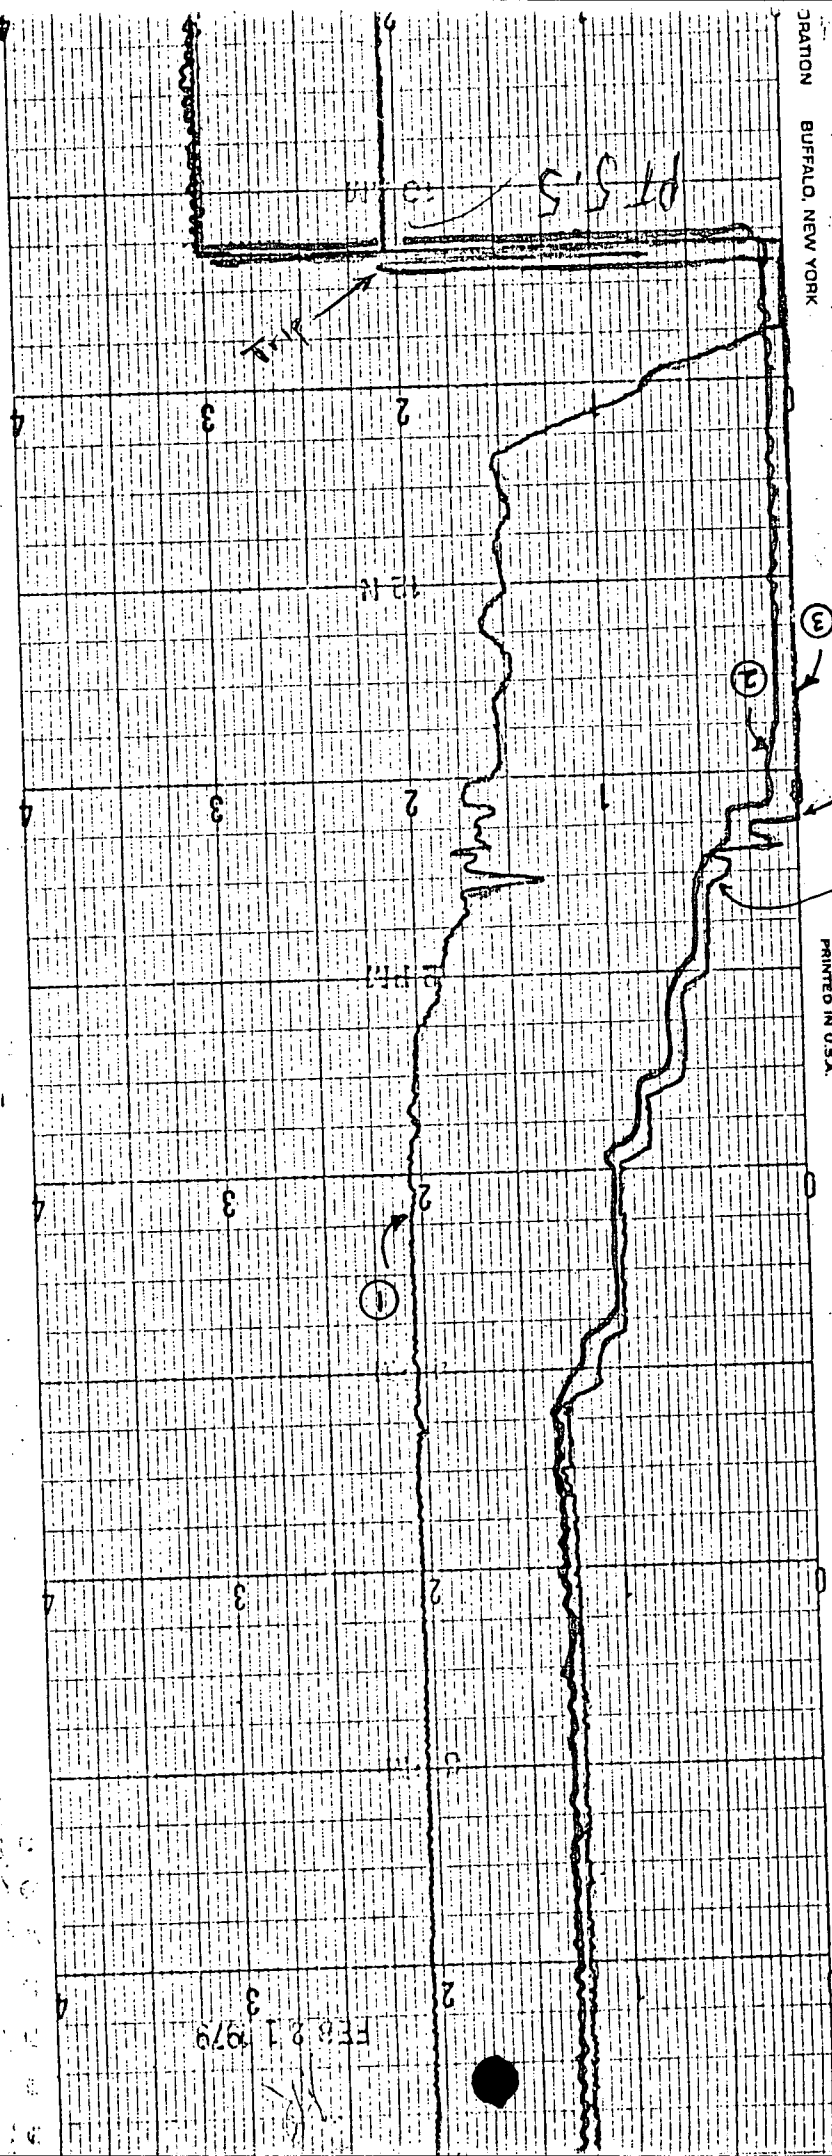
ATTACHMENT 1

# TRIP FROM 100% R<sub>s</sub> Power at 1029 on 2-21-79

- ① ——— A'  $\frac{5}{6}$  NARROW RANGE LEVEL (0-4 ON SCALE = 0-100%)
- ② ——— A'  $\frac{5}{6}$  STEAM FLOW (0-4 ON SCALE = 0-4 lbs./hr.  $\times 10^6$ )
- ③ ——— A'  $\frac{5}{6}$  FEED FLOW (SAME AS STEAM FLOW)

return to power  
feedwater to auto

FEB 21 1979

Plant Modification #490 provided instrumentation for two feedwater lines, as previously described in Section 7.0 of the July 10, 1979 letter to Mr. Albert Schwencer from Mr. E. E. Utley. Data gathering has been completed and no further action is planned. Data collected during a reactor trip from 30% power was included with no apparent evidence of water hammer observed.
