Carolina Power & Light Company

H. B. ROBINSON UNIT NO. 2
DOCKET NO. 50-263
LICENSE NO. DPR-23

RESPONSE TO QUESTIONS ON SPENT FUEL SHIPPING CRANE

CP&L RESPONSES TO NRC REQUESTS
FOR ADDITIONAL INFORMATION ON THE
SPENT FUEL CASK HANDLING SYSTEM
H. B. ROBINSON UNIT NO. 2, DOCKET NO. 50-261

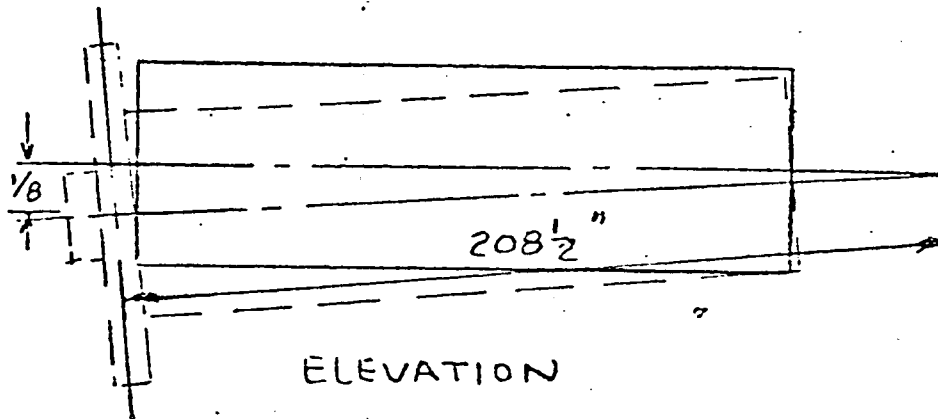
MISALIGNMENT OF GEARING DUE TO SHAFT FAILURE

$$\theta = \sin^{-1} \frac{.125}{208.5}$$

$$\theta = .035^\circ$$
