Grants Reclamation Project

RE: **Grants Reclamation Project** – Cibola County, NM
Homestake Comments on "Focused Review of Specific Remediation Issues -
An Addendum to the Remediation System Evaluation for the Homestake Mining
Company (Grants) Superfund Site, New Mexico" – February 2010

**Homestake Mining Company's Response to
Recommendations Contained in the U.S. Army Corps of Engineers'
Focused Review of Specific Remediation Issues:**

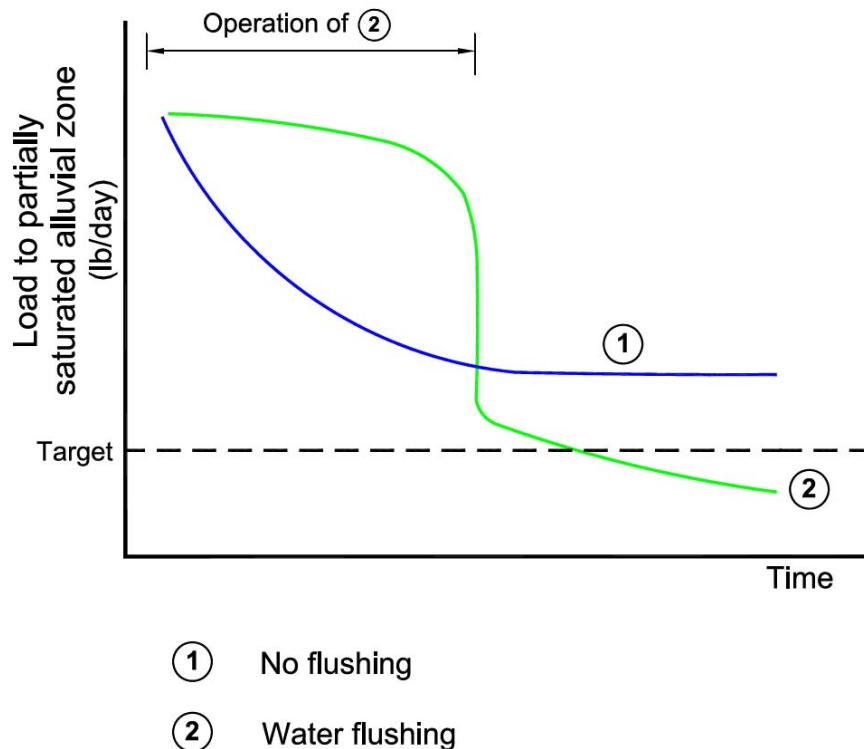
Figure 1. Conceptual performance of the large tailings pile with and without flushing.

Figure 1 depicts that, although uranium concentrations in the partially saturated alluvial zone beneath the tailings pile remain elevated for a period of time during flushing (line labeled “2” in Figure 1), the load to the partially saturated alluvial zone beneath the tailings is much more effectively controlled. Flushing provides a means to achieve concentrations well below the target corresponding to a concentration of 2 milligrams per liter (mg/L) underneath the tailings. Without flushing, uranium load drops off gradually, but concentrations remain high and, due to continual draindown of pore water with elevated concentrations of uranium, the target is never achieved (line labeled “1” in Figure 1). The Executive Summary of the ACOE report states as one of the conclusions that the seepage modeling likely overestimates the efficiency of flushing of the tailing; however, this is not the case. The model has been able to represent performance of the flushing program. There is currently a slight lag between actual and predicted performance because of the inability to flush at full capacity due to the lack of adequate evaporative capacity; however, this is not a function of model predictability and reliability. The flushing program can now proceed as planned in light of the recent approval of DP-725 and construction of Evaporation Pond 3 (EP-3).

HMC has evaluated the success of the flushing program in removal of source mass. HMC's response to Recommendation No. 2 (presented later) discusses the mass removed, and Figure 5 of that response shows that the mass is being consistently removed through the flushing program. As noted by the ACOE, there is a large amount of heterogeneity in the hydraulic conductivities within the pile due to the presence of low-permeability zones, principally composed of tailings slimes. However, the flushing program works to overcome this heterogeneity and provide the driving force for the movement of soluble uranium out of these low-permeability zones. Figure 1 provides a conceptual illustration of the performance of the flushing program.

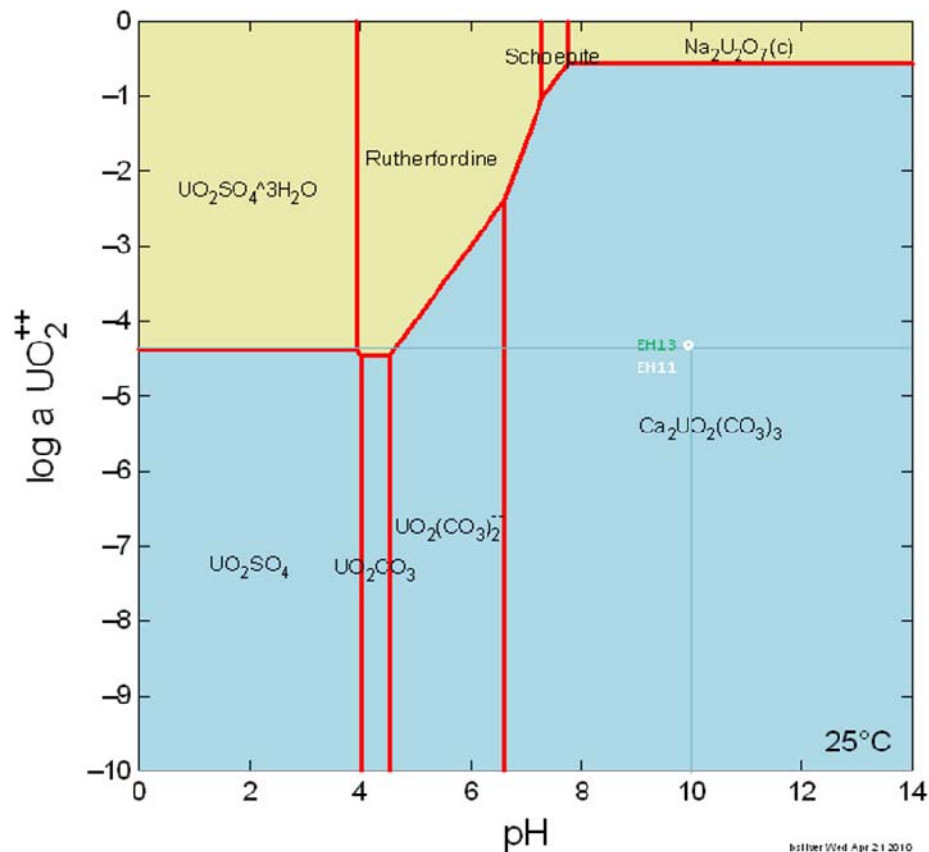
Geochemical modeling indicates that, at the pH of the pore water (pH 10), uranium is present as the soluble calcium uranium carbonate complex (Ca₂UO₂(CO₃)₃) in the tailings pore water. The soluble forms of uranium are dominant in the tailings pore water due to the excess of bicarbonate relative to uranium (Table 1), and similar concentration of calcium. Under these conditions, it is highly unlikely that any solid phase uranium can persist beyond the completion of flushing and remain available for re-dissolution. Studies have shown that uranium present as uranyl carbonate or calcium uranium carbonate is very poorly sorbed by solid mineral phases (Zheng et al. 2003), and this further supports the conceptual model based on soluble uranium resident in tailings pore water. Uranium solid phases are under-saturated (prone to dissolution), and are not expected to form at the uranium concentration and pH conditions in the pore water (solid phase forms of uranium are depicted in Figure 2 as yellow areas; soluble uranium is shown as blue areas).

Figure 2. Results of geochemical modeling of uranium chemical speciation as a function of uranium concentration and pH. Note that the wells screened in the tailings, EH-11 and EH-13, are shown on the figure, with uranium present as the calcium uranium carbonate soluble complex in these wells. Note that the y-axis shows the log of the activity of uranium (uranium concentration).

tailings pore water chemistry for well EH-11, screened within the tailings impoundment, is provided in Table 1. The results of geochemical modeling to predict uranium chemical speciation, based on the tailings pore water chemistry, are provided in Figure 2.

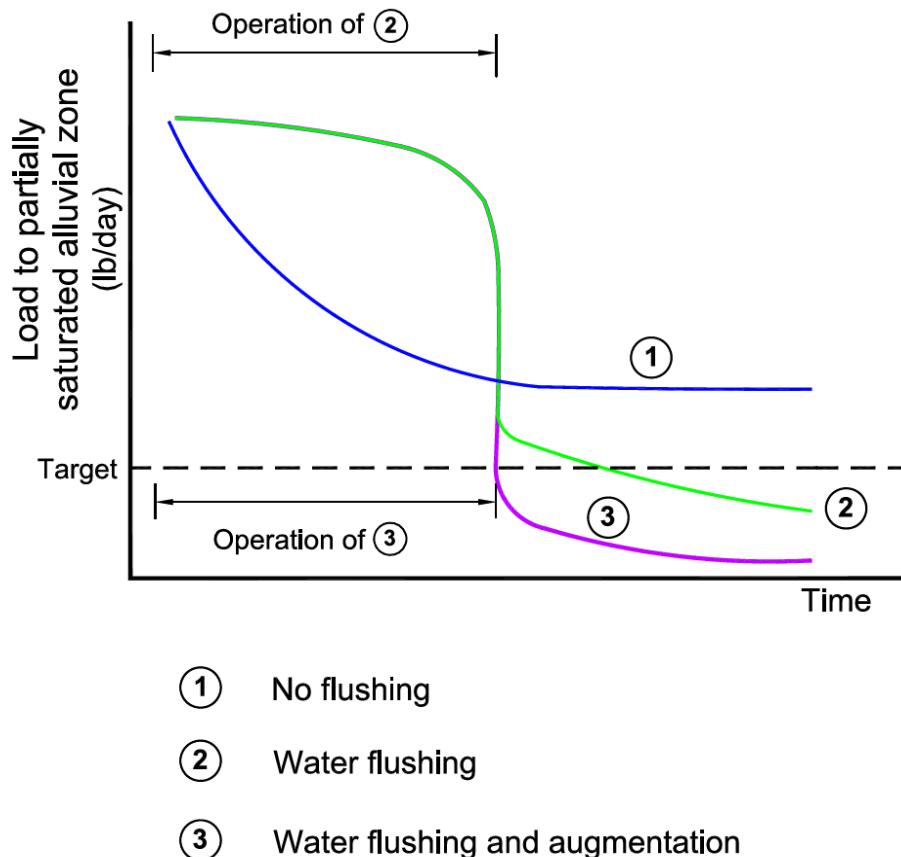
Figure 3. Conceptual remedial performance of the large tailings pile with and without flushing, and with flushing and an augmentation approach.

With respect to ACOE's evaluation of an in-situ immobilization approach, continuation of the flushing program will provide the ability to transition to an approach to stabilize uranium leaching to the partially saturated zone through an augmentation program if determined appropriate. The augmentation program may be implemented at the appropriate time when it can be most effective, after flushing has been completed. Figure 3 illustrates the potential benefit of an augmentation approach.

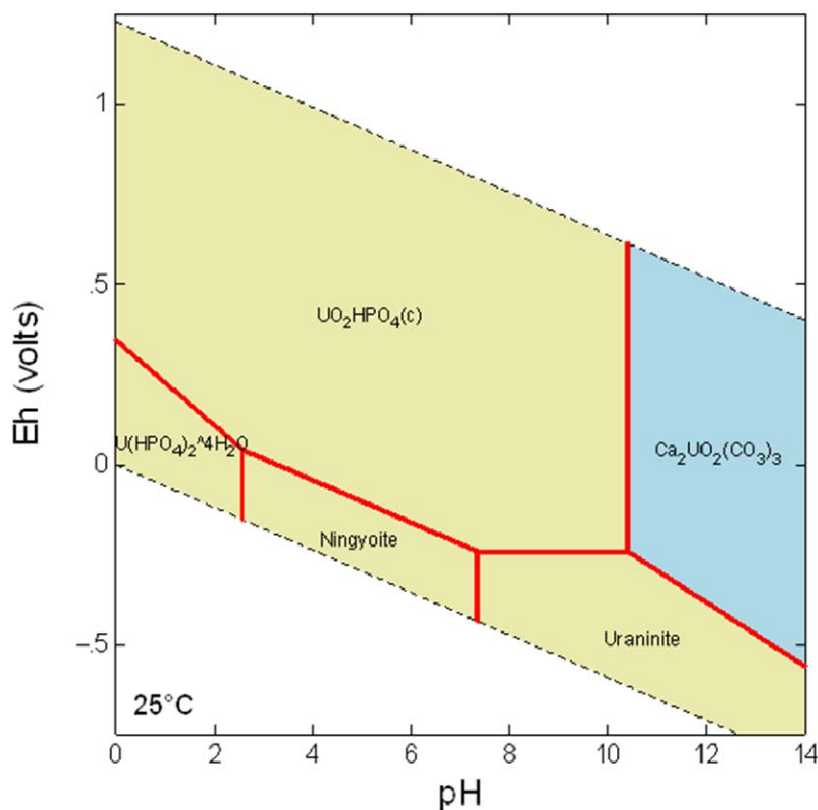
Figure 4. Evaluation of the addition of 1 mM (30 mg/L) of phosphate to the tailings pore water (water chemistry provided in Table 1). The result of the phosphate addition is precipitation of uranium as $\text{UO}_2\text{HPO}_4(\text{c})$, an insoluble uranium phosphate mineral phase (yellow shaded region on the figure shows the stability field of solid forms of uranium; the blue shaded area shows the stability field of soluble uranium). Note that the y-axis shows Eh, or a measure of the oxidation-reduction potential (redox).

Because of the known occurrence and relatively low permeability of fine-grained materials (slimes) in the large tailings pile, and the presence of dissolved uranium in the slimes, an option is to create insoluble forms of uranium through the addition of a phosphate amendment. A preliminary geochemical modeling evaluation has been performed for the current uranium chemistry prevalent in the large tailings pile. The aqueous geochemistry data for wells EH-11 and EH-13 indicate that the prevalent forms of uranium in the tailings are soluble uranyl carbonates (Figure 2). A phosphate amendment (HPO_4^{3-}) was simulated and the minerals and aqueous species with a phosphate treatment solution were found to be stable over most of the pH range. This was simulated through a geochemical modeling evaluation of the addition of phosphate to the tailings (Figure 4). These initial conclusions suggest that the flushing of the tailings should be continued to remove the soluble uranium present in the slimes, then the remaining low levels of uranium could be fixed by introduction of a phosphate amendment to form insoluble uranium phosphate minerals, or another amendment that is proven to assist in remediation. The modeling results, therefore, validate that an in-situ immobilization approach using sodium tripolyphosphate (reviewed by the ACOE in Section 4.4.3) is feasible; this will be

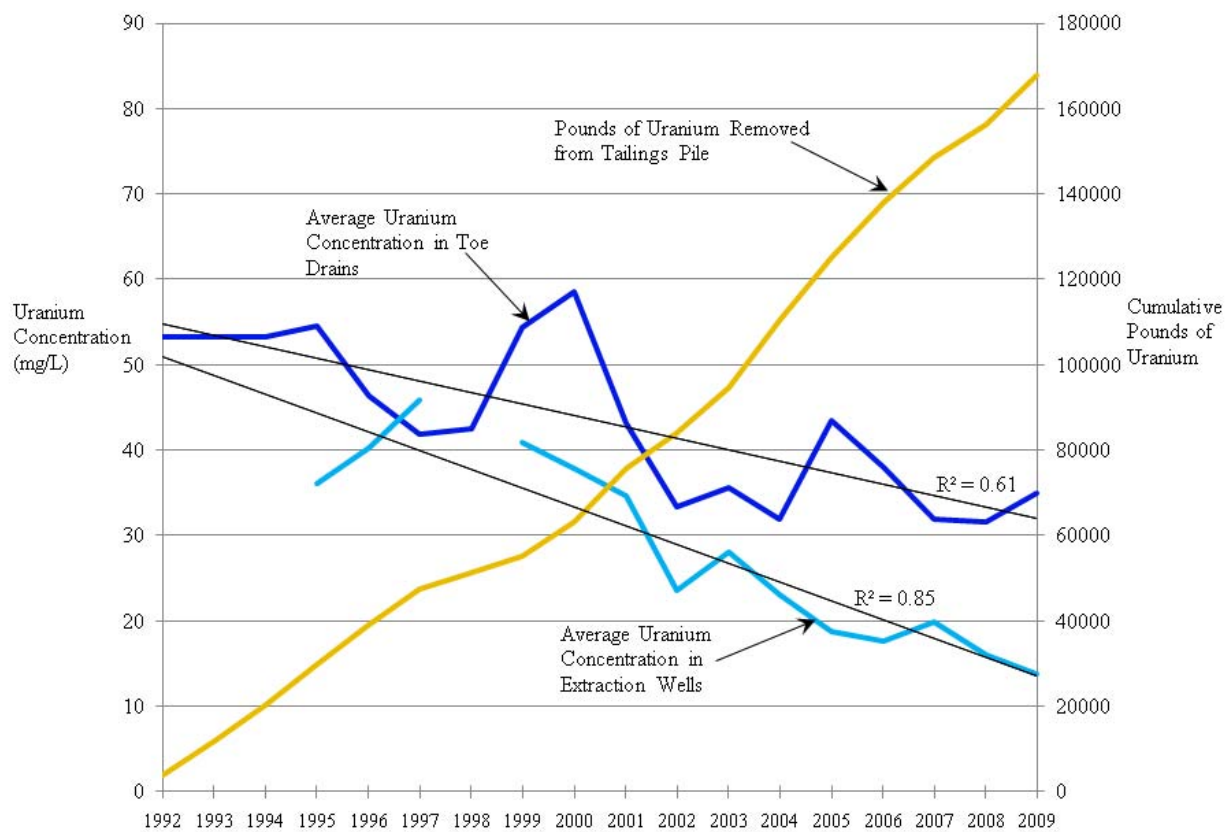
Figure 5. Mass of uranium removed by the large tailing pile extraction wells and toe drains and decreasing uranium concentrations.

The effectiveness of the combined flushing and extraction system can be measured by the mass of uranium removed from the tailings. A graph of the total mass of uranium removed by the toe drains along the perimeter of the tailings pile and extraction wells in the tailings since 1992 is provided as Figure 3. The toe drains began in 1992, whereas the extraction wells began operation in 1995. The cumulative mass of uranium removed from the tailings reached approximately 170,000 pounds by the end of 2009, and the removal rate has been relatively steady through time, indicating that the system continually removes a substantial amount of uranium in addition to other constituents such as sulfate, molybdenum, and selenium that also have similar and steady removal rates. This amount of uranium is no longer available to leach and migrate into the alluvial aquifer.

The effectiveness of the system is also measured in the overall reduction in uranium concentration within the tailings pile. The annual average uranium concentrations in the extraction wells and toe drains are shown on Figure 5. Uranium concentrations from the extraction wells have decreased from around 40 to 14 mg/L, or an approximate 65 percent reduction since 1995. The decrease in concentrations from extraction wells is steady. A regression trend line was fitted to the extraction well concentration data with a coefficient of determination (R^2) value of 0.85. The coefficient of determination provides a measure of how well future outcomes are likely to be predicted by the model, and in this case the linear regression line. A value near 1.0 indicates that the regression line perfectly fits the data, and the 0.85 value indicates a good fit. The uranium concentration in the toe drains has decreased from 53 to 30 mg/L, or an approximate 34 percent reduction since 1992. The uranium concentration has fluctuated through time but it has an overall decreasing trend, as depicted by the linear regression line that has an R^2 of 0.61. It is important to point out that the toe drains primarily remove tailings water from the permeable sand dikes, and this has not been the focus of flushing remediation to date. Instead, the focus has been on flushing the tailings slimes through the injection and extractions wells, which addresses the low-mobile mass that is difficult to remove. After the mass is removed from the slimes, the system can then focus on the mobile mass in the tailings sands and this is expected to occur relatively quickly. Overall, the system continues to remove uranium and other constituent mass, and concentrations are steadily decreasing.

The ACOE's recommendation states that "dilution" is a significant component of the current remedy. HMC believes that a minor degree of dilution may be occurring, but dilution is not as significant as implied by the ACOE. This is evidenced in the mass of uranium removed and concentrations presented on Figure 5. If dilution was a significant component of the remedy, the mass removed would not have a steady cumulative rate as it has had since 1992; instead, the mass removal would taper off or flatten. Therefore, the fact that mass continues to be removed at a relatively constant rate combined with concentrations that are decreasing is evidence that dilution is a minor component.

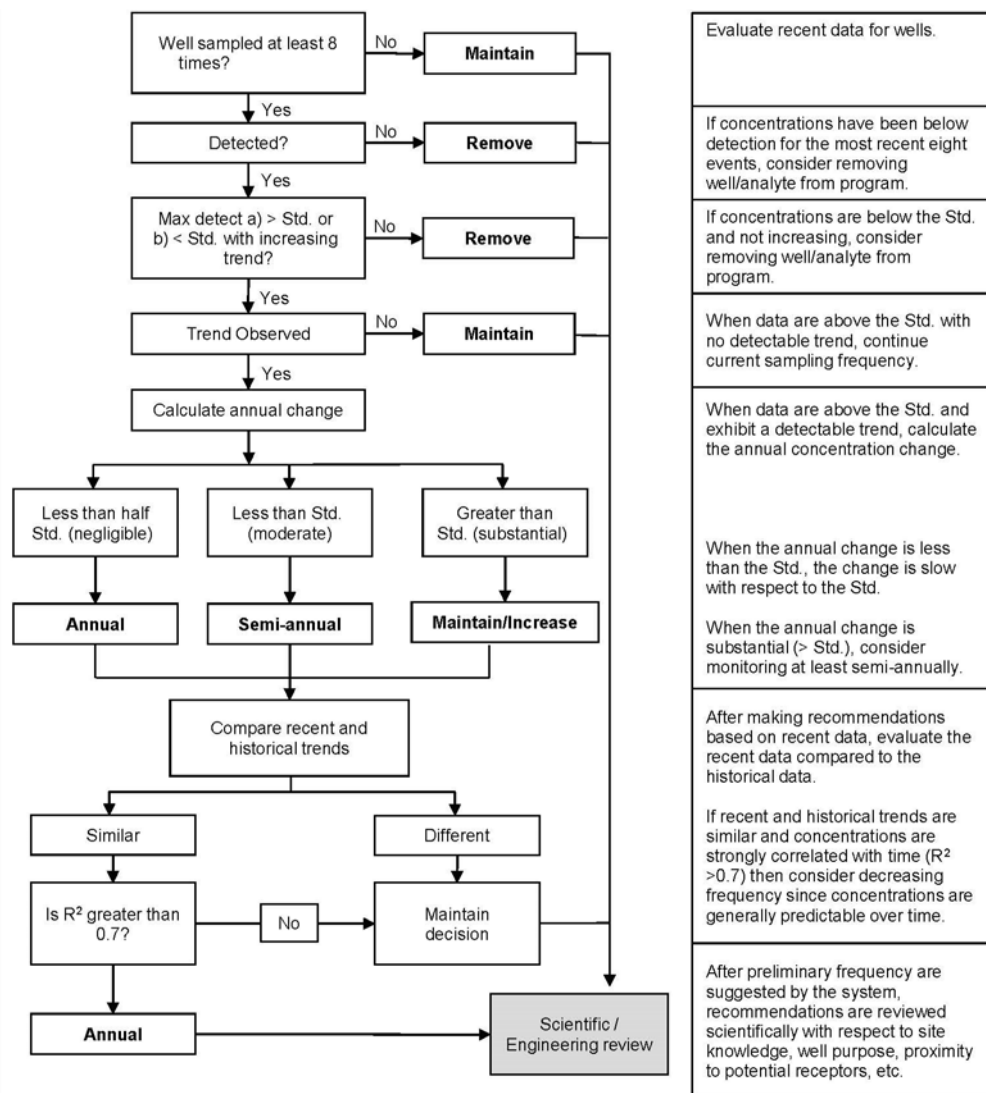
Figure 6. Decision support process for sampling optimization

Each well is then subjected to a decision process, and Figure 6 is an example of a commonly used systematic approach for evaluation and optimizing a monitoring program. Data sets are first evaluated to determine that sufficient samples have been collected. Historical and recent trends are evaluated to identify both long-term and short-term concentration trends, and the direction and magnitude of the trend can be evaluated using the relatively simple statistical tests. If no statistically significant trend is detected, the well and constituent is proposed for continued sampling at the current frequency. If a statistically significant trend is identified, the magnitude of change is evaluated with respect to the site standard. In this way, rapidly changing concentrations can indicate an important change in conditions of the plume. Wells with rapidly changing concentrations would be proposed for continued monitoring at the current frequency. Wells with negligible annual change, including those above the site standard, do not benefit from more frequent sampling and are, therefore, proposed for a lower frequency. Moreover, wells with recent trends that are similar to the overall long-term trends can be reduced to annual sampling. Because concentrations are predictable and more frequent sampling does not yield additional information. Final recommendations are subjected to scientific and engineering review to ensure that the proposed sampling program would continue to meet program needs and related permit requirements.

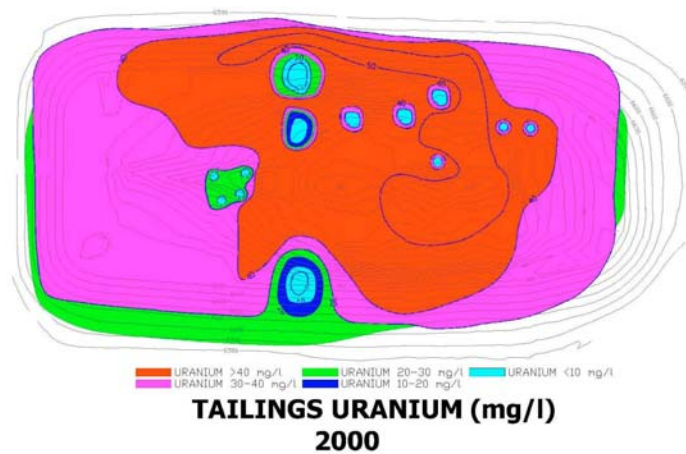
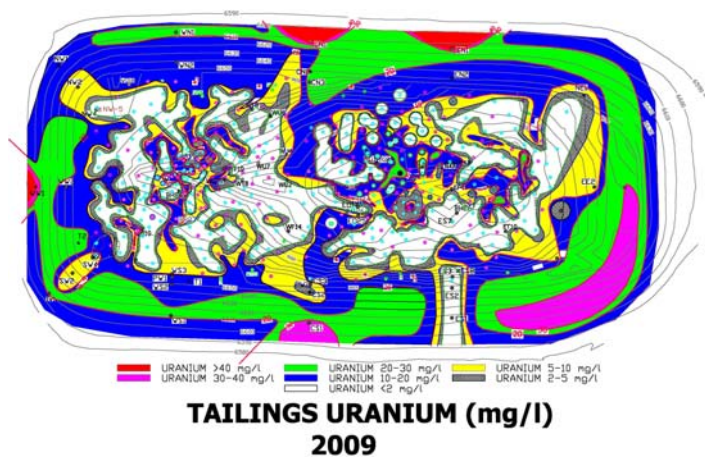
Section 4.1 and Figure 14, Flushing of Large Tailings Pile; page 17. The flushing of the large tailings pile is discussed and Figure 14 is used to show the 2008 uranium concentrations in the tailings. Although the ACOE uses this figure to show the variability of uranium in the pile and illustrate their belief that the flushing has not been effective, HMC believes that the flushing has been effective at removing uranium mass. This is demonstrated by comparing the 2000 and 2009 maps for uranium in the tailings pile, which shows that a significant amount of uranium has been removed. See also HMC’s response to Recommendation No. 2 for additional evidence of the effectiveness of the flushing and extraction program. Below is the 2000 uranium concentration map for the tailings pile showing uranium concentrations exceeding 30 mg/L in much of the pile. Also below is a map of the 2009 uranium concentrations in the pile, which illustrates the significant reduction in concentrations resulting from the flushing and extraction program. For 2009, approximately 67.5 percent of the west side slime area has uranium concentrations less than 5.0 mg/L, and 45.5 percent of the same area has concentrations lower than 2.0 mg/L.
