U. S. NUCLEAR REGULATORY COMMISSION
OFFICE OF INSPECTION AND ENFORCEMENT

Report No. 70-33/81-04

Licensee: Texas Instruments Inc.

Facility Name: Texas Instruments Inc.

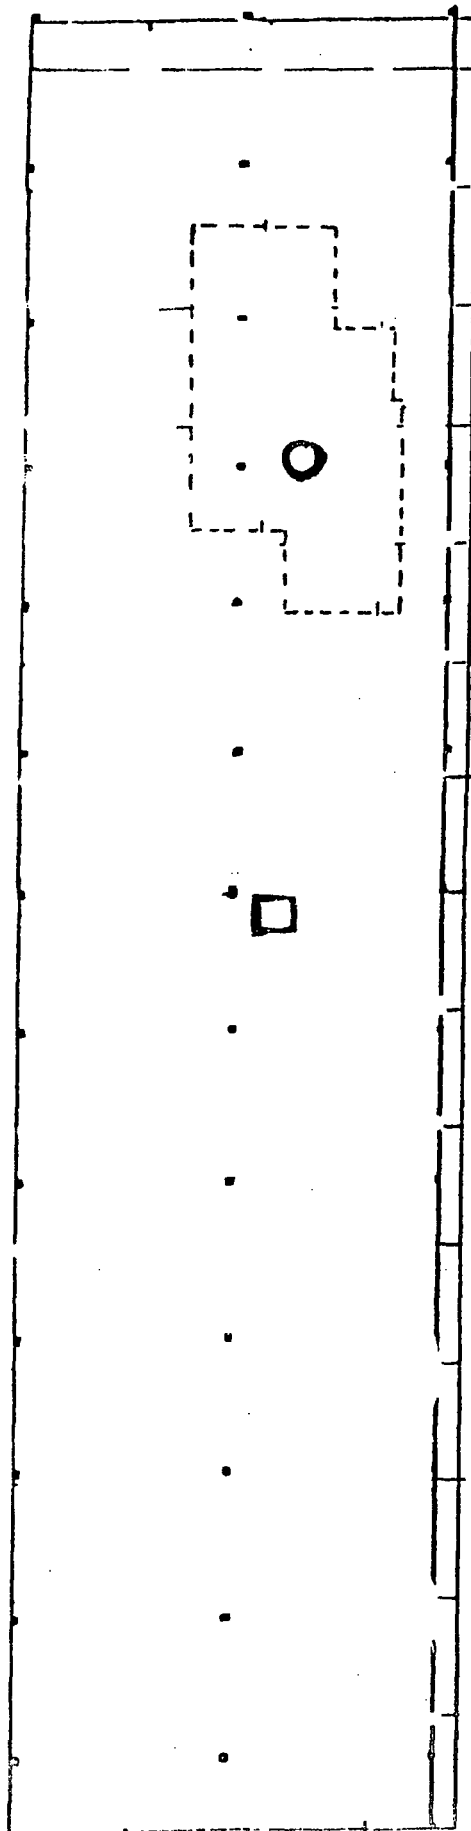
Attachment 3
Region I Report
70-33/82-03

Ceiling/Pipe Areas
Surveyed

X Area Surveyed

• Columns

Fixed and removable contamination levels measured during this inspection are comparable to those in the licensee's close-out survey and are within the limits established in Annex C of the facility license (Guidelines for Decontamination of Facilities and Equipment Prior to Release for Unrestricted Use or Termination of License for Byproduct, Source, or Special Nuclear Material, dated November, 1976).

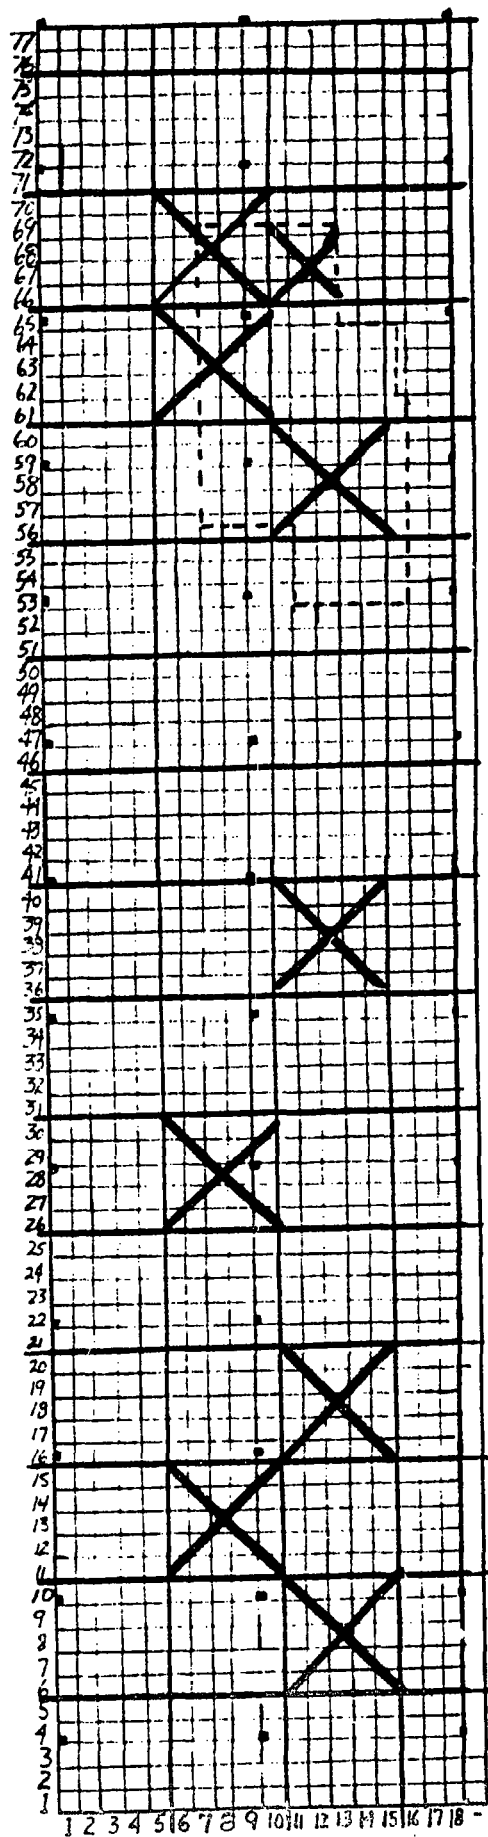
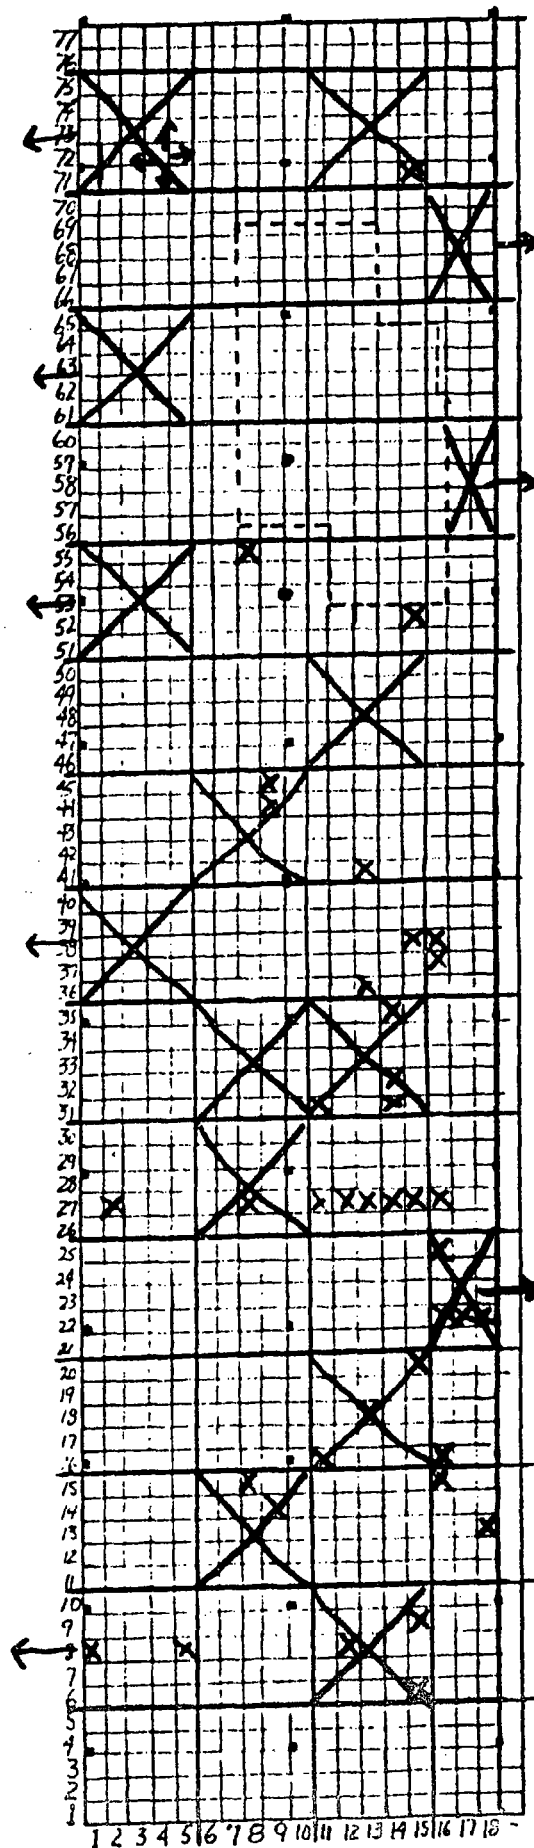
Attachment 4
 Region I Report 70-33/82-03
 Floor/Walls/Columns/Holes Surveyed
 General Manufacturing Area
 ---Outline Fuel Manufacturing Area
 X Area Surveyed
 ← Walls Surveyed
 ■ Columns

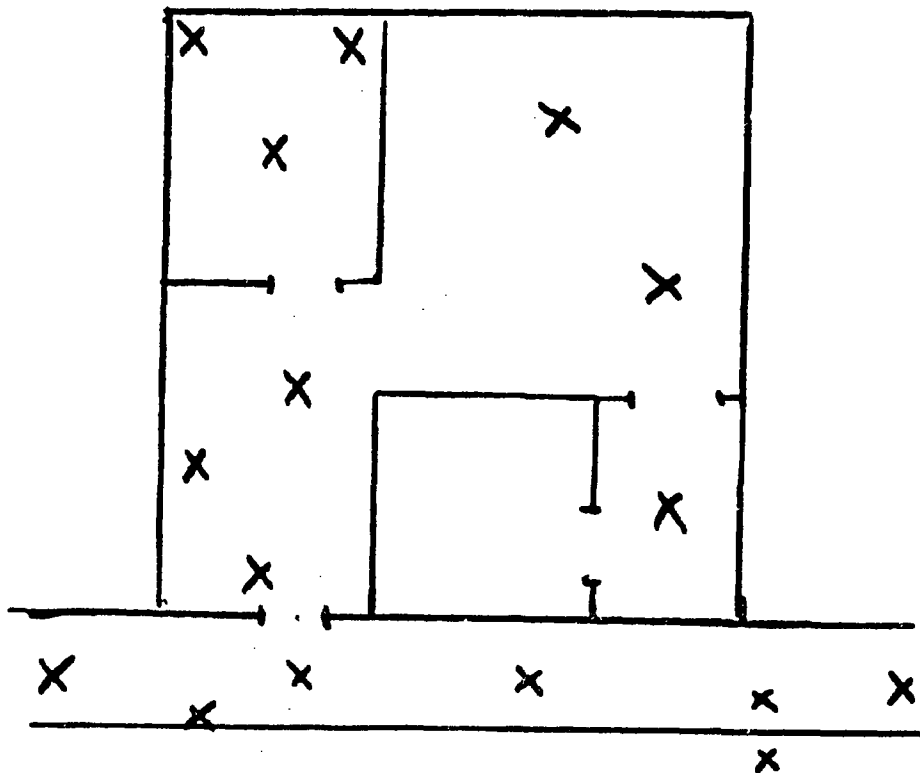
Attachment 7

Metallographic Laboratory

X = Areas Surveyed
