Subject: Durango, Colorado, Disposal Site, Revised Long-Term Surveillance Plan

Enclosed is a copy of the *Long-Term Surveillance Plan for the Durango, Colorado, Disposal Site, April 2015* (LTSP). In response to your letter dated January 20, 2015, the U.S. Department of Energy, Office of Legacy Management (DOE-LM) has revised the LTSP. The LTSP revision allows for site inspectors to inspect the new signs instead of four existing perimeter signs during annual site inspections and identifies the two new sign locations.

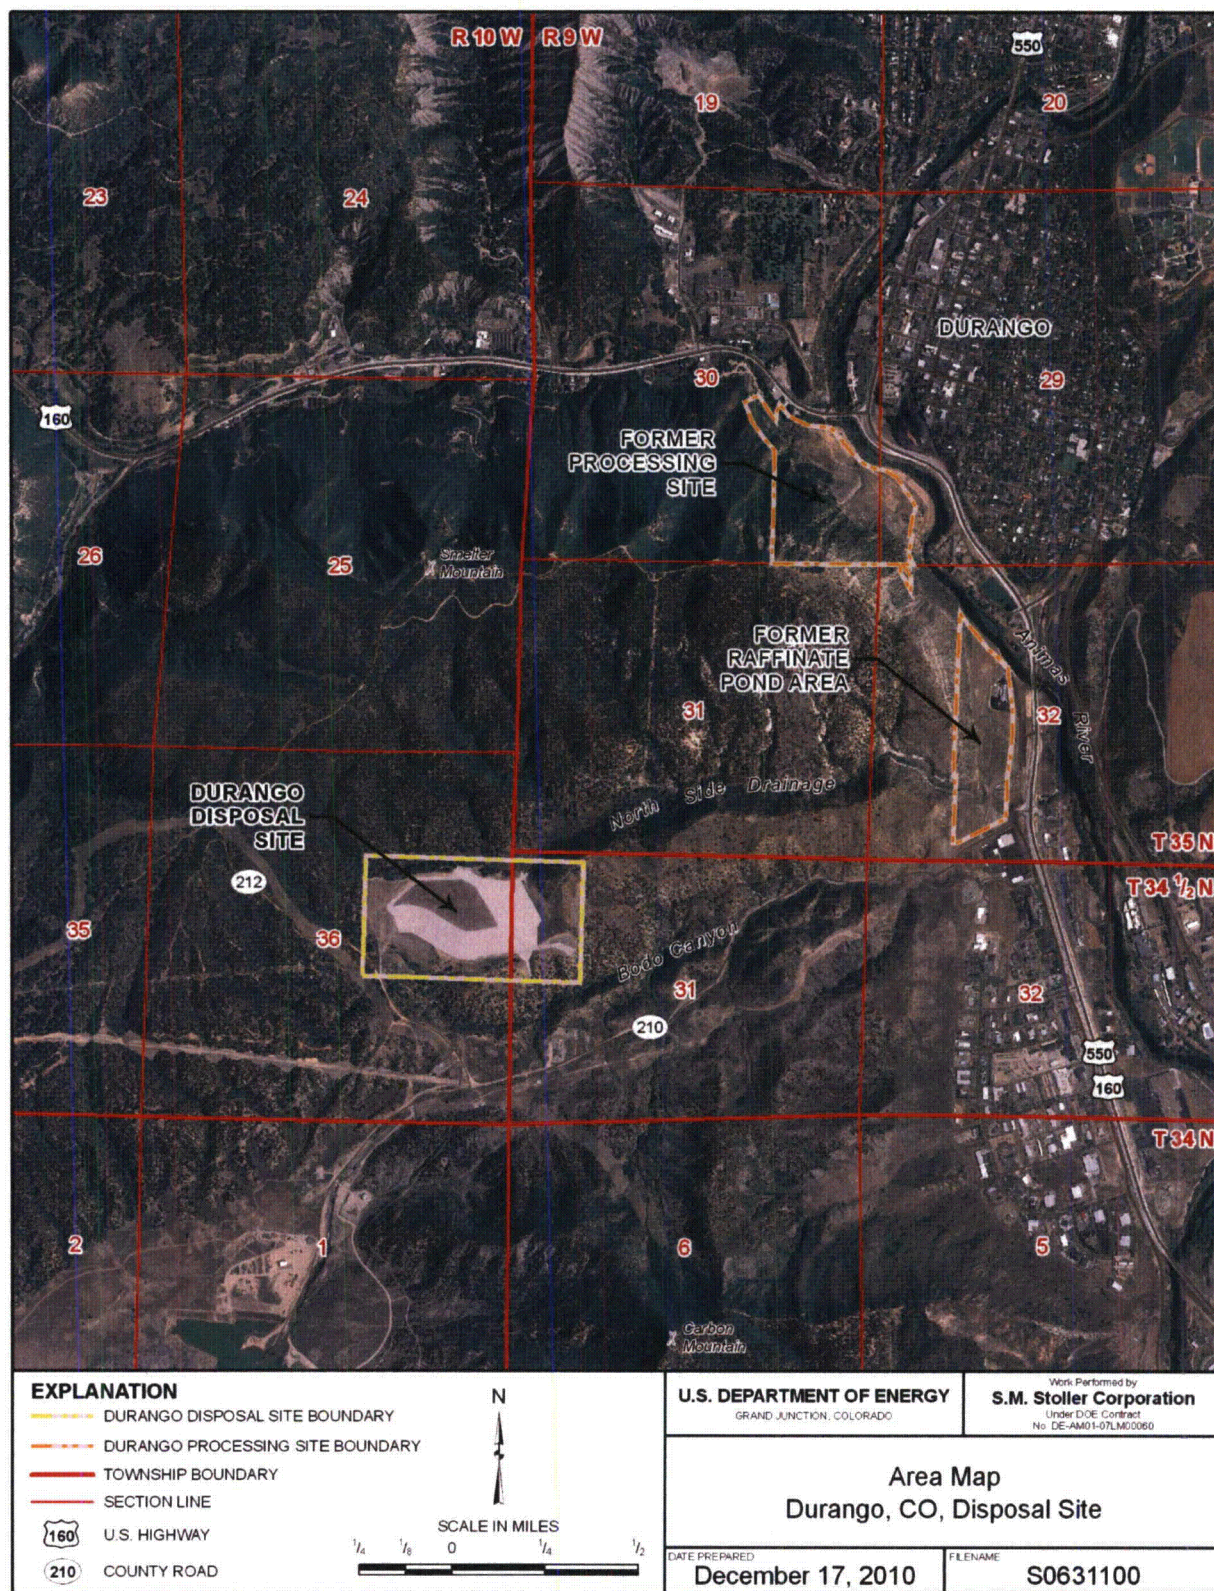
Figure 2. Area Map of the Durango, Colorado, Disposal Site

The disposal site is on a small, upland plateau in the upper west part of the Bodo Canyon area. The Bodo Canyon area is an ephemeral drainage basin of about 4.5 square miles (11.6 square km), bordered by Smelter Mountain on the north, Carbon Mountain on the south, and the Animas River on the east (Figure 2). Prior to receiving tailings and contaminated soils from the processing site, the Bodo Canyon area was used as pastureland and wildlife habitat. The land was managed by the U.S. Department of the Interior Bureau of Land Management. No mining, milling, or other industrial activities occurred in the valley before the disposal cell was established.

Figure 2 is a map of the Durango, Colorado, area. The disposal site can be accessed using the following directions:

The drainage features of the embankment and general site grading ensure long-term embankment stability as required in 40 CFR 192.02(b) (Figure 5). Runoff from the embankment flows to the apron and then to the adjacent natural ground on the northern slope of the cell. All other side slopes of the cell drain to perimeter catchment ditches that channel the concentrated flows to outfall structures. Ditch No. 1 carries run off from the eastern slope and drains to an outfall structure into the North Side Drainage. Ditch No. 2 carries run off from the southern face of the cell eastward to an outfall structure that drains into Bodo Canyon. Ditch No. 3 captures a smaller drainage from the northwestern and western slopes of the cell and a small upland drainage area. The eastern part of this ditch drains to the North Side Drainage, and the western part drains to the South Side Drainage. The ditches have sufficient depth and rock protection to carry runoff from a probable maximum precipitation (PMP) event. Significant precipitation events can create velocities capable of moving sediment buildup in the ditches. Flows in the North and South Side Drainages off of the cell, produced from a PMP event in the upland drainage area, will not impact the toe of the disposal cell. Flows in both the North Side Drainage and Bodo Canyon go eastward to the Animas River (Figure 2).

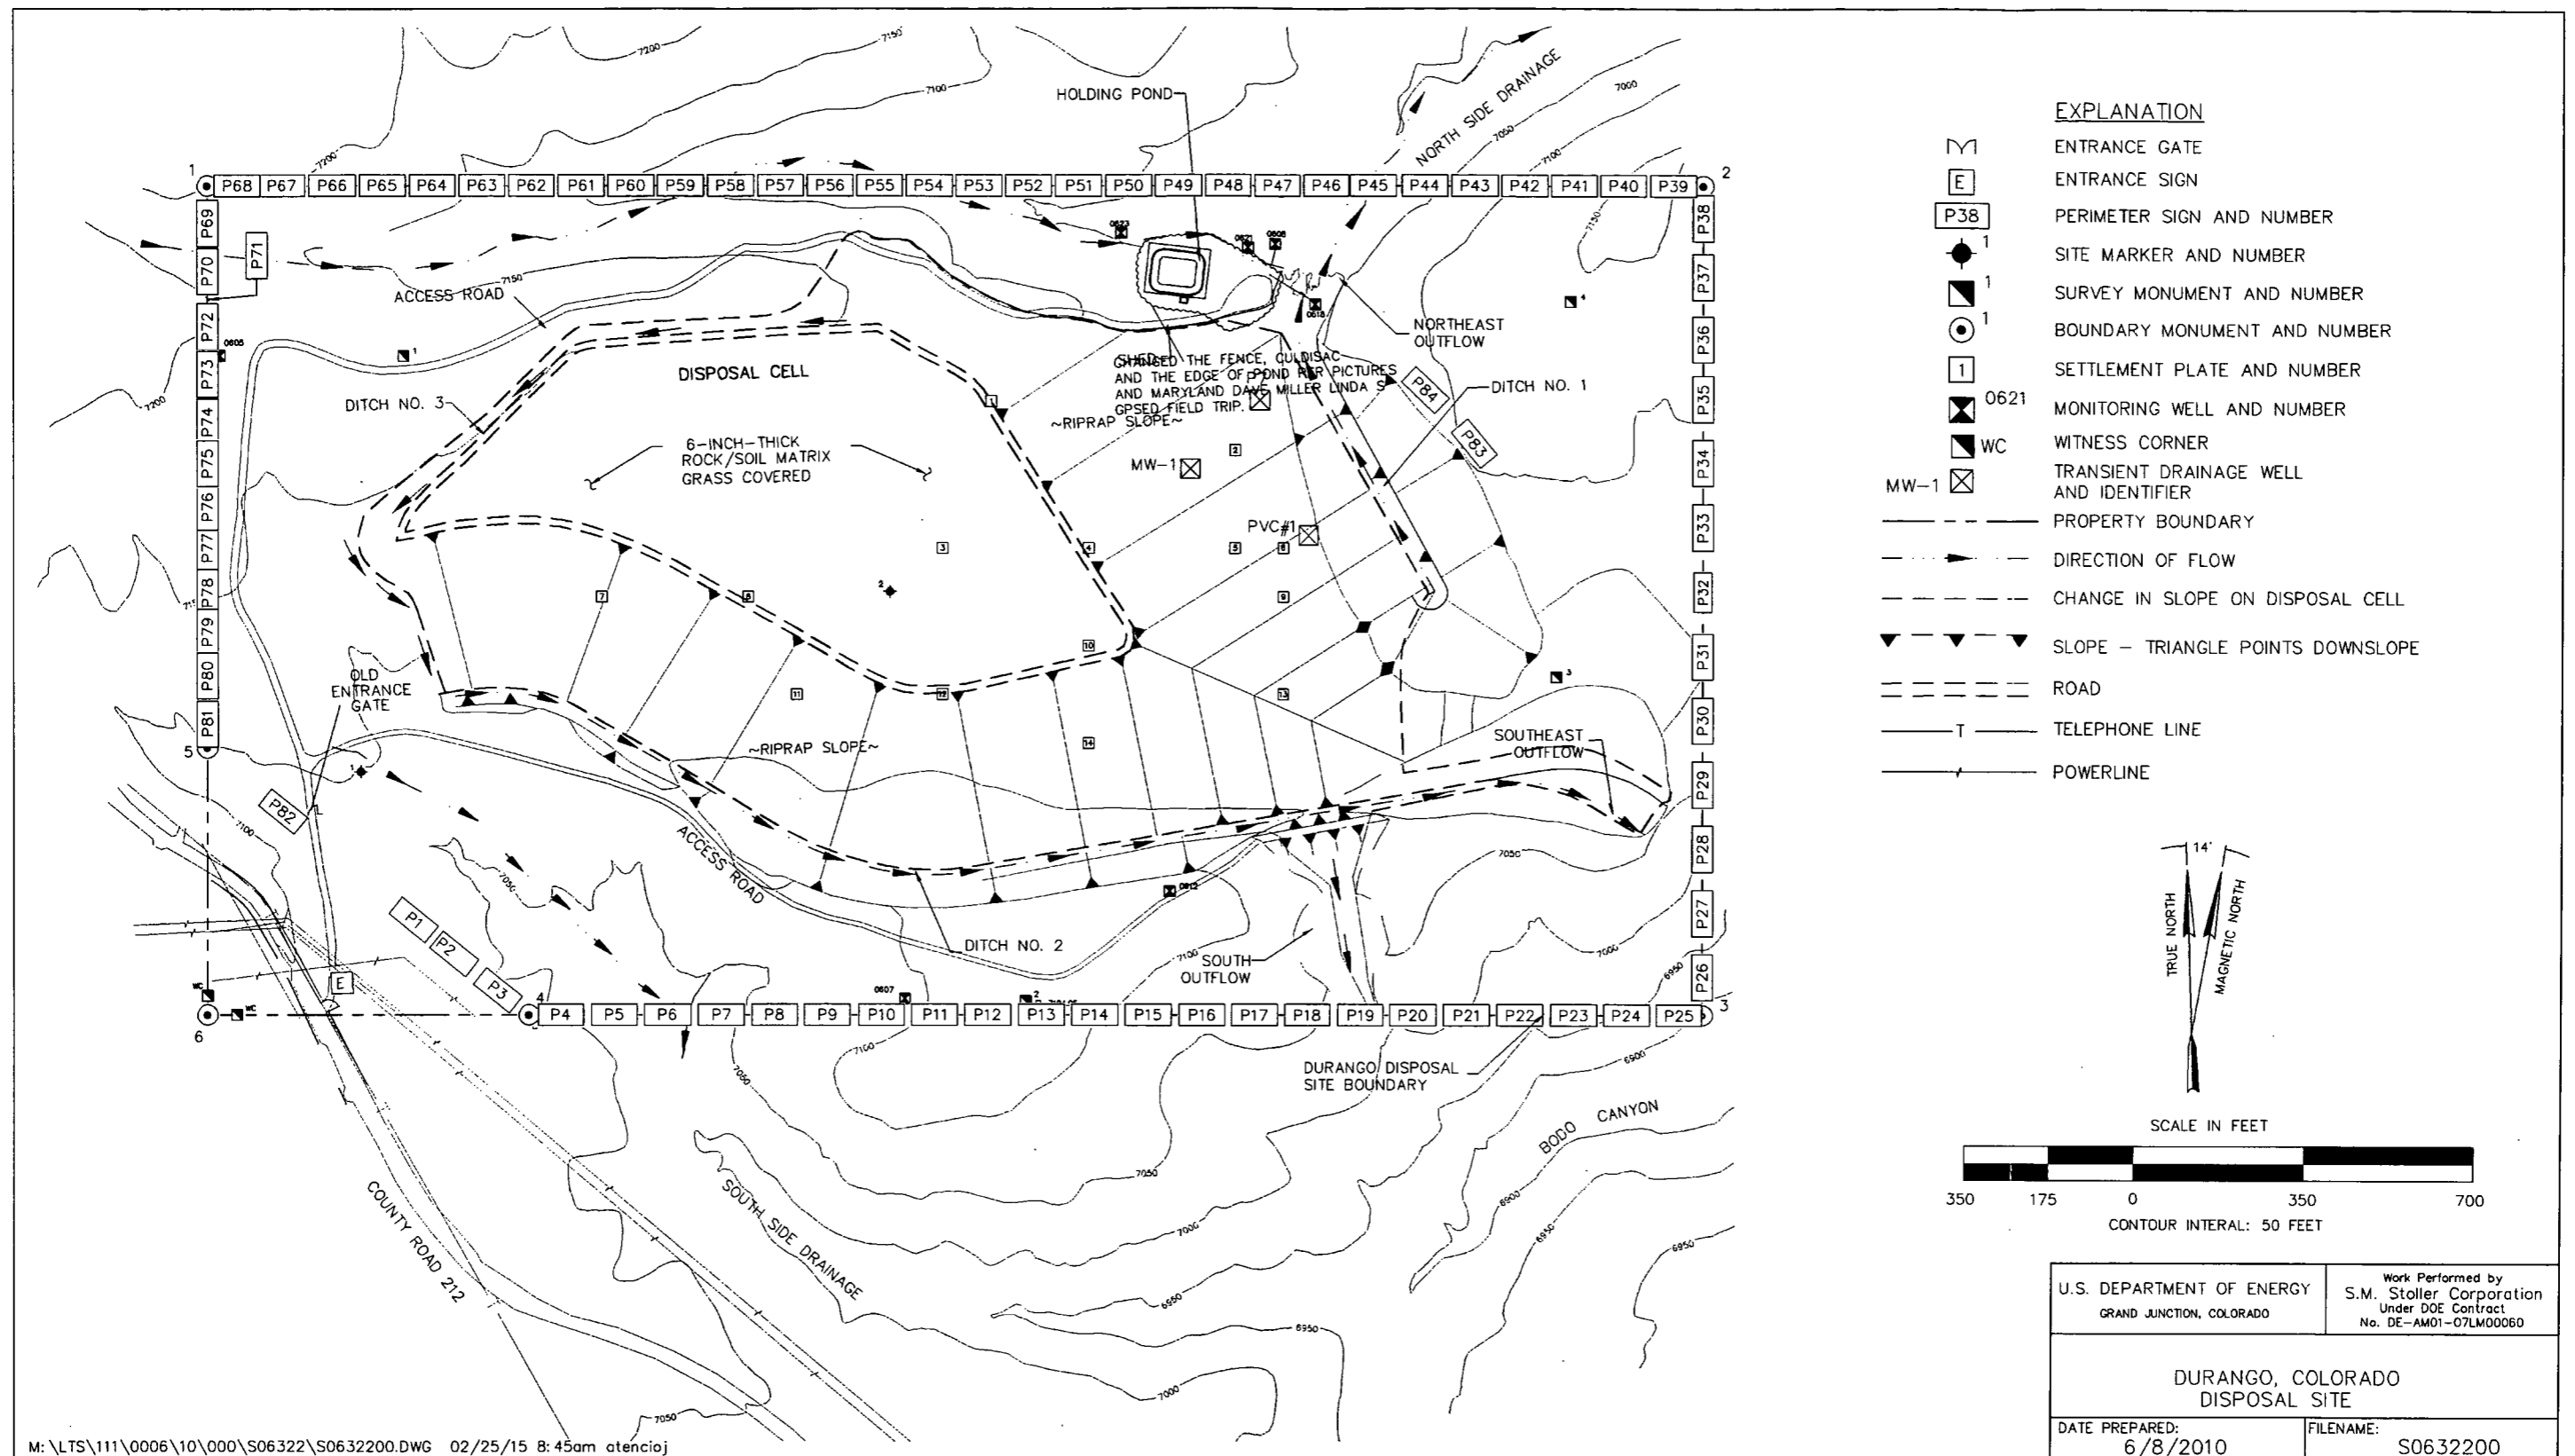
Figure 6. Map of the Durango, Colorado, Disposal Site

Survey monuments (SM), boundary monuments (BM), site markers (SMK), and entrance and perimeter signs are the permanent surveillance features at the disposal site. Five boundary monuments define the corners of the unfenced perimeter of the disposal site. Eighty-two warning signs are placed around the perimeter of the disposal site (Figure 6).

Survey Monuments—SM-1 is in the northwest part of the site, SM-2 is south of the disposal cell, and SM-3 and SM-4 are to the east (Table 2 and Figure 6). The monuments, Berntsen RT-1 metal markers, were set into the top of a truncated cone of reinforced concrete set in concrete (DOE 2001).

Boundary Monuments—Five Berntsen federal aluminum survey monuments, Model A-1 (DOE 2001), were used for the site boundary monuments (BM-1 through BM-6) (Table 2 and Figure 6). BM-1, BM-2, and BM-3 mark the northwest, northeast, and southeast corners, respectively, of the site. BM-4 is at the west end of the proposed truncated south boundary, and BM-5 is at the south end of the truncated west boundary, however DOE retained the full area that is marked by BM-6 in the southwest corner (MK-F 1991).

Entrance and Perimeter Signs—The site entrance sign (Figure 8) is at the entrance gate. In addition to the entrance sign, 82 perimeter signs (Figure 9) mark the boundary around most of the site, with two additional signs (numbered 83 and 84) located inside the site boundary (Table 2 and Figure 6). The two signs located inside the site boundary (83 and 84) were installed in 2015. These signs were placed in an area near the northeast corner of the site to supplement perimeter signs 40, 41, 42, and 43. Perimeter signs 40, 41, 42, and 43 are located on a steep and densely vegetated hillside, which acts as a natural deterrent; and the signs are not clearly visible. Annual inspection of signs 40 through 43 will not be included unless the dense vegetation recedes. Signs 83 and 84 are included in the inspection. These signs display the international trefoil symbol indicating the presence of radioactive materials. They also state that the disposal site is U.S. Government property and that trespassing is forbidden. The entrance sign has the same information as the perimeter signs, plus the name of the site and the telephone numbers of DOE and CDPHE offices (Figure 8).

The Durango disposal site map (Figure 6) identifies the following site features:

The Durango disposal site map (Figure 6) will serve as the base map for site inspections (Section 3.3.5). A new, separate inspection map will be prepared after each inspection. Each site inspection map will indicate the year and type of inspection.

A new site inspection map will be prepared after each annual inspection using the disposal site map (Figure 6) as a base. This map will include at a minimum the following:

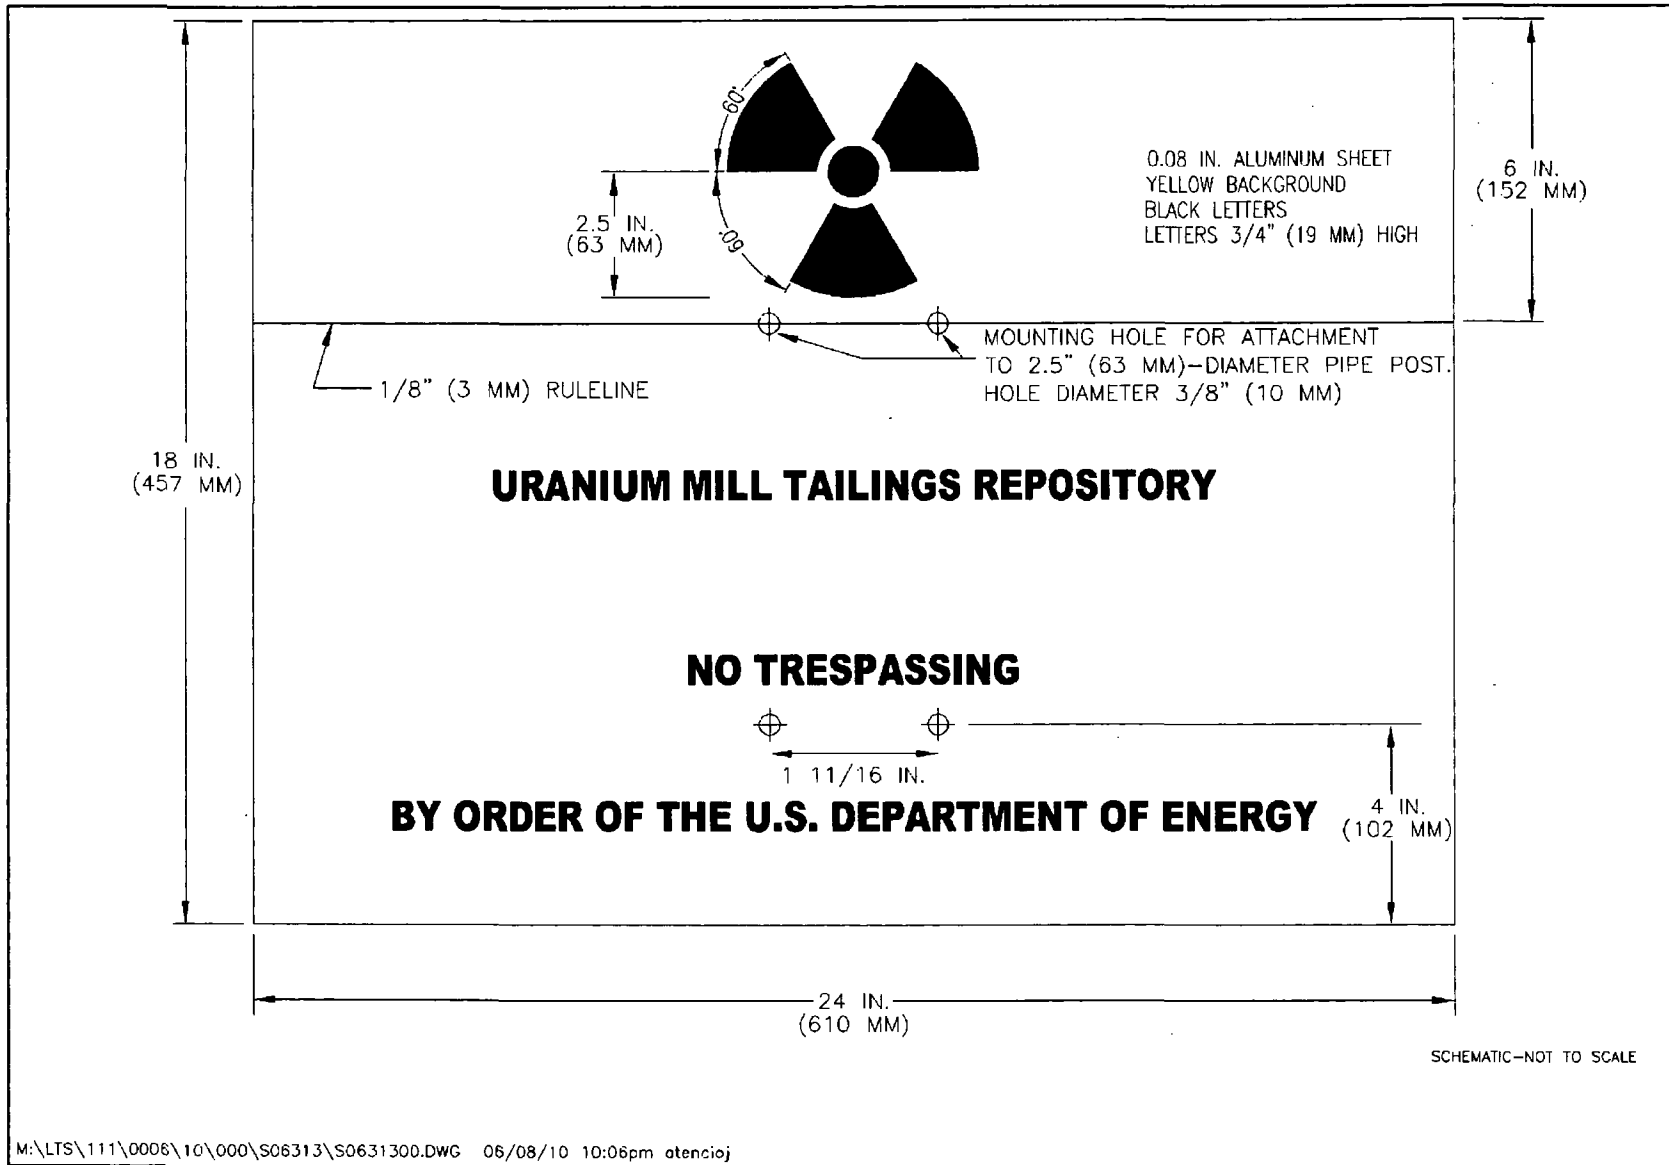
Figure 9. Perimeter Sign, Durango, Colorado, Disposal Site
