**Office of Nuclear Regulatory Research
Division of Risk Analysis
Fire Research Branch**

Development of Metric Monitoring Methodologies

May 4, 2015

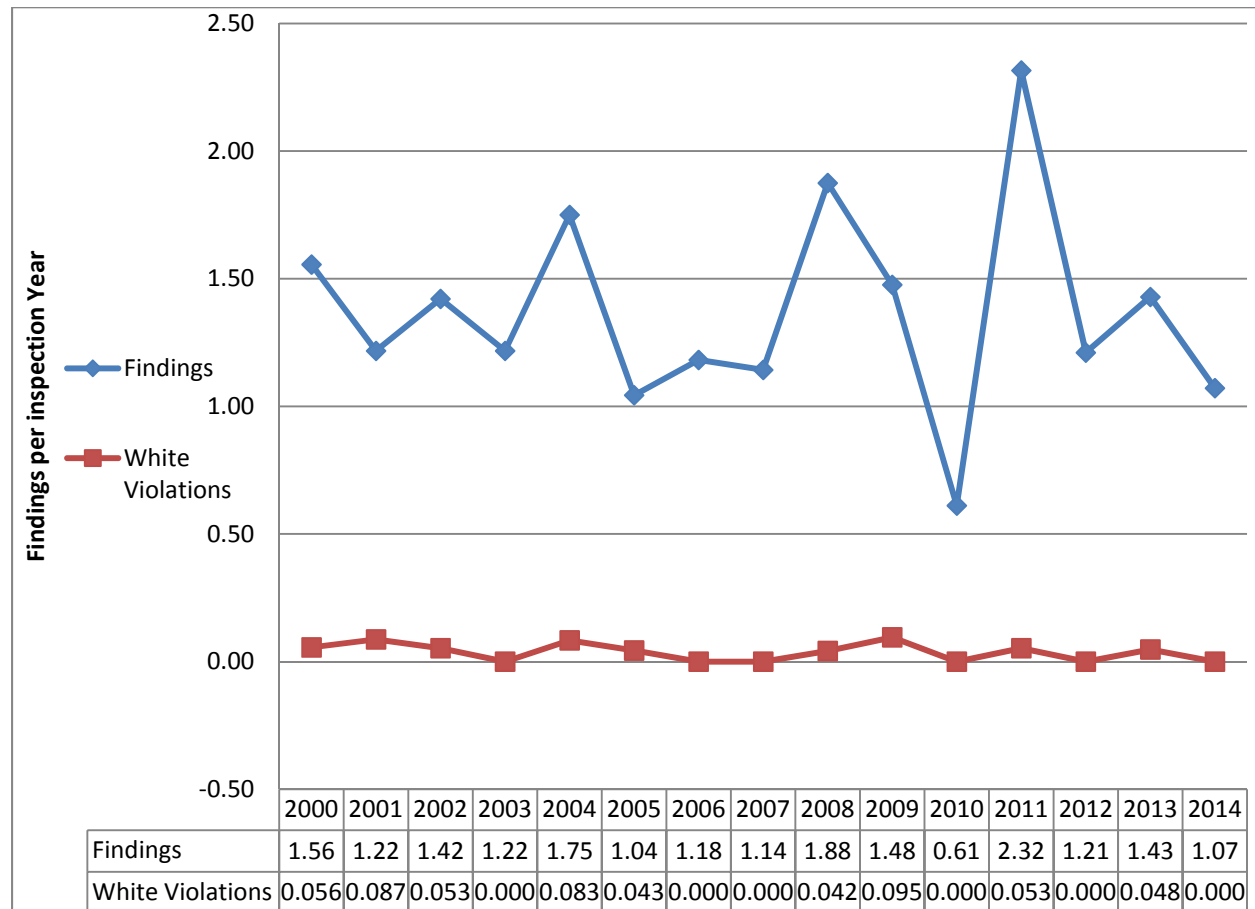
Figure 4: Triennial Fire Protection Findings Normalized per Year

Figures 4 and 5 show the results of the fire protection inspection findings data collection process. Refer to Appendix B for the complete set of data for all inspections.

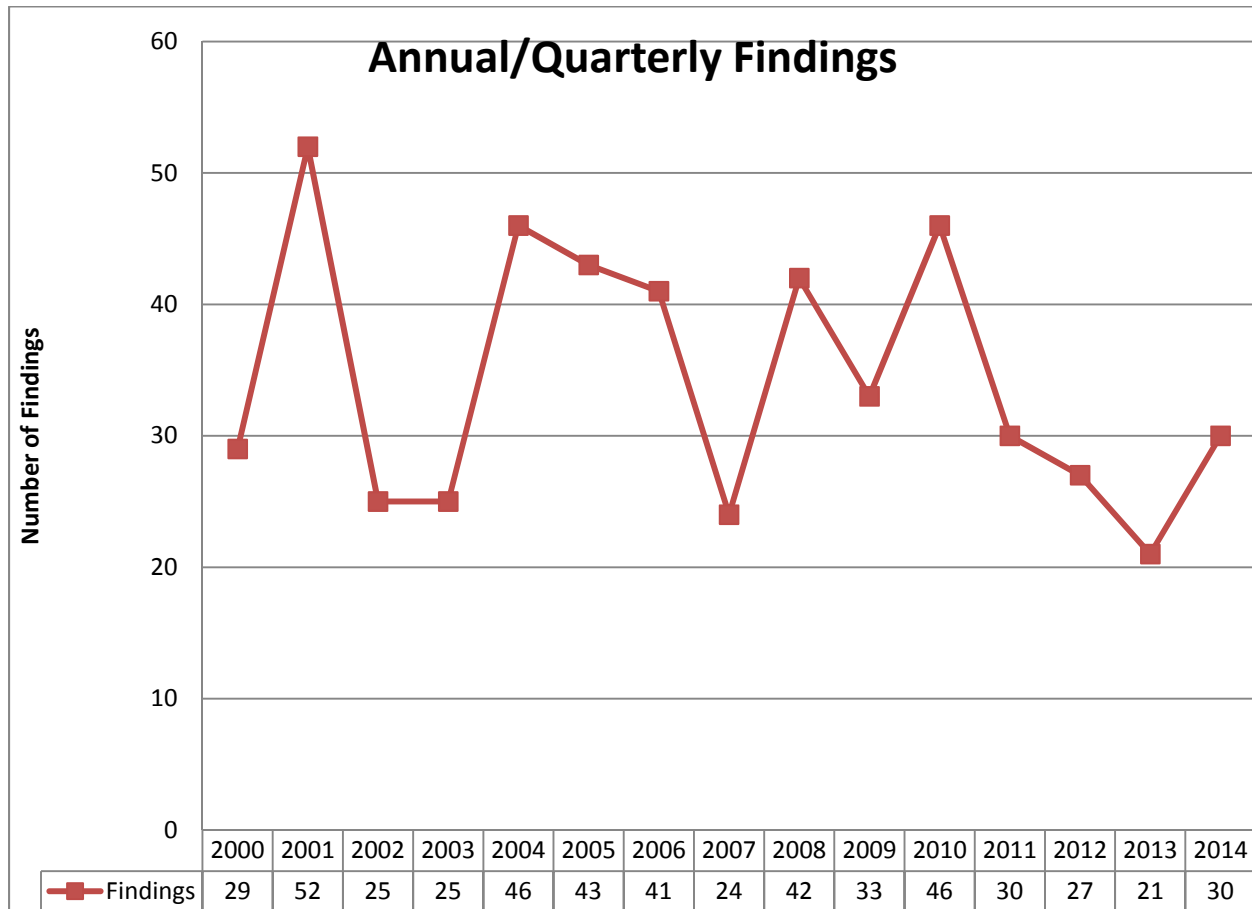
Figure 5: Annual/Quarterly Fire Protection Findings

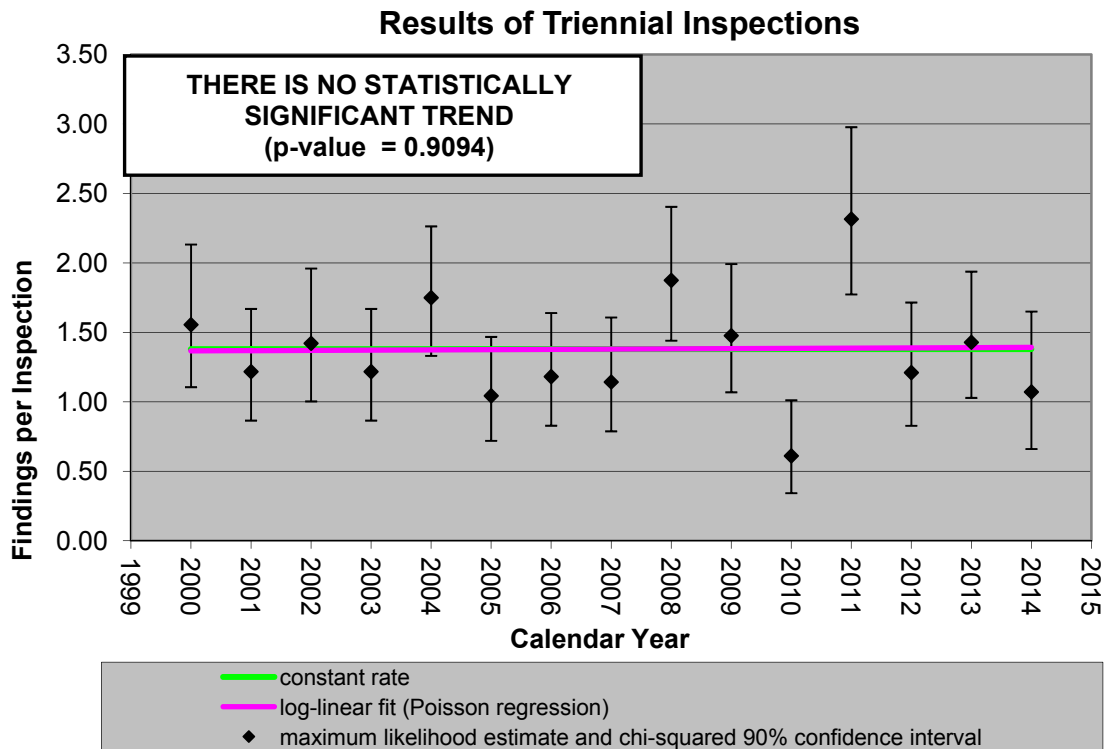
The results of the trend analysis for the triennial fire protection inspections are shown in Figure 6. The fitted values of a and b are 0.3108 and 0.0116, respectively. Analysis indicates that there is no statistically significant trend for the findings noted during the triennial fire protection inspections (p-value of 0.9094).

Figure 6: Trend analysis of findings made during triennial fire protection inspections for the period 2000-2014.

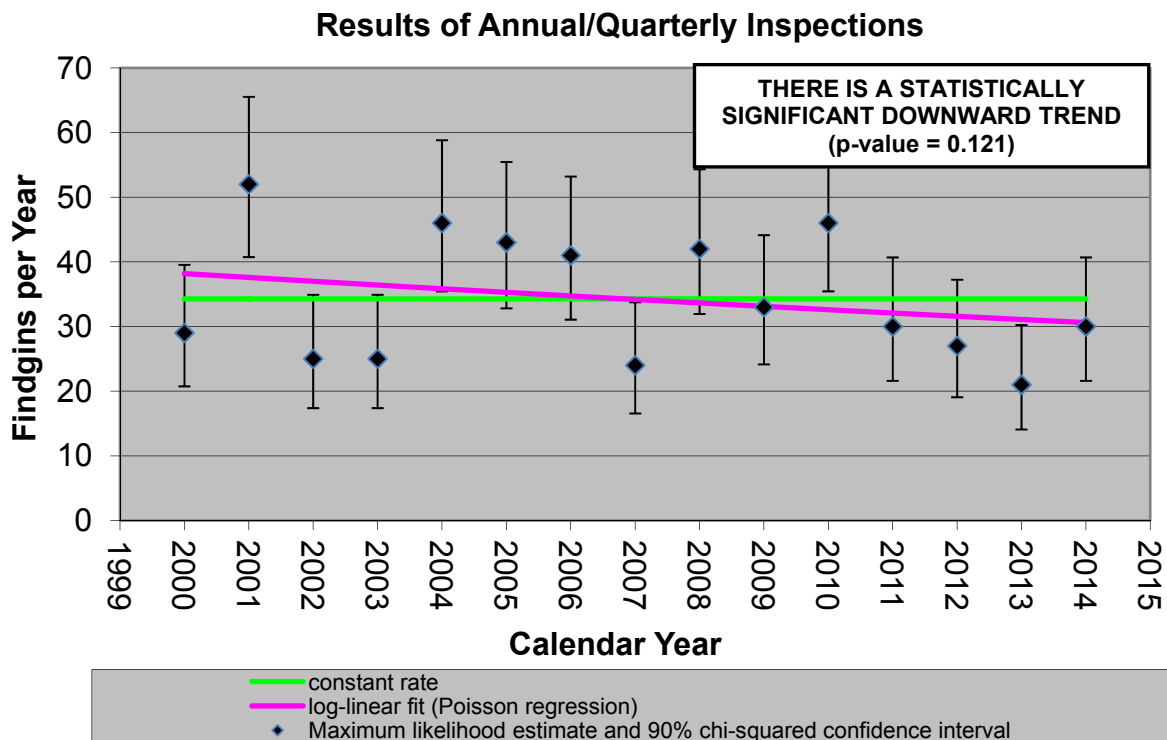
The results of the trend analysis for the quarterly fire protection inspections are shown in Figure 7. The fitted values of a and b are 3.6621 and -0.0158, respectively. Analysis indicates that there is a statistically significant downward trend for the findings made during the annual/quarterly fire protection inspections (p-value of 0.122).

Figure 7: Trend analysis of findings noted during quarterly fire protection inspections for the period 2000-2014.
