Safety Culture Reactor Oversight Process Training

Training Overview

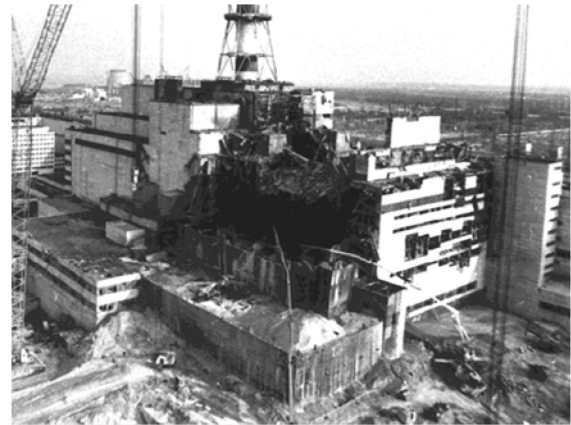
Chernobyl (1986)

“Safety Culture” describes the human element to the Chernobyl accident

Causes to the Chernobyl accident included design issues.
