Richard Smith, Sr. Associate  
Structural Integrity Associates

# Background

# Divider Plate Crack Propagation

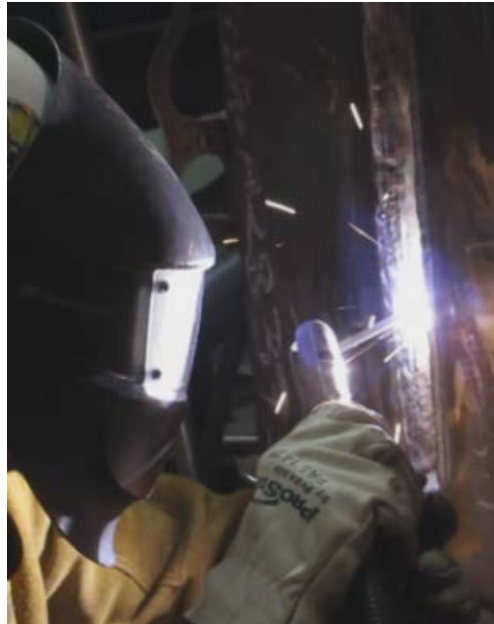
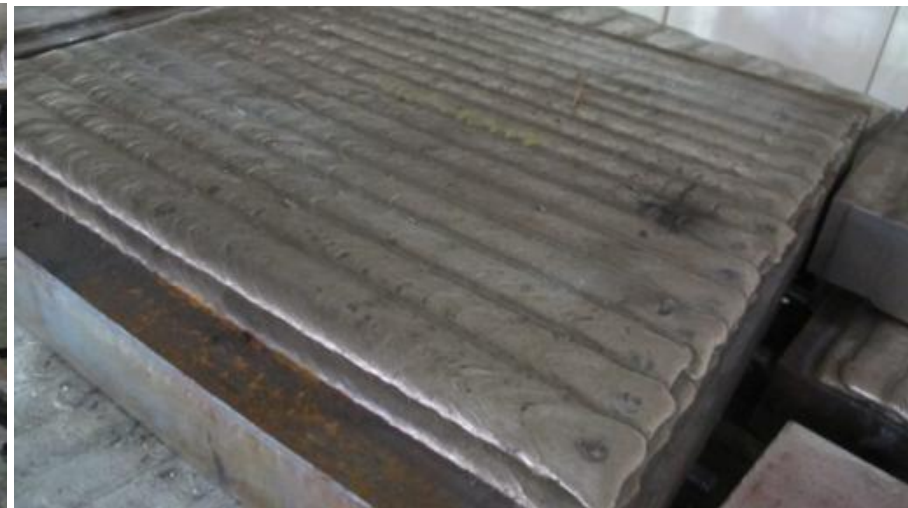
82 - Electroslag Welding (ESW)  
Strip cladding

182 Shielded Metal Arc Welding (SMAW) process

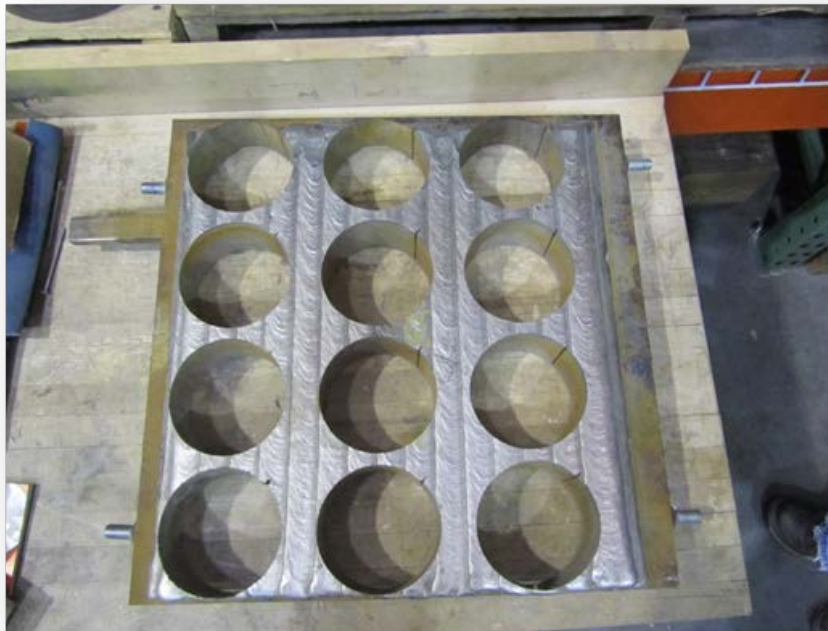
- The mockup was designed as a 3 X 4 tube-to-tubesheet matrix having 82 cladding on one side and 182 cladding on the other side
- An Alloy 690 tube was inserted into each drilled cylinder, positioned flush with each end, and welded autogenously using the Liburdi Dimetric P-Head autogenous GTAW welder (see next slide).

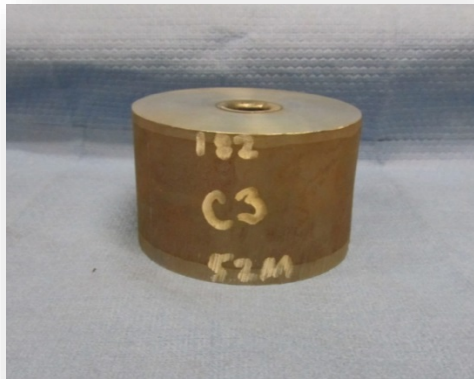
- Plugs were removed from the tubesheet, cross sectioned, and weld dilution was evaluated
- It had been estimated that the weld dilution would be 50% from the tube material and 50% from the cladding material since the weld is autogenous GTAW

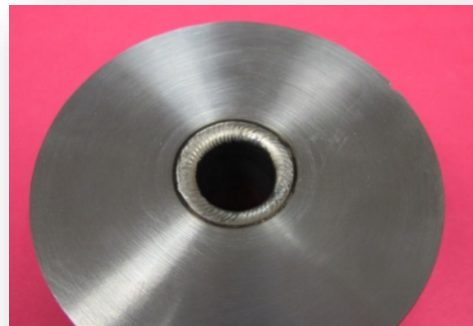
40 cross-sections were available for 82 welds and 34 for 182 welds to include in the tube-to-tubesheet weld dilution distributions

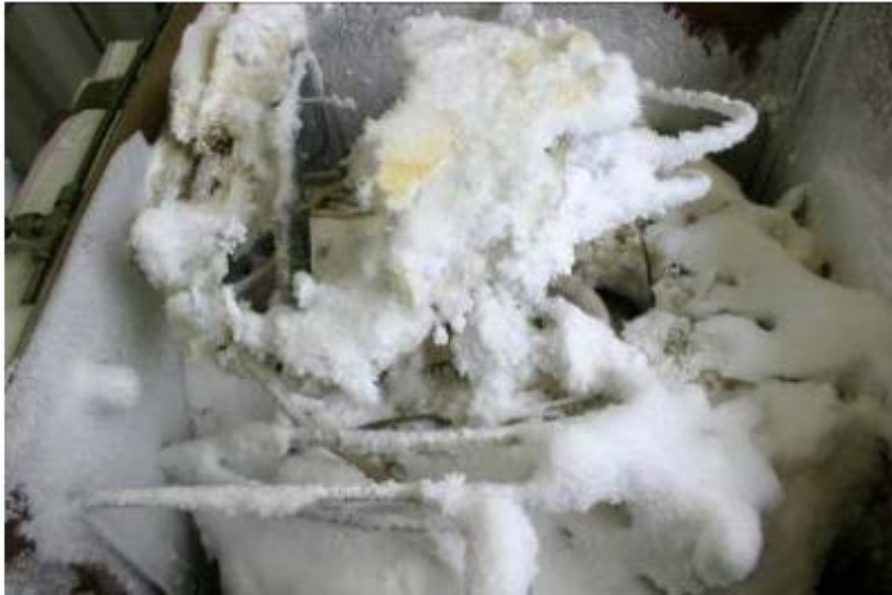
# Example of Boric Acid Leakage from Reactor Vessel Bottom Mounted Nozzle Full Scale Mockups

0.01gpm

- One Z-weld is required to be inspected every 10 years per ASME Section XI
  - This inspection would identify leakage in the SG being examined
- The area is part of routine boric acid walk downs
  - These inspections would most likely identify leakage
    - Research conducted on full scale mockups on reactor vessel bottom mounted nozzles indicates that significant boric acid deposits can result from relatively small leaks
    - Research results provide a qualitative reference to support the conclusion that a leak from the channel head, even at levels below safety significance, would most likely produce boric acid residue that would be detectable through the insulation.
