5 Laboratory Test Results

6 Conditions in Commercial Reactors

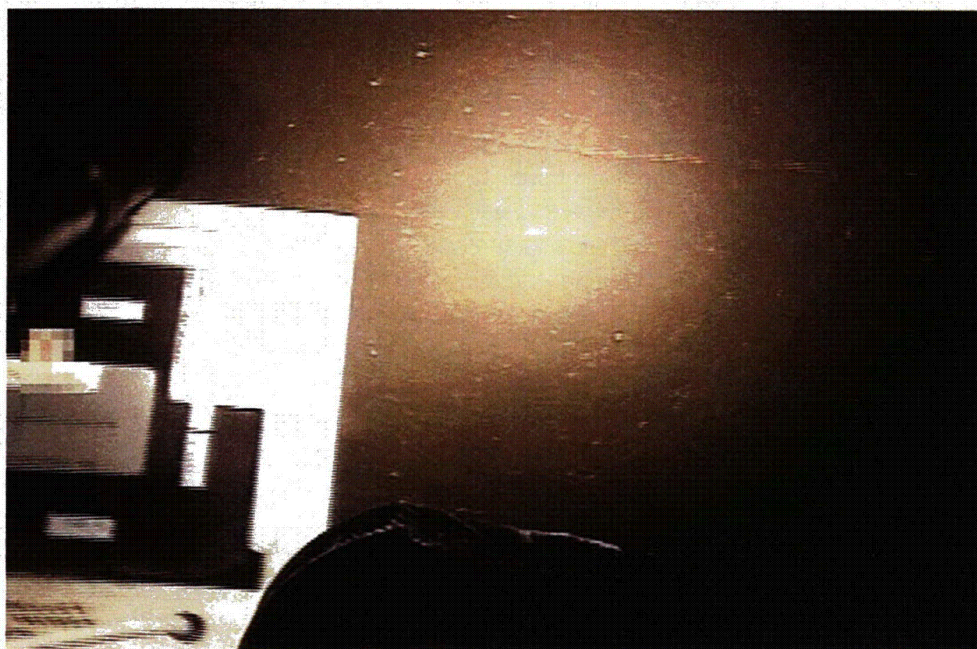
Figure 6.2 Bottom of PWR Pressure Vessel

BWRs primarily have red hematite-based deposits on all internal components. In PWRs, which have magnetite-based deposits, one sees dark grey or black deposits on internal components. Examples of each are shown in Figure 6.1. The image on the left was taken during an EVT-1 inspection in a BWR during a scheduled outage and shows a component prior to any cleaning. The surface is highly diffuse and dull red. The image on the right shows the wetted side surface of a control rod drive mechanism (CRDM) that had been removed from service and sent to PNNL for examination. The CRDM has been decontaminated using a wide variety of techniques, and the surface is somewhat specular. Prior to the decontamination, the CRDM wetted surface was also very diffusely reflecting. The bottom surface in a PWR is shown in Figure 6.2. Also shown at the left of the image are a resolution target and a bottom-mounted instrument penetration. The white section of the resolution target was used to white-balance the image. The bottom of the PWR appears to be dark brown, suggesting a mix of oxides.

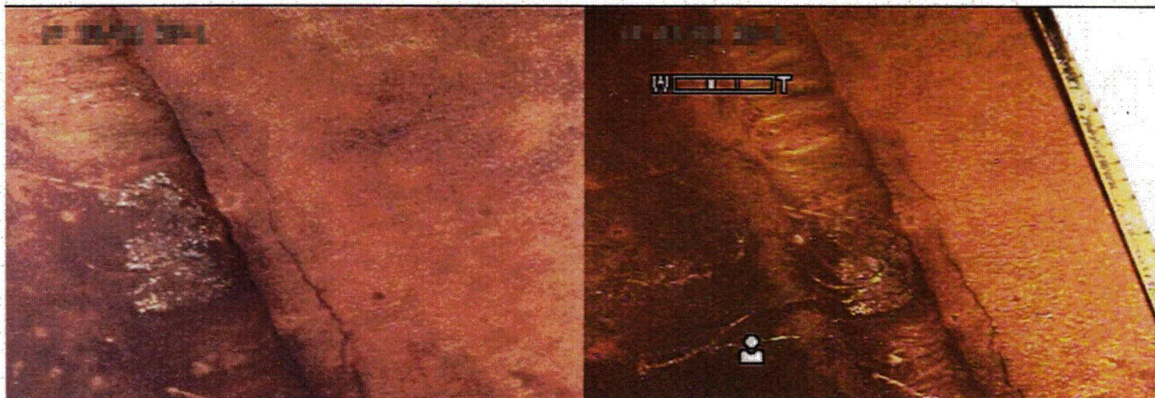
The deposits usually accumulate in two layers, an adherent layer on the metal surface and a loose layer on top of the adherent layer. The loose layer can usually be removed with a brush or water jet, while the adherent layer requires aggressive methods such as wire brushing or acid etching to remove it. For practical purposes during visual testing in a reactor, soft brushing or hydrolasing is convenient to remove the loose layer and leave the adherent layer. Also, as virtually all visual testing is performed using spot lighting, removing the adherent layer and exposing a highly specular surface would severely degrade the inspectability of the cleaned components. An example of a component in a BWR before and after light brushing is shown in Figure 6.3. The image on the left shows a cracked component before cleaning, with the loose and adherent layers present. The image on the right shows the same area after the loose

Figure 6.3 A Crack Before (left image) and After (right image) Cleaning Loose Oxide Layer from Surface

deposits have been brushed off, as well as part of a tape measure that has been lowered to facilitate measuring the length of the crack. The image of the area before brushing shows the layers to be almost entirely diffuse, and the spotlights provide very even illumination with no signs of glare. The cleaned image shows the adherent layer to be somewhat specular with slight glare but still less specular than the tape measure, which shows significant glare.

It should be noted that for the purposes of this study, PNNL focused on analyzing under laboratory conditions pertinent issues associated with the reliability of VT. In the course of the study, some limited information was found regarding field conditions. For example, VT practitioners have indicated that the oxide layer may sometimes be helpful in finding cracks. There is anecdotal evidence of the oxide patina being discolored around cracks, making the cracks easier to find. It was learned that a recent examination of a BWR provided two cases in which crack detection was assisted by markings and discolorations in the oxide layer. Both cracks were mechanical fatigue cracks. In the first case, the crack was very long, had a large COD, and would have been found even without the discoloration. This crack is shown in Figure 6.4. The discoloration is near the end of the crack, where it is the tightest. For the second crack, the oxide layer was disturbed near the crack, greatly enhancing the crack visibility. This crack is shown in Figure 6.5, both before and after the loose oxide layer was brushed off. The crack was, in fact, more visible before the loose oxide layer was removed.

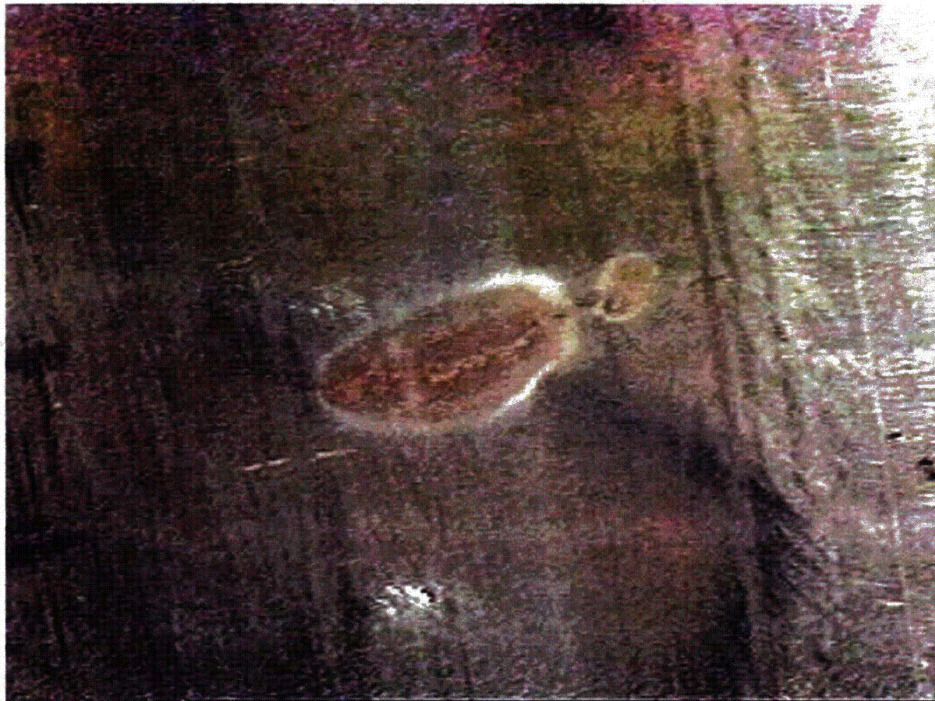
Another example of a crack that was made more visible by oxides is shown in Figure 6.6. In this case, the component had stainless steel cladding over carbon steel. When the stainless cladding cracked through, the carbon steel oxidized, and the resulting oxide bled through the crack, decorating the surface of the stainless steel. This oxide decoration draws attention to the cracked region. While the crack is faintly visible without the oxide, the oxide decoration does help in crack detection.

Figure 6.6 Stress Corrosion Crack Through Stainless Steel Made More Visible by Oxide Decoration

The oxide layer can help in crack detection with the periodic decoration of the outside of the crack. This phenomenon has been observed several times, and some photographs of this are shown in Section 6.3. The cause of this decoration and the probability of it occurring are as yet unknown.
