NRC Questions / Industry Responses

Industry's Position for Aging Management Programs for Steam Generator Channel Head Components

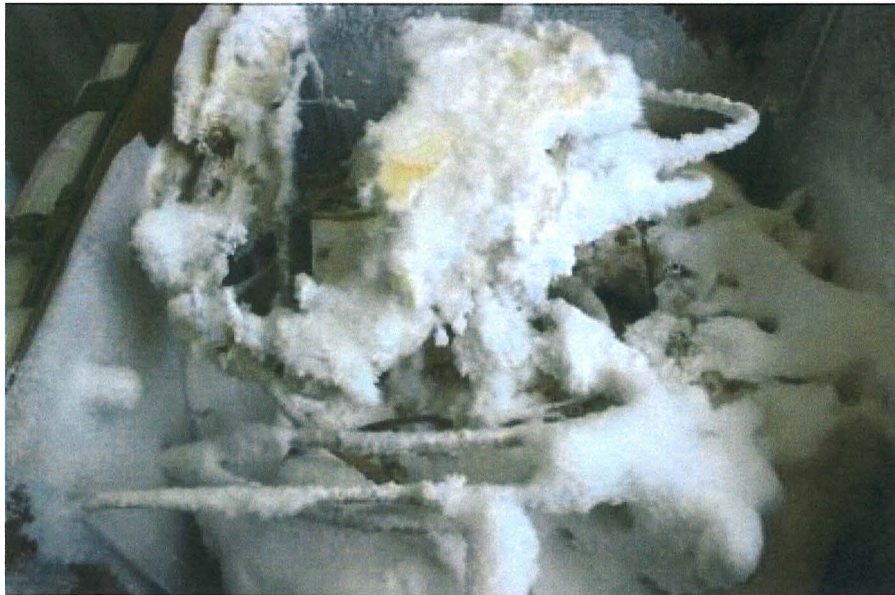
Example of Boric Acid Leakage from Reactor Vessel Bottom Mounted Nozzle Full Scale Mockups

0.01gpm

- One Z-weld is required to be inspected every 10 years per ASME Section XI
 - This inspection would identify leakage in the SG being examined
- The area is part of routine boric acid walk downs
 - These inspections would most likely identify leakage
 - Research conducted on full scale mockups on reactor vessel bottom mounted nozzles indicates that significant boric acid deposits can result from relatively small leaks
 - Research results provide a qualitative reference to support the conclusion that a leak from the channel head, even at levels below safety significance, would most likely produce boric acid residue that would be detectable through the insulation.
