ANNUAL REPORT

WASHINGTON STATE UNIVERSITY

TRIGA REACTOR

**Facility License R-76 for the Reporting Period of
July 1, 2014 to June 30, 2015**

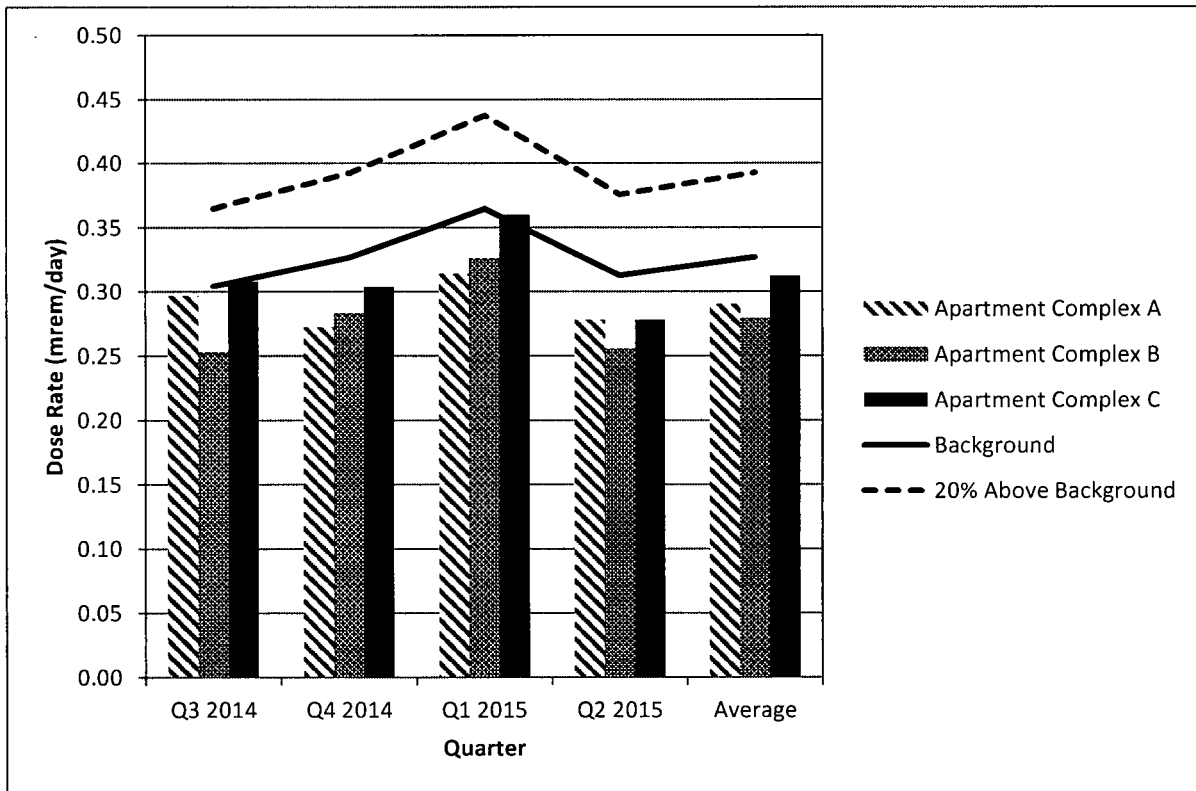
Chart I
Environmental Radiation Levels for the Closest Off-site Point of Extended Occupancy as Compared to Background Radiation Levels and 20% Above Background Radiation Levels

The dose rate for the closest offsite points of extended occupancy can be found in Table X. In Chart I the closest offsite points of extended occupancy are compared to both the background radiation levels and the 20% above background radiation levels from Table XI. Technical Specifications describing ALARA effluent releases in 3.5.2(3) specify annual radiation exposure due to reactor operation, at the closest offsite extended occupancy, shall not, on an annual basis, exceed the average offsite background radiation by more than 20%. For the reporting period, the average background radiation dose rate for off-site locations was 0.33 mrem/day, while the average radiation dose rate at the closest extended occupancy area 600 meters away was 0.29 mrem/day. This result indicates that no exposure level above normal background radiation was found. While Chart I indicates TLD 36 was higher than background radiation levels for Q3 2014 and Q1 2015, TLD 36 was still well below the 20% above background radiation levels required by the Technical Specifications. This result shows that no dose levels exceeded Technical Specifications requirements for an offsite area of extended occupancy.
