SUBJECT: COMMUNICATIONS INFORMATION ON DEGRADED BAFFLE-
FORMER BOLTS

Baffle-former bolts help hold together a structure inside the reactor vessel of Westinghouse four-loop pressurized water reactors (PWRs). Two of these reactors recently identified a large number of degraded baffle-former bolts during their 2016 spring refueling outage inspections. Indian Point, Unit 2 and Salem, Unit 1 found and reported these degraded bolt conditions in event notifications: [EN 51829](#) and [EN 51902](#).

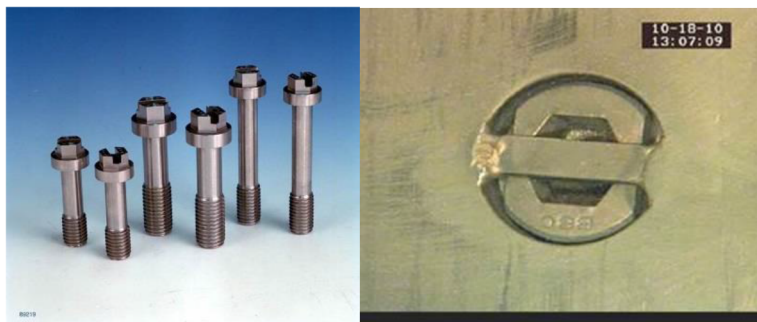
Baffle bolts (left); typical baffle bolt lock tab (right)

Typical baffle-former bolts are stainless steel (Type 347, Type 316, or Type 304), approximately 5/8" diameter, and typically 1.5 - 2" long. Plants that have replaced baffle-former bolts have done so per a Westinghouse-approved design using bolts with less susceptible material properties (i.e., Type 316 stainless steel vs. Type 347 stainless steel) and an improved head geometry to reduce stress concentrations. Most baffle-former bolt designs secure the bolt heads with a welded locking tab (see photo below, right). These lock tabs normally retain the bolt heads should they become detached. However, if the failed bolts protrude, the tabs, weld materials, and bolt heads could crack and detach, generating foreign material in the reactor coolant system.

Baffle-former bolt issues during normal plant operations include broken parts and lock tabs becoming foreign material in the reactor coolant system. This could potentially lead to fuel leaks and/or localized fuel failure issues. The additional stresses of a loss of coolant accident (LOCA) or seismic event could displace baffle plates if significant numbers of bolts are damaged or missing. LOCA stresses are more likely to cause this damage; and during the worst case scenario of a large LOCA, the potential exists for a baffle plate to detach or deform. Such an event would likely only affect the fuel assemblies next to the baffle plates and would not meet the definition of "core damage." A detached or deformed plate is unlikely to block reactor coolant flow, or to challenge the ability to safely shut down the reactor since most plants don't have control rods located in fuel assemblies near the edge of the core. Many factors reduce the "worst case" scenario, including the fact that most bolts that fail ultrasonic testing (UT) are only partially cracked and can still bear some load. Baffle edge bolts remain intact, providing significant restraint against plate detachment; this factor is not normally credited in minimum bolting analyses.
