**BEFORE THE UNITED STATES  
NUCLEAR REGULATORY COMMISSION**

In the Matter of	)	
	)	
	)	Docket Nos. 50-247
ENTERGY NUCLEAR OPERATIONS, INC.	)	50-286
	)	
(Indian Point Nuclear Generating Station, Units 2 and 3)	)	
	)

**FRIENDS OF THE EARTH’S EMERGENCY PETITION TO PROHIBIT RESTART  
OF INDIAN POINT UNIT 2 AND INSPECT INDIAN POINT UNIT 3**

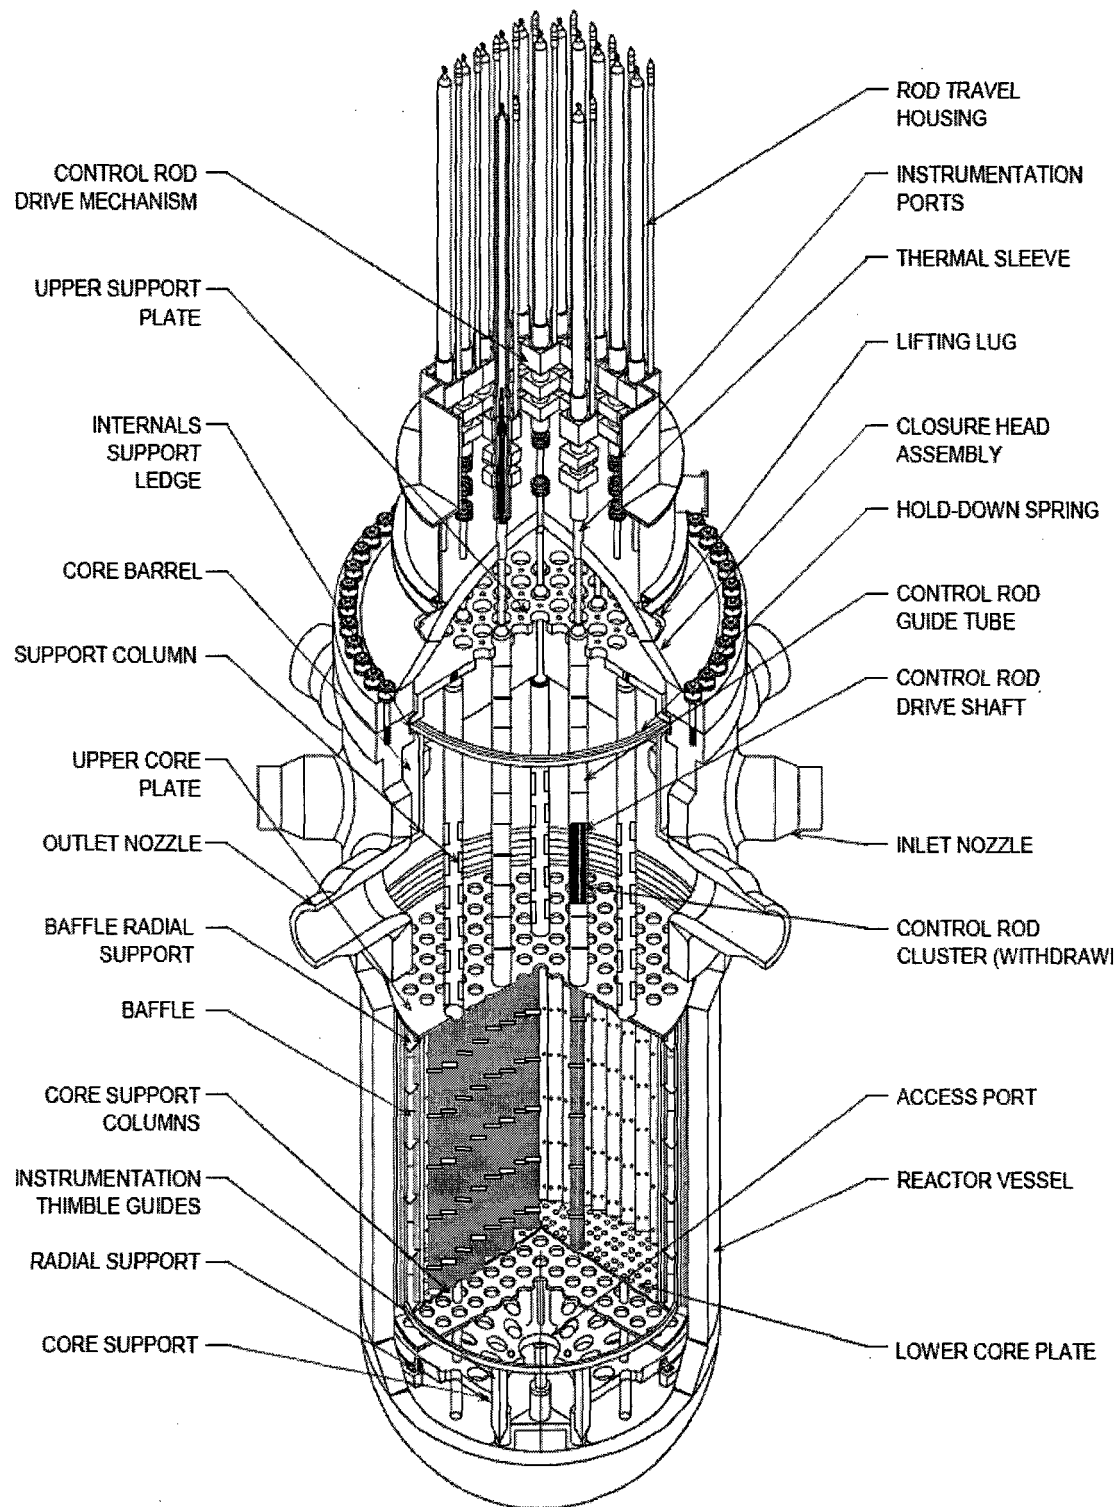
Indian Point Units 2 and 3 are Westinghouse pressurized water reactors. Each reactor contains hundreds of baffle-former bolts, which are stainless steel bolts approximately 5/8" in diameter and 2" long that hold the baffle plates to the former plates to form the baffle/former assembly. The baffle/former assembly forms the interface between the reactor core and the reactor core barrel, as shown in Figure 1, below.

Figure 1 – typical Westinghouse reactor vessel internals (source: ML15331A179)

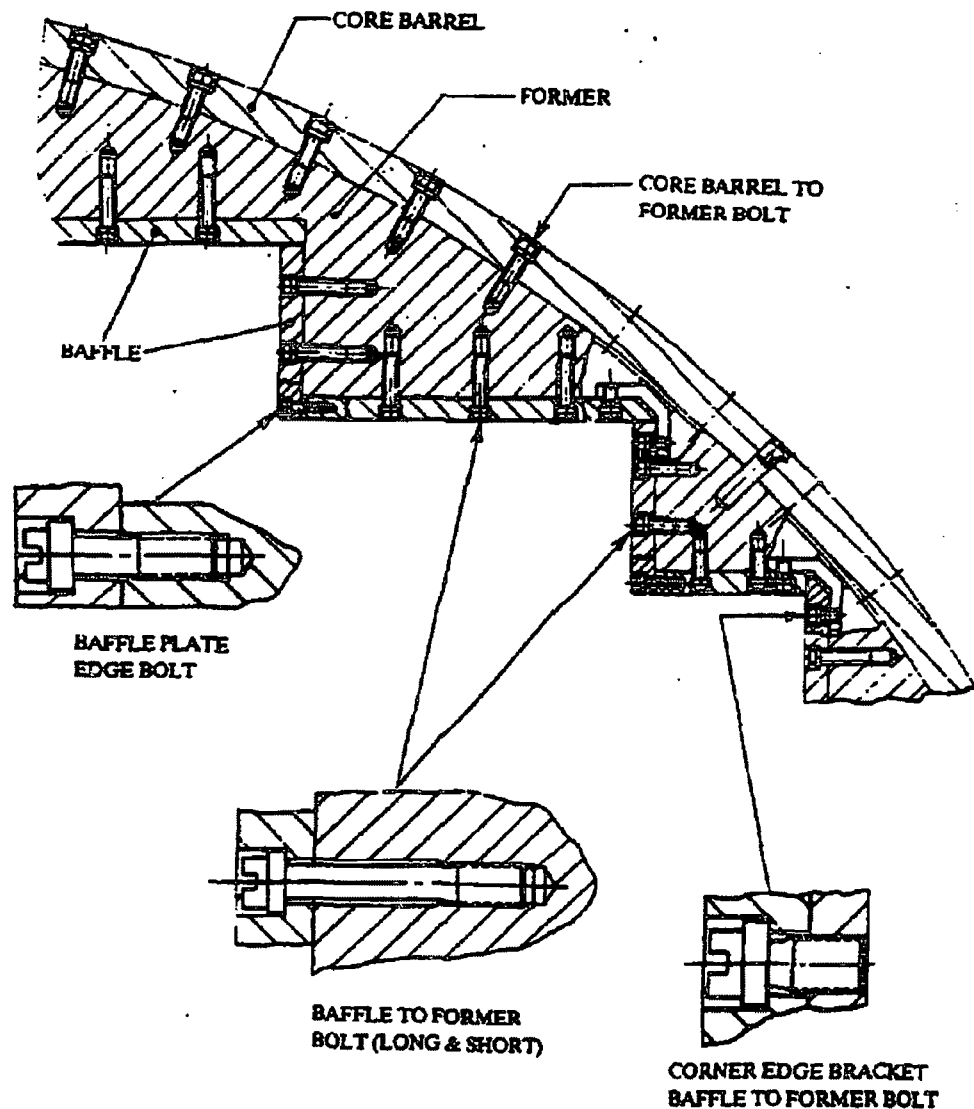
The bolts have a number of important safety-related functions. The baffles provide a barrier between the reactor core and the former to direct coolant flow through the reactor core. The bolts also provide lateral support to the reactor core during an earthquake or a loss-of-coolant accident and reduce neutron flux on the vessel, as shown in Figure 2, below.

Figure 2 – bolt locations in typical Westinghouse baffle-former-barrel structure  
(source: ML15331A179)

Failure of baffle-former bolts could cause coolant to leak through gaps between adjacent baffle plates, providing pathways for coolant to bypass the reactor core, potentially leading to a core meltdown. NRC Briefing of Commissioners on Indian Point Baffle Bolt Inspections (Apr. 19, 2016) at 4 (“NRC Slides”).<sup>1</sup> Degraded or missing bolts can also impede the assurance of core safety during an earthquake.
