SEABROOK STATION
UPDATED FINAL SAFETY
ANALYSIS REPORT

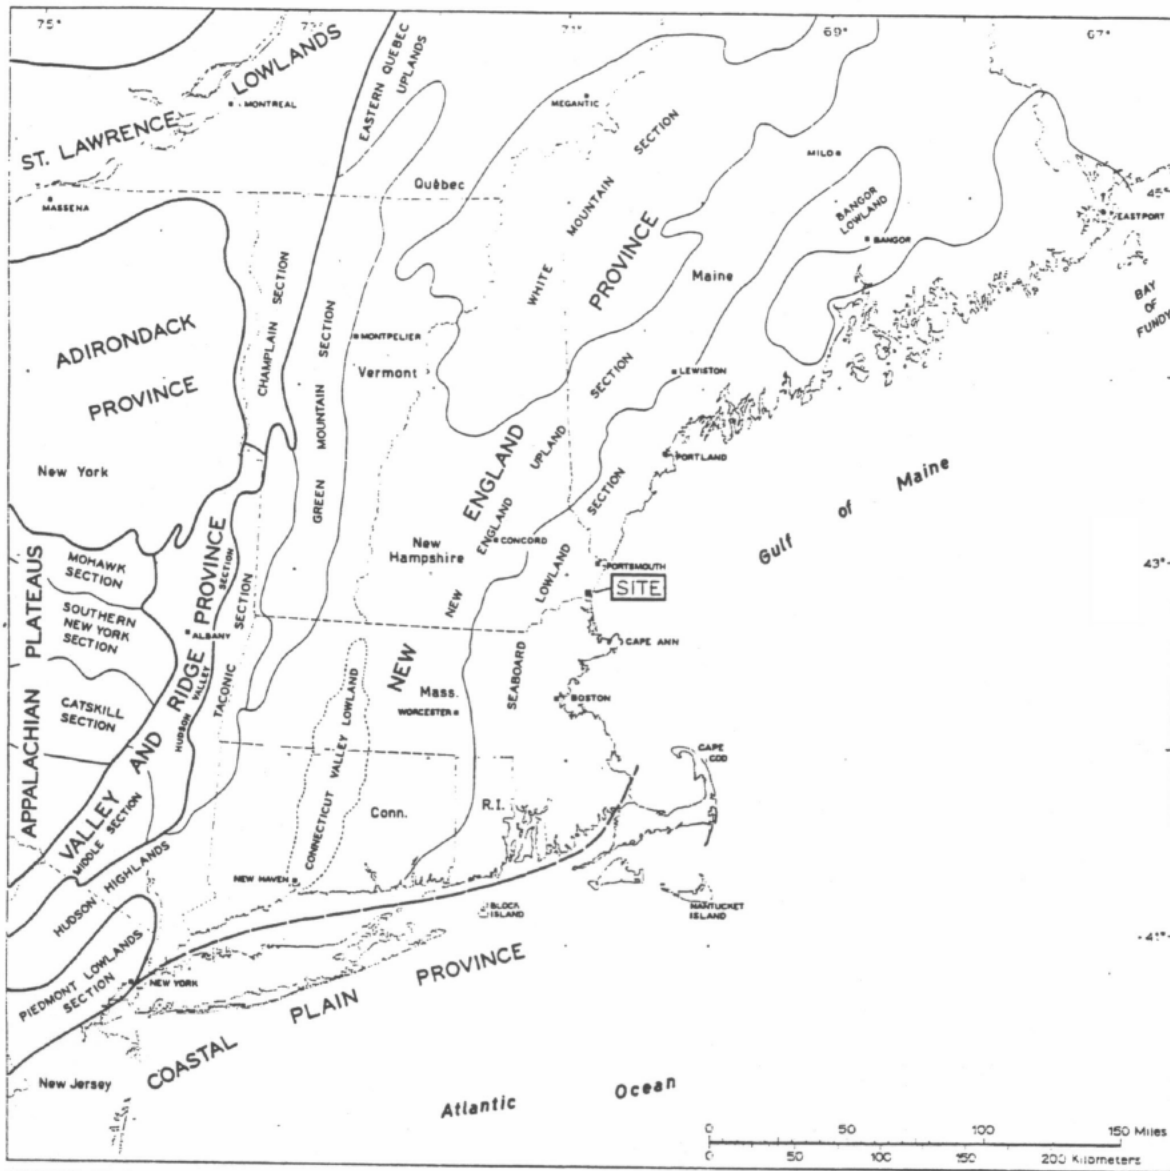
Figure 2.5-1

Regional Physiographic Map

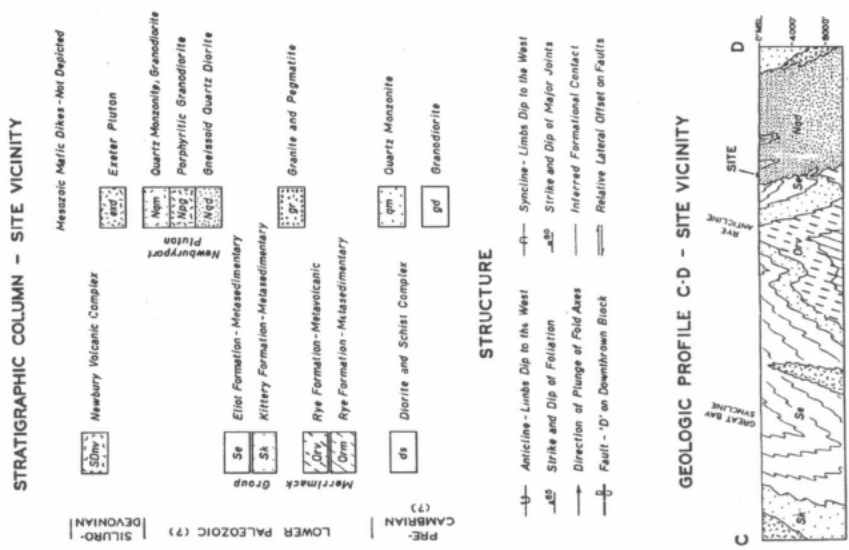
GEOLOGIC PROFILE C-D - SITE VICINITY

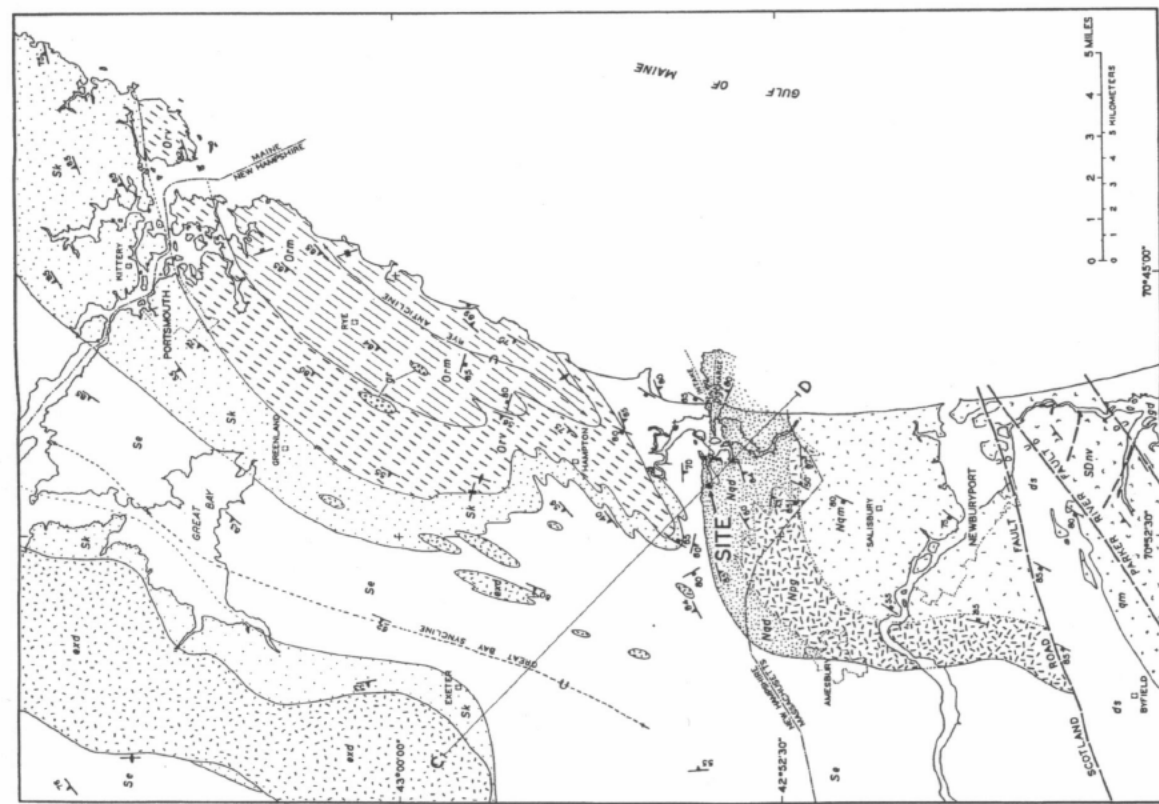
SEABROOK STATION UPDATED FINAL SAFETY ANALYSIS REPORT	Site Vicinity - Bedrock Geology	
		Figure 2.5-7

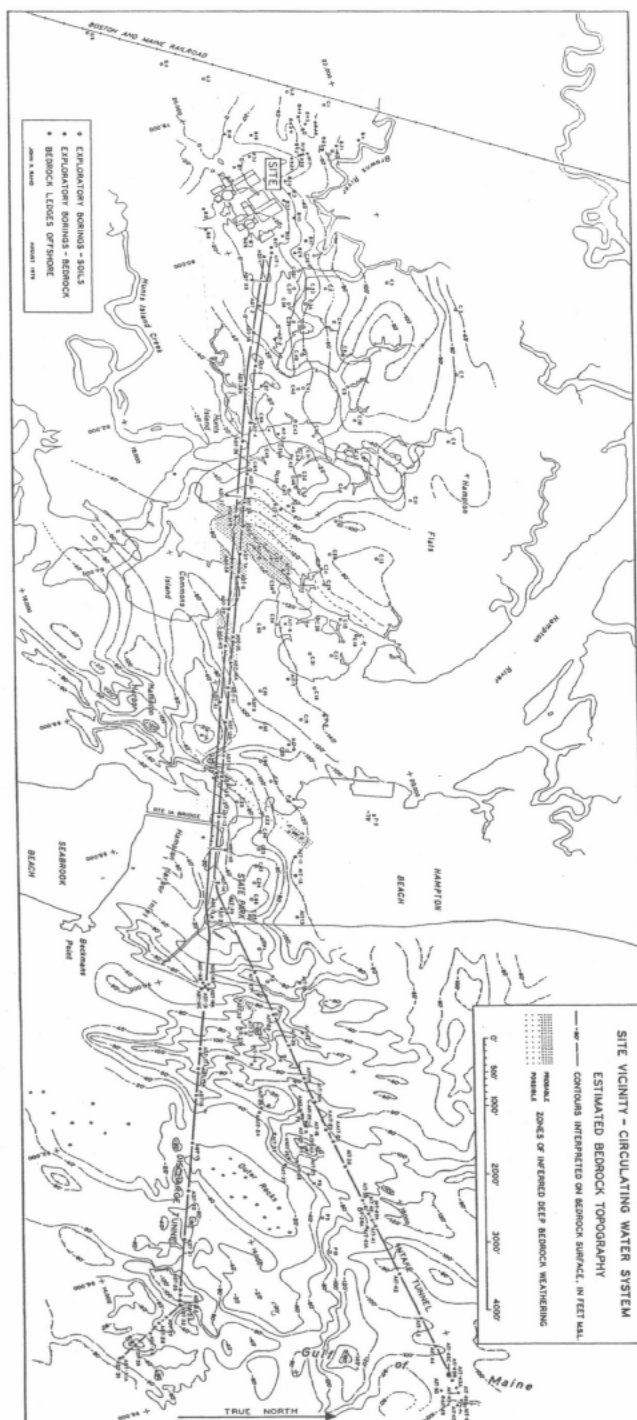
Figure 2.5-10

Site Vicinity - Estimated Bedrock Topography – Circulating
Water System

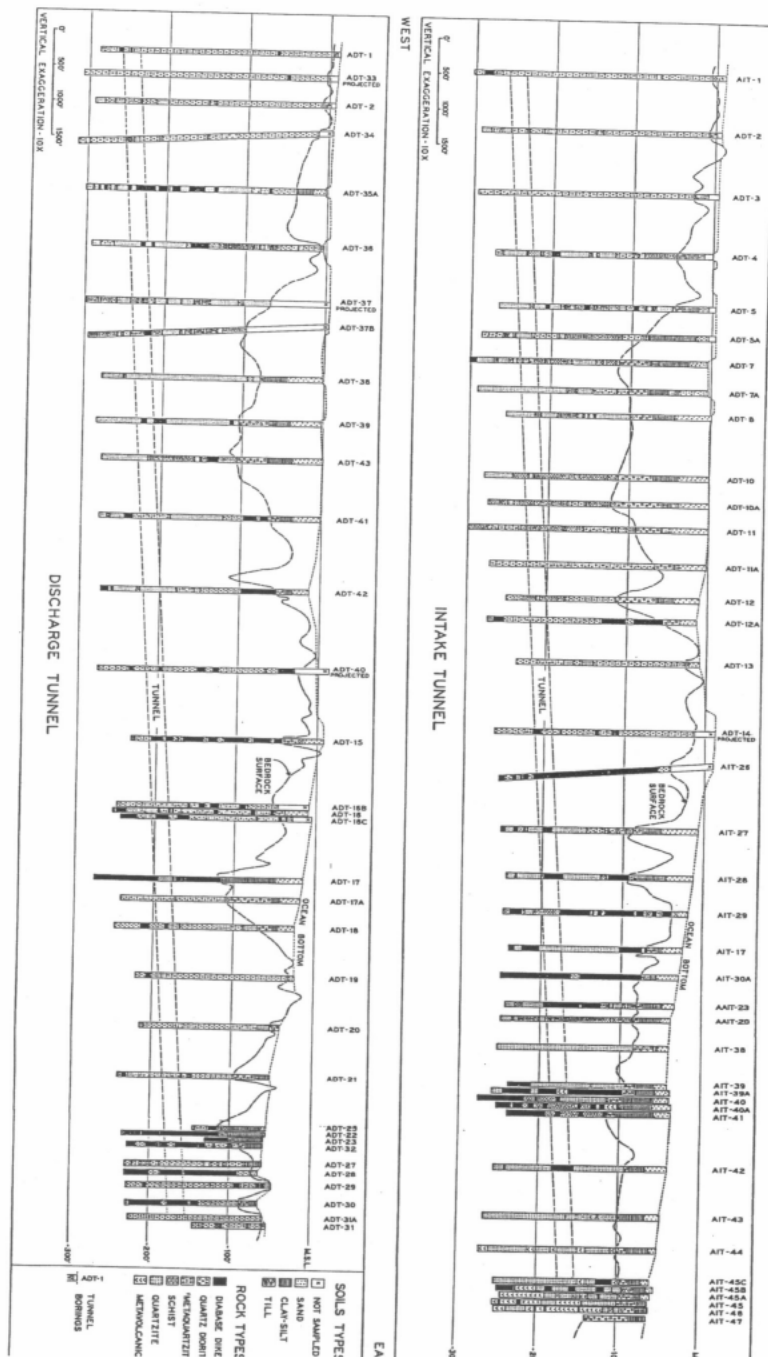
SEABROOK STATION UPDATED FINAL SAFETY ANALYSIS REPORT	Site Vicinity - Geological Profile – Circulating Water System	
		Figure 2.5-11

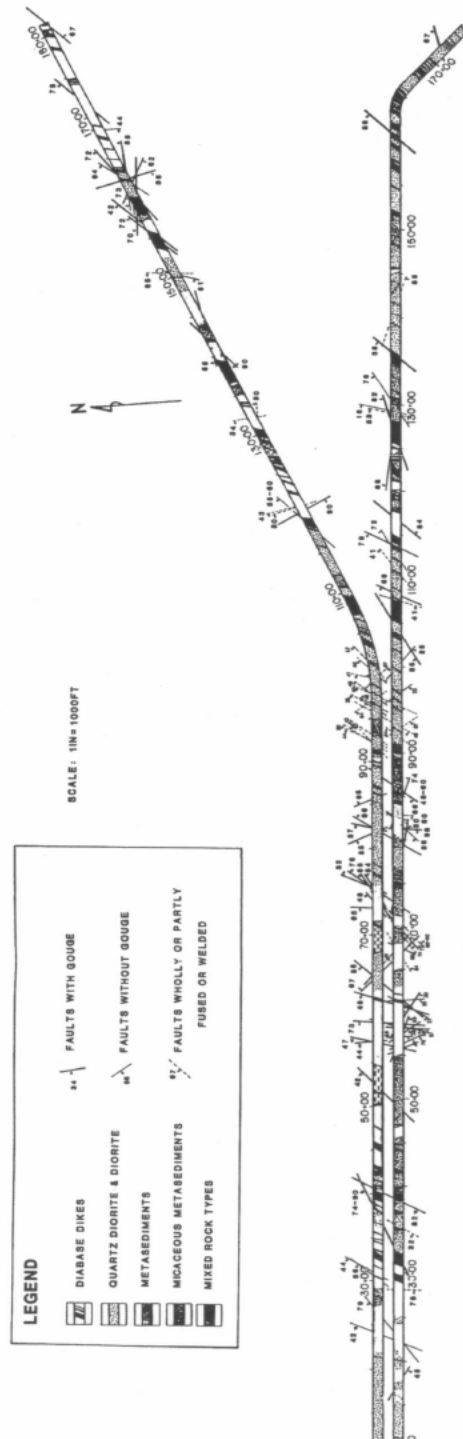
Figure 2.5-12

Site Vicinity - Circulating Water Tunnels Geology Plan

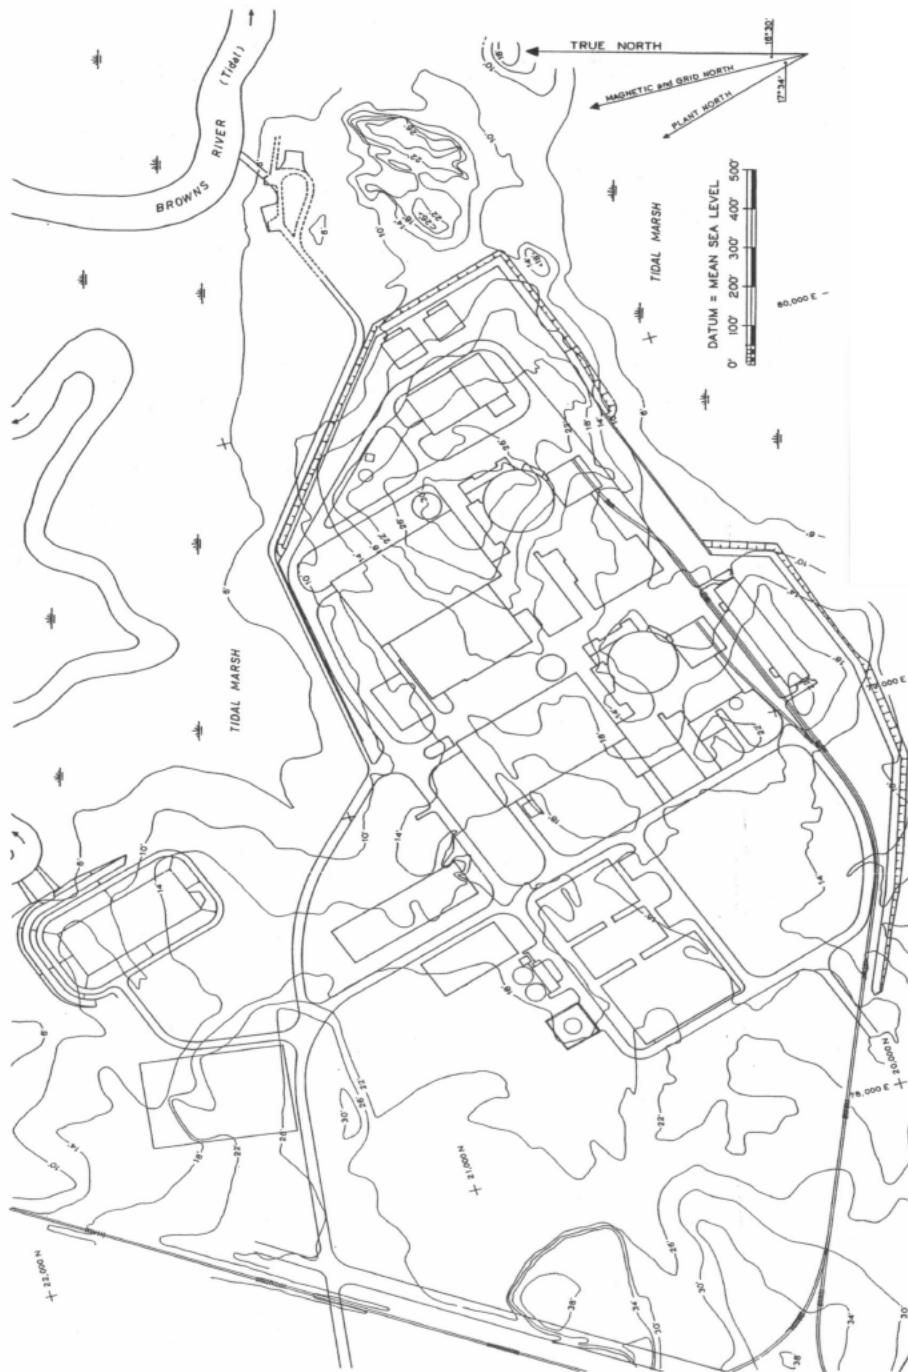
SEABROOK STATION UPDATED FINAL SAFETY ANALYSIS REPORT	Site Area – Plot Plan and Original Surface Topography	
		Figure 2.5-15

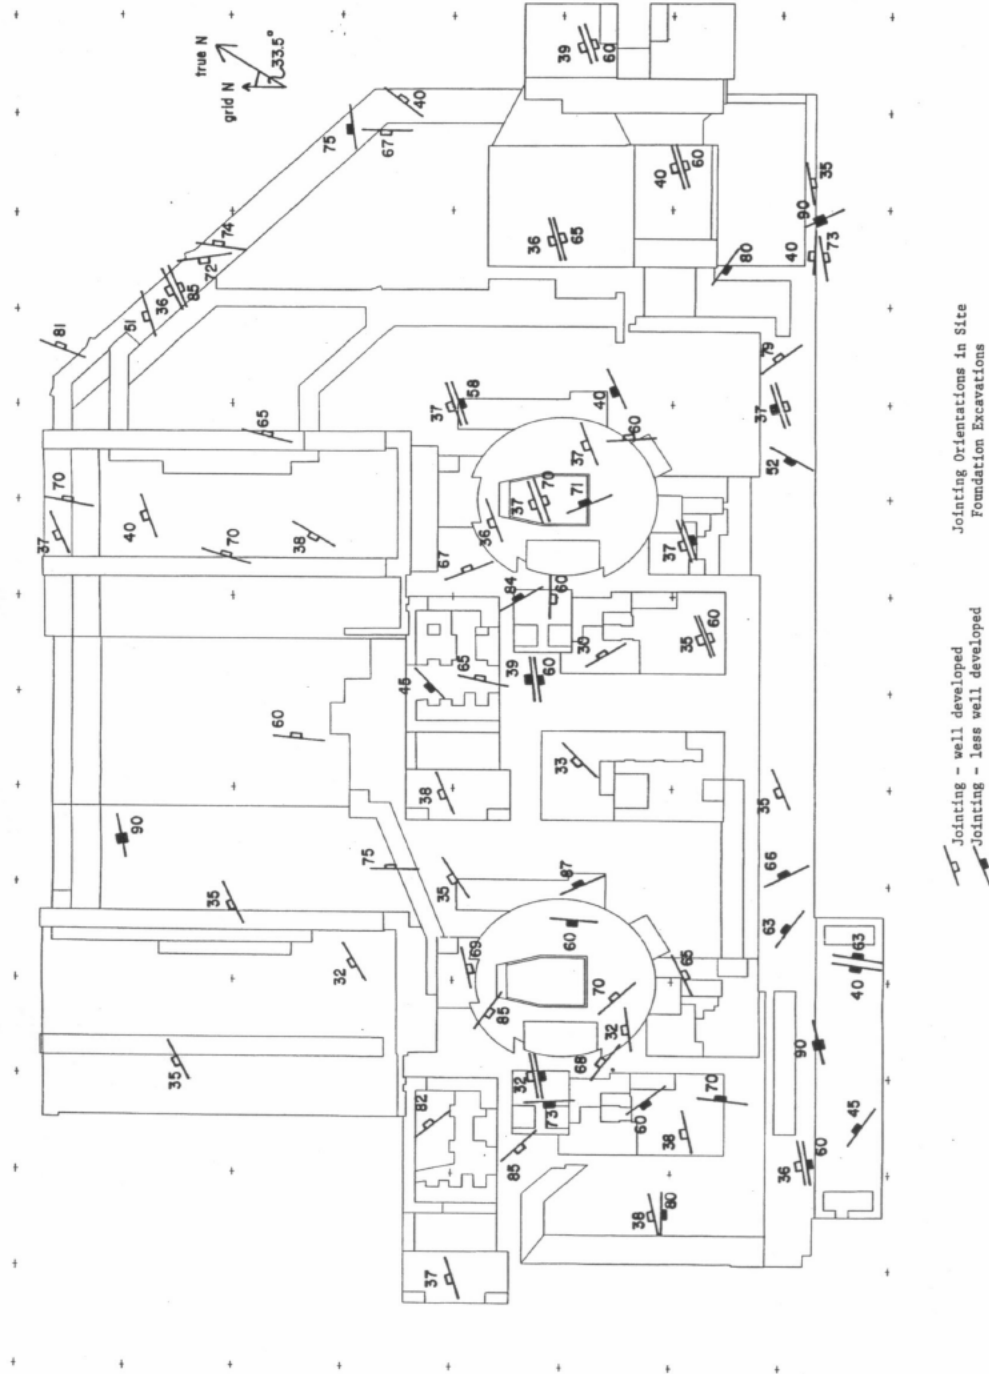
Figure 2.5-21

Jointing Orientations in Site Foundation Excavations

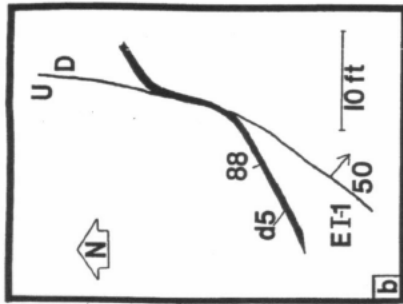
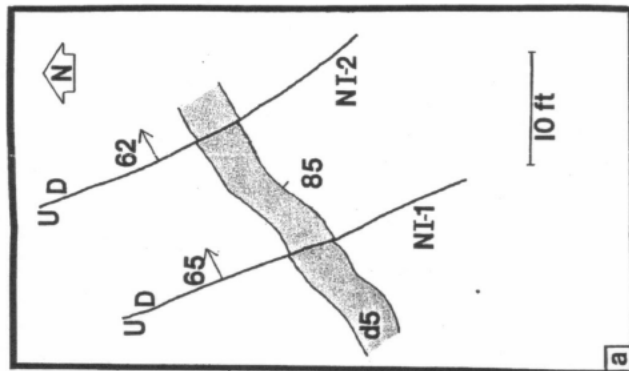
a. PLAN SKETCH FROM THE CBI. FAULTS NI-1 AND NI-2 CLEANLY OFFSET DIKE d5 AND THE HOST ROCK, NEWBURYPORT. b. PLAN SKETCH FROM DI. FAULT W-6 DEFLECTS AND OFFSETS DIKE d5 AND THE HOST ROCK, NEWBURYPORT. c. PLAN SKETCH FROM THE AREA BETWEEN THE CWI AND THE ESFPCI. DIKE d5 CROSS-CUTS FAULT EI-1.

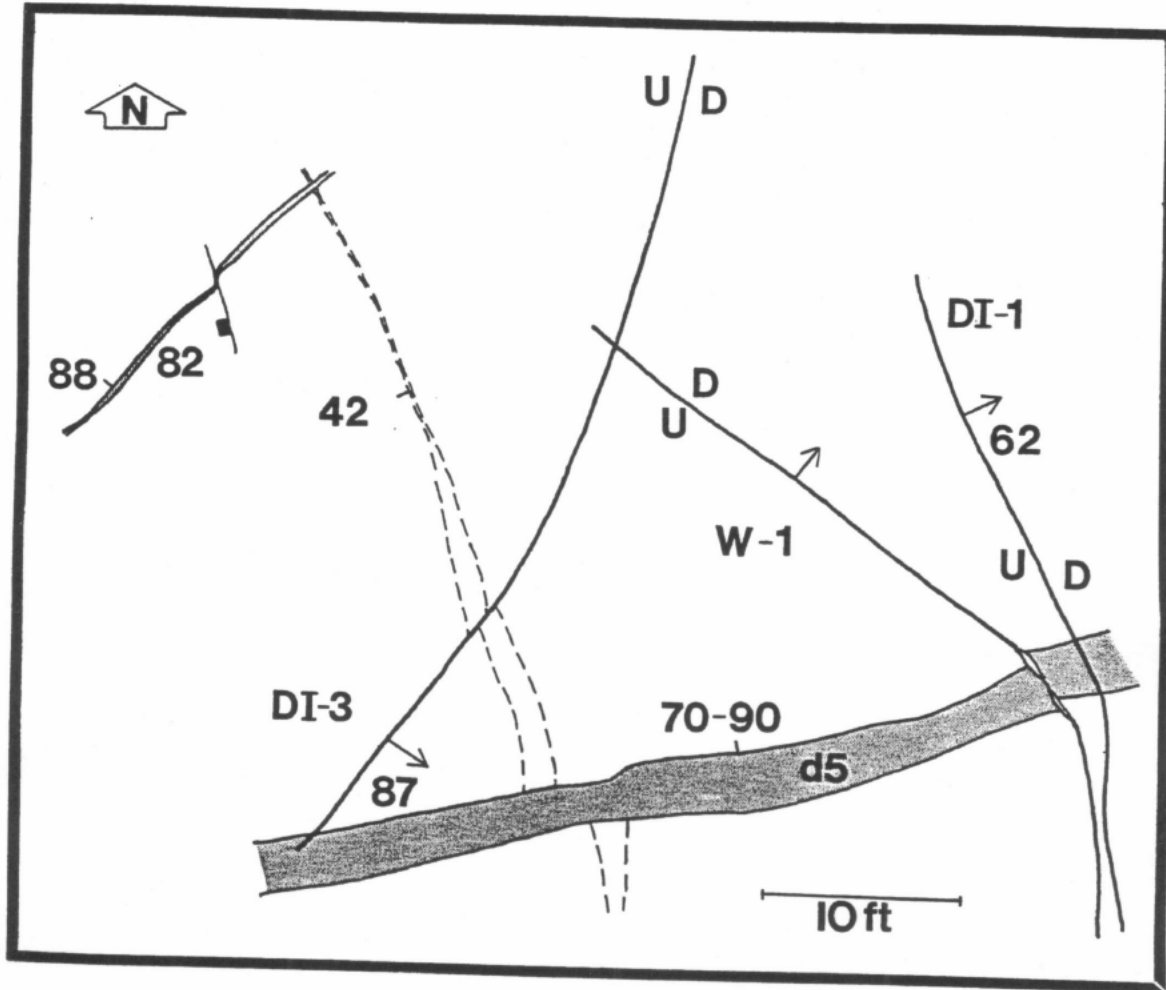
PLAN SKETCH FROM D1. FAULT DI-3 ENDS WITH DIKE d5. FAULT DI-1 APPARENTLY DISPLACES DIKE d5 ALTHOUGH THE FAULT NARROWS TO A SINGLE, NARROW, TIGHT FRACTURE BETWEEN TWO CALCITE PODS AT THE DIKE'S CENTER. FAULT DI-1 APPARENTLY DISPLACES d5 ALTHOUGH HEAVY CALCITE COATINGS PREVENT MEASUREMENT OF DIKE OFFSET. A DIKELET ASSOCIATED WITH d5 IS DEFLECTED ALONG A JOINT IN A MANNER WHICH MIMICS SOME APPARENT OFFSETS OF DIKES ALONG FAULTS OVER THE SITE. DILATION OPENING FOR d5 TOOK PLACE OTHER THAN AT RIGHT ANGLES TO DIKE CONTACTS. DIABASE DIKELET SHOWS PSEUDO-OFFSET ALONG JOINT. HOST ROCK IS NEWBURYPORT.

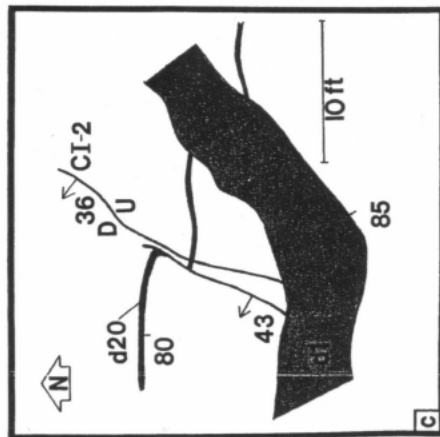
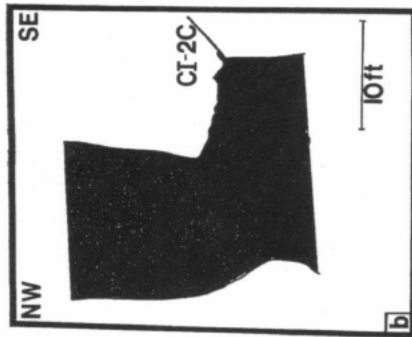
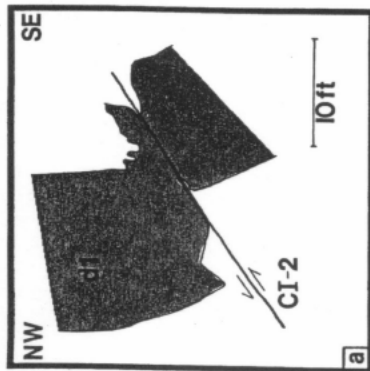
a. PROFILE SKETCH FROM THE NORTHEAST WALL OF E11. FAULT CI-2 DEFLECTS AND CROSS-CUTS BUT DOES NOT APPEAR TO DISPLACE DIKE d1. HOST ROCK IS THE NEWBURYPORT.
b. PROFILE SKETCH FROM THE CWT'S EAST WALL ADJACENT TO THE CP. FAULT CI-20 DEFLECTS AND OFFSETS DIKE d1. APPARENT REVERSE MOTION SENSE RESULTS FROM DIKE FLOW DEFLECTION. HOST ROCK IS NEWBURYPORT. c. PLAN SKETCH FROM CWT SOUTH OF WPB. DIKE d1 CUTS DIKE d20. FAULT CI-2 OFFSETS AND DEFLECTS DIKE d20 AND ENDS AGAINST DIKE d1. HOST ROCK IS KITTEERY MIXED WITH SOME NEWBURYPORT.

SEABROOK STATION UPDATED FINAL SAFETY ANALYSIS REPORT	Sketches Detailing CI-2 and CI-2C	
		Figure 2.5-25

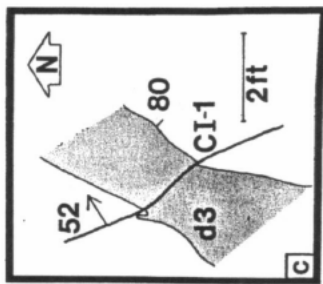
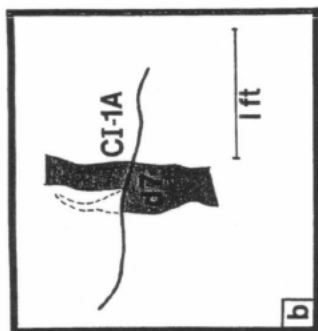
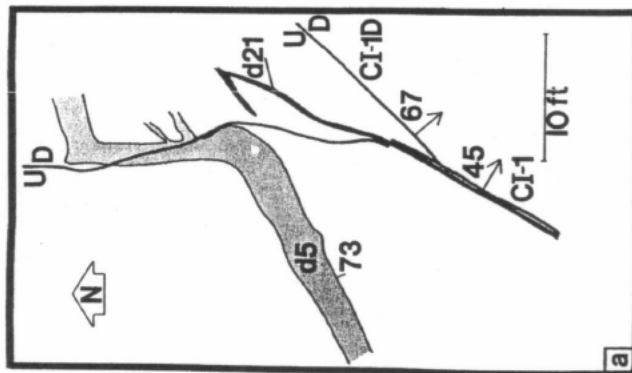
a. PLAN SKETCH FROM NORTHEAST QUADRANT OF CI AND ADJACENT EFPBI. DIKE d21 CROSS-CUTS FAULT CI-1. FAULT CI-1 DEFLECTS DIKE d5 AND TRENDS THROUGH THE DEFLECTED SEGMENT AS A TIGHT, NARROW FRACTURE, BUT DOES NOT OFFSET DIKE CONTACTS. FAULT CI-1D SPLAYS FROM CI-1. HOST ROCK IS NEWBURYPORT. b. FAULT CI-1A DEFLECTS DIKE d7 AND TRENDS THROUGH THAT DIKE AS A NARROW FRACTURE, BUT DOES NOT OFFSET DIKE CONTACTS. THE VUGGY CRACK ADJACENT TO THE d7 IS THE REMNANT OF THE ABANDONED DIKE PATH. HOST ROCK IS NEWBURYPORT. c. PLAN SKETCH FROM RI. FAULT CI-1 CUTS DIKE d3 OFFSETTING ONE DIKE CONTACT BUT APPARENTLY ONLY DEFLECTING AND NOT OFFSETTING THE OTHER CONTACT.

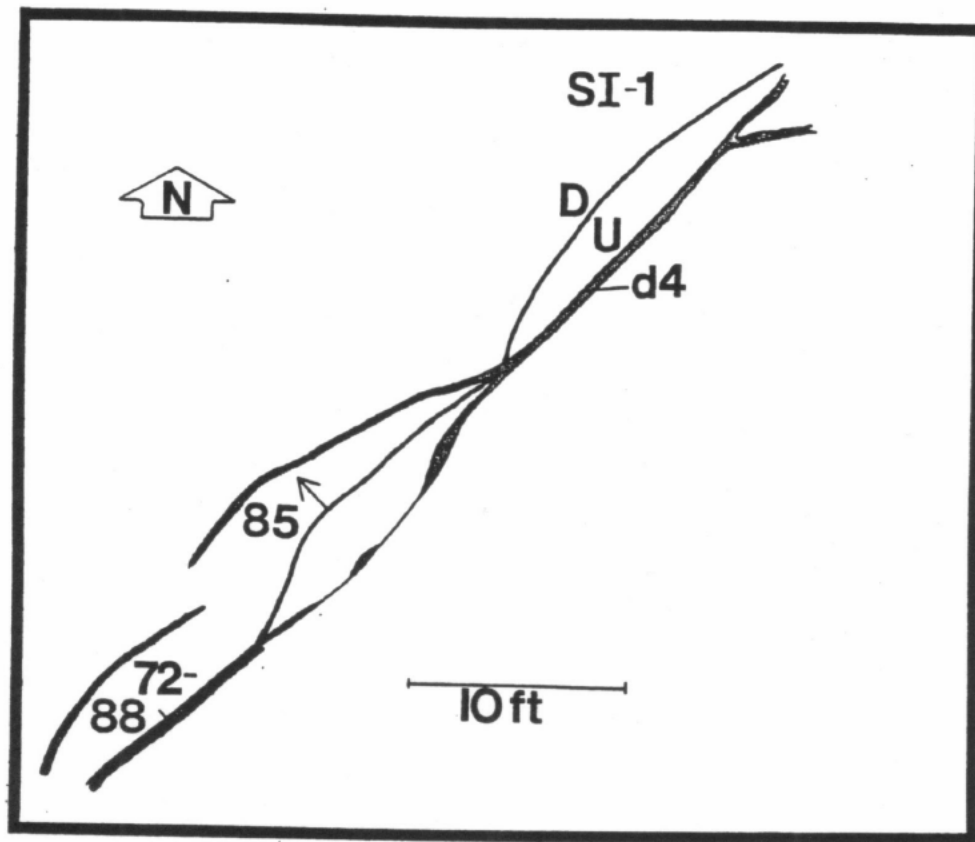
PLAN SKETCH FROM ESFPCI. DIKE d4 BOTH CROSS-CUTS AND WAS CHanneled ALONG FAULT SI-1. HOST ROCK IS NEWBURYPORT.

SEABROOK STATION UPDATED FINAL SAFETY ANALYSIS REPORT	Sketches Detailing SI-1	
		Figure 2.5-27

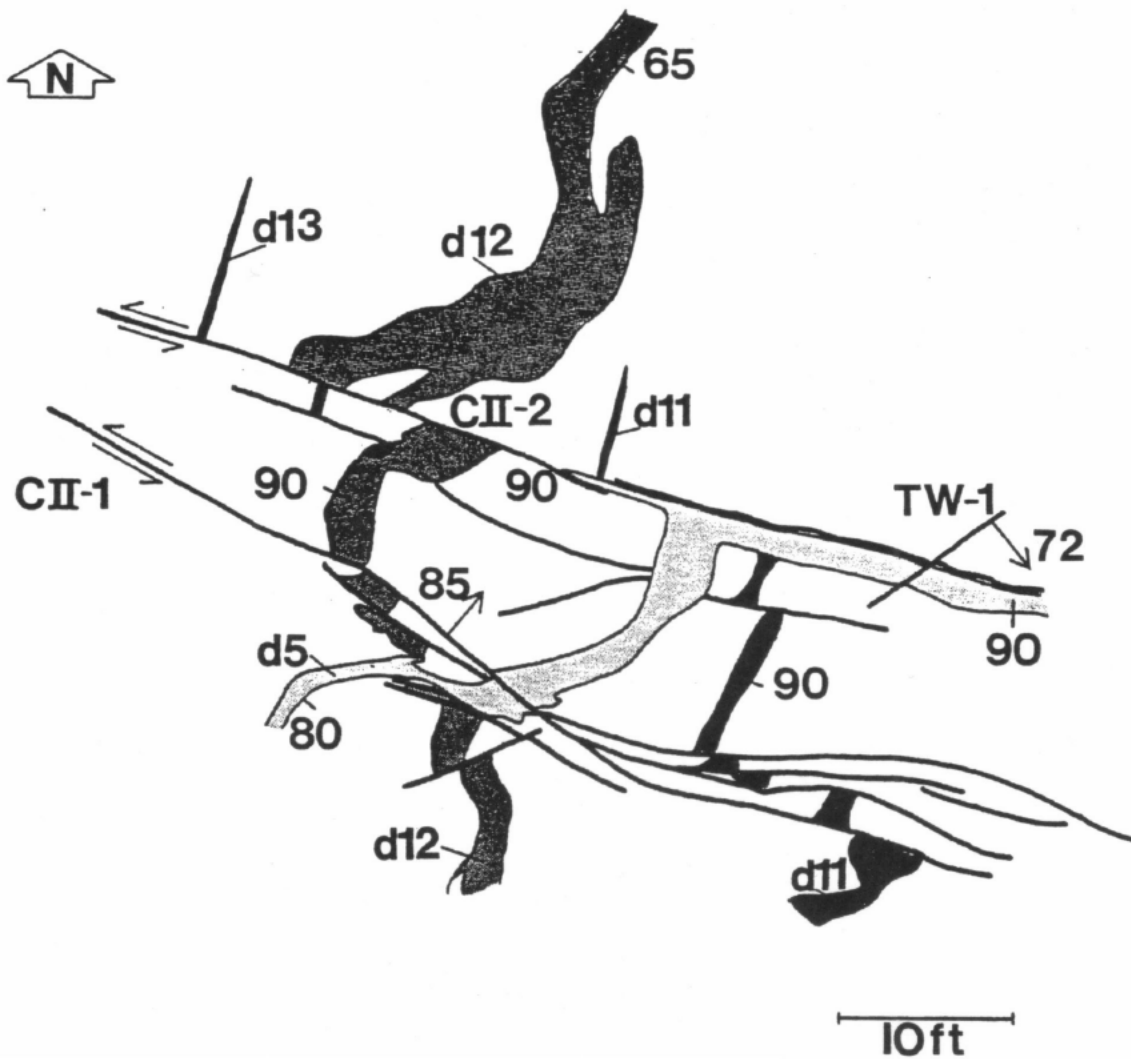
PLAN SKETCH FROM TWII. FAULT CII-1 OFFSETS DIKES d11, d12, d13, AND d5. FAULT CII-2 OFFSETS DIKES d11, d12, AND d13. FAULT TW-1 OFFSETS DIKE d5 AND FAULT CII-2. DIKE d5 CROSS-CUTS CII-2 AND PARTIALLY CROSS-CUTS CII-1. HOST ROCK IS KITTEERY WITH MINOR NEWBURYPORT.

SEABROOK STATION UPDATED FINAL SAFETY ANALYSIS REPORT	Sketches Detailing CII-1, CII-2 and TW-1	
		Figure 2.5-28

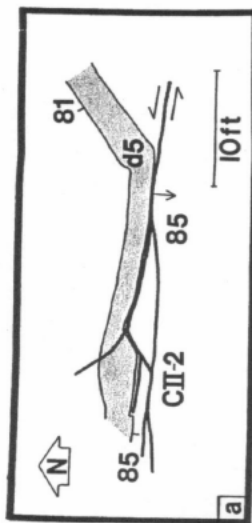
a. PLAN SKETCH FROM JUST WEST OF EFPBII. DIKE d5 TURNS AT AND IS CHANNELLED ALONG FAULT CII-2. HOST ROCK IS KITTERY WITH SUBSTANTIAL NEWBURYPORT. b. PLAN SKETCH FROM SWT AT NORTH SIDE OF CT. DIKE d1 CROSS-CUTS FAULT PII-1A WITH VERY MINOR FRACTURING AT THE DIKE'S SOUTHEAST CONTACT. FAULT CT-2 ENDS AGAINST PII-1A. HOST ROCK IS MOSTLY NEWBURYPORT WITH KITTERY (ms) AS SHOWN.

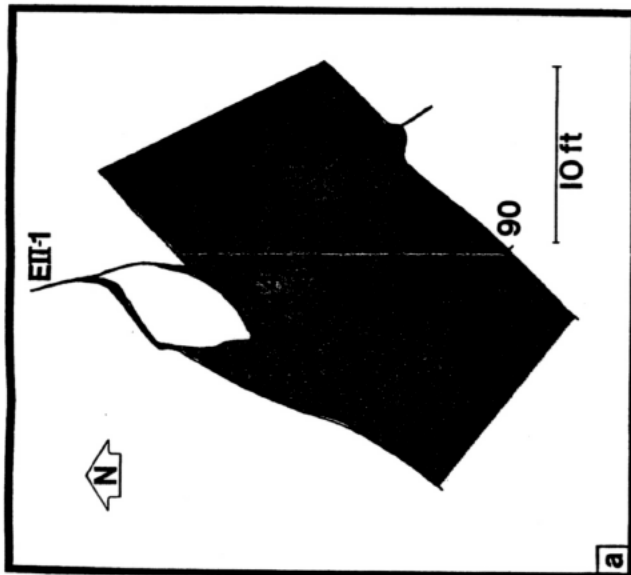
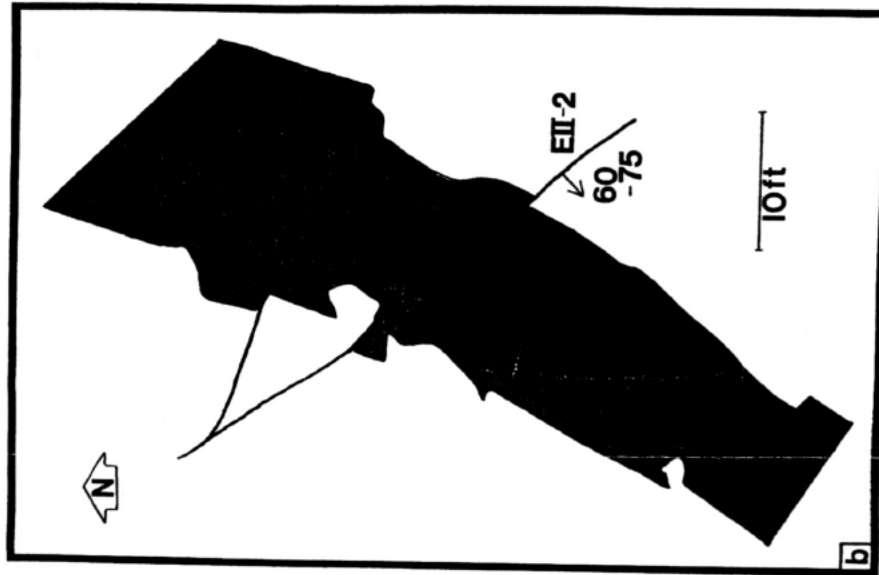
a. PLAN SKETCH FROM SWT NORTHEAST OF CT. FAULT EII-1 CROSS-CUTS DIKE d1. DEFLECTION OF DIKE CONTACTS PREVENTS PRECISE DEFINITION OF DISPLACEMENT. CONTRARY TO APPARENT MOTION OF EII-1 (NORMAL-RIGHT-LATERAL) ON OFFSET COOLING JOINT SUGGESTS REVERSE OR LEFT-LATERAL MOTION. HOST ROCK IS NEWBURYPORT.

b. PLAN SKETCH FROM SWT SOUTHEAST OF WPB. FAULT EII-2 OFFSETS DIKE d1.

SEABROOK STATION UPDATED FINAL SAFETY ANALYSIS REPORT	Sketches Detailing EII-1 and EII-2	
		Figure 2.5-30

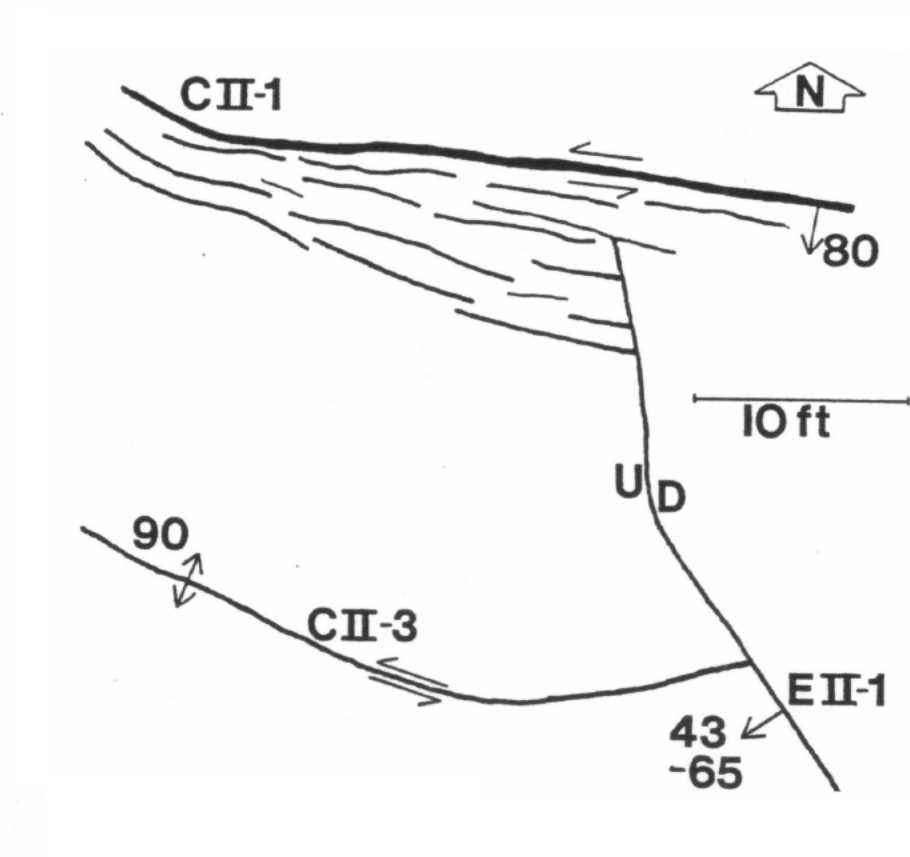
PLAN SKETCH FROM SOUTHEAST OF CII. FAULT CII-1 OFFSETS FAULT EII-1. THE CONTINUATION OF EII-1 EMERGES FROM CII-1 TO THE WEST; EII-1, HOWEVER, DOES PARTIALLY CROSS-CUT PART OF THE ZONE REPRESENTING THE MORE ANCIENT MOTION ON CII-1. CII-3 ENDS AGAINST EII-1. ROCK IS KITTERY WITH MINOR NEWBURYPORT.

SEABROOK STATION UPDATED FINAL SAFETY ANALYSIS REPORT	Sketch Detailing CII-1, CII-3 and EII-1	
		Figure 2.5-31

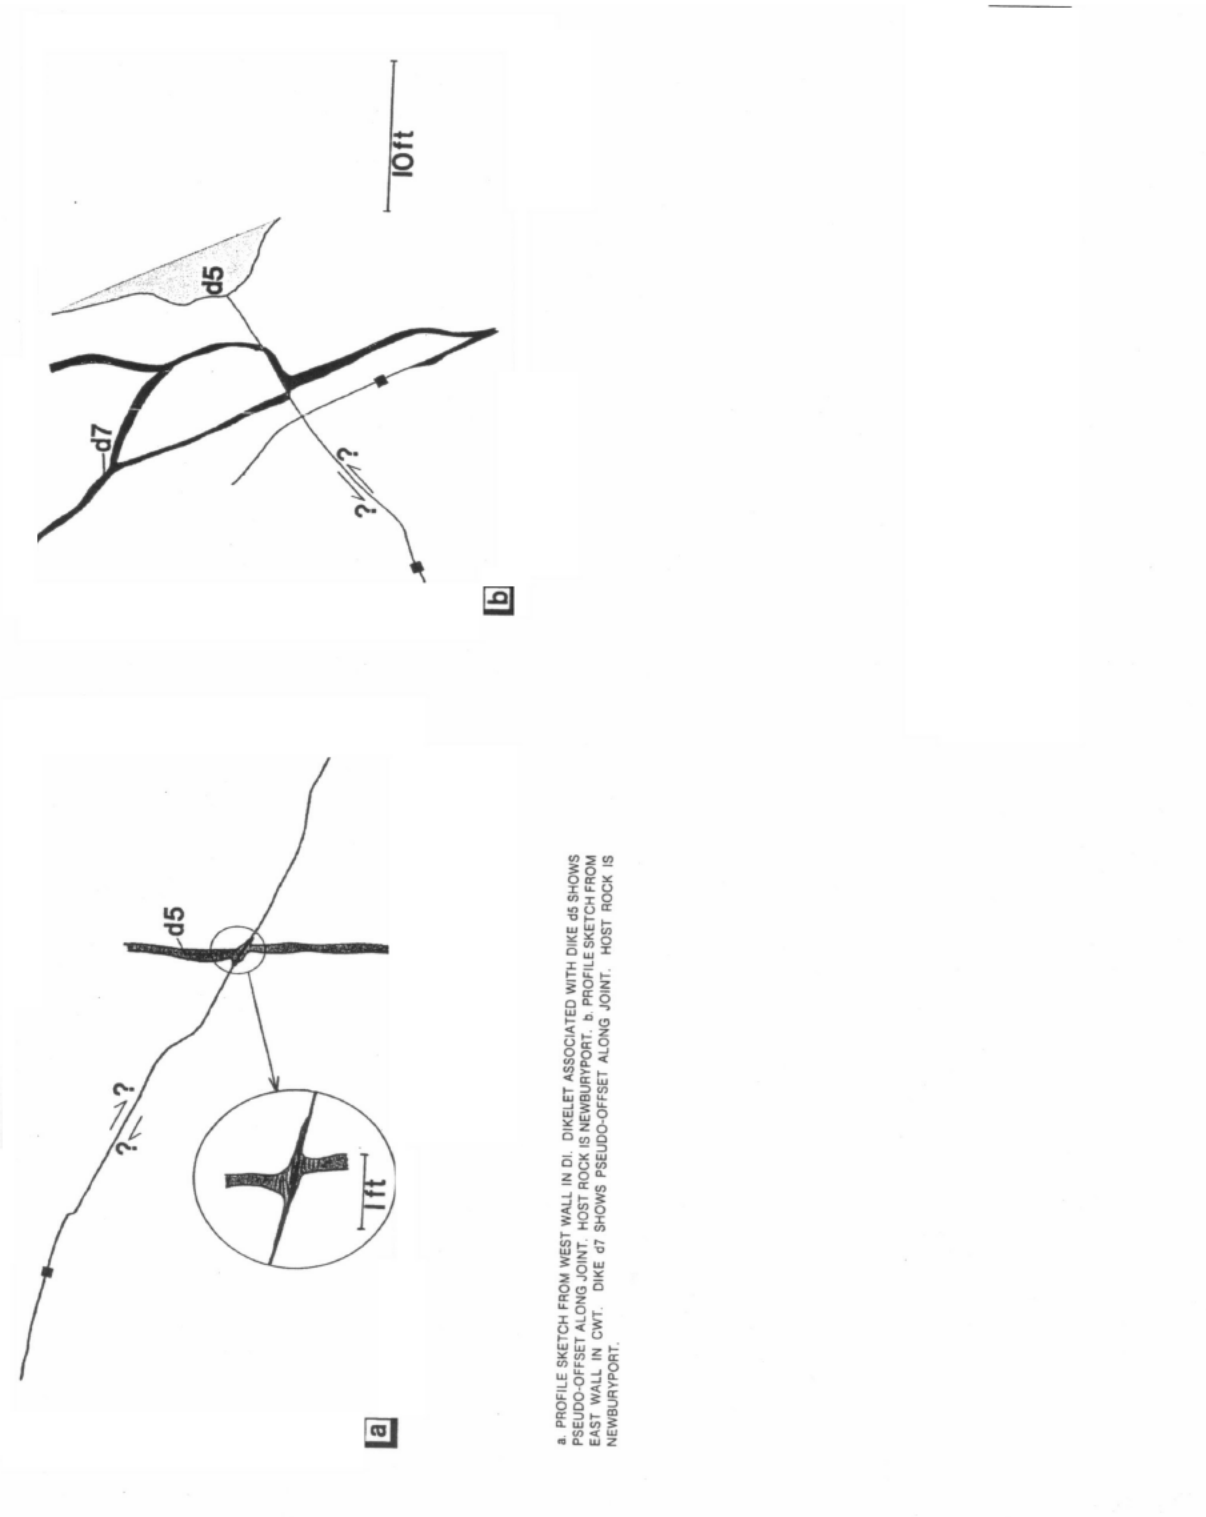
SEABROOK STATION UPDATED FINAL SAFETY ANALYSIS REPORT	Sketch Detailing Pseudo-Offset of Dikes	
		Figure 2.5-32

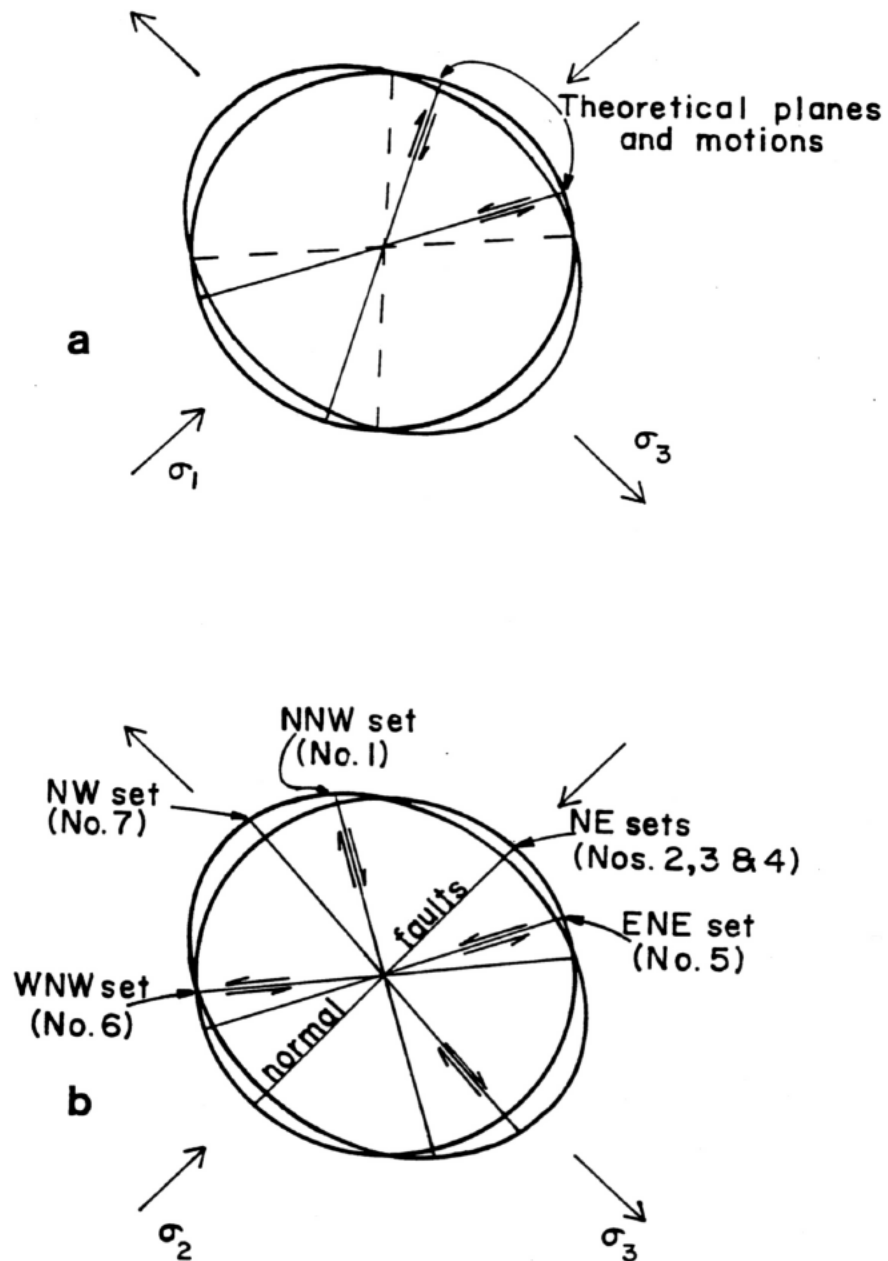
a. FAILURE PLANES AND MOTIONS AS PREDICTED BY "STRAIN THEORY" (BADGLEY, 1962) FOR NW-SE TENSIONAL STRESS FIELD. b. ACTUAL FAULT PLANES WITH LATERAL MOTION COMPONENTS OBSERVED IN SITE EXCAVATIONS. OBSERVED MOTIONS CONFORM TO PREDICTIONS IN a. FAULT MOTIONS AND INTRUSION OF NE-TRENDING DIKES ARE BOTH CONSISTENT WITH A NW-SE TENSIONAL STRESS.

SEABROOK STATION UPDATED FINAL SAFETY ANALYSIS REPORT	Strain Ellipsoid for NW-SE Tensional Stress	
		Figure 2.5-33

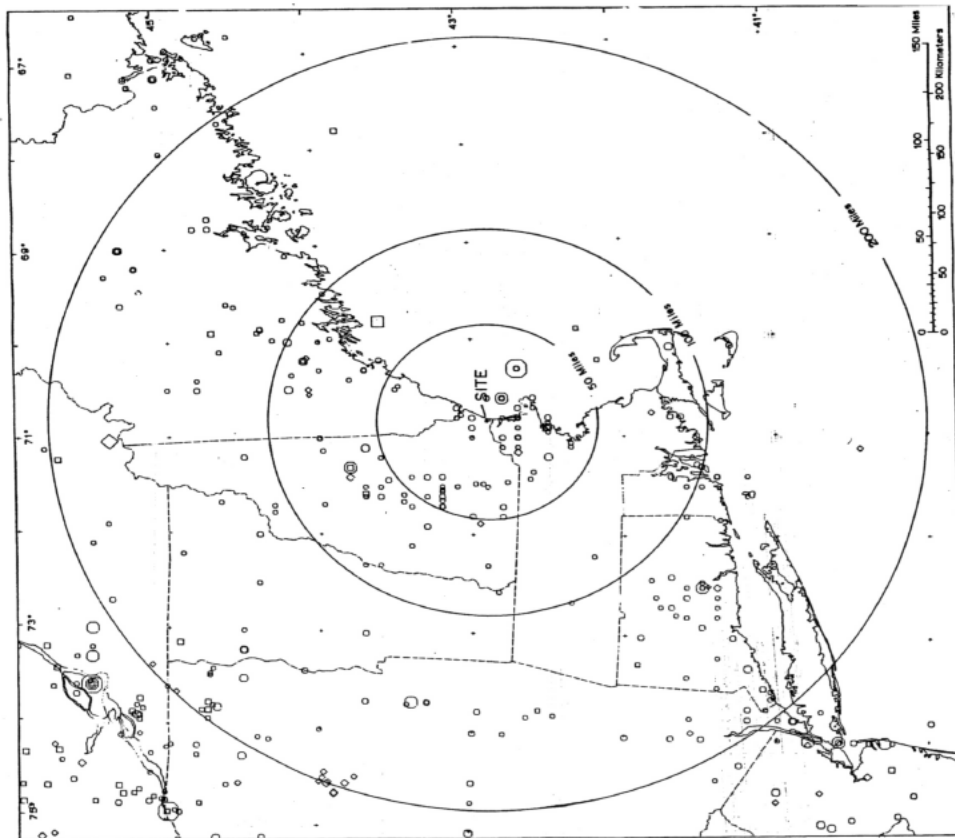
Figure 2.5-34

Cumulative Seismicity Map

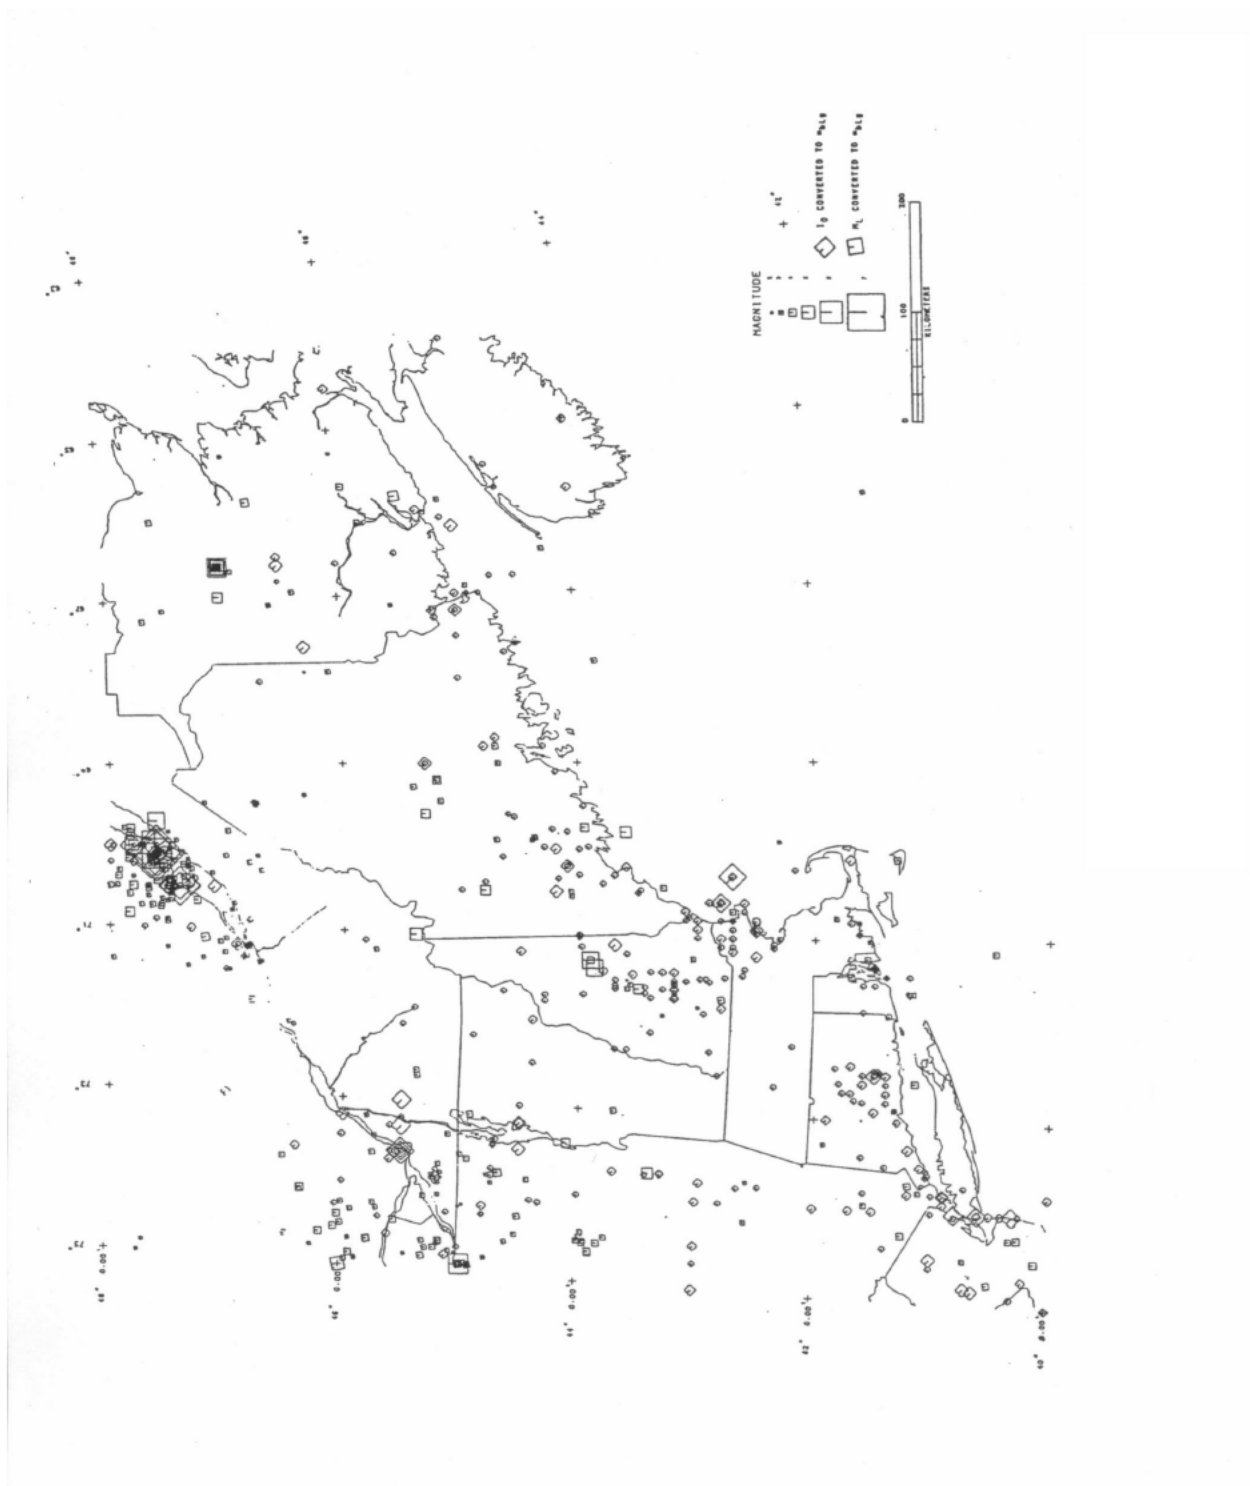
Figure 2.5-35

Regional Seismicity Map

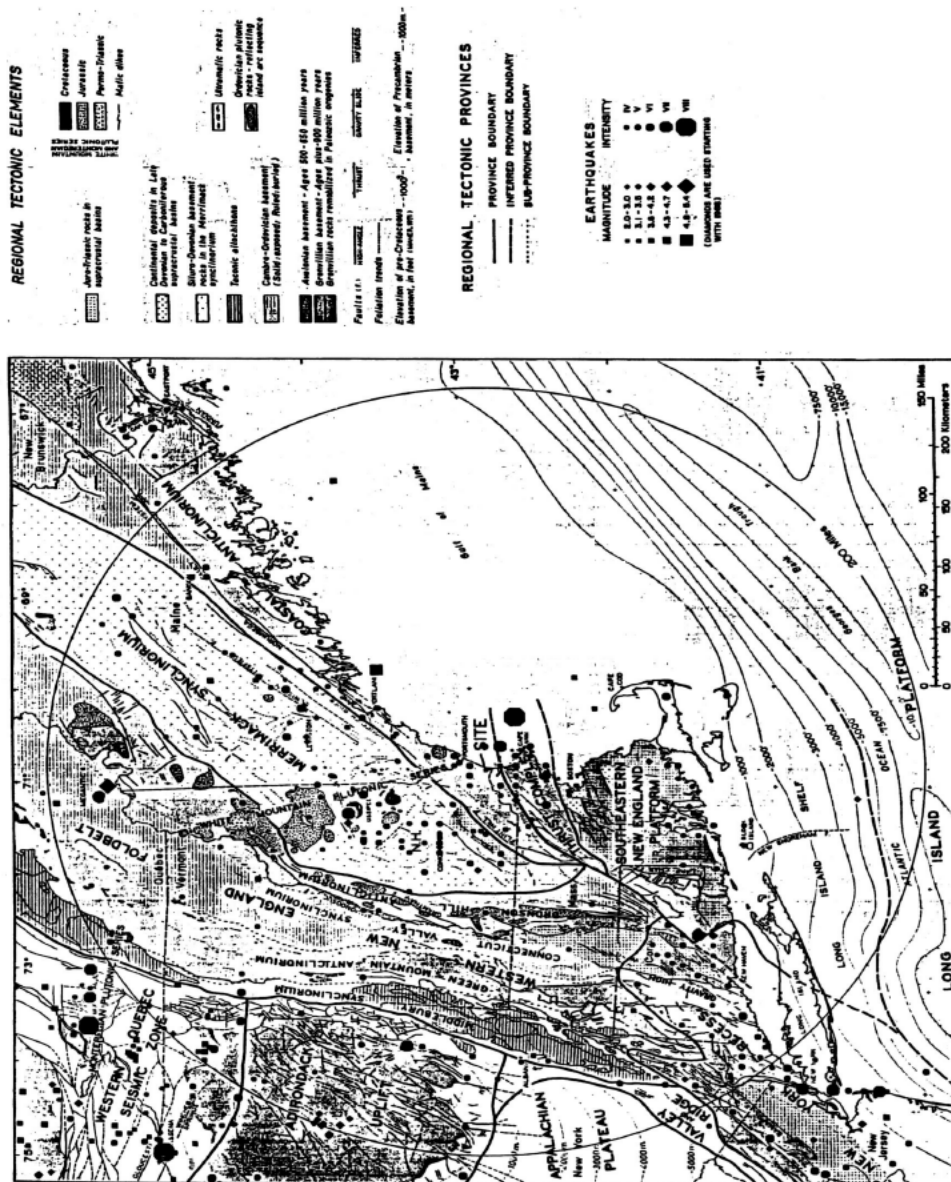
Figure 2.5-36

Epicenter Tectonic Map, 200 Miles
