SEABROOK STATION
UPDATED FINAL SAFETY
ANALYSIS REPORT

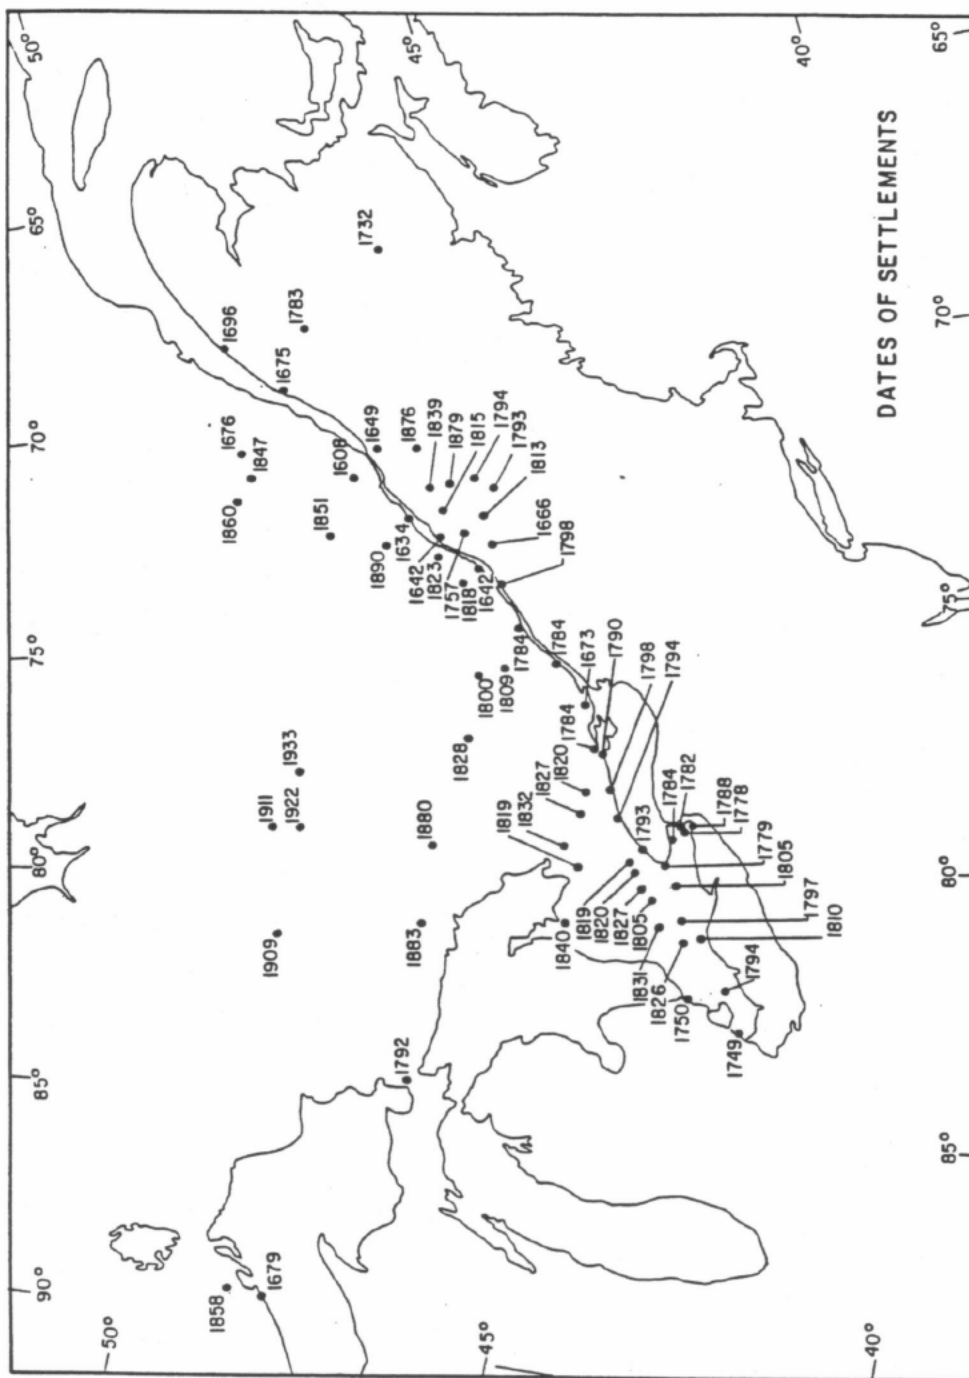
SEABROOK STATION UPDATED FINAL SAFETY ANALYSIS REPORT	Settlement in Canada	
		Figure 2.5-39

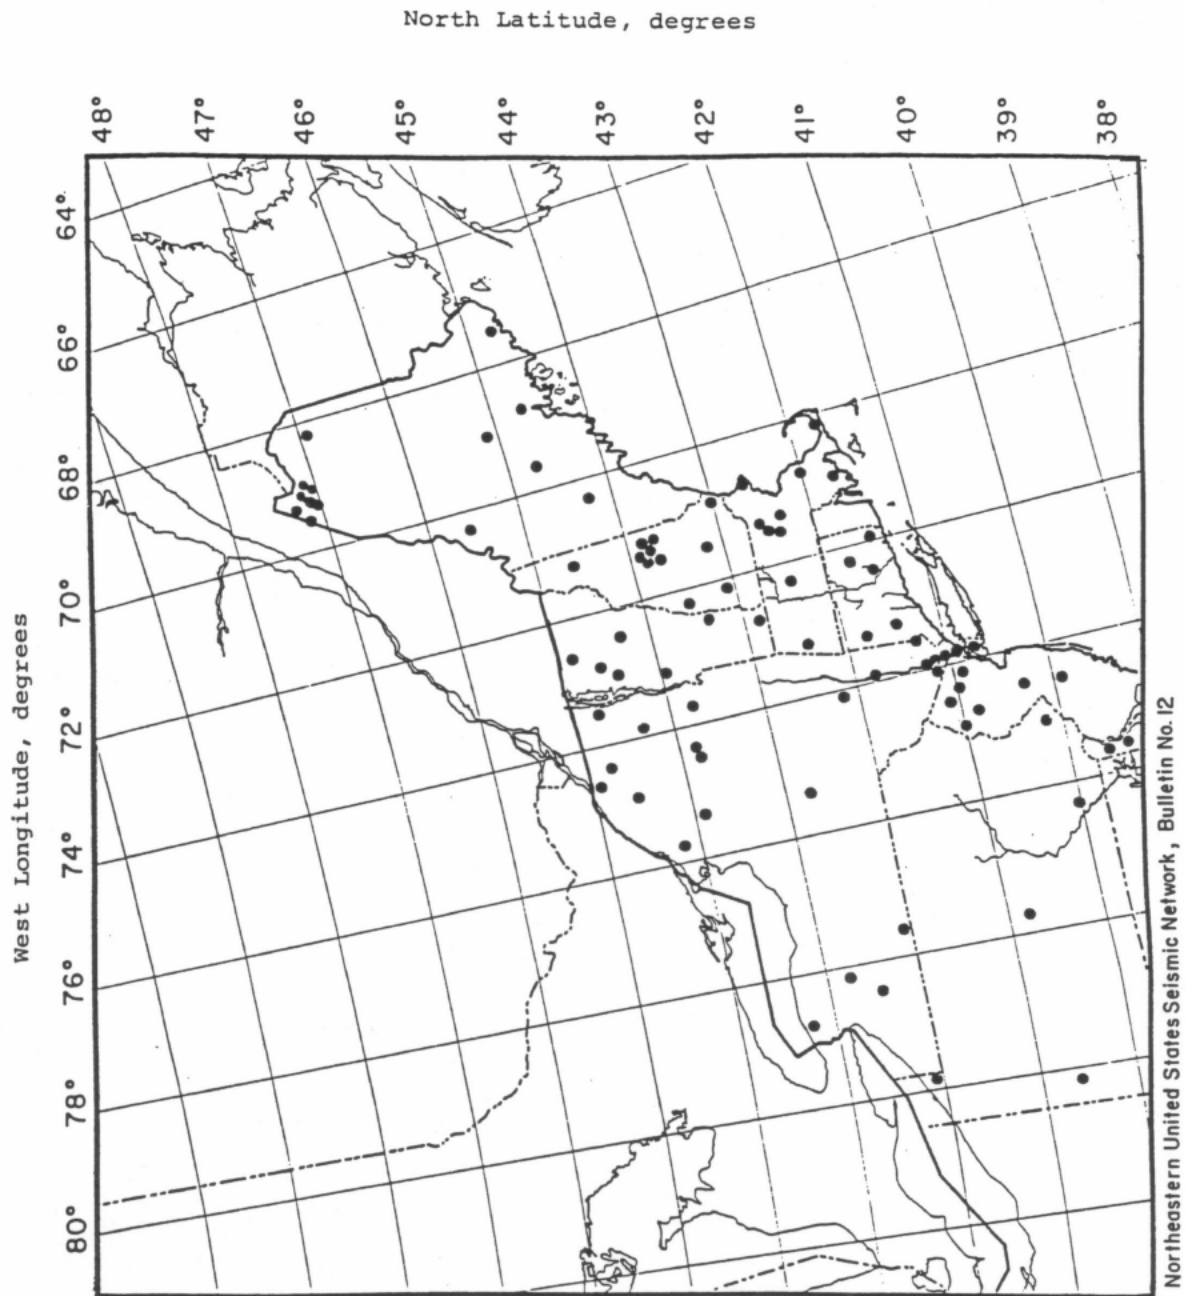
Figure 2.5-40

Northeastern U.S. Seismic Network, Bulletin No. 12

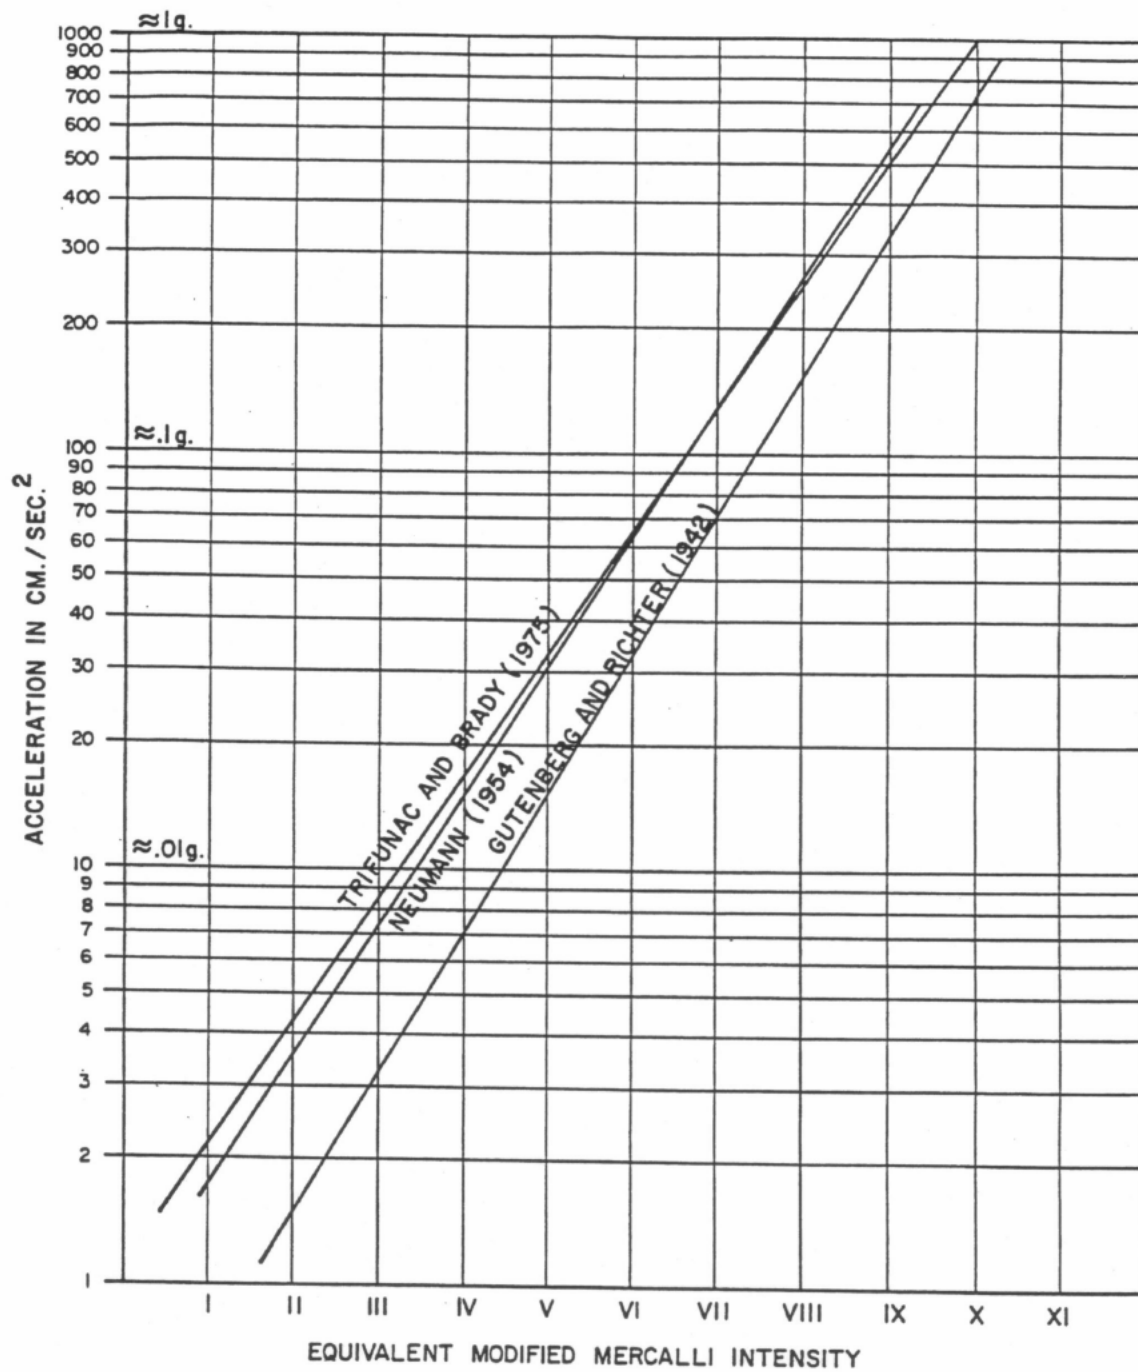
Figure 2.5-42

Intensity-Acceleration Relationship

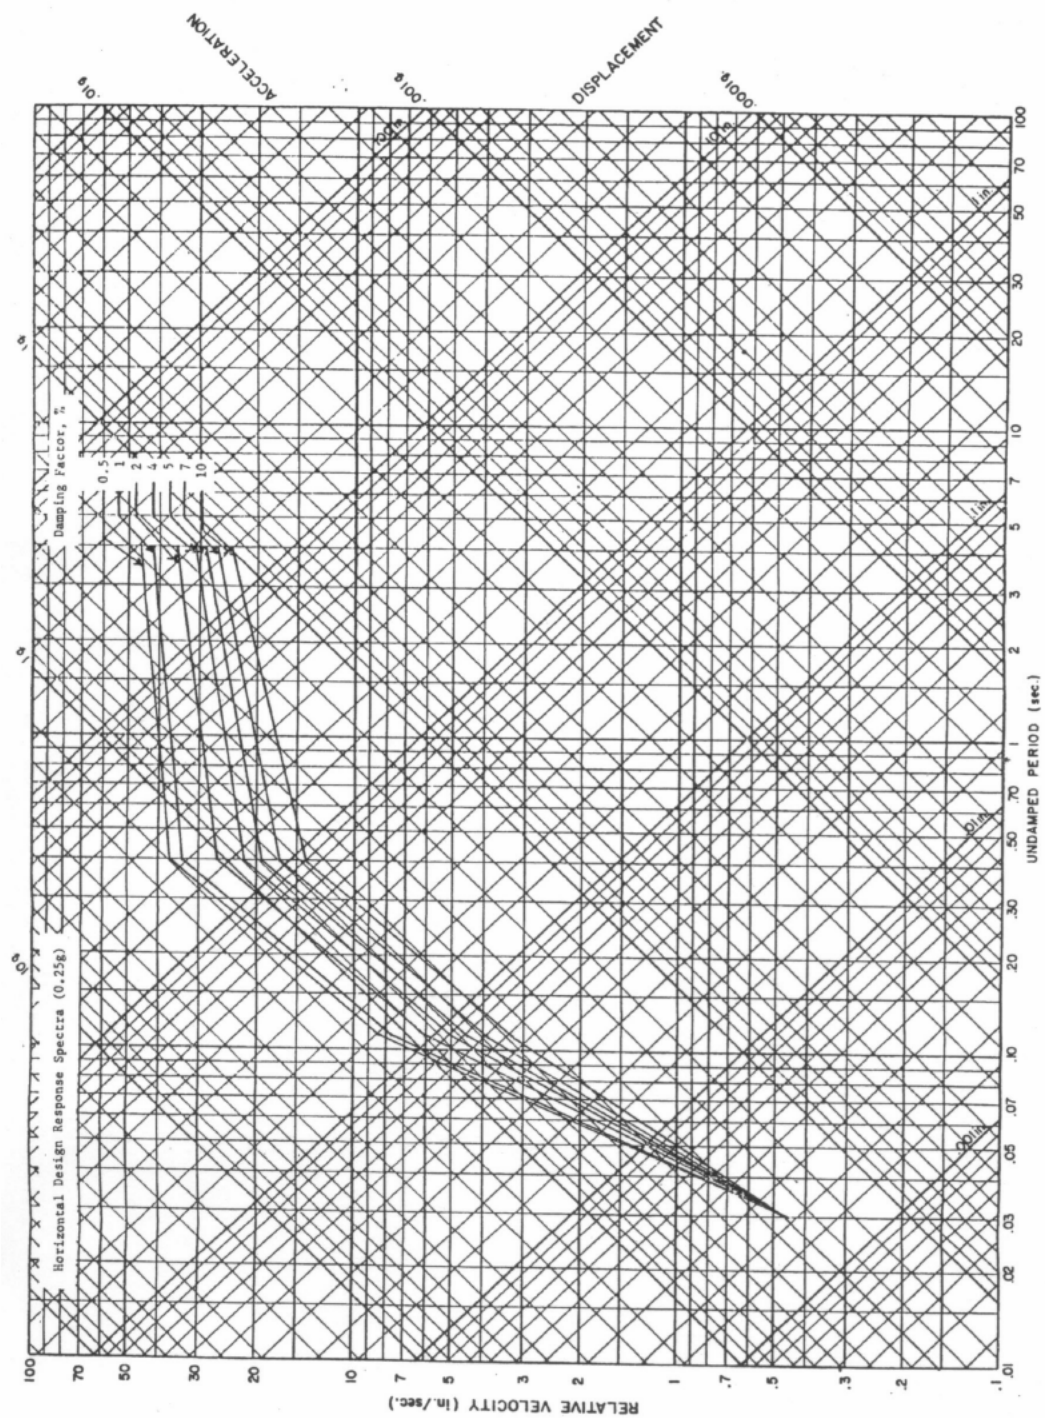
Figure 2.5-43

Safe Shutdown Earthquake Design Response Spectra,
Horizontal Motion

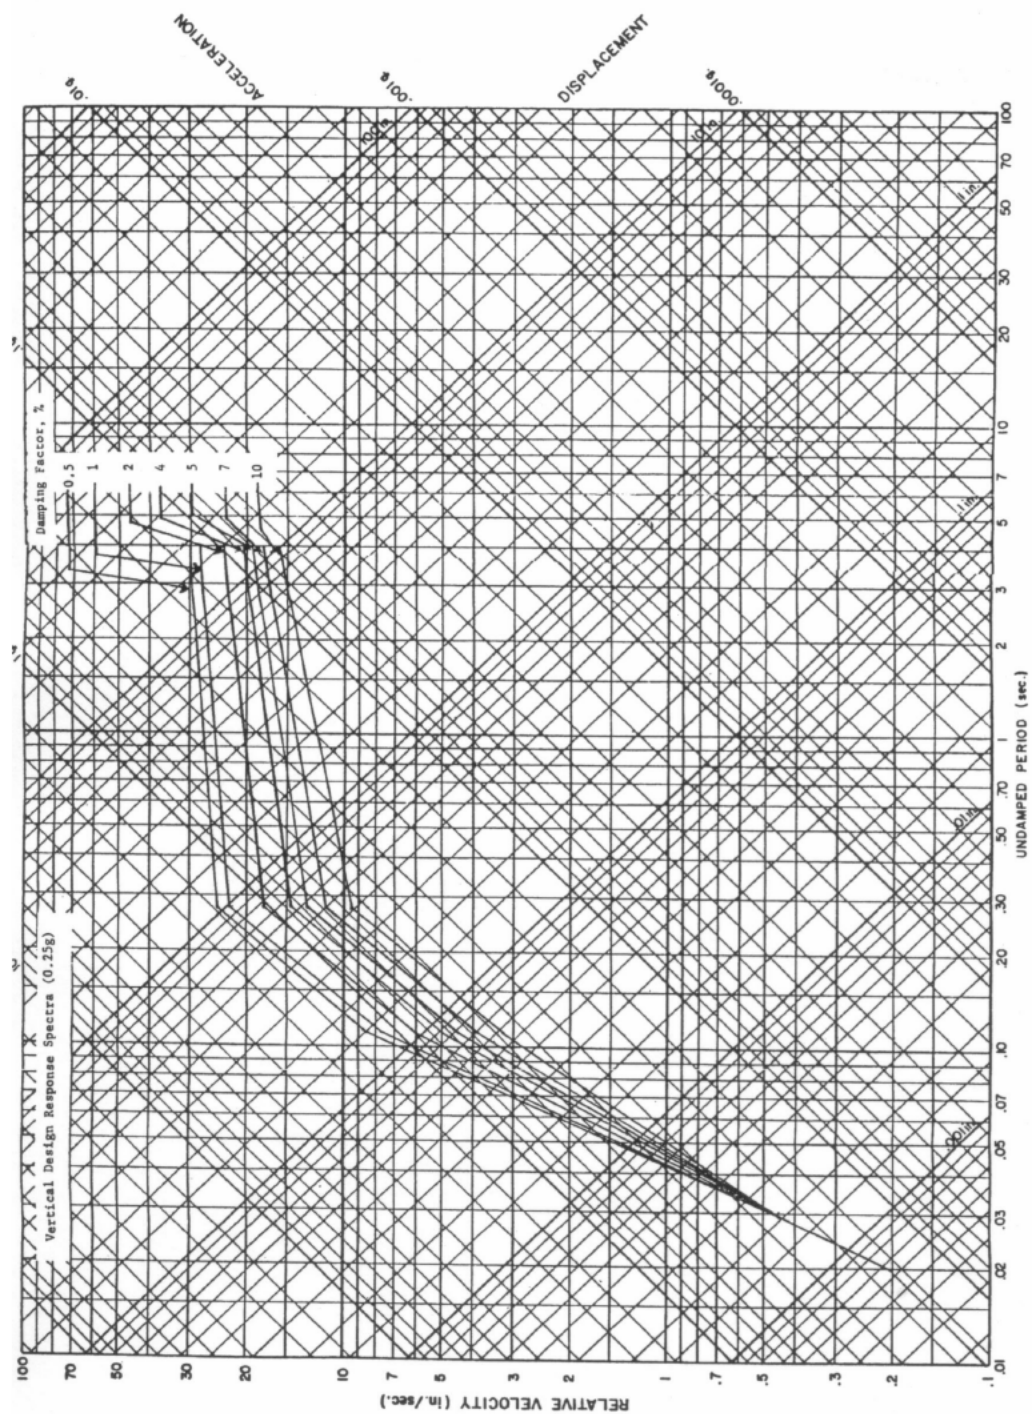
Figure 2.5-44

Safe Shutdown Earthquake Design Response Spectra,
 Vertical Motion

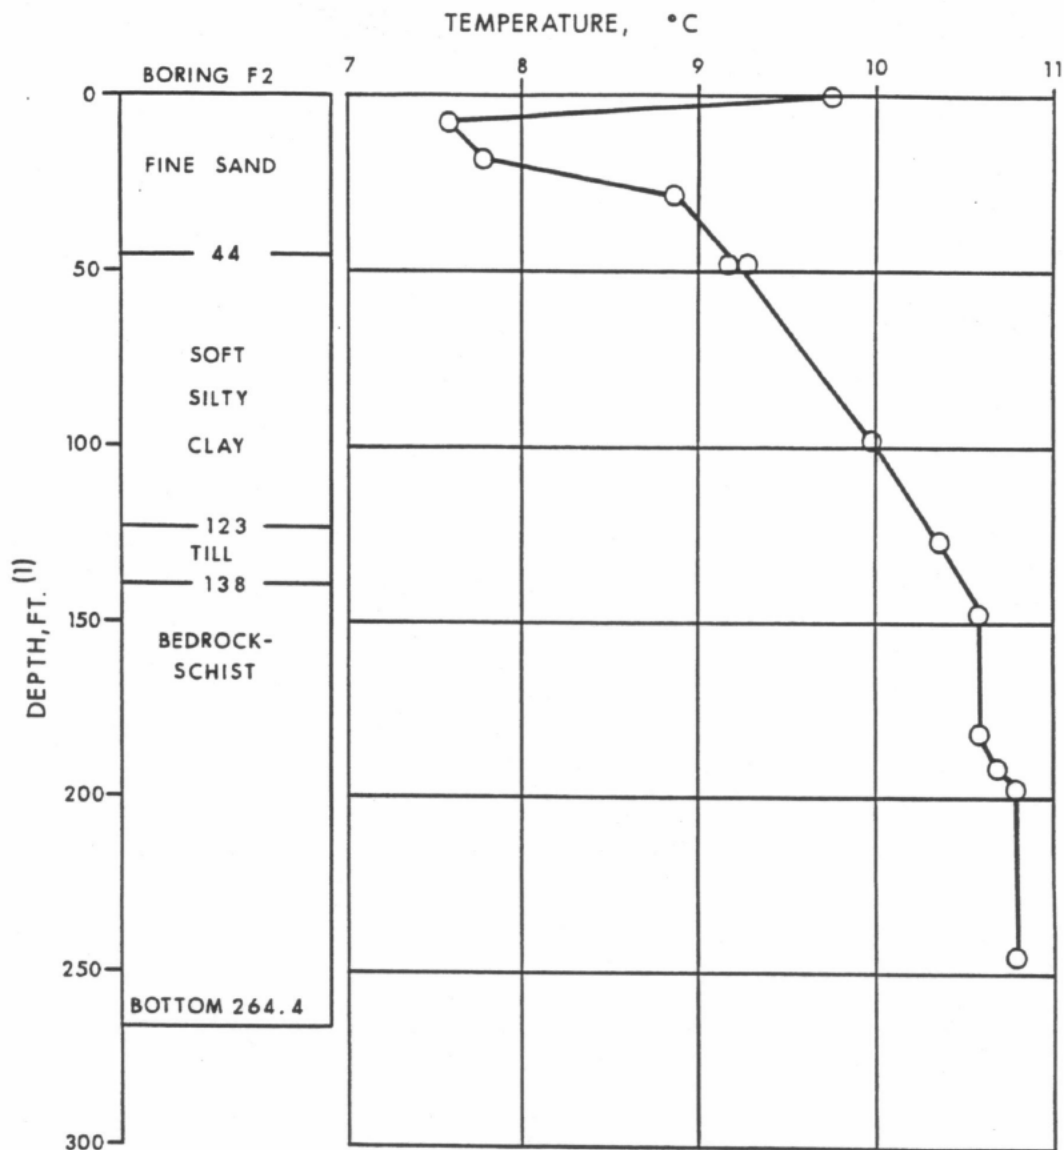
NOTE: DATA RECORDED MAY 16, 1973 ON DAY AFTER DRILLING OF BOREHOLE WAS COMPLETED.

(1) GROUND ELEVATION = -1.4 (MSL=0)

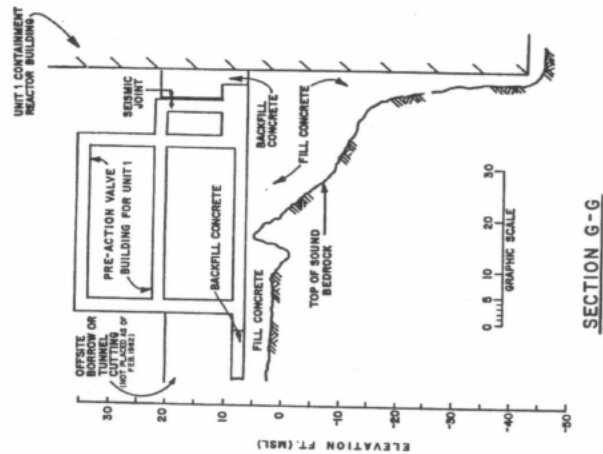
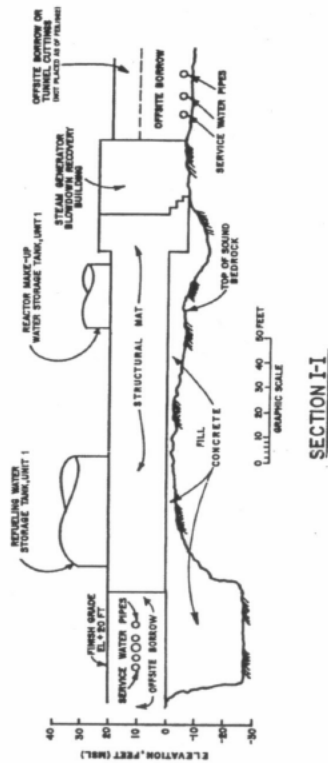
NOTE: TUNNEL CUTTINGS WILL NOT BE PLACED AGAINST NOR WITHIN 10 FT. HORIZONTAL DISTANCE OF ANY SEISMIC CATEGORY I BUILDING WALL.
