SEABROOK STATION UPDATED FINAL SAFETY ANALYSIS REPORT	Site Topography and Plot Plan	
		Figure 2.4-1

<p>SEABROOK STATION UPDATED FINAL SAFETY ANALYSIS REPORT</p>	<p>Topographic Map Depicting Major Hydrologic Features of Region</p>	
		<p>Figure 2.4-2</p>

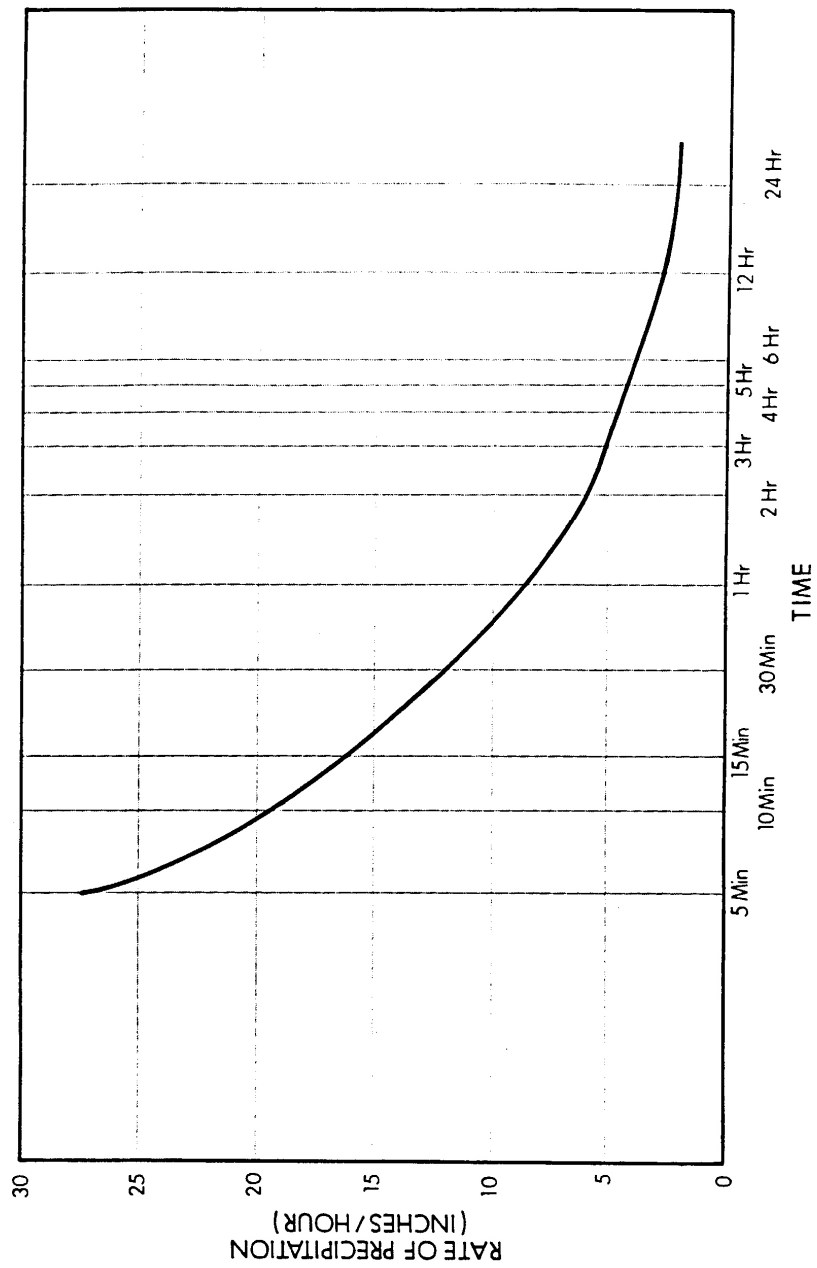
SEABROOK STATION UPDATED FINAL SAFETY ANALYSIS REPORT	Time Incremental Distribution of Local PMP	
		Figure 2.4-3

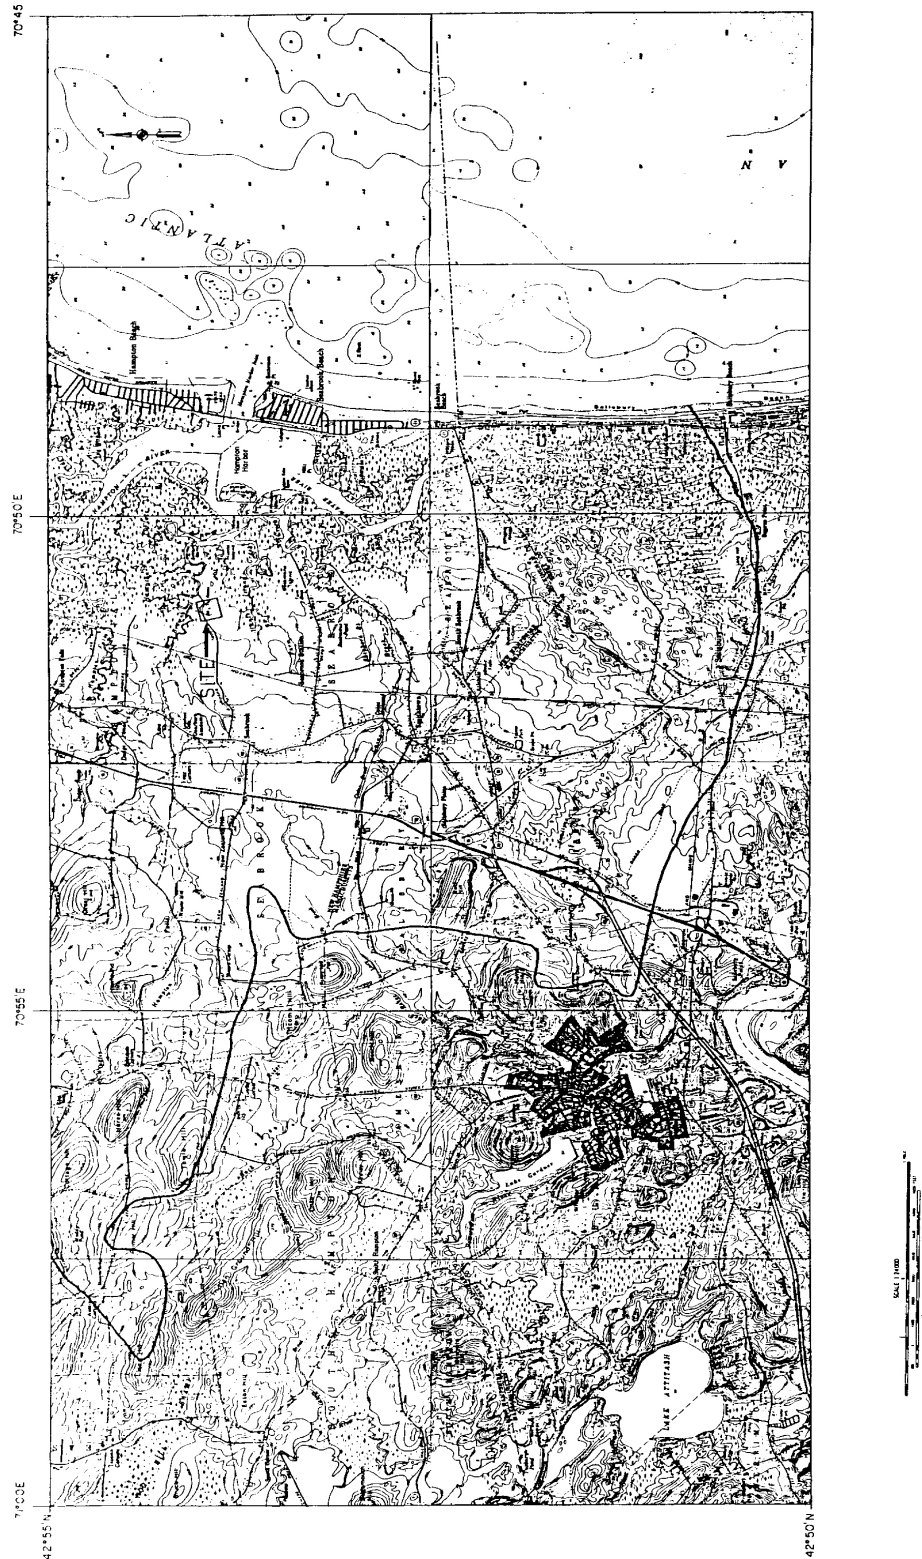
SEABROOK STATION UPDATED FINAL SAFETY ANALYSIS REPORT	Hampton Harbor Drainage Basin Detailed Topography [2 Sheets]	
		Figure 2.4-7 Sh. 2 of 2

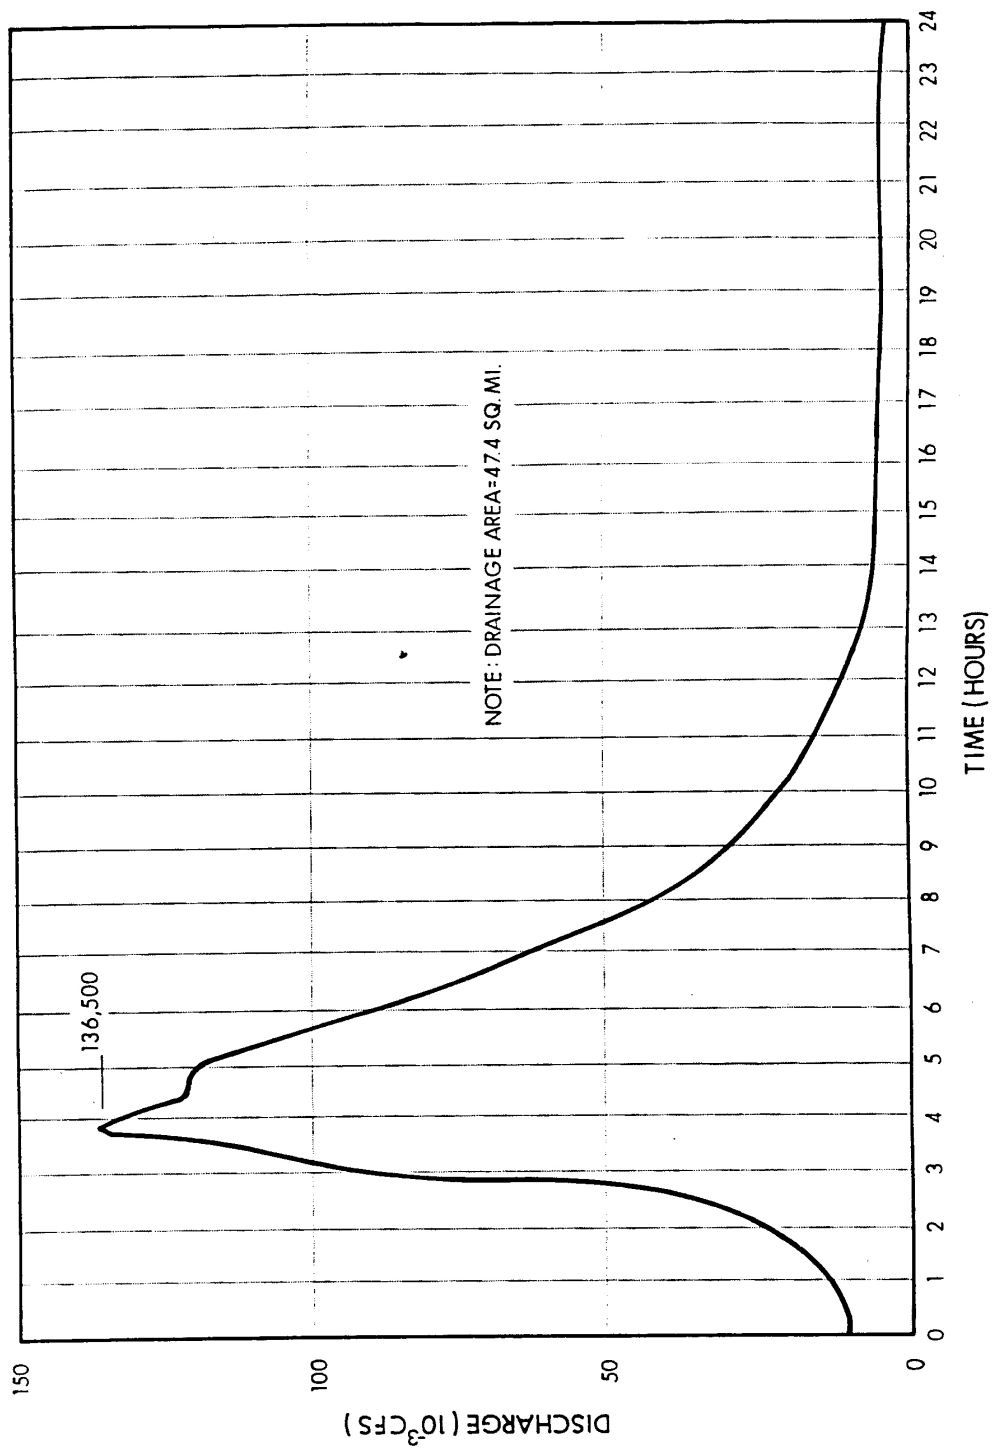
SEABROOK STATION UPDATED FINAL SAFETY ANALYSIS REPORT	PMF Discharge Hydrograph	
		Figure 2.4-9

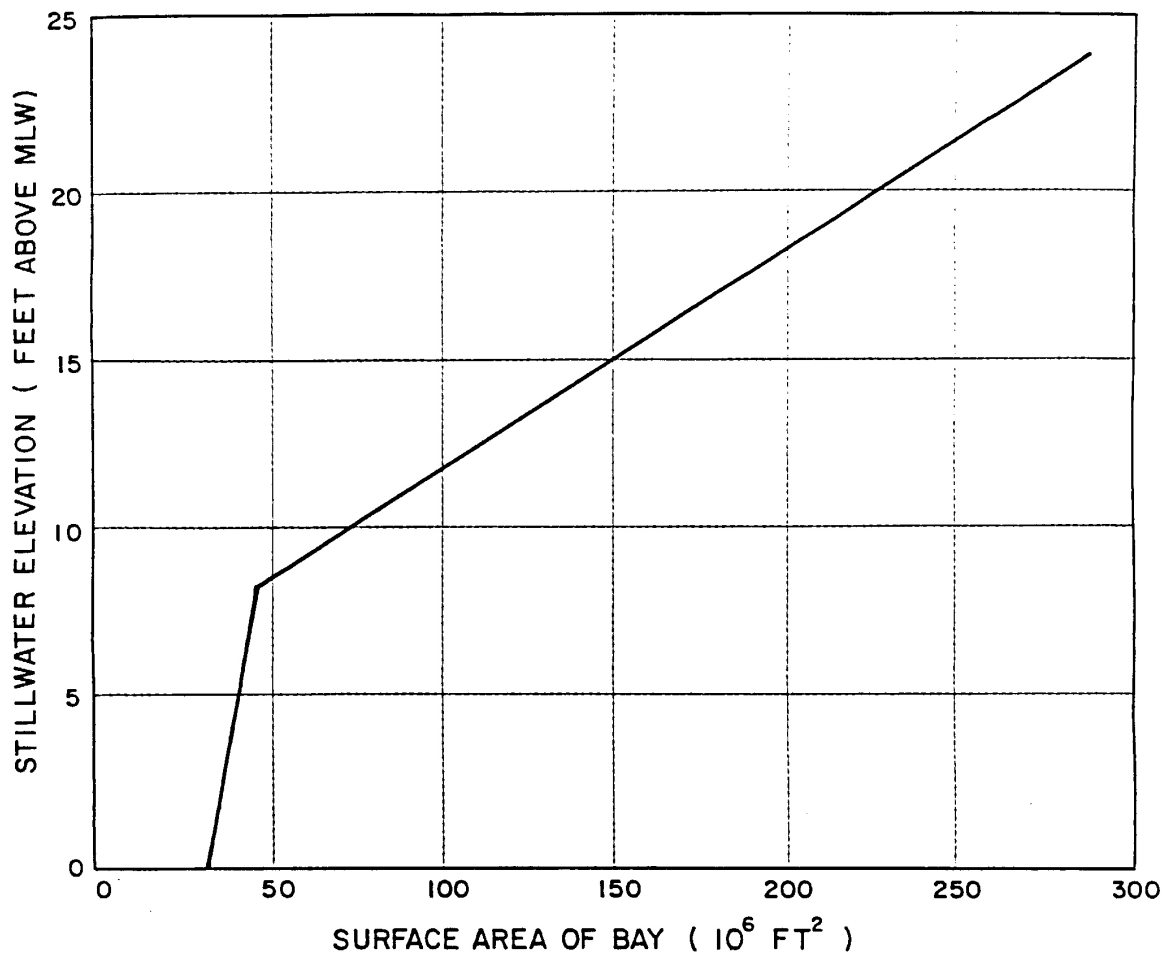
SEABROOK STATION UPDATED FINAL SAFETY ANALYSIS REPORT	Hampton Harbor Surface Area vs. Elevation	
		Figure 2.4-10

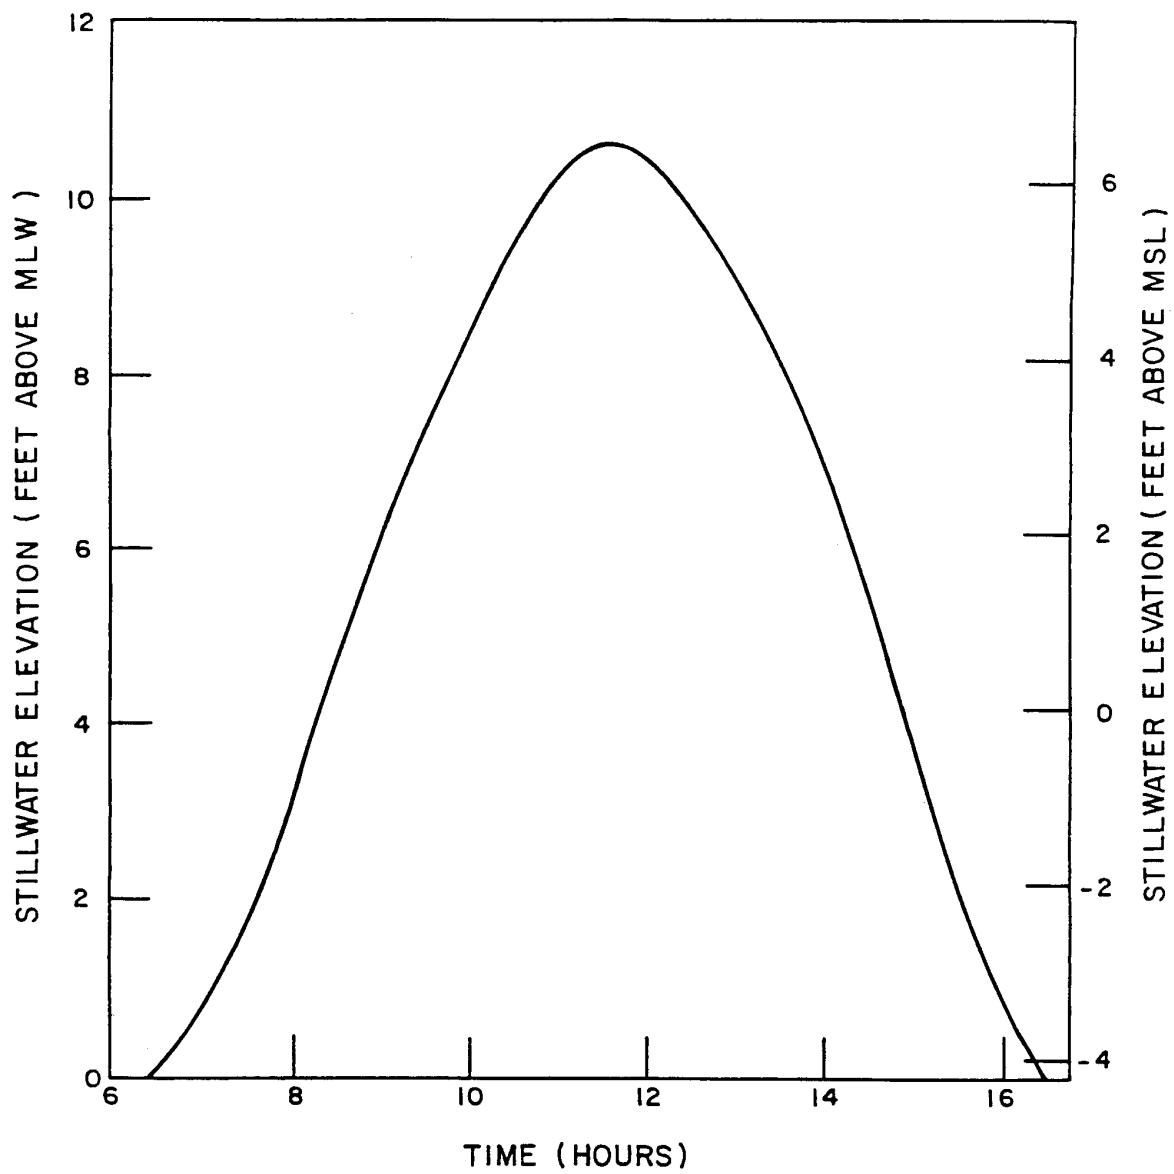
SEABROOK STATION UPDATED FINAL SAFETY ANALYSIS REPORT	Astronomical Tidal Cycle Hampton Harbor November 22, 1972		
		Figure	2.4-11

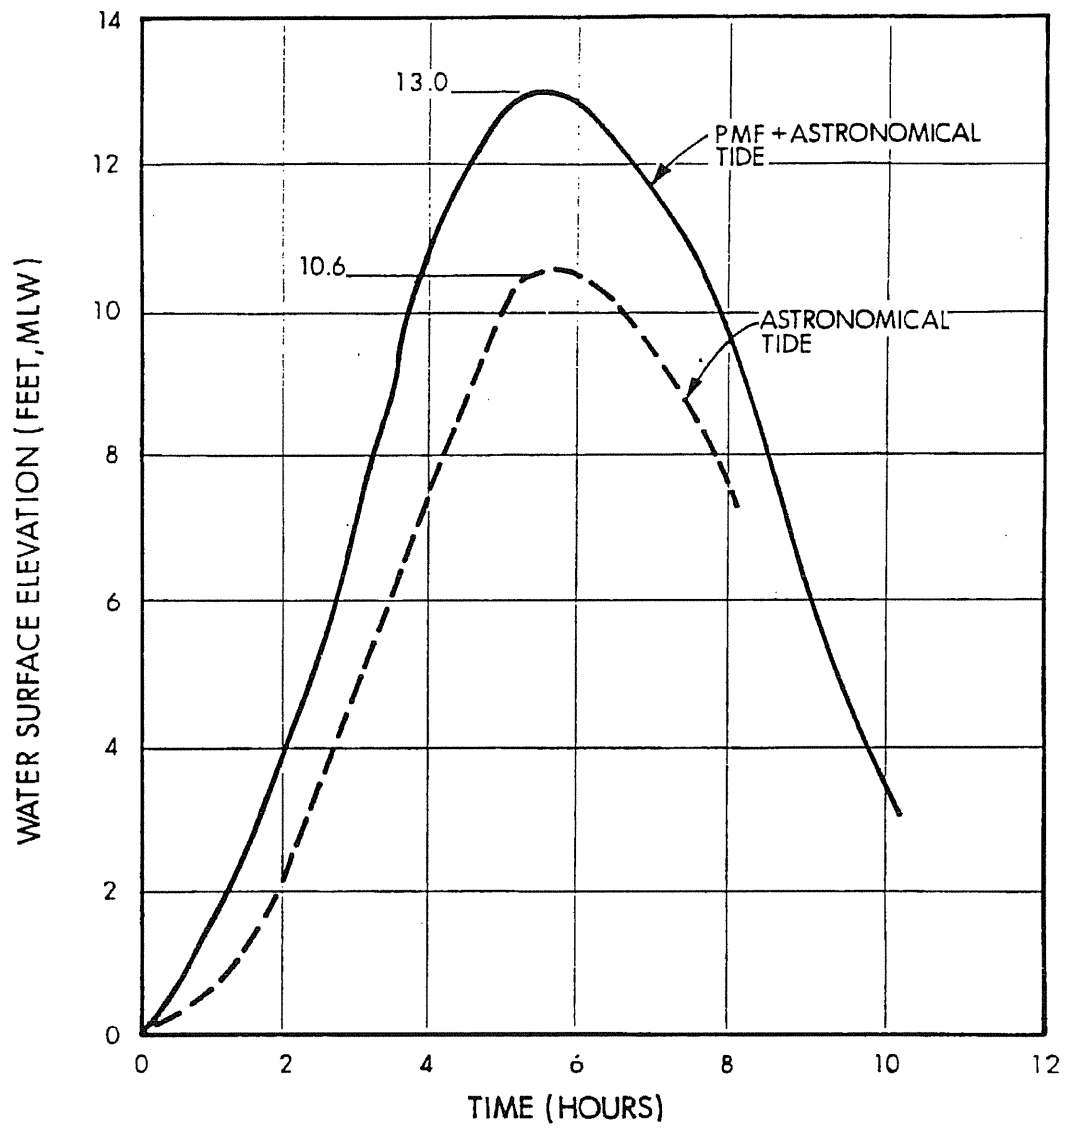
SEABROOK STATION UPDATED FINAL SAFETY ANALYSIS REPORT	Hampton Harbor PMF Hydrograph	
		Figure 2.4-12

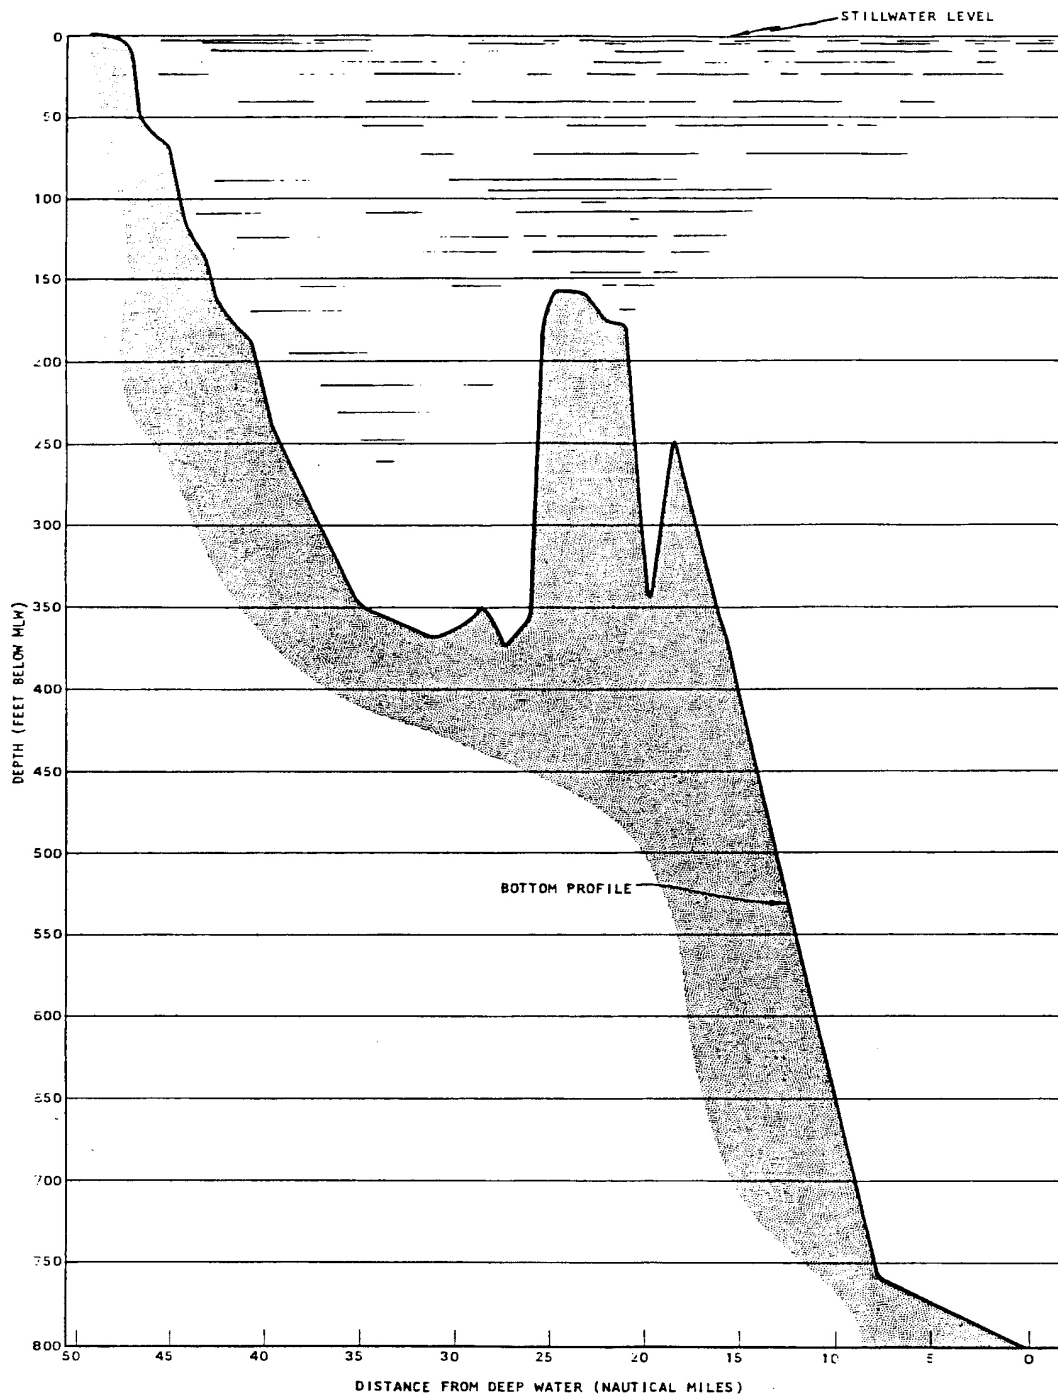
Figure 2.4-14

Offshore Depth Profile Transverse Line N75°W (True)

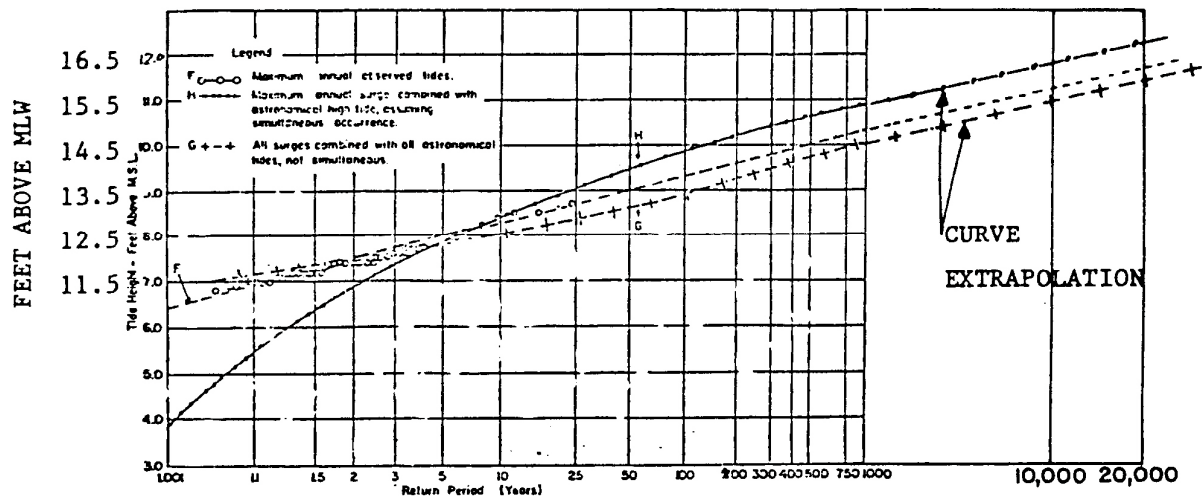
Estimated probability of extreme high tide height at Portland, Maine. (Based on data for 1914-1959.)

SEABROOK STATION UPDATED FINAL SAFETY ANALYSIS REPORT	Estimated Probability of Extreme High Tide at Portland, Maine and Boston, Mass.	
		Figure 2.4-15

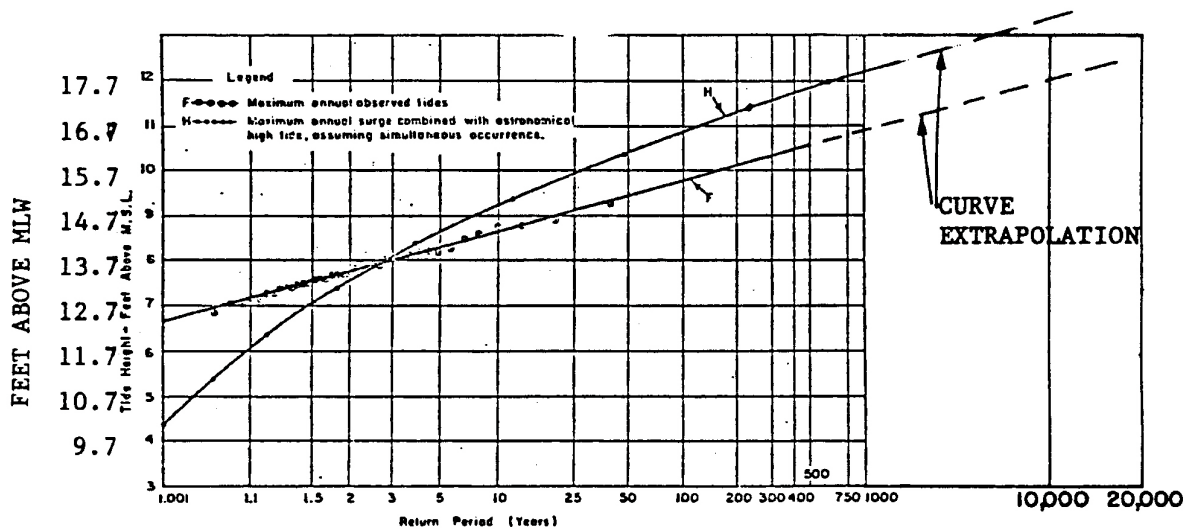
Estimated probability of extreme high tide height at Boston, Mass. (Based on data for 1922-1960)

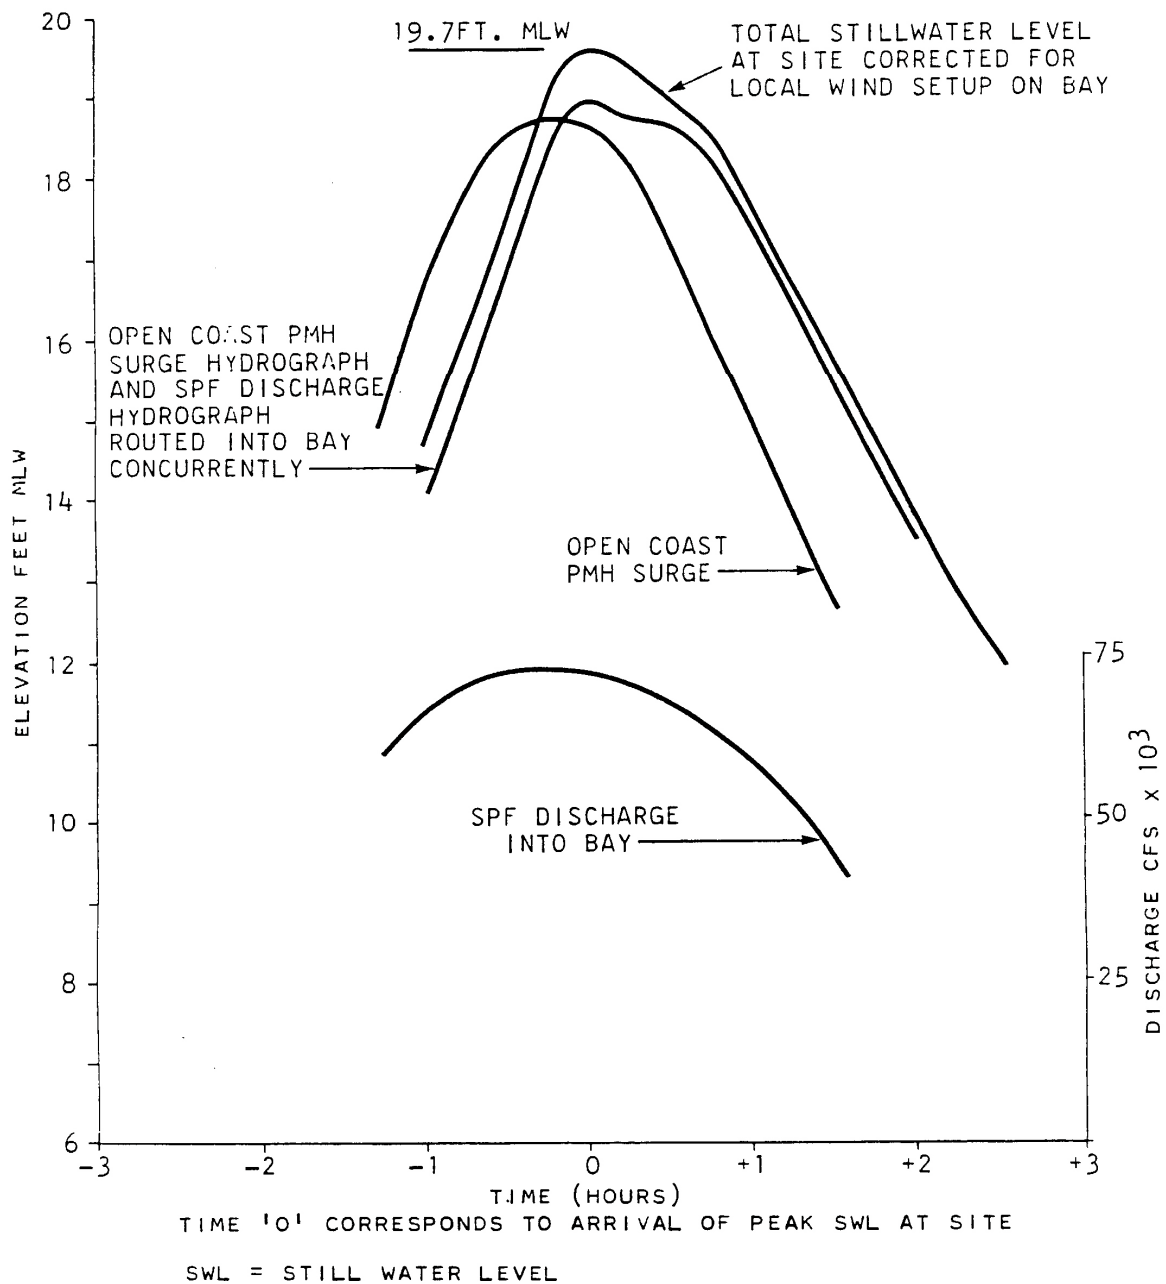
SEABROOK STATION UPDATED FINAL SAFETY ANALYSIS REPORT	Resultant PMH and SPF Stillwater Levels	
		Figure 2.4-18

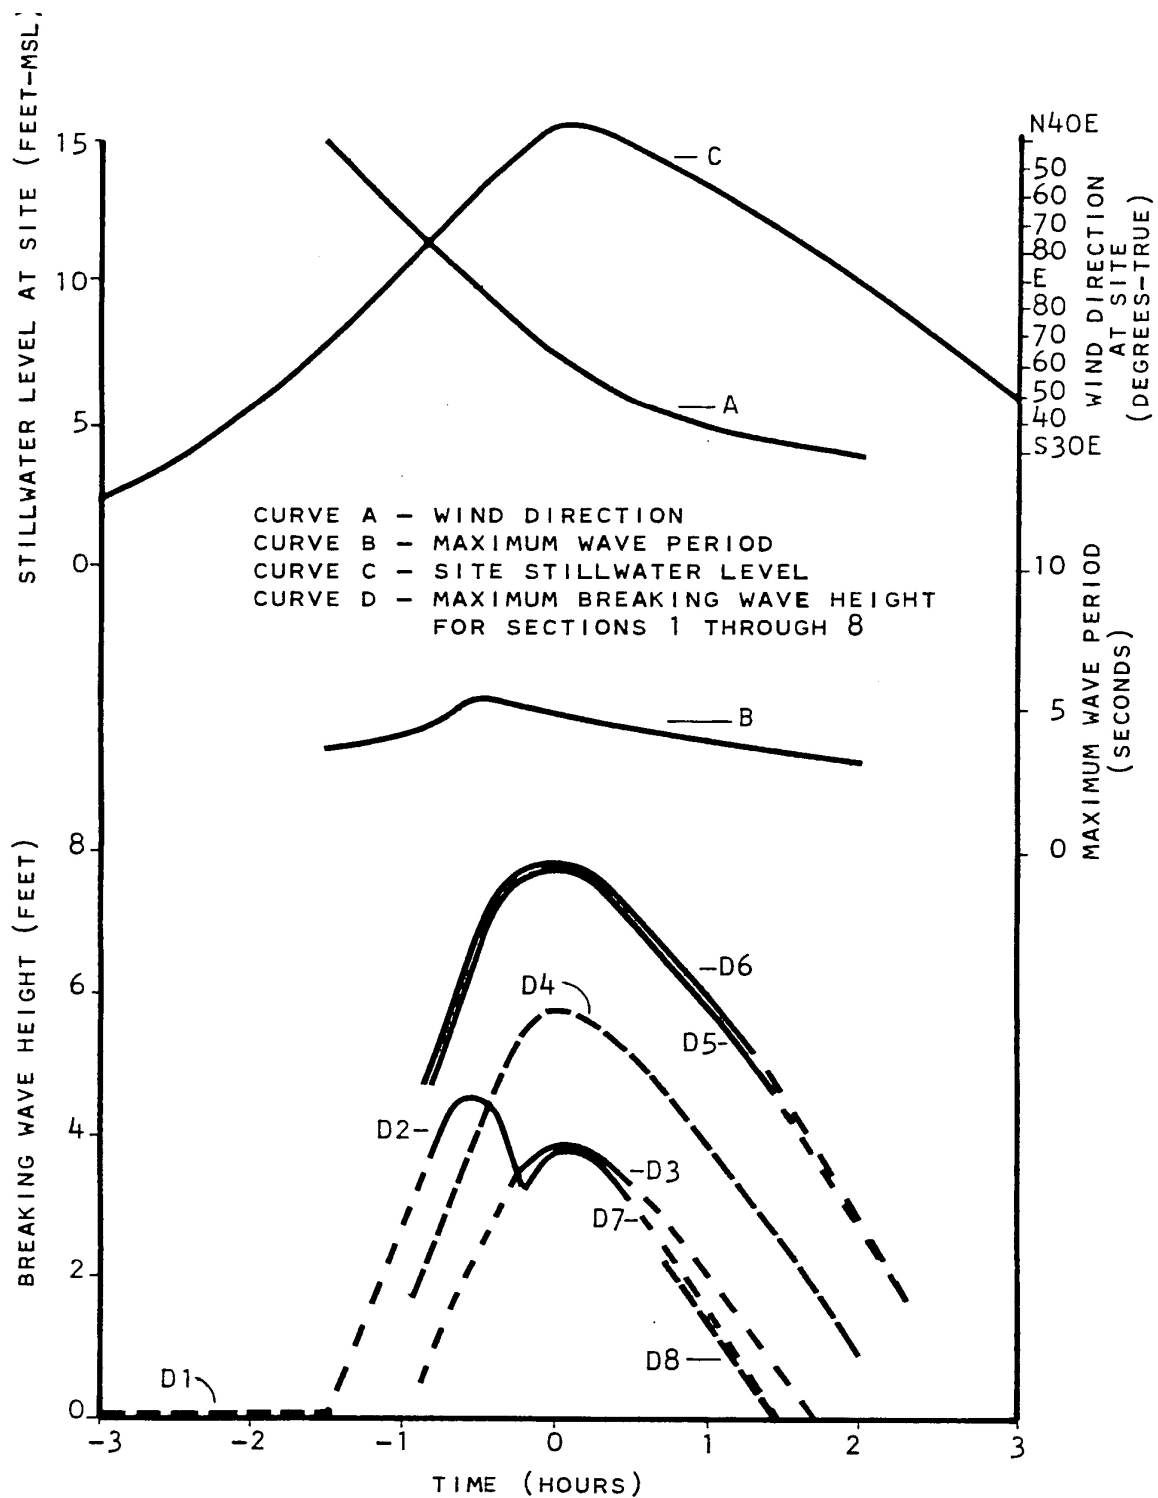
SEABROOK STATION UPDATED FINAL SAFETY ANALYSIS REPORT	Design Wave Heights, Periods and Waterlevels	
		Figure 2.4-19

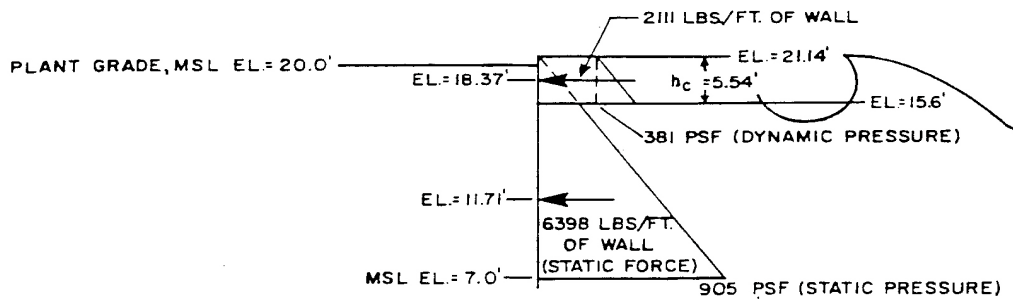
BROKEN WAVE CONDITION ON VERTICAL SEAWALL

WAVE PARAMETERS

$H_b = 7.91'$ (BREAKING WAVE HEIGHT)

$T =$ (INDEPENDENT OF WAVE PERIOD)

$d_s = 8.6'$ (WATER DEPTH IN FRONT OF STRUCTURE)

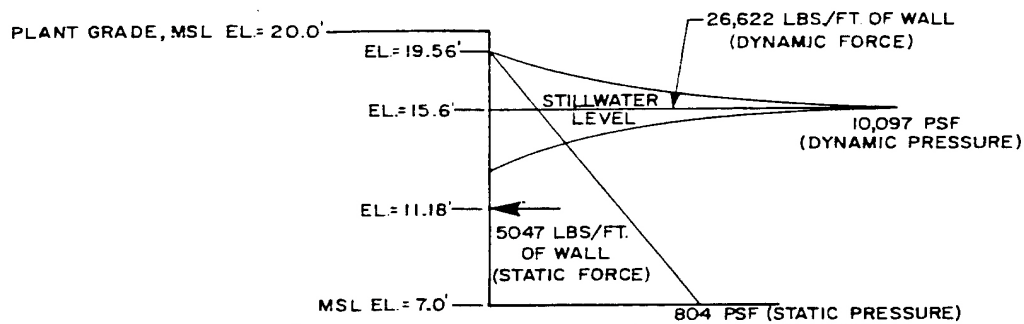
BREAKING WAVE CONDITION ON VERTICAL SEAWALL

WAVE PARAMETERS

$H_b = 7.91'$ (BREAKING WAVE HEIGHT)

$T = 4.8$ SECONDS (WAVE PERIOD)

$d_s = 8.6'$ (WATER DEPTH IN FRONT OF STRUCTURE)

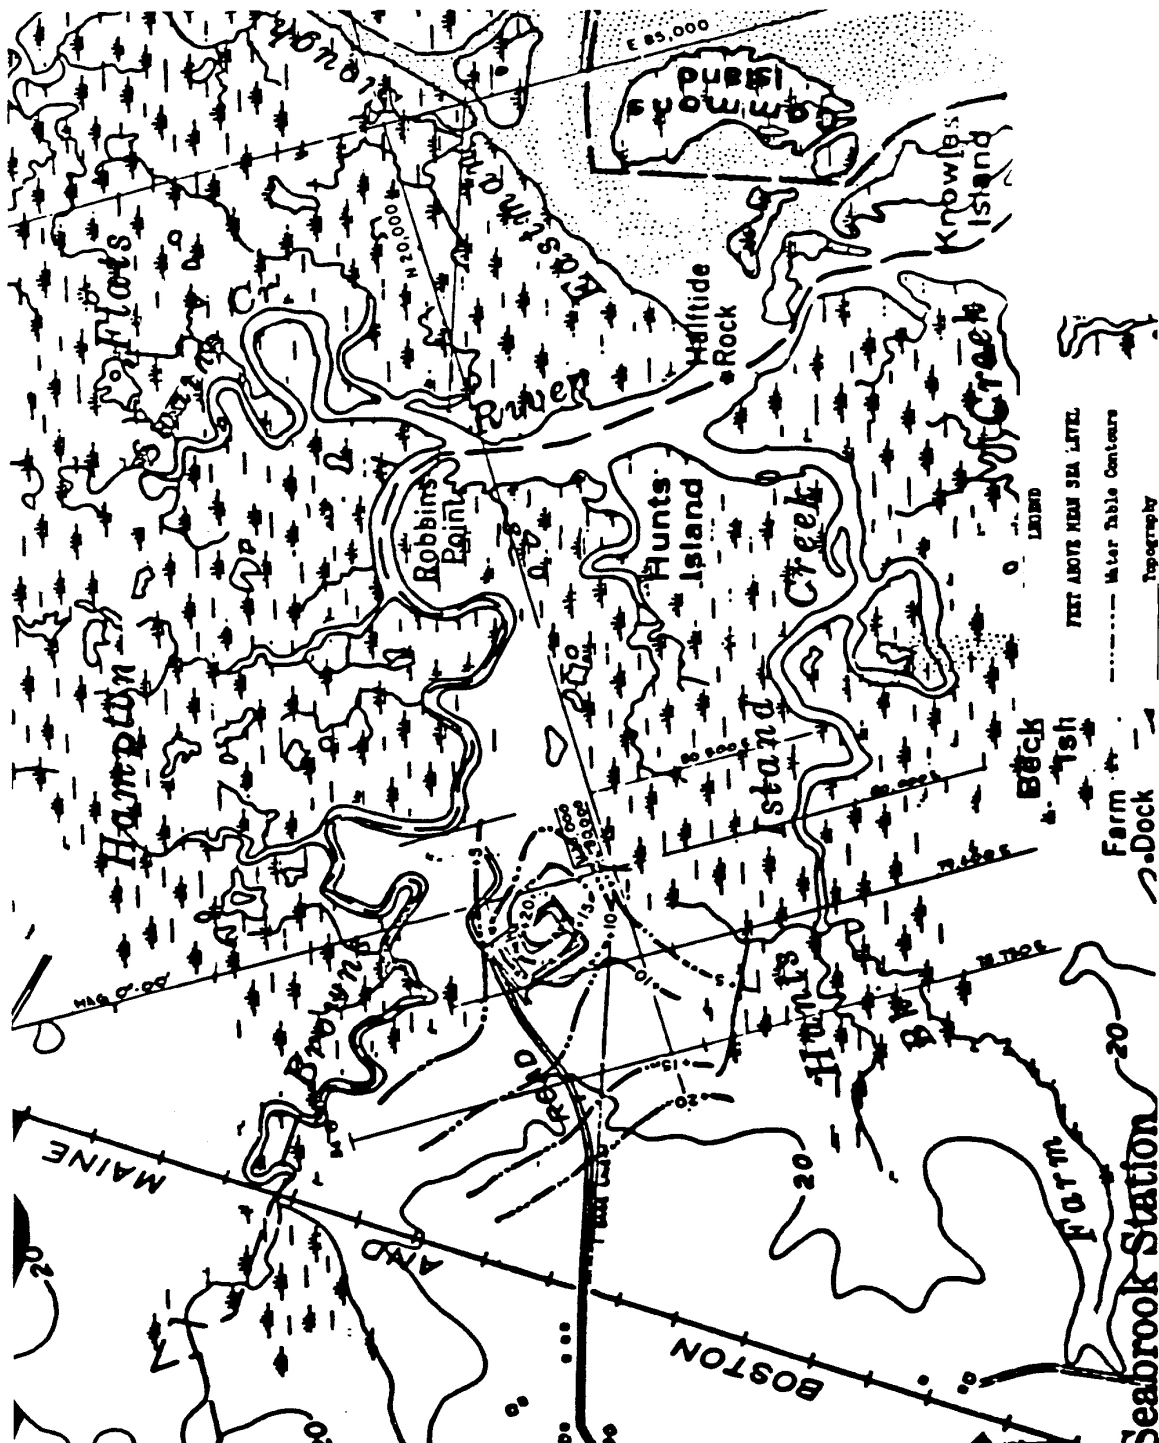
SEABROOK STATION UPDATED FINAL SAFETY ANALYSIS REPORT	Water Table Contours	
		Figure 2.4-28

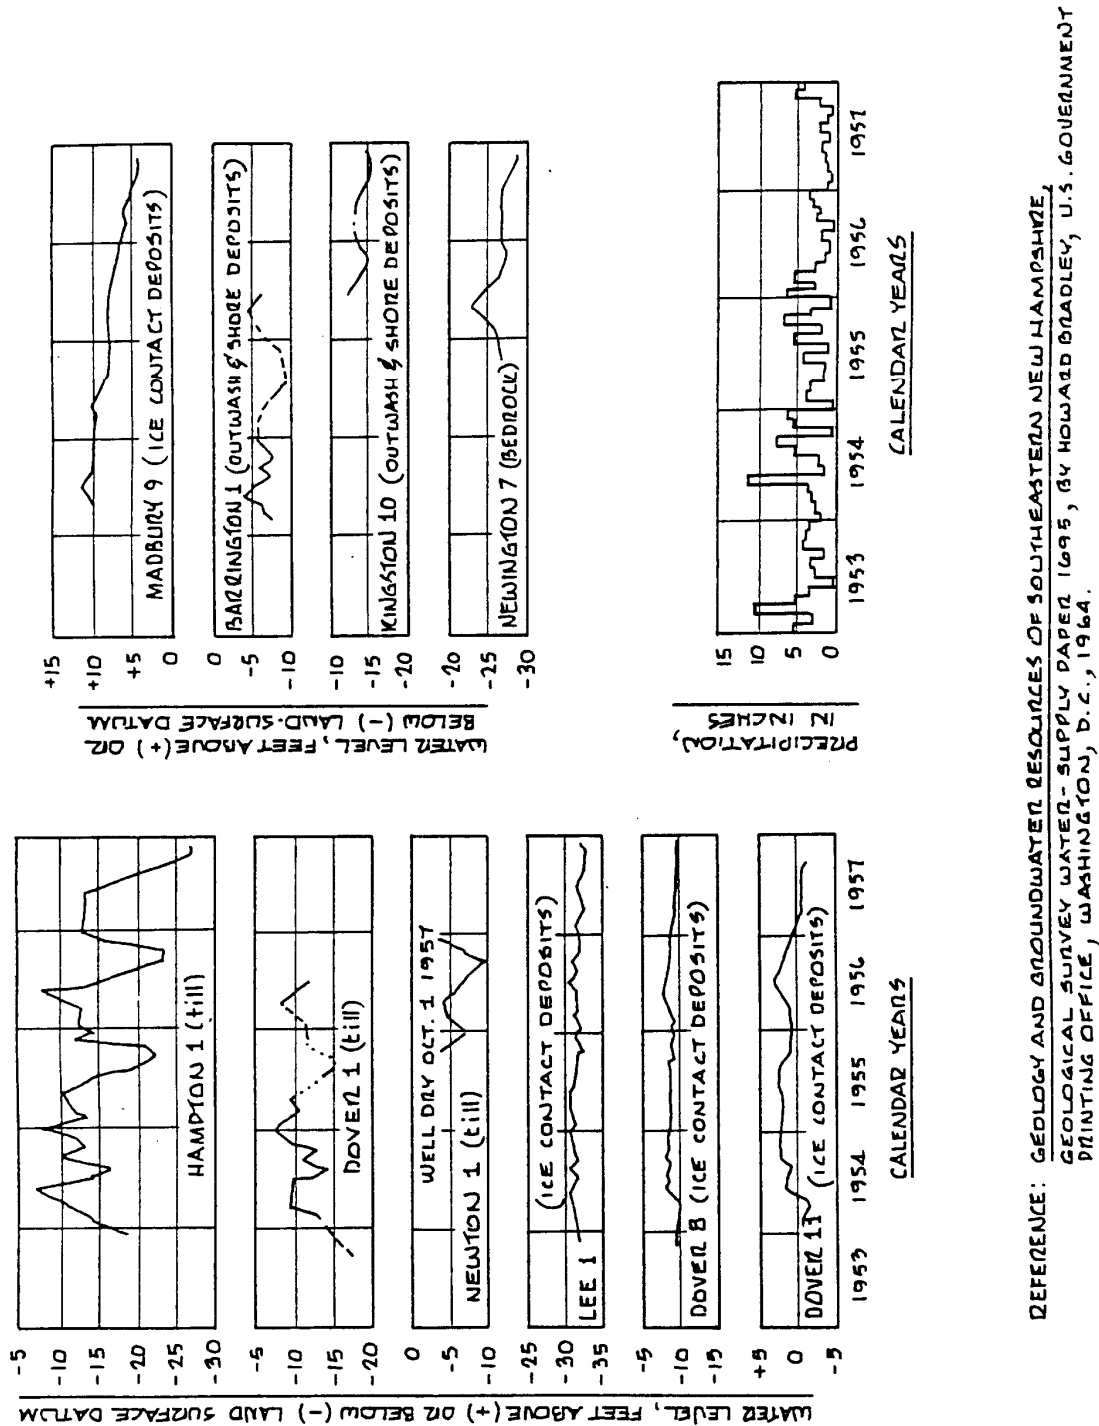
SEABROOK STATION UPDATED FINAL SAFETY ANALYSIS REPORT	Water Level Variations in the Seabrook Area	
		Figure 2.4-32

REFERENCE: GEOLOGY AND GROUNDWATER RESOURCES OF SOUTHEASTERN NEW HAMPSHIRE,
GEOLOGICAL SURVEY WATER-SUPPLY PAPER 1695, BY HOWARD BRADLEY, U.S. GOVERNMENT
PRINTING OFFICE, WASHINGTON, D.C., 1964.

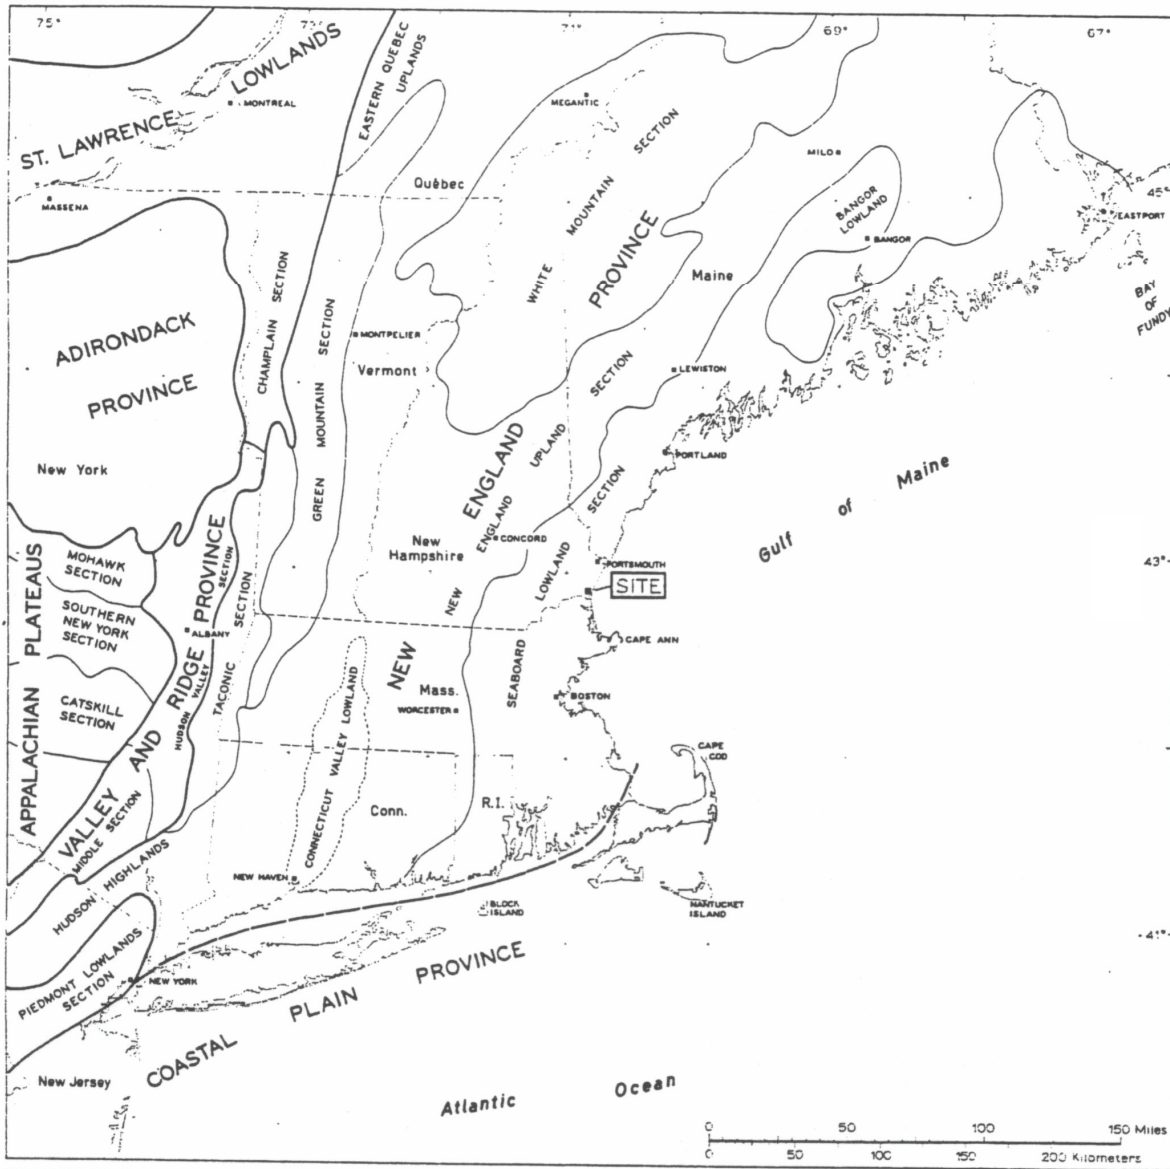
Figure 2.5-1

Regional Physiographic Map

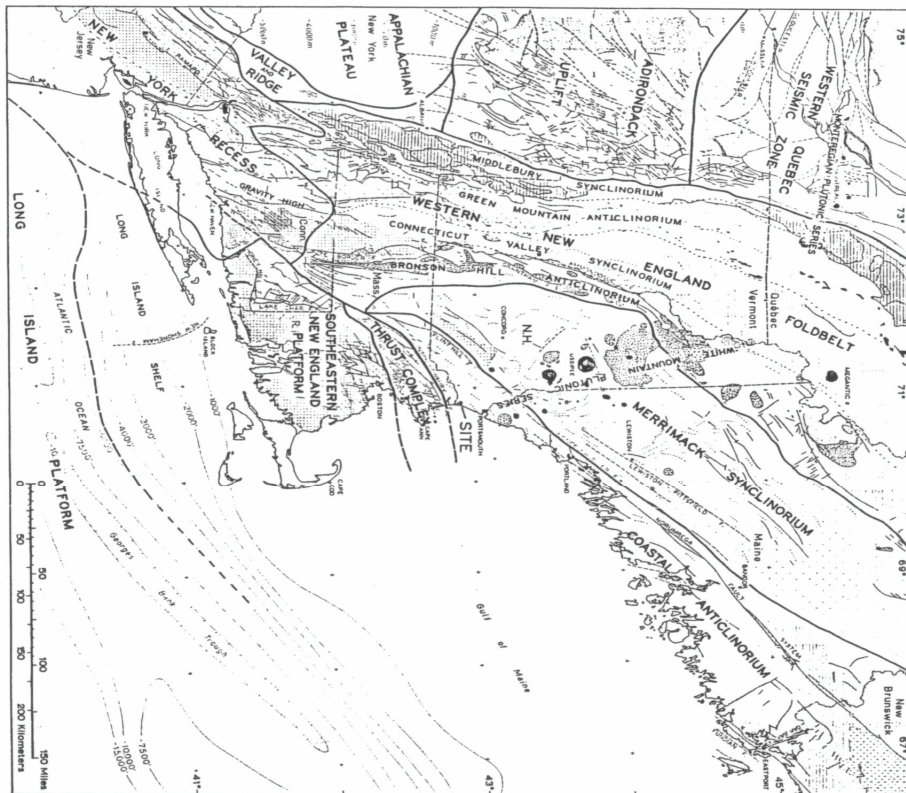
SEABROOK STATION UPDATED FINAL SAFETY ANALYSIS REPORT	Regional Tectonic Provinces	
		Figure 2.5-5

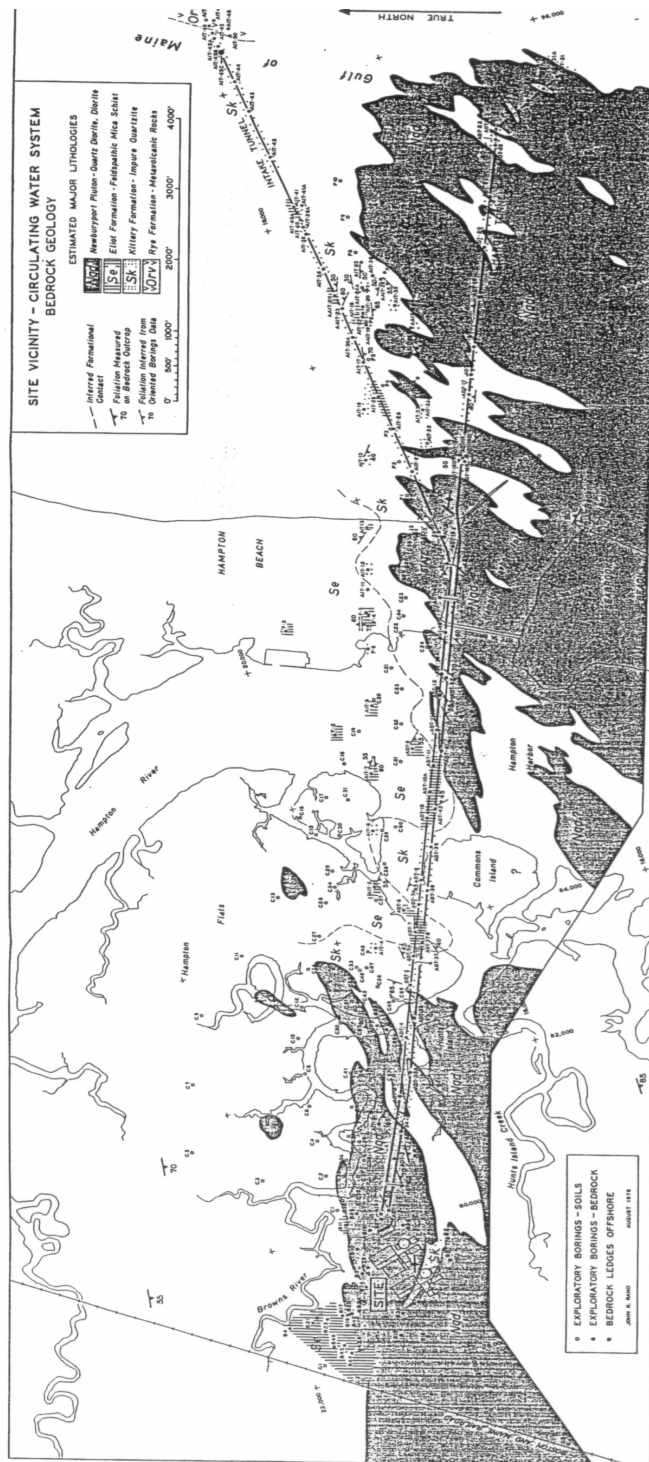
SEABROOK STATION UPDATED FINAL SAFETY ANALYSIS REPORT	Site Vicinity - Bedrock Geology Circulating Water System	
		Figure 2.5-9

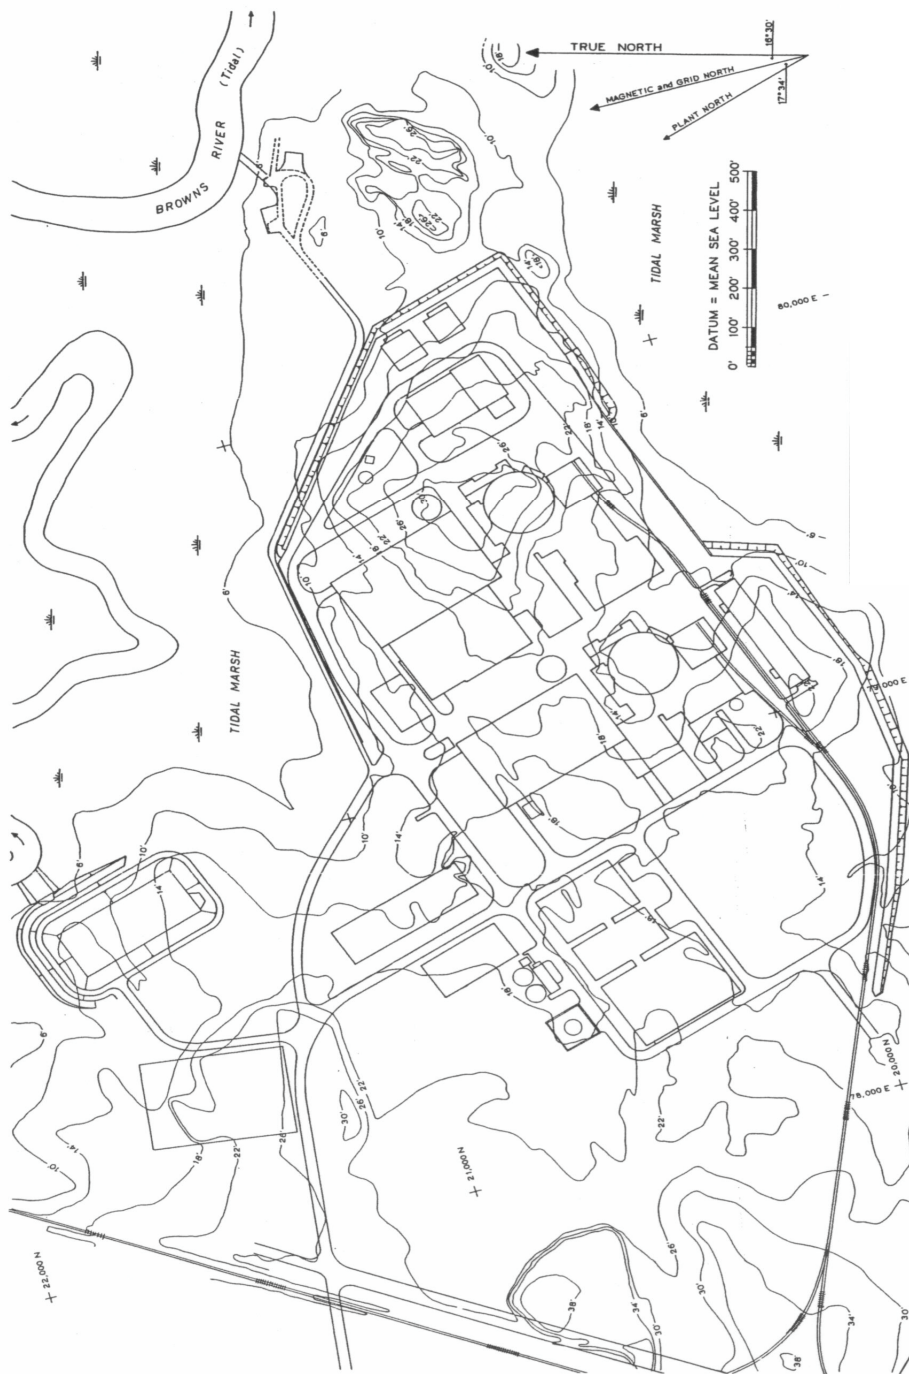
SEABROOK STATION UPDATED FINAL SAFETY ANALYSIS REPORT	Site Area Plot Plan and Original Surface Topography	
		Figure 2.5-15
