SEABROOK STATION UPDATED FINAL SAFETY ANALYSIS REPORT	Site Topography and Plot Plan	
		Figure 2.4-1

<p>SEABROOK STATION UPDATED FINAL SAFETY ANALYSIS REPORT</p>	<p>Topographic Map Depicting Major Hydrologic Features of Region</p>	
		<p>Figure 2.4-2</p>

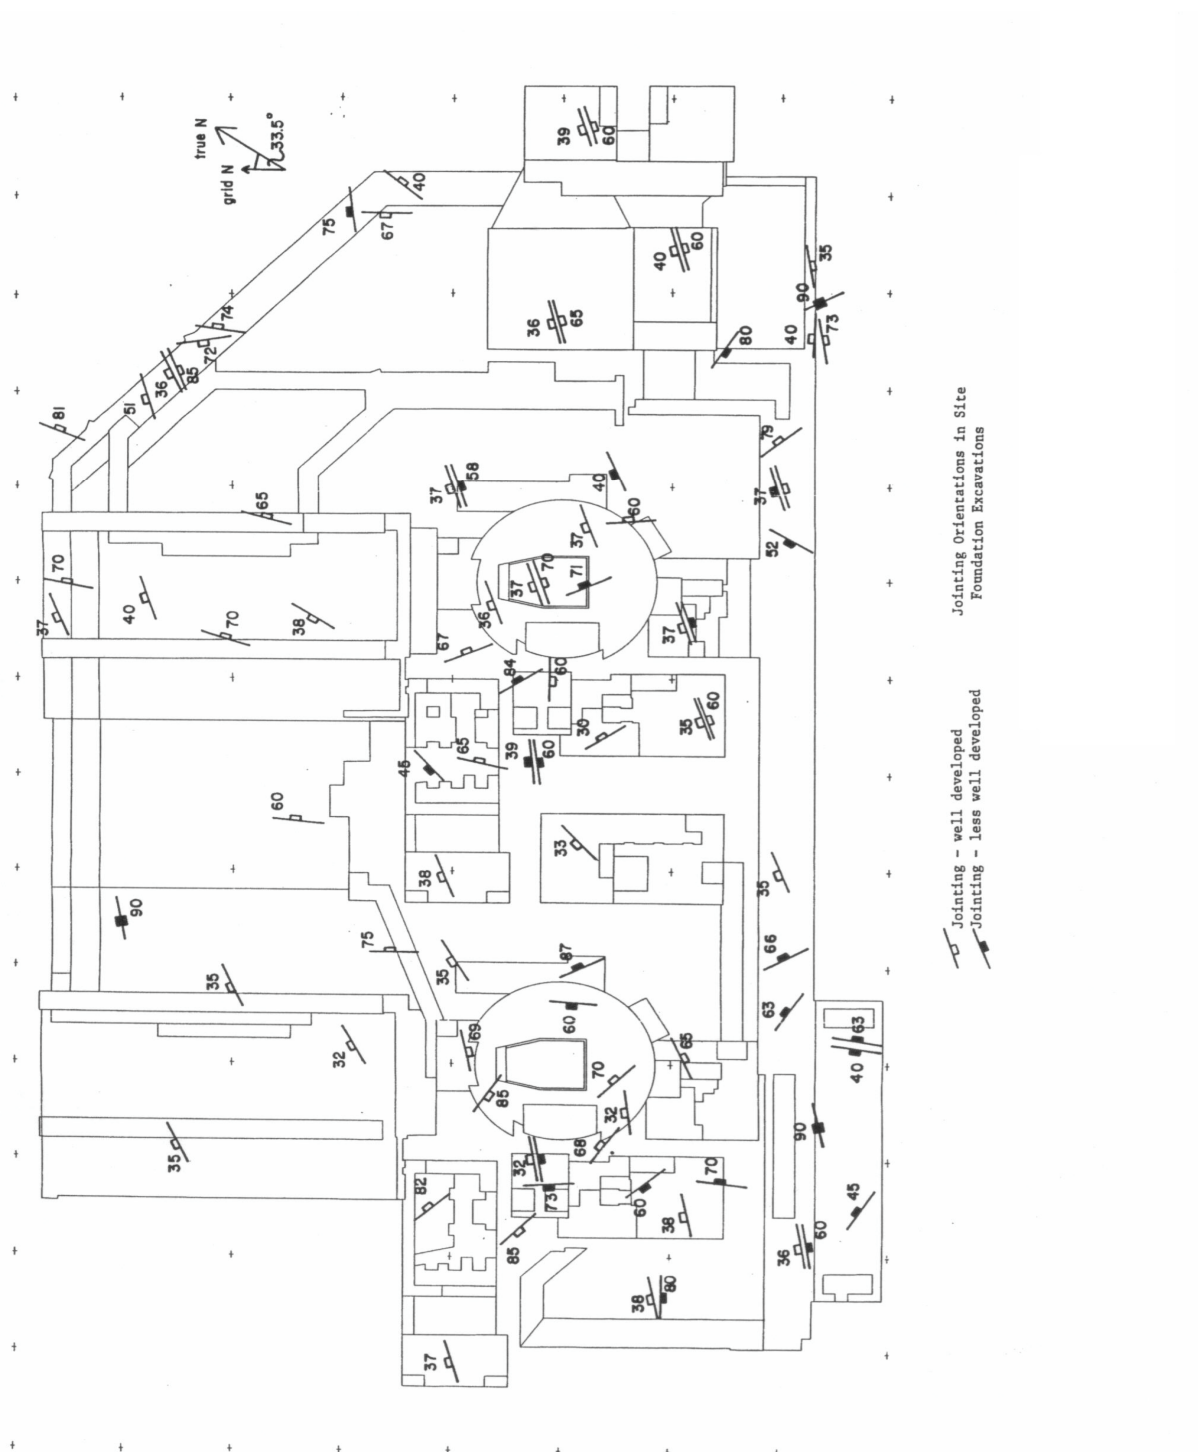
Figure 2.5-21

Jointing Orientations in Site Foundation Excavations

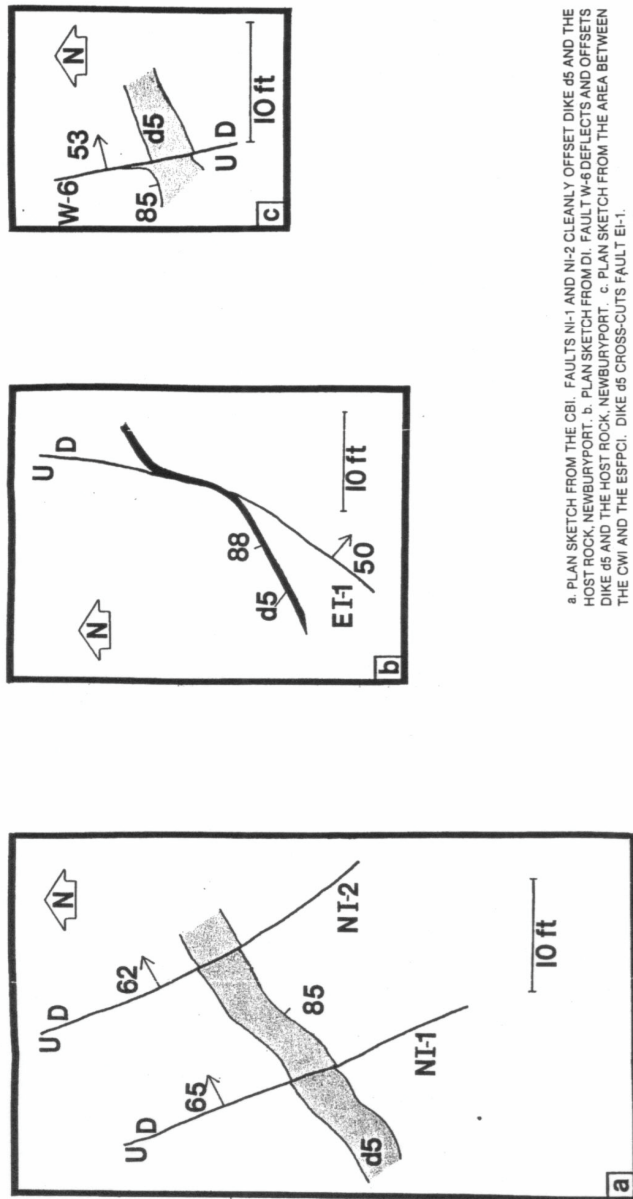
a. PLAN SKETCH FROM THE CBI. FAULTS NI-1 AND NI-2 CLEANLY OFFSET DIKE d5 AND THE HOST ROCK, NEWBURYPORT. b. PLAN SKETCH FROM DI. FAULT W-5 DEFLECTS AND OFFSETS DIKE d5 AND THE HOST ROCK, NEWBURYPORT. c. PLAN SKETCH FROM THE AREA BETWEEN THE CWI AND THE ESFPCI. DIKE d5 CROSS-CUTS FAULT EI-1.

SEABROOK STATION UPDATED FINAL SAFETY ANALYSIS REPORT	Sketches Detailing NI-1, NI-2, EI-1, and W-6	
		Figure 2.5-23
