NUCLEAR REGULATORY COMMISSION

Title: Advisory Committee on Reactor Safeguards
 Metallurgy and Reactor Fuels Subcommittee

Date: Wednesday, November 16, 2016

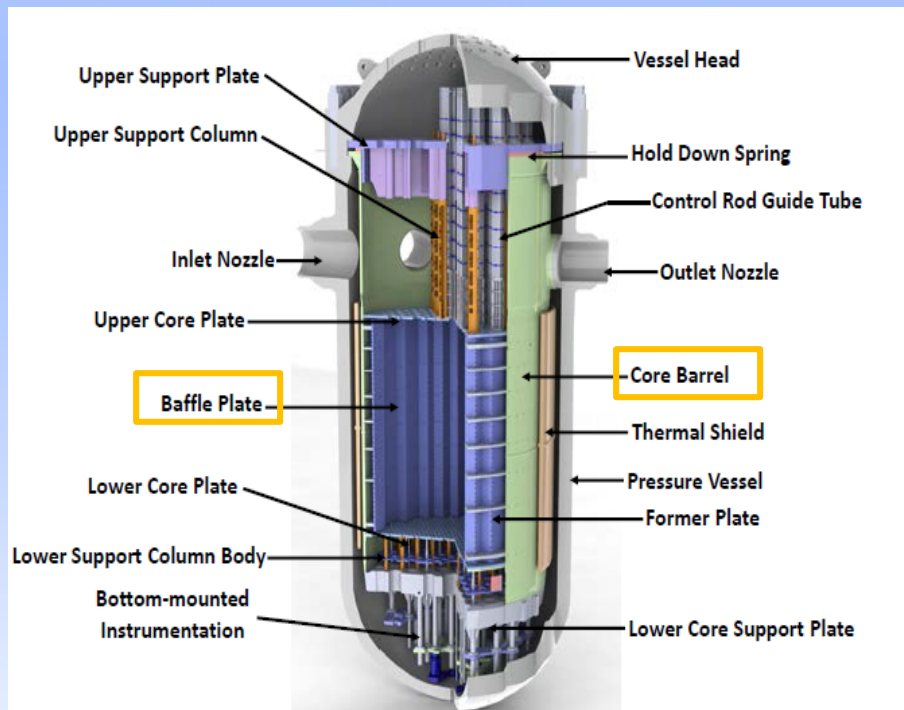
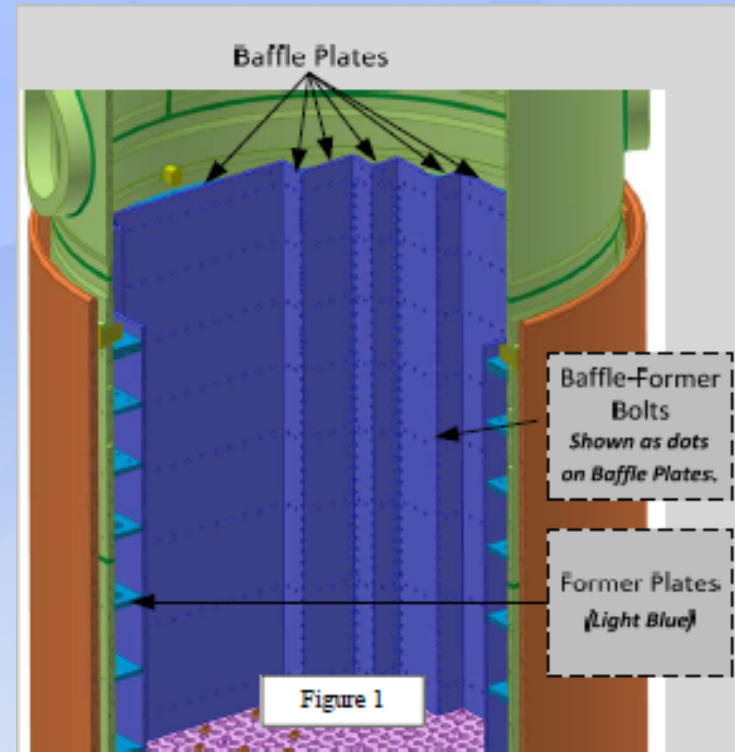
Design and Functions of the Baffle-former Assembly

Function of baffle-former assembly is to direct coolant flow through the core. It also provides lateral support to the core during a seismic event or loss-of-coolant accident (LOCA).

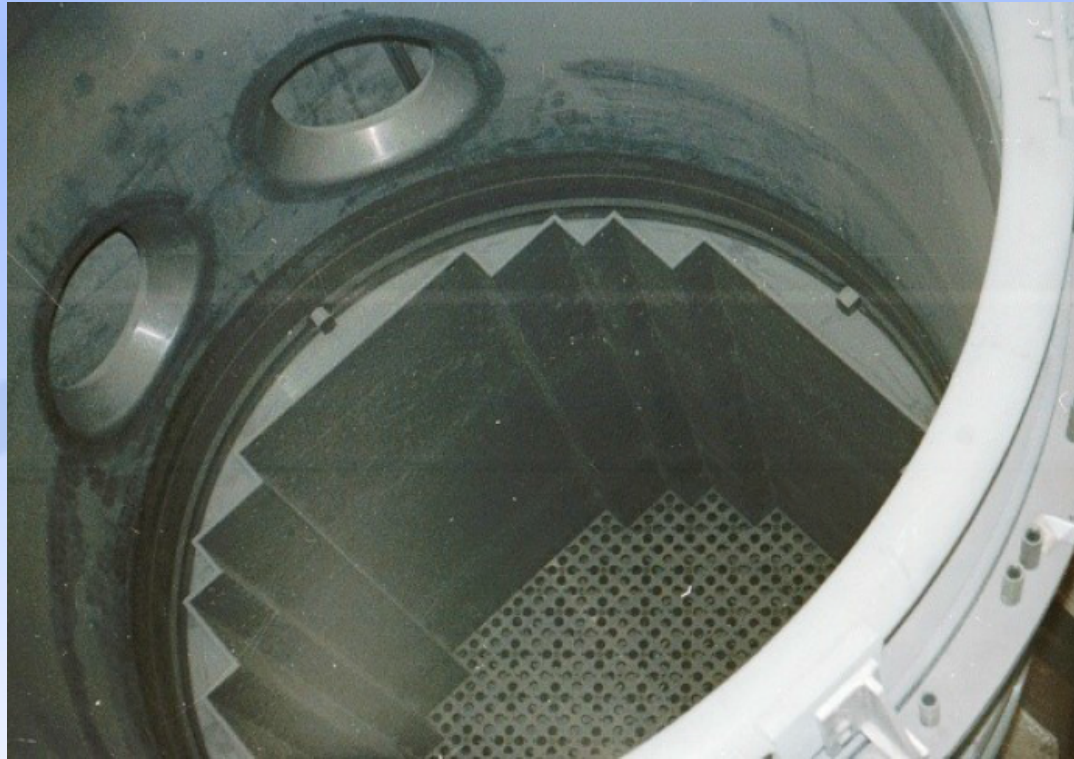
Design and Functions of the Baffle-former Assembly

Looking down into the core barrel of a Westinghouse-design PWR

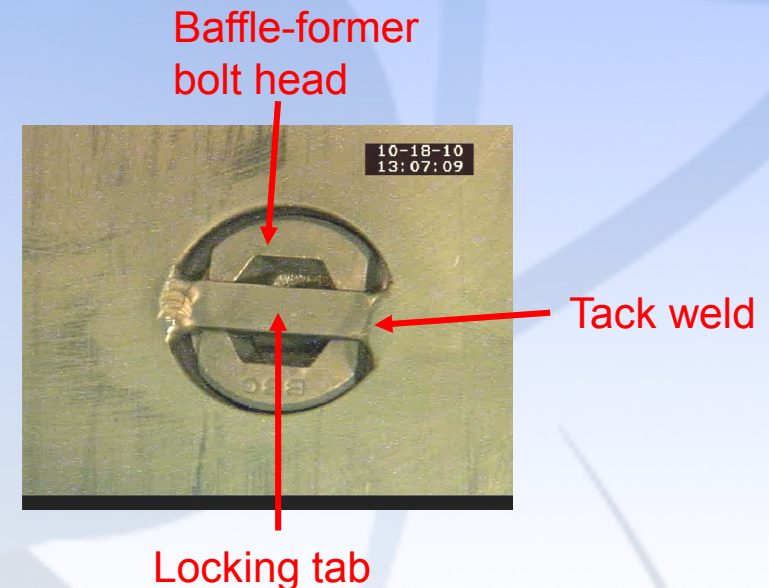
Design and Functions of the Baffle-former Assembly - Design of Baffle-former bolts

- Stainless steel bolts are 5/8" dia. x ~2" long and attach the baffle plates to the former plates to form the baffle-former assembly.

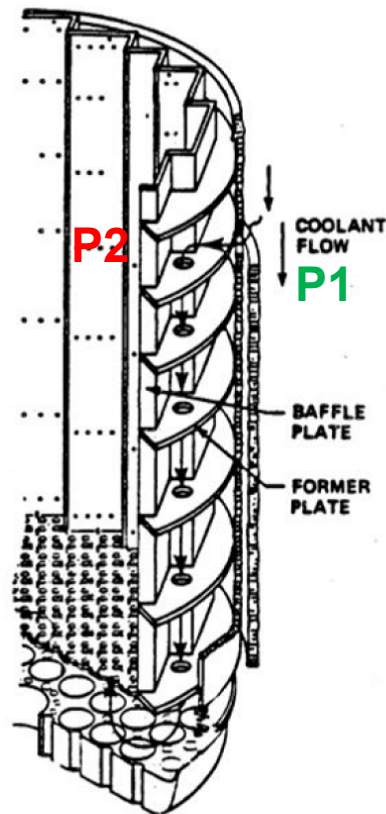
DOWNFLOW
CONFIGURATION

$$P1 > P2$$

Tries to force baffle plate
inward = higher stress on bolts

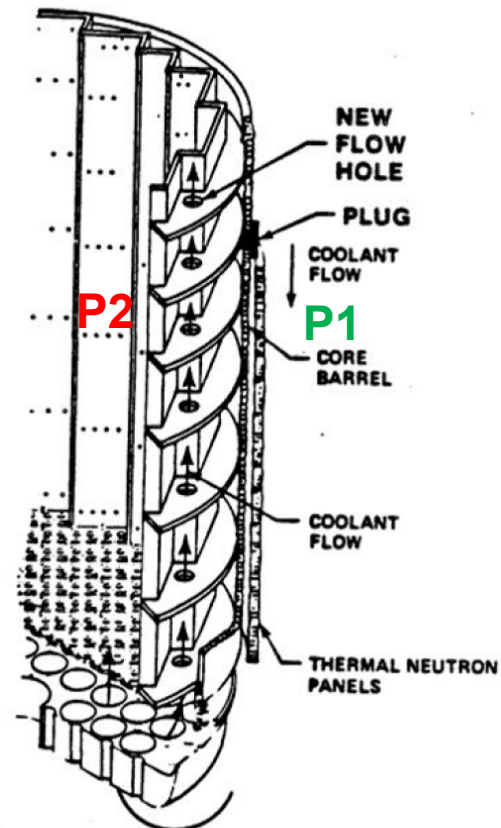
UPFLOW
CONFIGURATION

$$P1 \approx P2$$

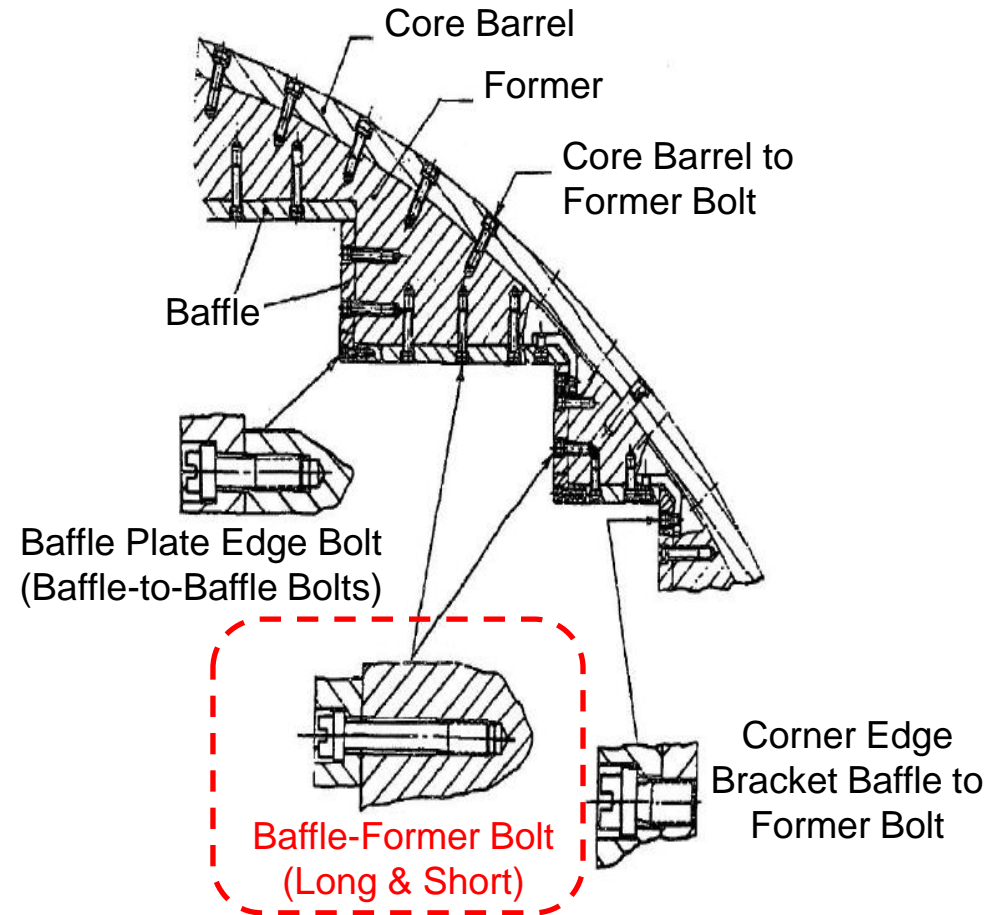
Baffle-Former Assembly Details

- Core barrel, baffle and former plates
 - Type 304 austenitic stainless steel material
- Baffle-Former Bolts (BFBs)
 - Attach the baffle plates to the former plates in the reactor lower internals assembly
 - Type 347 or Type 316 cold worked austenitic stainless steel material
 - Bolt head designs and shank lengths vary from plant-to-plant

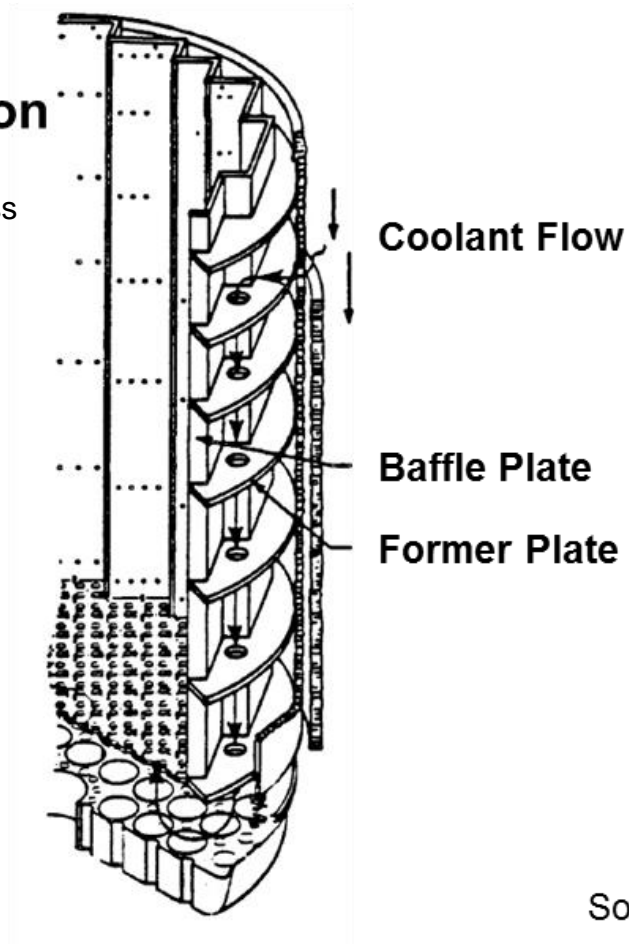
Downflow Configuration

Large Differential Pressure (ΔP) Across the Baffle Plate -> greater BFB bolt loads

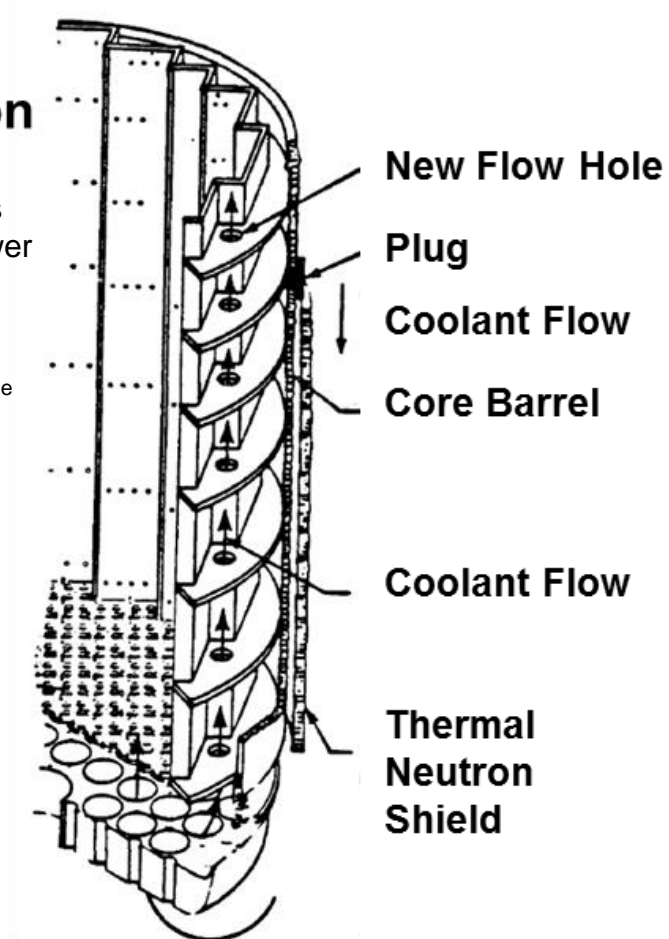
Upflow Configuration

Small Differential Pressure (ΔP) across the baffle plate -> lower BFB bolt load

*Figure shows modification made for Upflow Conversion

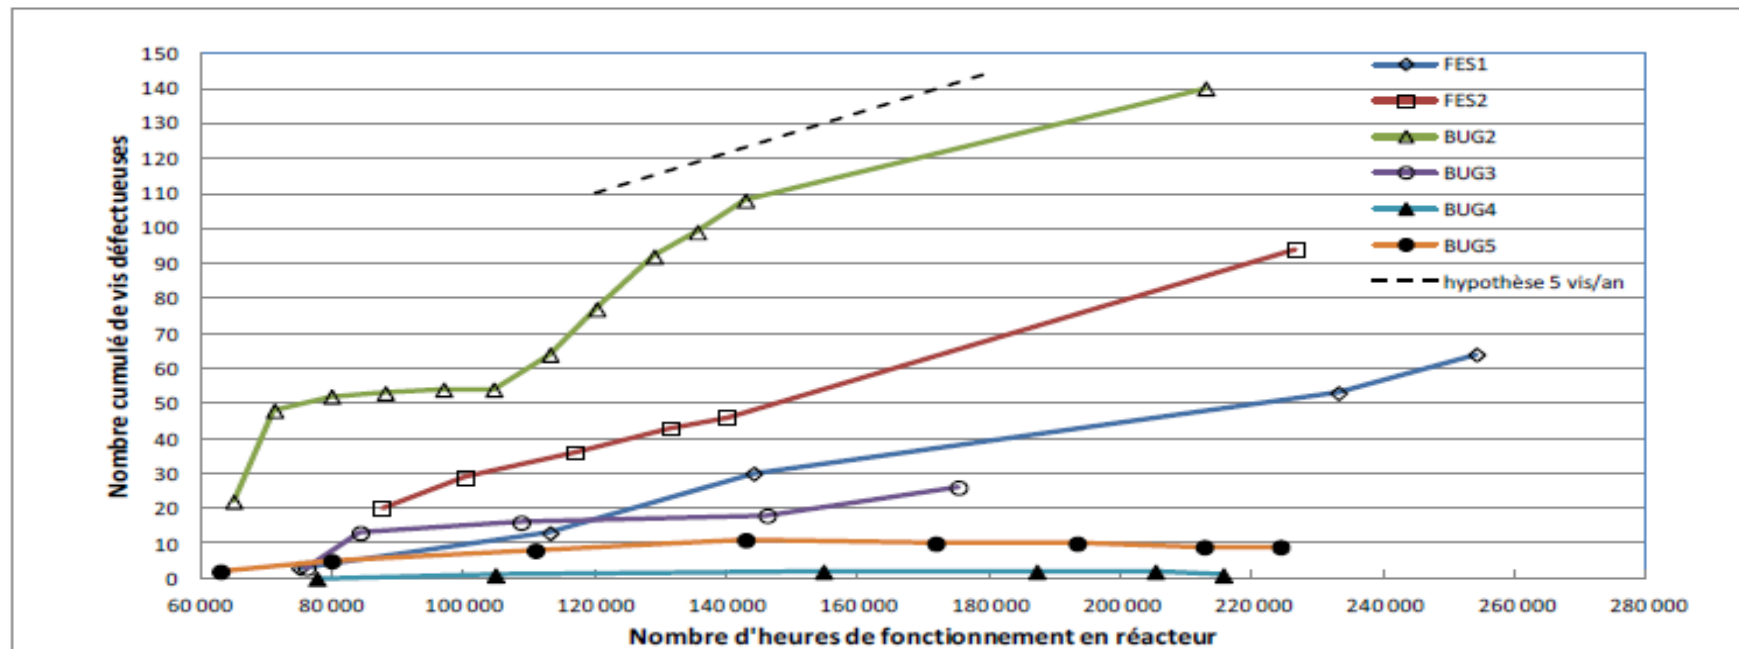
Overall BFB Timeline – CP0 Units

- X-axis: number of operating hours
 - Y-axis: cumulative number of bolts found 'failed'/'unconclusive'
 - ----- : evolution trend, assuming 5 failed bolts per year
- BUG2-FES2-FES1-BUG3: 4/6 CP0 units are 'affected'**
BUG5-BUG4: 2/6 CP0 units are 'unaffected'

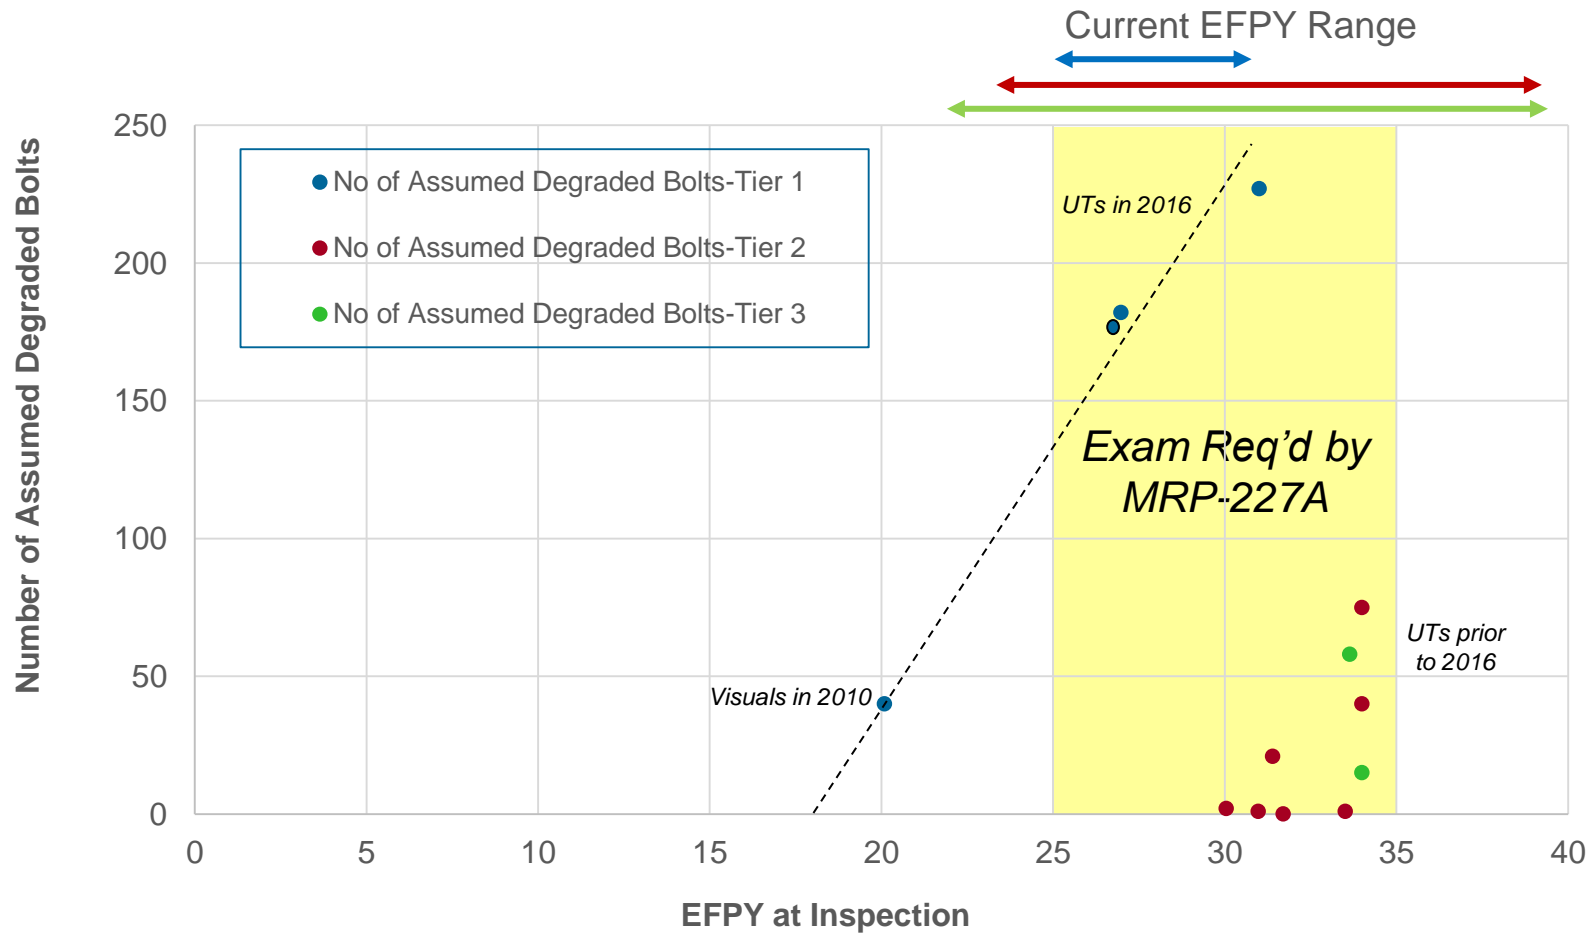
US Trends – BFB Focus Group Industry OE Database

- These three plants share a common plant design configuration (4-loop downflow), bolt design, and bolt material
- Bolts with visual or UT indications tend to be clustered
- Distributions seem to indicate the presence of a mechanism causing adjacent bolts to become more susceptible to failure
- Assessing impact of new findings from DC Cook 2 exams:
 - Replacement 316 CW BFBs (6) from 2010 event with UT indications
 - Visually degraded edge bolts (5) on one panel, in the center of a large area/cluster of BFB failures

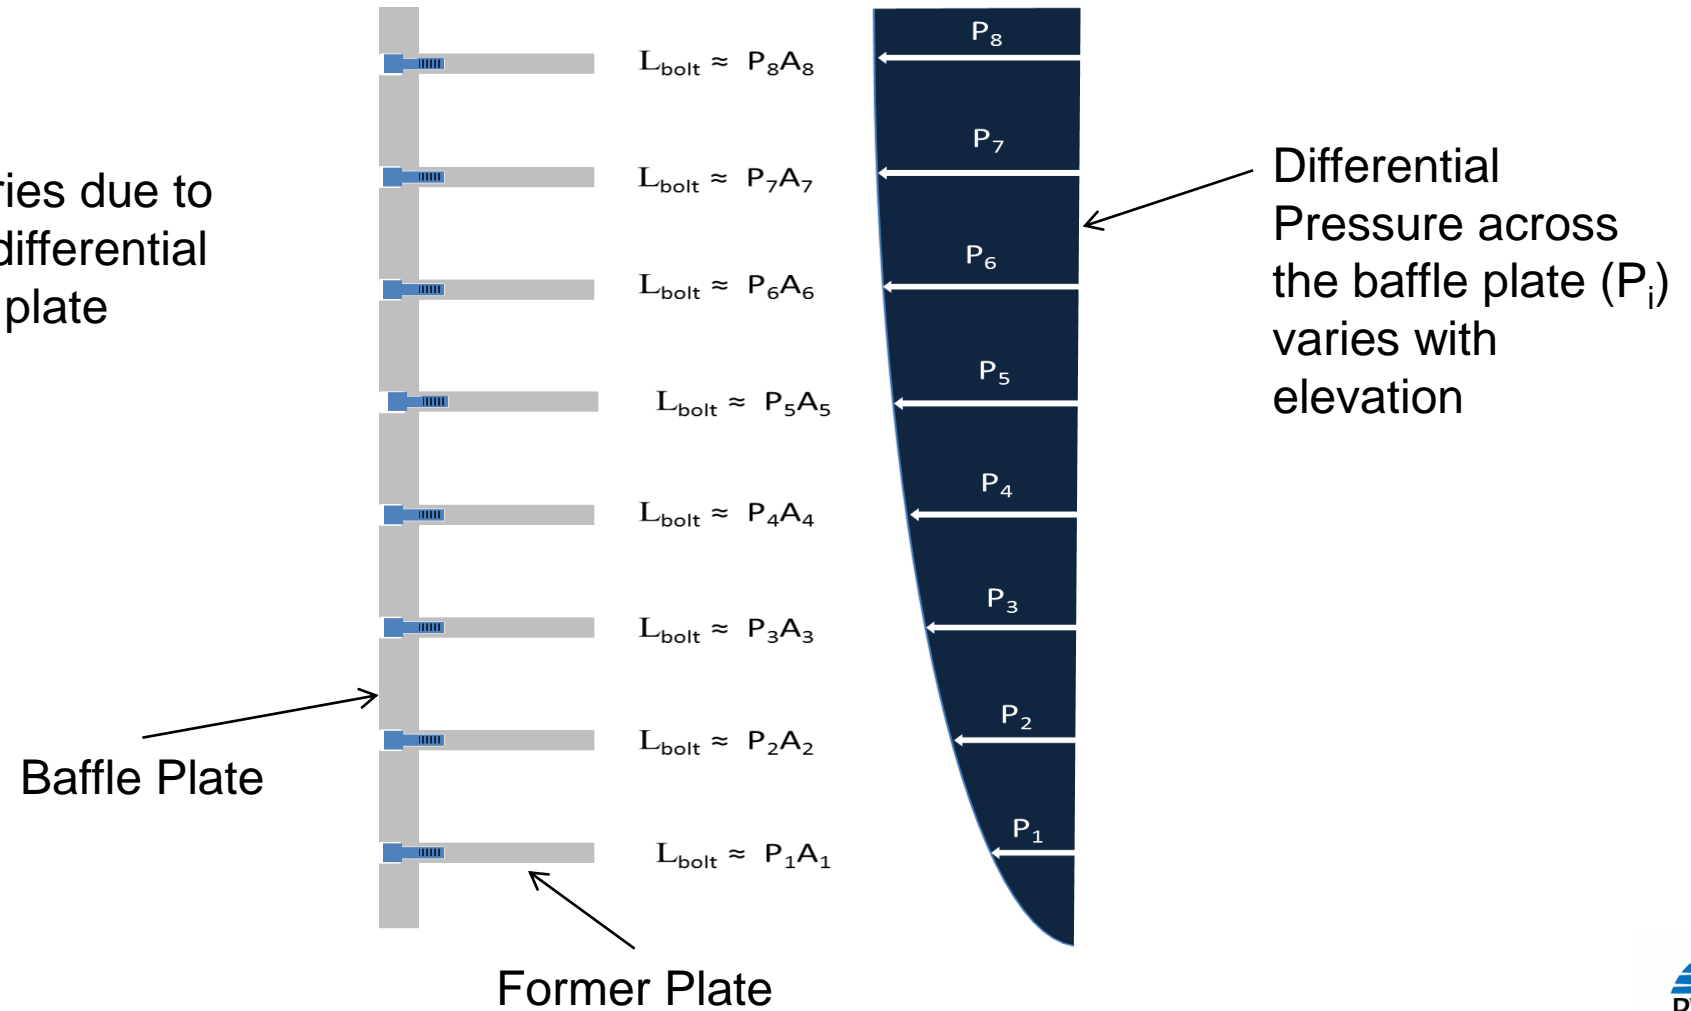
Vertical Stress Variation in Downflow Design

Bolt load (L_{bolt}) varies due to varying pressure differential across baffle plate

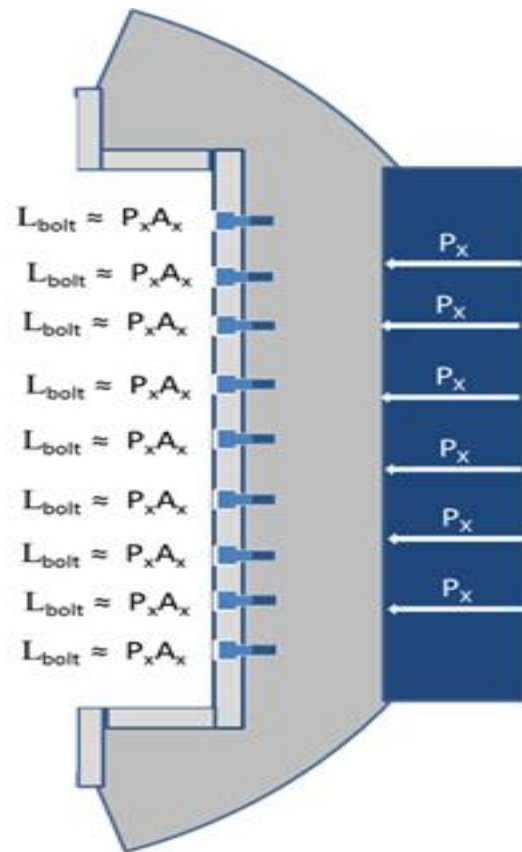
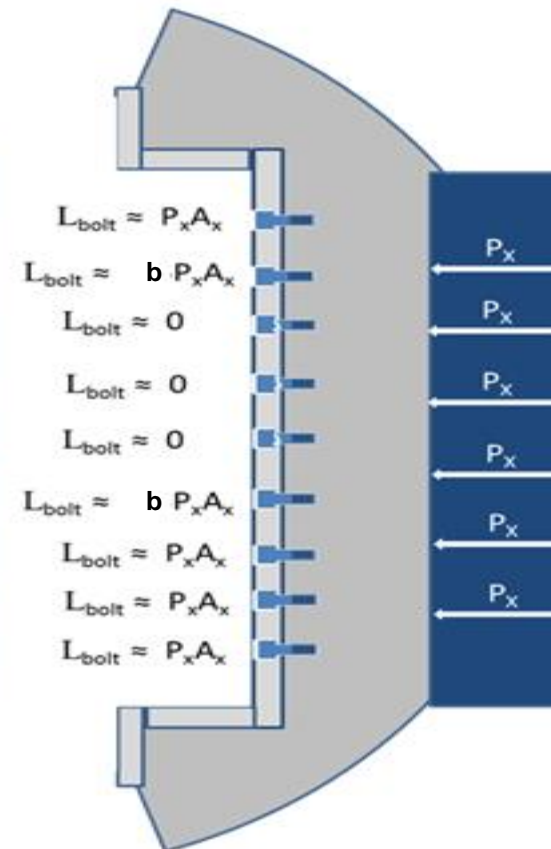
Stress Redistribution to Adjacent Bolts - Primary

0 Failed Bolts

1 Failed Bolt

3 Failed Bolts

Primary stresses dominate after irradiation stress relaxation occurs.

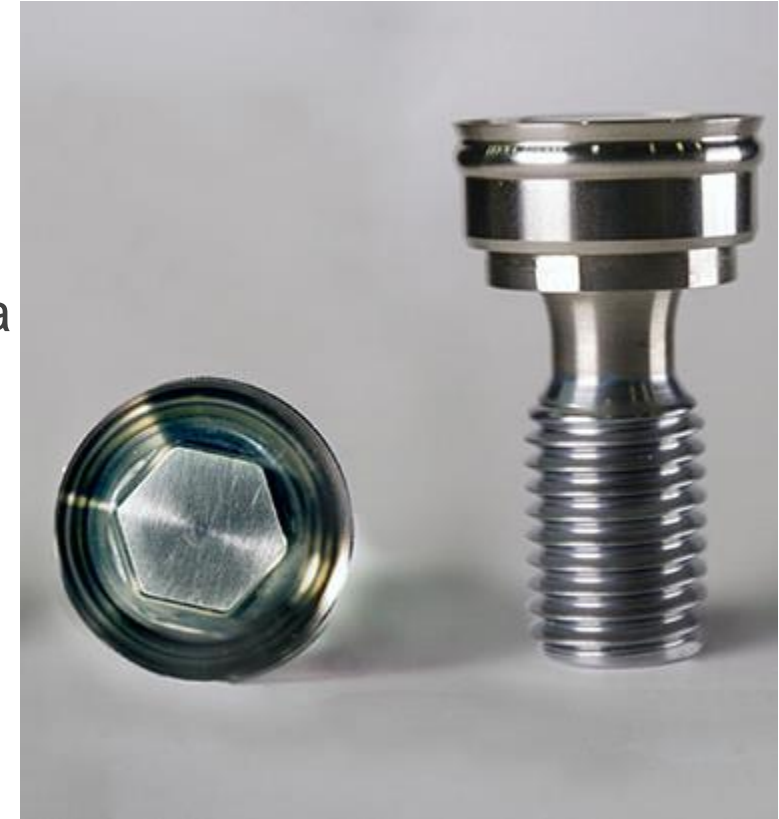
Westinghouse Replacement Bolts

- Replacement bolt design improvements to reduce impact of factors influencing bolt degradation
 - Cold Worked Type 316
 - Past operating experience using this material for baffle-former bolts and guide tube support pins has generally been positive. However, insufficient direct comparative data exists at this point to make a definitive conclusion
 - Semi-Parabolic head-to-shank transition fillet radius to reduce stress concentration and increase flexibility
 - Improved fatigue resistance
 - Reduced susceptibility to IASCC initiation
- Additional design improvements made for installation efficiency and ease of examination
