SUBJECT:                CERTIFICATION OF THE MINUTES OF THE ACRS  
                              METALLURGY AND REACTOR FUELS SUBCOMMITTEE  
                              MEETING ON NOVEMBER 16, 2016, IN ROCKVILLE,  
                              MARYLAND

# Design and Functions of the Baffle-former Assembly

Bryan Wilson, Fellow Engineer, Westinghouse-PWROG

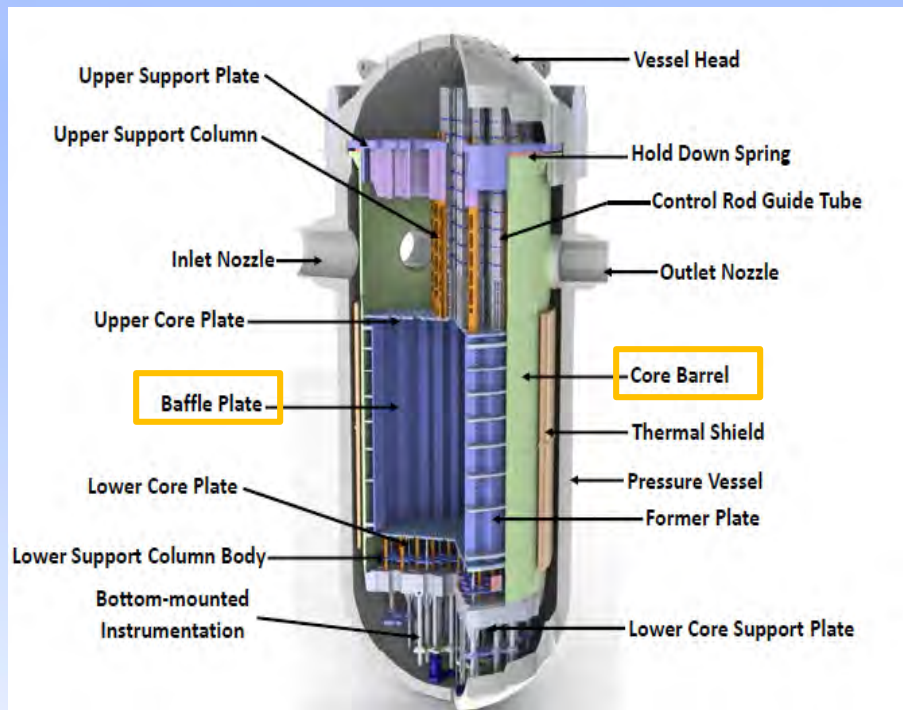
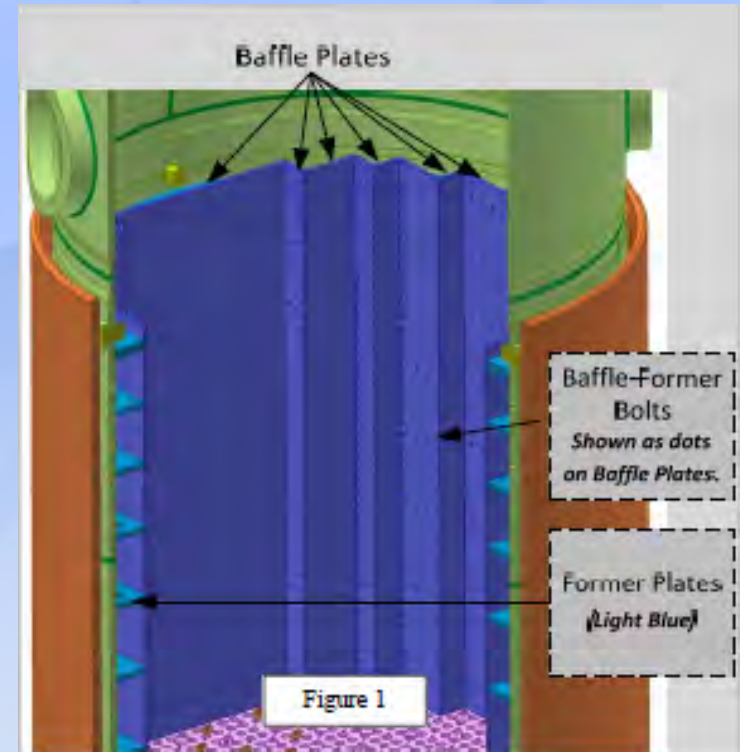
Function of baffle-former assembly is to direct coolant flow through the core. It also provides lateral support to the core during a seismic event or loss-of-coolant accident (LOCA).

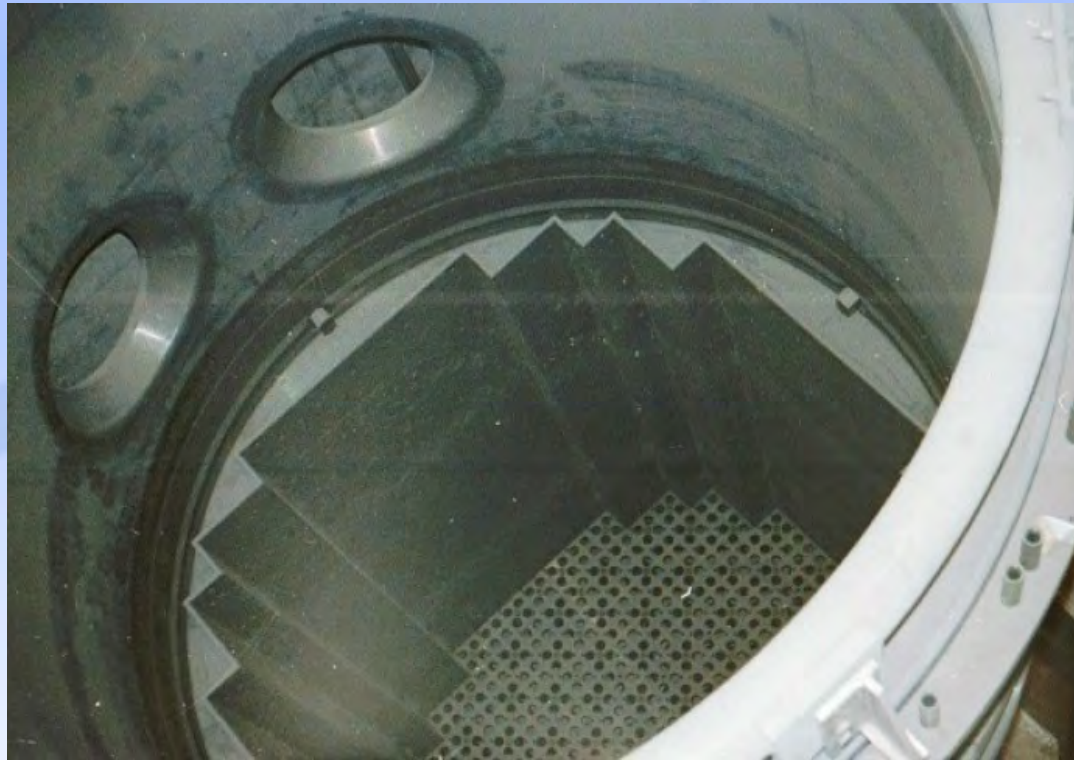
Looking down into the core barrel of a Westinghouse-design PWR

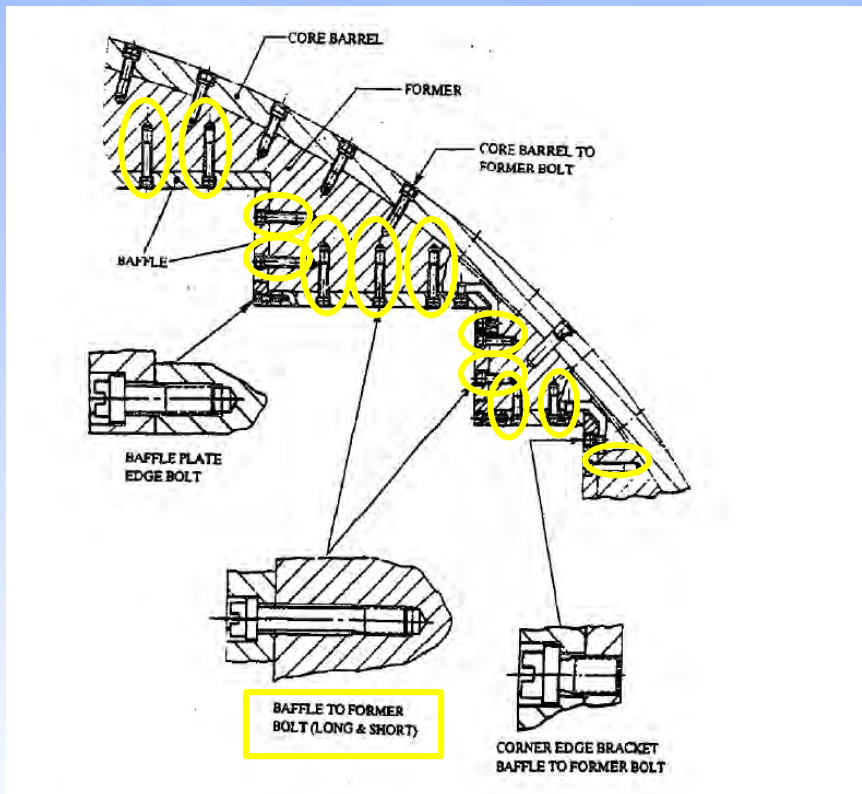
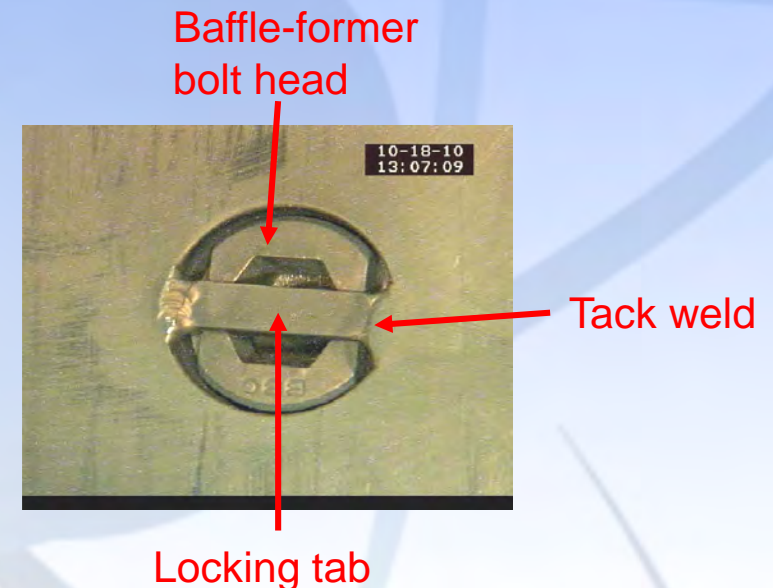
# Design and Functions of the Baffle-former Assembly - Design of Baffle-former bolts

- Stainless steel bolts are 5/8" dia. x ~2" long and attach the baffle plates to the former plates to form the baffle-former assembly.

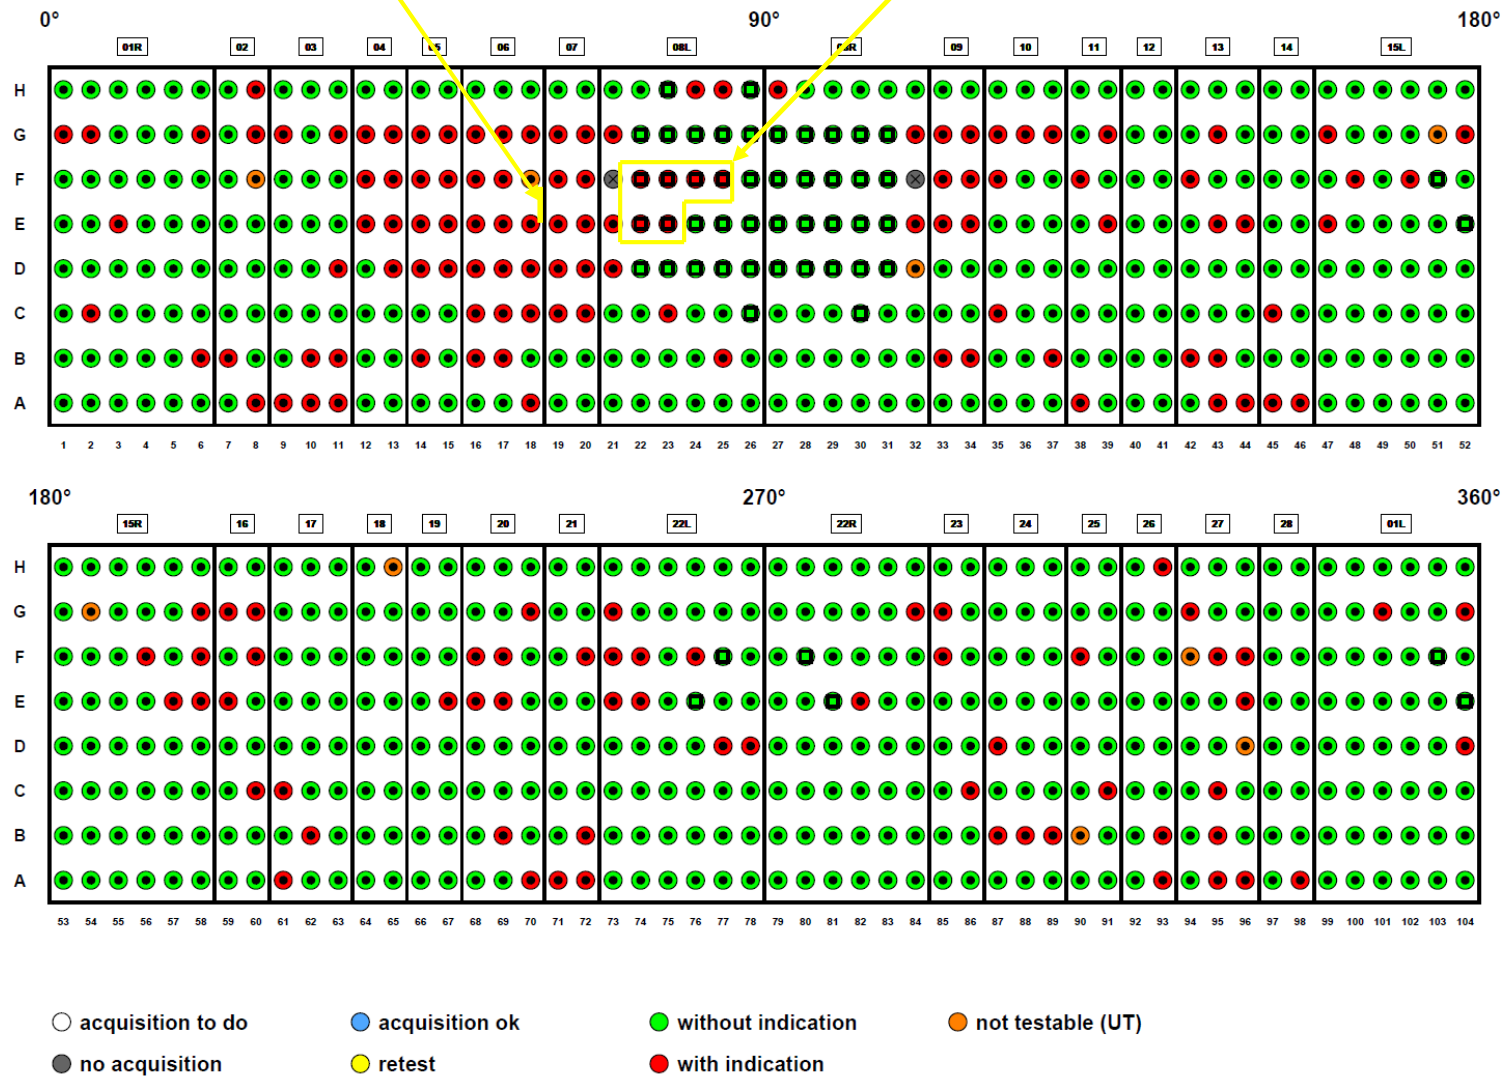
## As-Found Condition of D.C. Cook, Unit 2 Baffle-Former Bolts Fall, 2016 Refueling Outage

- During October 2016, D.C. Cook, Unit 2 performed UT examination of baffle-former bolts (832 total) on accelerated schedule in accordance with MRP interim guidance.
- Total of 179 potentially degraded bolts
  - 170 with UT indications
  - 9 untestable bolts
- 2 vacant bolt locations from 2010
- Six (6) replacement bolts installed in 2010 had indications.
- At least one vacant bolt location correlated with a damaged fuel assembly.
- Visual examination of baffle-edge bolts found 5 degraded bolts.

Location of Degraded Edge Bolts

Degraded Replacement Bolts

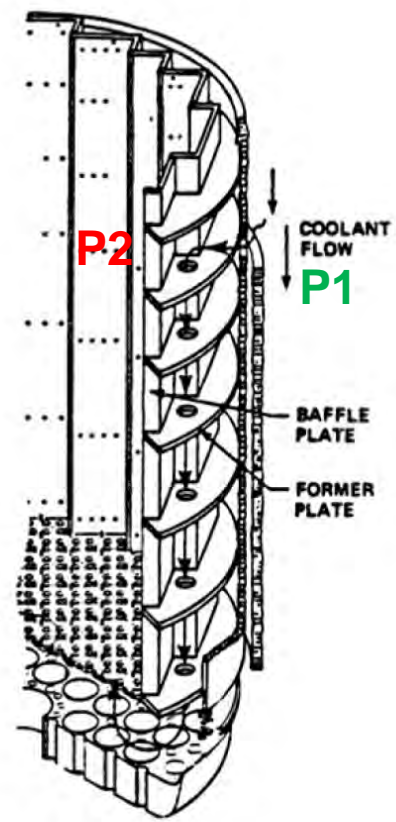
DOWNFLOW CONFIGURATION

$P1 > P2$

Tries to force baffle plate inward = higher stress on bolts

Large Differential Pressure ( $\Delta P$ ) Across the Baffle Plate -> greater BFB bolt loads

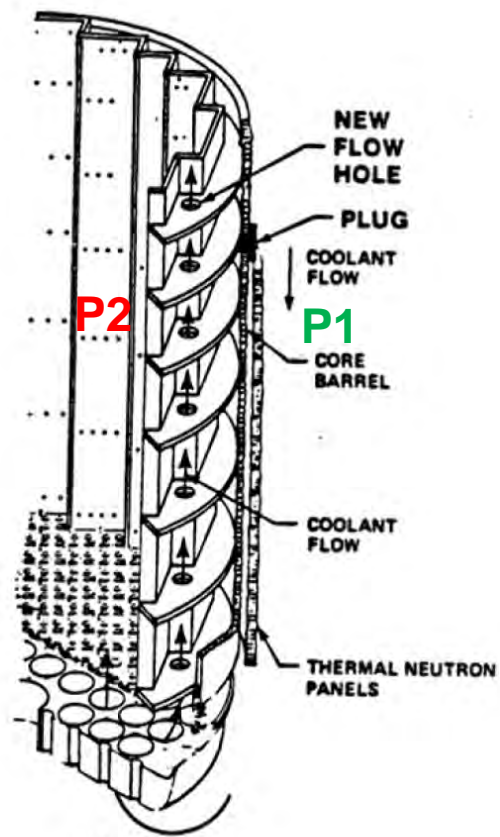
UPFLOW CONFIGURATION

$P1 \approx P2$

Small Differential Pressure ( $\Delta P$ ) across the baffle plate -> lower BFB bolt load

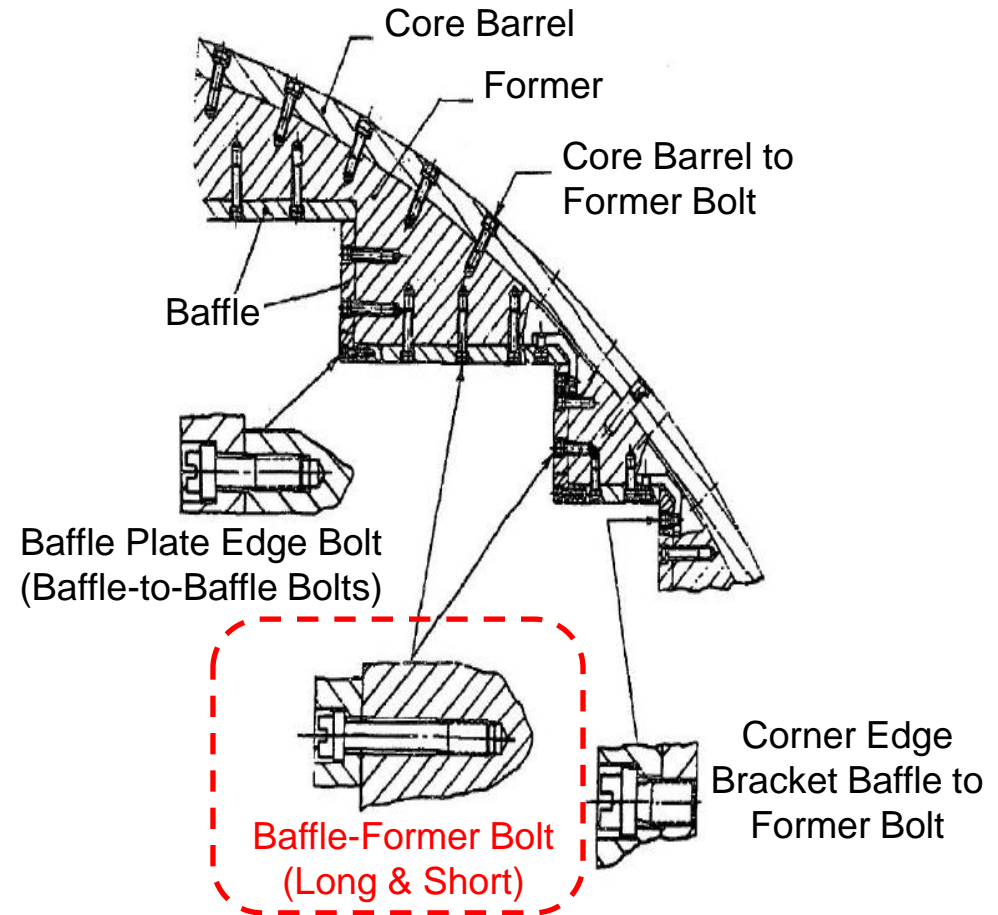
# Baffle-Former Assembly Details

- Core barrel, baffle and former plates
  - Type 304 austenitic stainless steel material
- Baffle-Former Bolts (BFBs)
  - Attach the baffle plates to the former plates in the reactor lower internals assembly
  - Type 347 or Type 316 cold worked austenitic stainless steel material
  - Bolt head designs and shank lengths vary from plant-to-plant

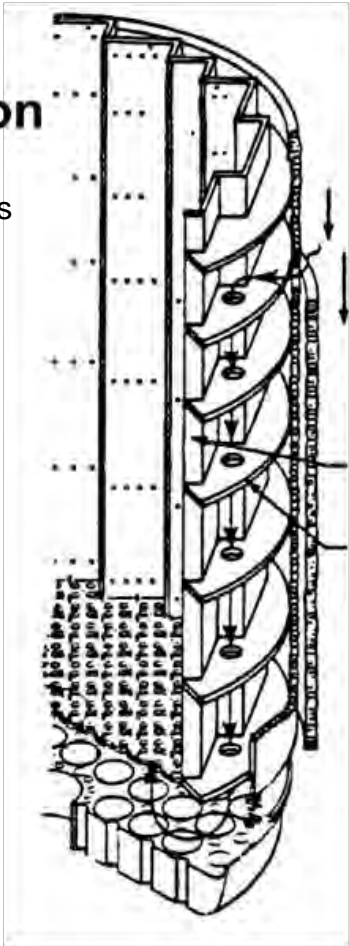
## Downflow Configuration

Coolant Flow

Baffle Plate

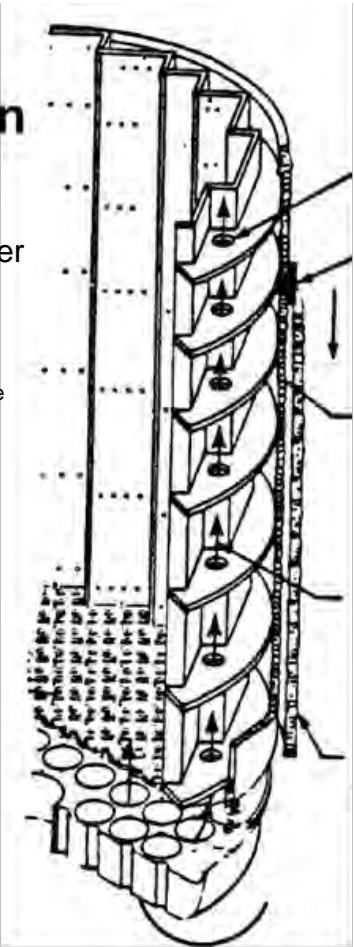
\*Figure shows modification made for Upflow Conversion

New Flow Hole

Plug

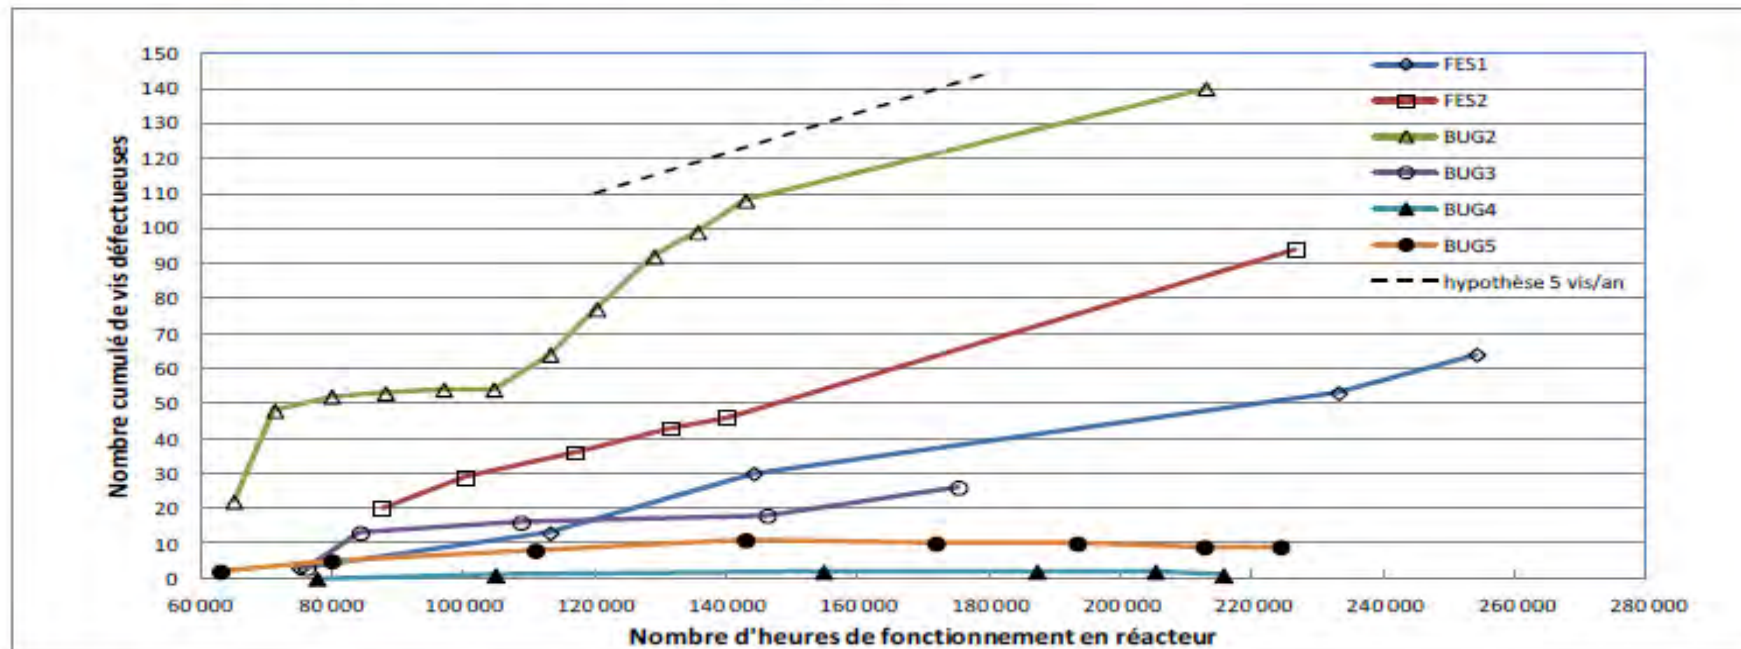
## Overall BFB Timeline – CP0 Units

- X-axis: number of operating hours
  - Y-axis: cumulative number of bolts found ‘failed’/‘unconclusive’
  - ----- : evolution trend, assuming 5 failed bolts per year
- BUG2-FES2-FES1-BUG3: 4/6 CP0 units are ‘affected’**  
**BUG5-BUG4: 2/6 CP0 units are ‘unaffected’**

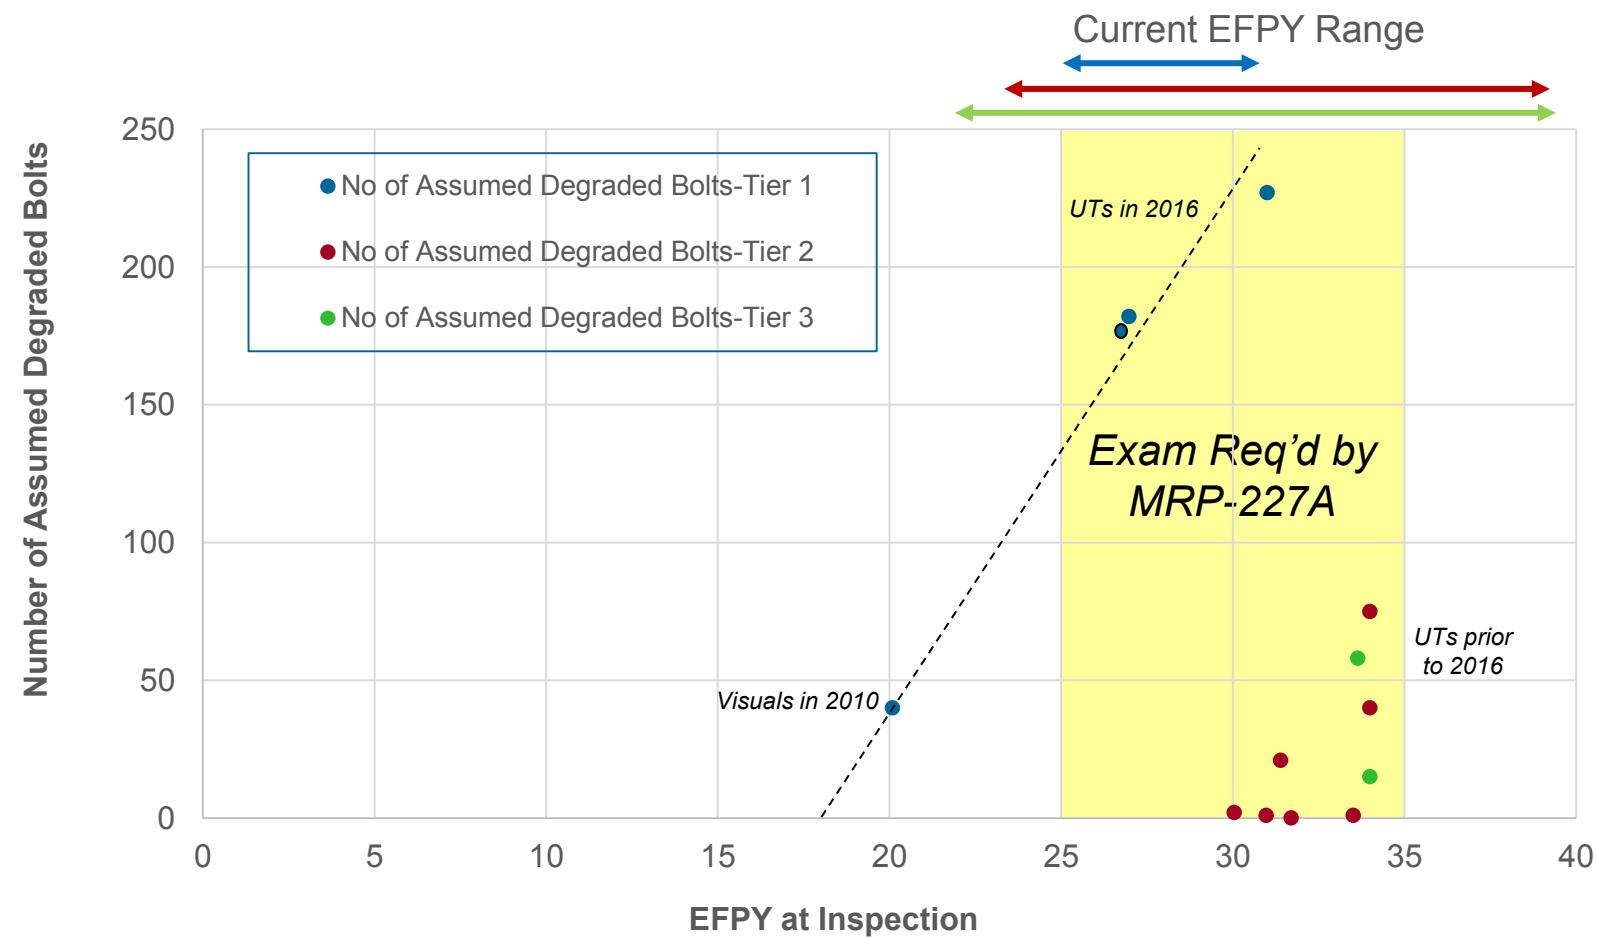
# US Trends – BFB Focus Group Industry OE Database

- These three plants share a common plant design configuration (4-loop downflow), bolt design, and bolt material
- Bolts with visual or UT indications tend to be clustered
- Distributions seem to indicate the presence of a mechanism causing adjacent bolts to become more susceptible to failure
- Assessing impact of new findings from DC Cook 2 exams:
  - Replacement 316 CW BFBs (6) from 2010 event with UT indications
  - Visually degraded edge bolts (5) on one panel, in the center of a large area/cluster of BFB failures

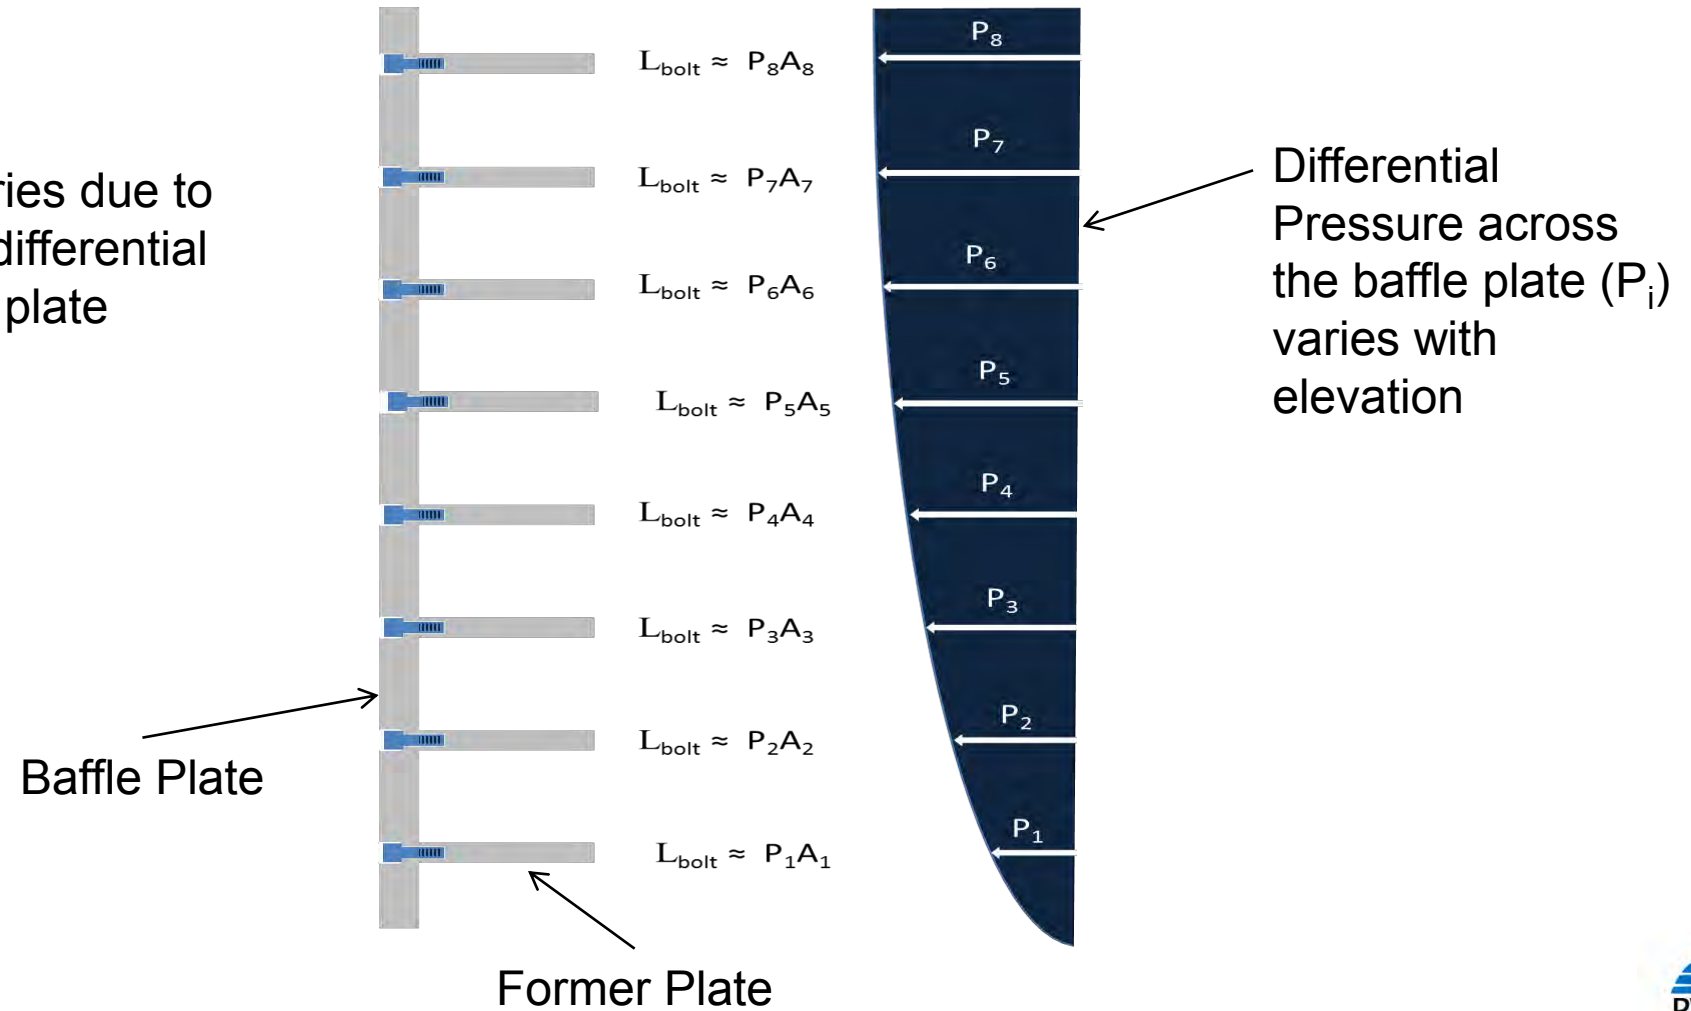
# Vertical Stress Variation in Downflow Design

Bolt load ( $L_{\text{bolt}}$ ) varies due to varying pressure differential across baffle plate

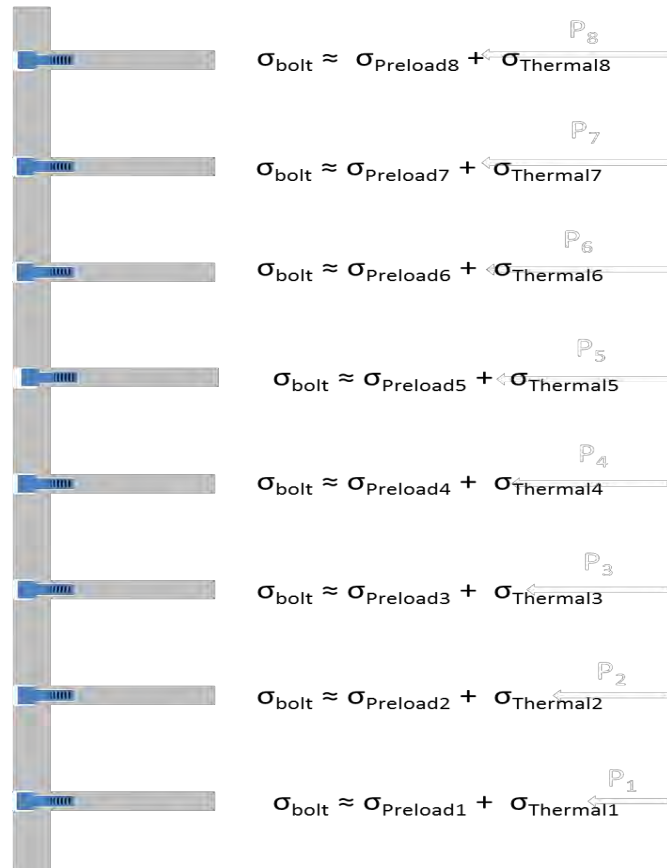
0 Failed Bolts

# Stress Redistribution to Adjacent Bolts - Secondary

Secondary stresses predominant in early life (bolt preload)

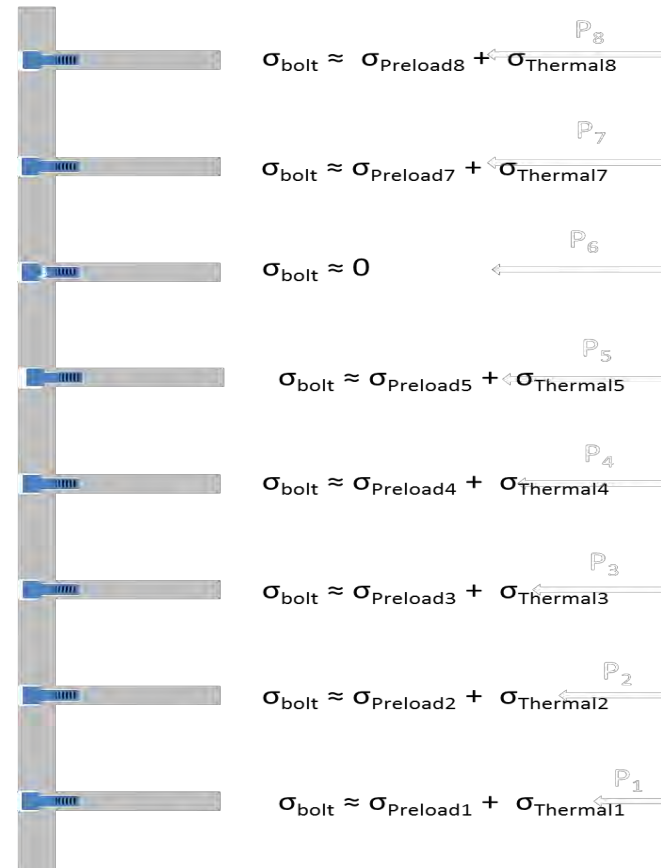
1 Failed Bolt

Irradiation Induced Stress Relaxation diminishes secondary stresses over time

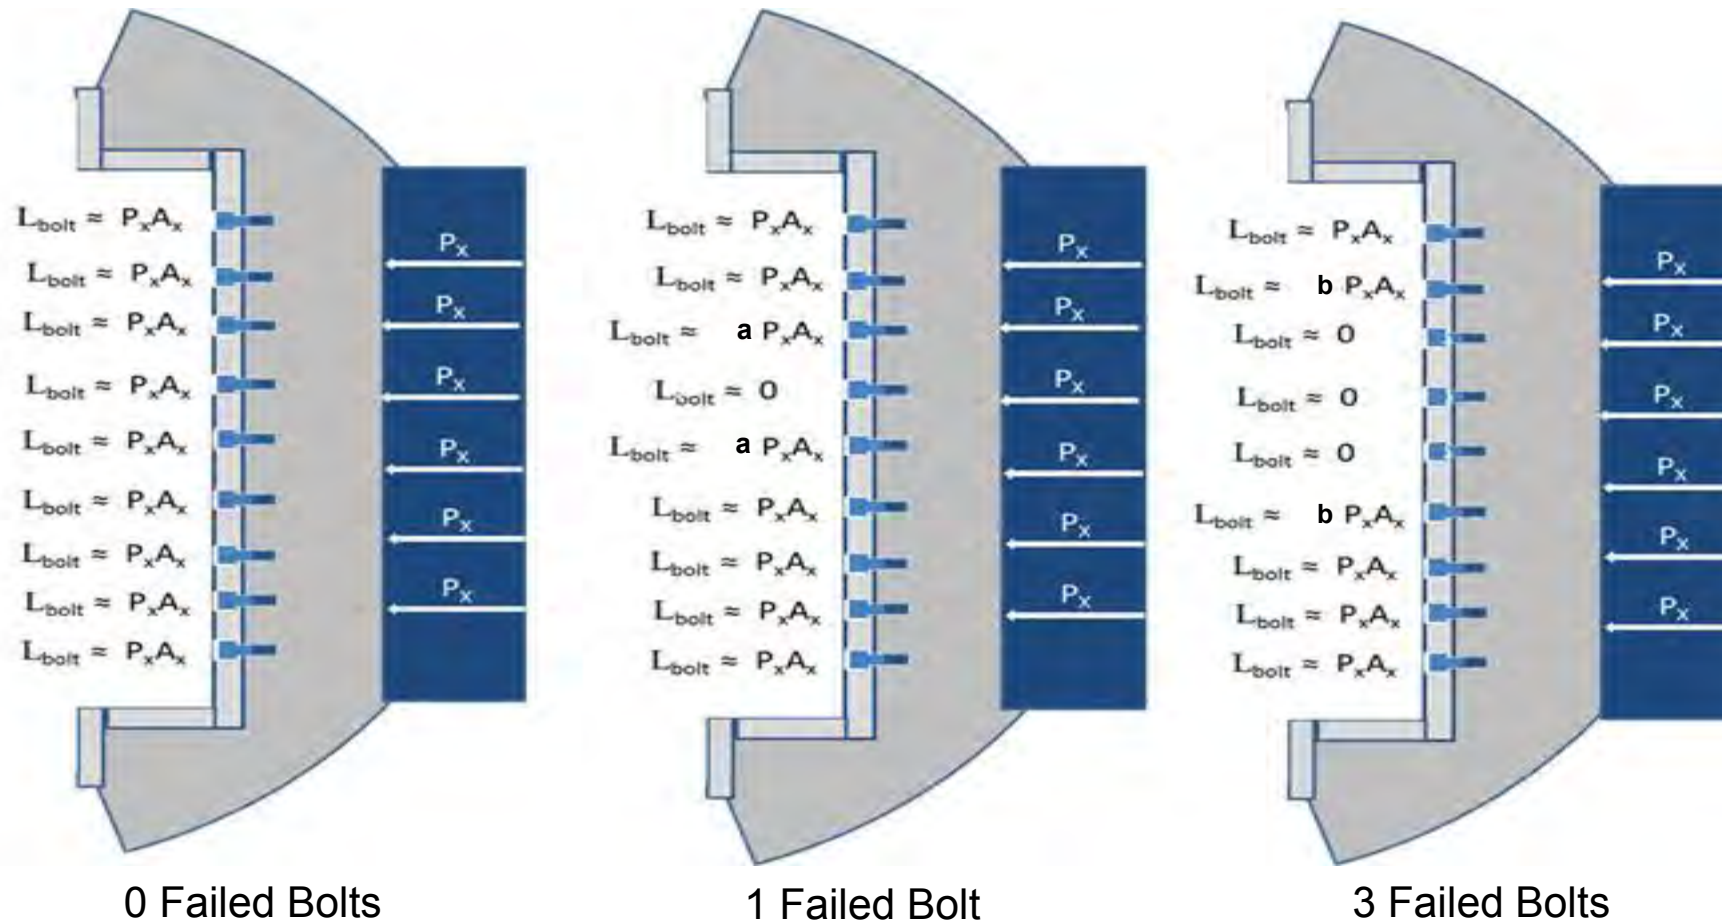
# Stress Redistribution to Adjacent Bolts - Primary

Primary stresses dominate after irradiation stress relaxation occurs.

Stress redistributes as bolts fail.

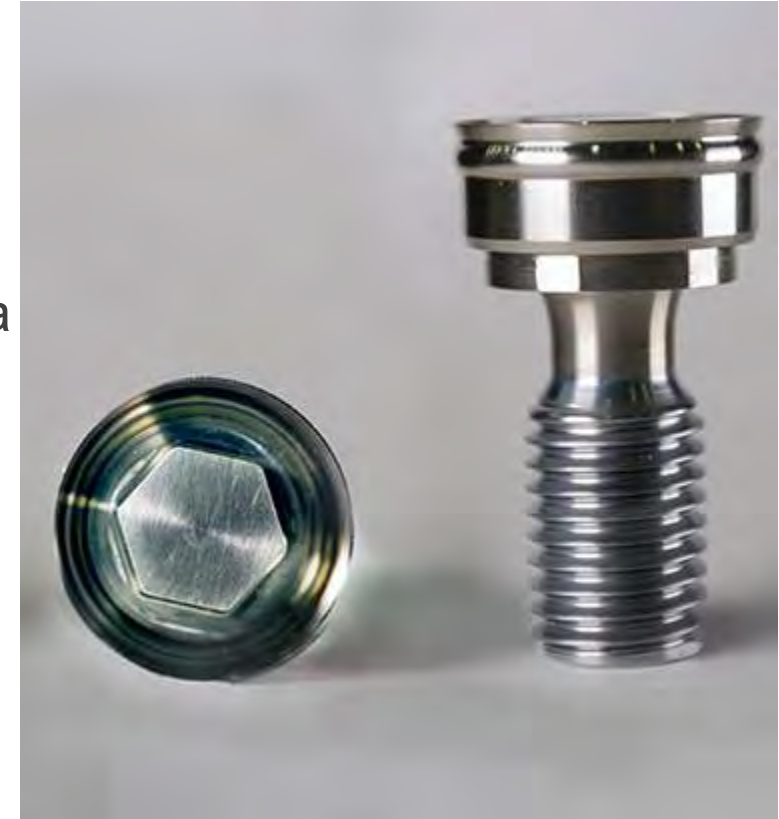
# Westinghouse Replacement Bolts

- Replacement bolt design improvements to reduce impact of factors influencing bolt degradation
  - Cold Worked Type 316
    - Past operating experience using this material for baffle-former bolts and guide tube support pins has generally been positive. However, insufficient direct comparative data exists at this point to make a definitive conclusion
  - Semi-Parabolic head-to-shank transition fillet radius to reduce stress concentration and increase flexibility
    - Improved fatigue resistance
    - Reduced susceptibility to IASCC initiation
- Additional design improvements made for installation efficiency and ease of examination
