REGULATORY INFORMATION DISTRIBUTION SYSTEM (RIDS)

SUBJECT: "Washington Nuclear Power Plant Unit 2 Annual Operating  
 Rept." W/920228 Ltr.

SUBJECT: NUCLEAR PLANT WNP-2, ANNUAL OPERATING REPORT 1991

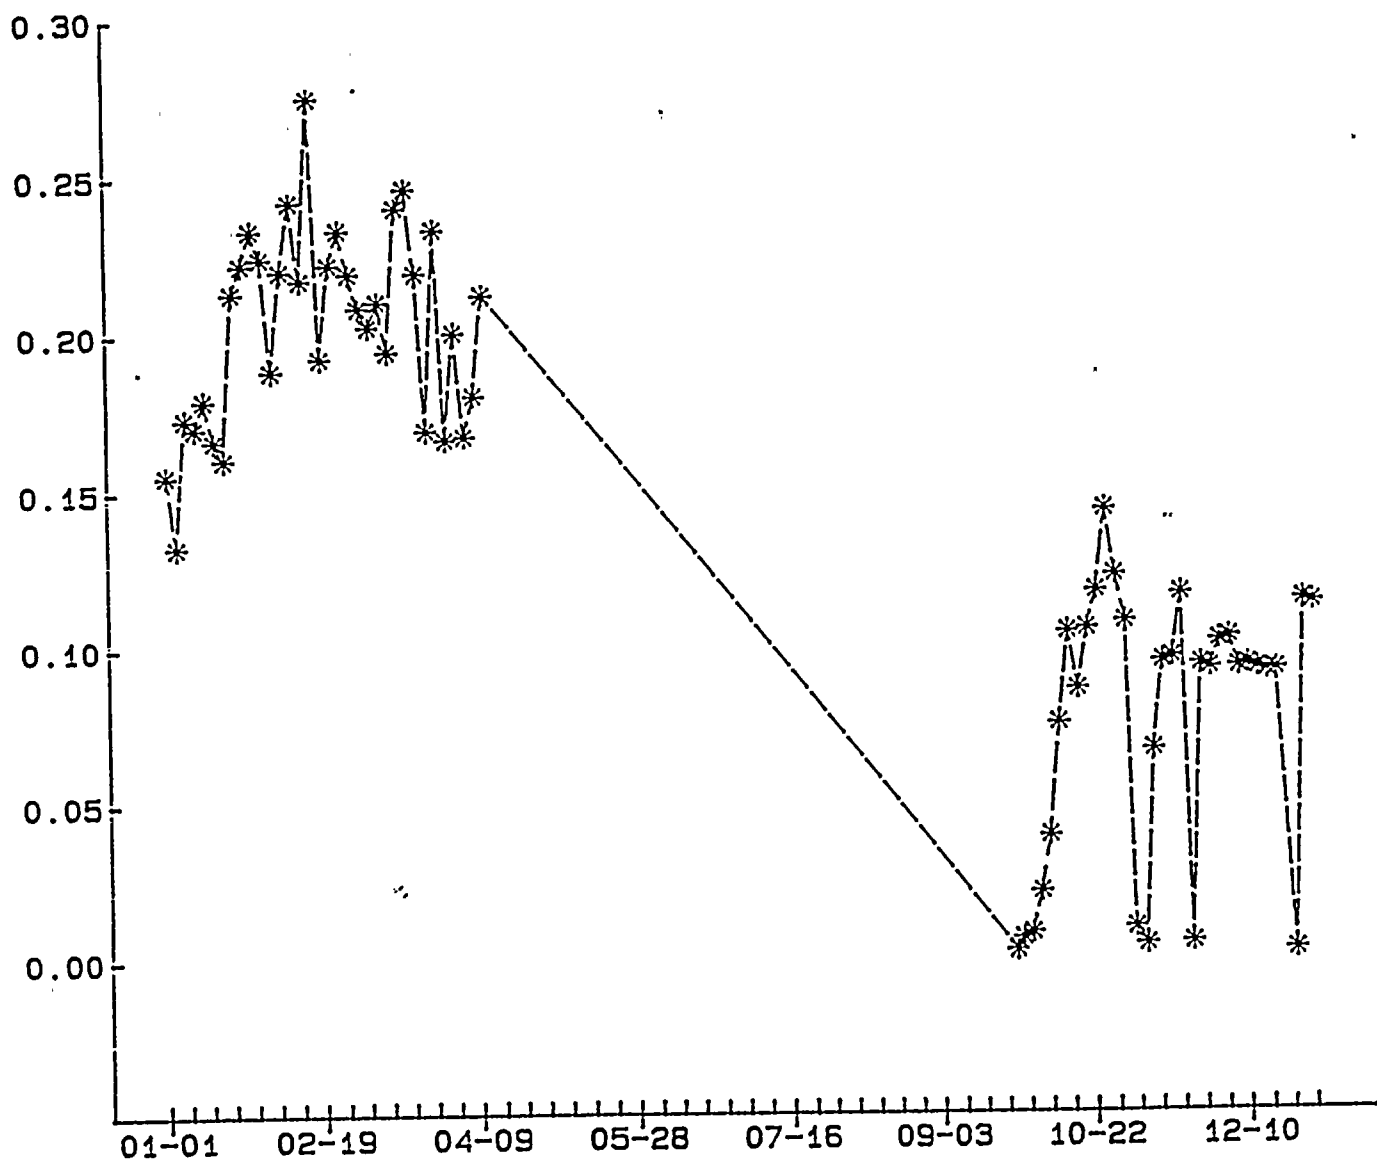
## 1.2 REACTOR COOLANT SPECIFIC ACTIVITY LEVELS

This section contains information relative to reactor coolant cumulative iodine levels, iodine spikes and specific activity of all isotopes other than iodine, and is reported in accordance with Technical Specifications paragraph 6.9.1.5.c.
