REGULATOR INFORMATION DISTRIBUTION SYSTEM (RIDS)

SUBJECT: "Annual Operating Rept for 1996." W/970228 ltr.

Subject: **WNP-2, OPERATING LICENSE NPF-21
ANNUAL OPERATING REPORT 1996**

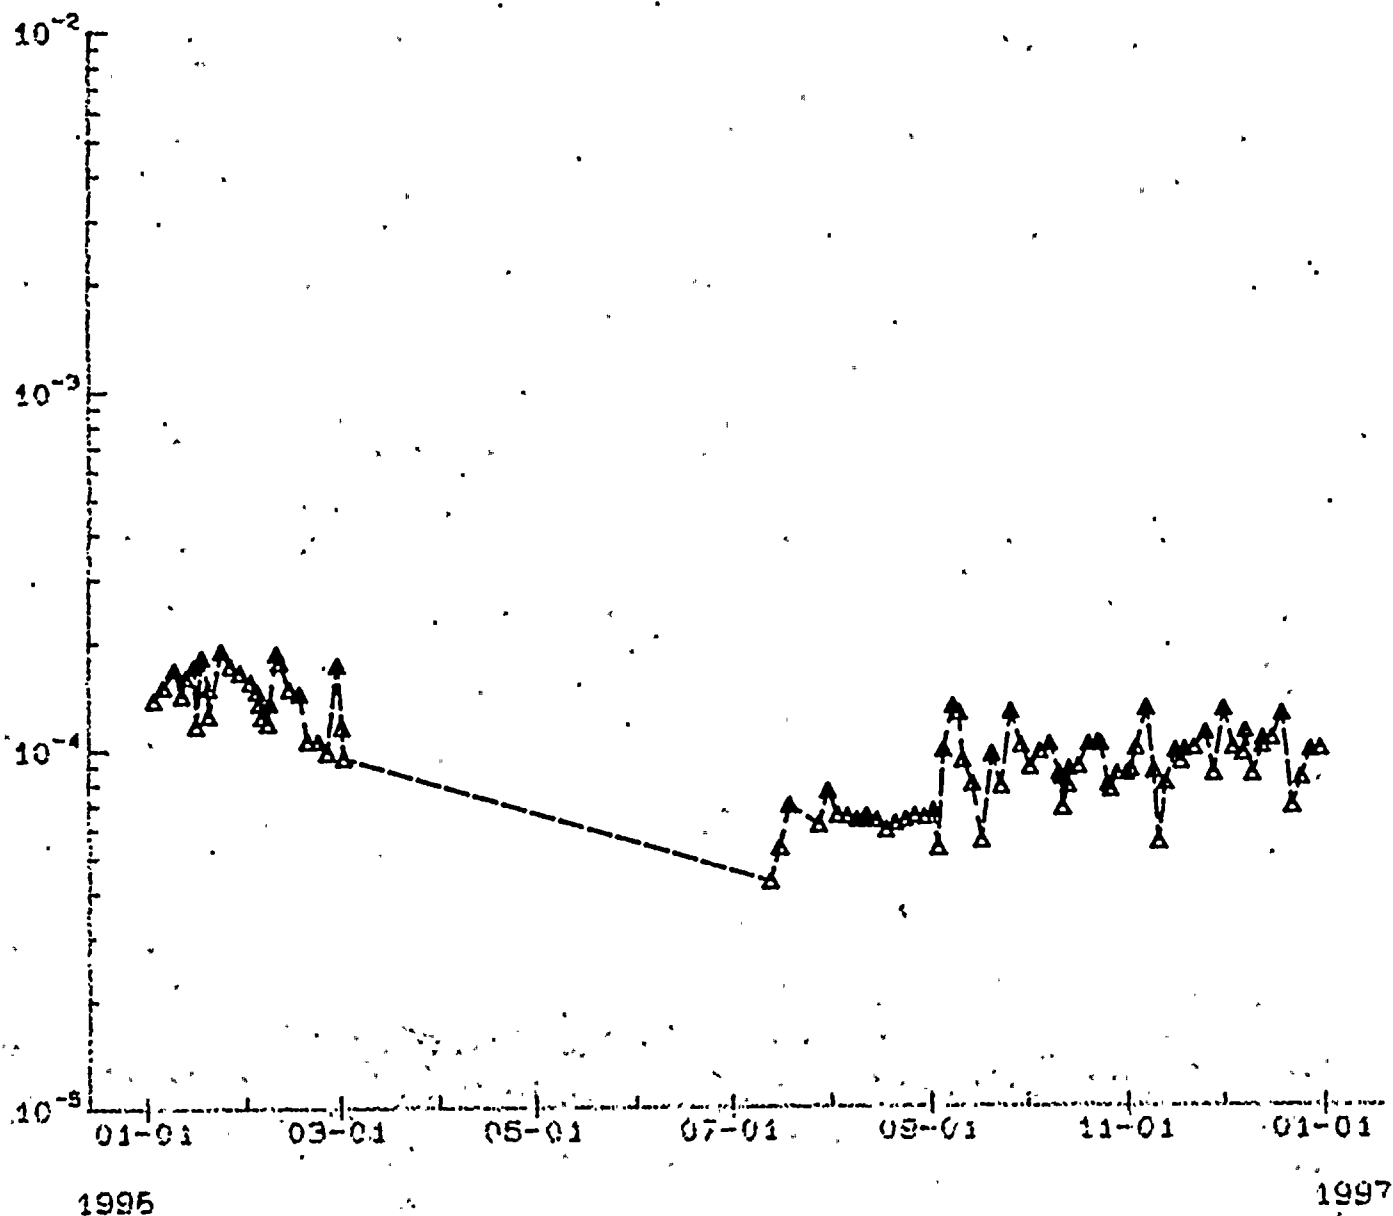
This section contains information pertaining to reactor coolant dose-equivalent iodine. The specific activity of the primary coolant was significantly less than 0.2 microcuries per gram dose-equivalent I-131 and 100/E-Bar microcuries per gram as required by Technical Specification 3.4.5.
