SUBJECT: Forwards Bechtel Power Corp responses to outstanding open items of Class IE dc power sys review. Responses are intended to resolve outstanding concerns of DC Power Sys Review Board. Final resolution of open items will be provided.

Subject: Palo Verde Nuclear Generating Station  
PVNGS Units 1, 2 and 3  
Docket Nos. STN-50-528/529/530

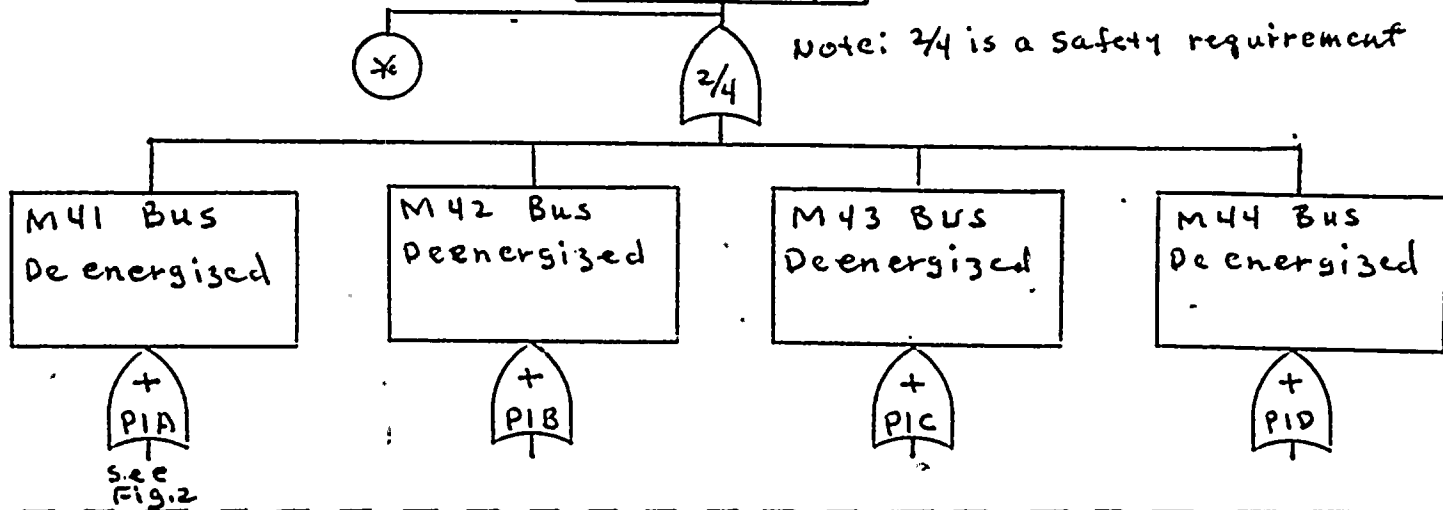
2/4 120V DC  
Control Center  
Buses Deenergized (given  
AC Blackout)

$1.5 \times 10^{-7}$  (Case 1)

In Case 2, events

- Cleared fault correction (U)  $(.457 \times 10^{-6} + 13.149 \times 10^{-6}) \text{ hrs} = 1.09 \times 10^{-4}$
- Spurious breaker trip SBR3A1  $.38 \times 10^{-6}$
- Breaker does not open on fault BR3A1  $(4.28 \times 10^{-8}) 24 \text{ hrs} = 1.02 \times 10^{-6}$

The results indicate that, given the assumptions discussed above, case 2, the air breaker on the battery, is slightly more reliable. Therefore it is recommended that no changes be made to the present system design.

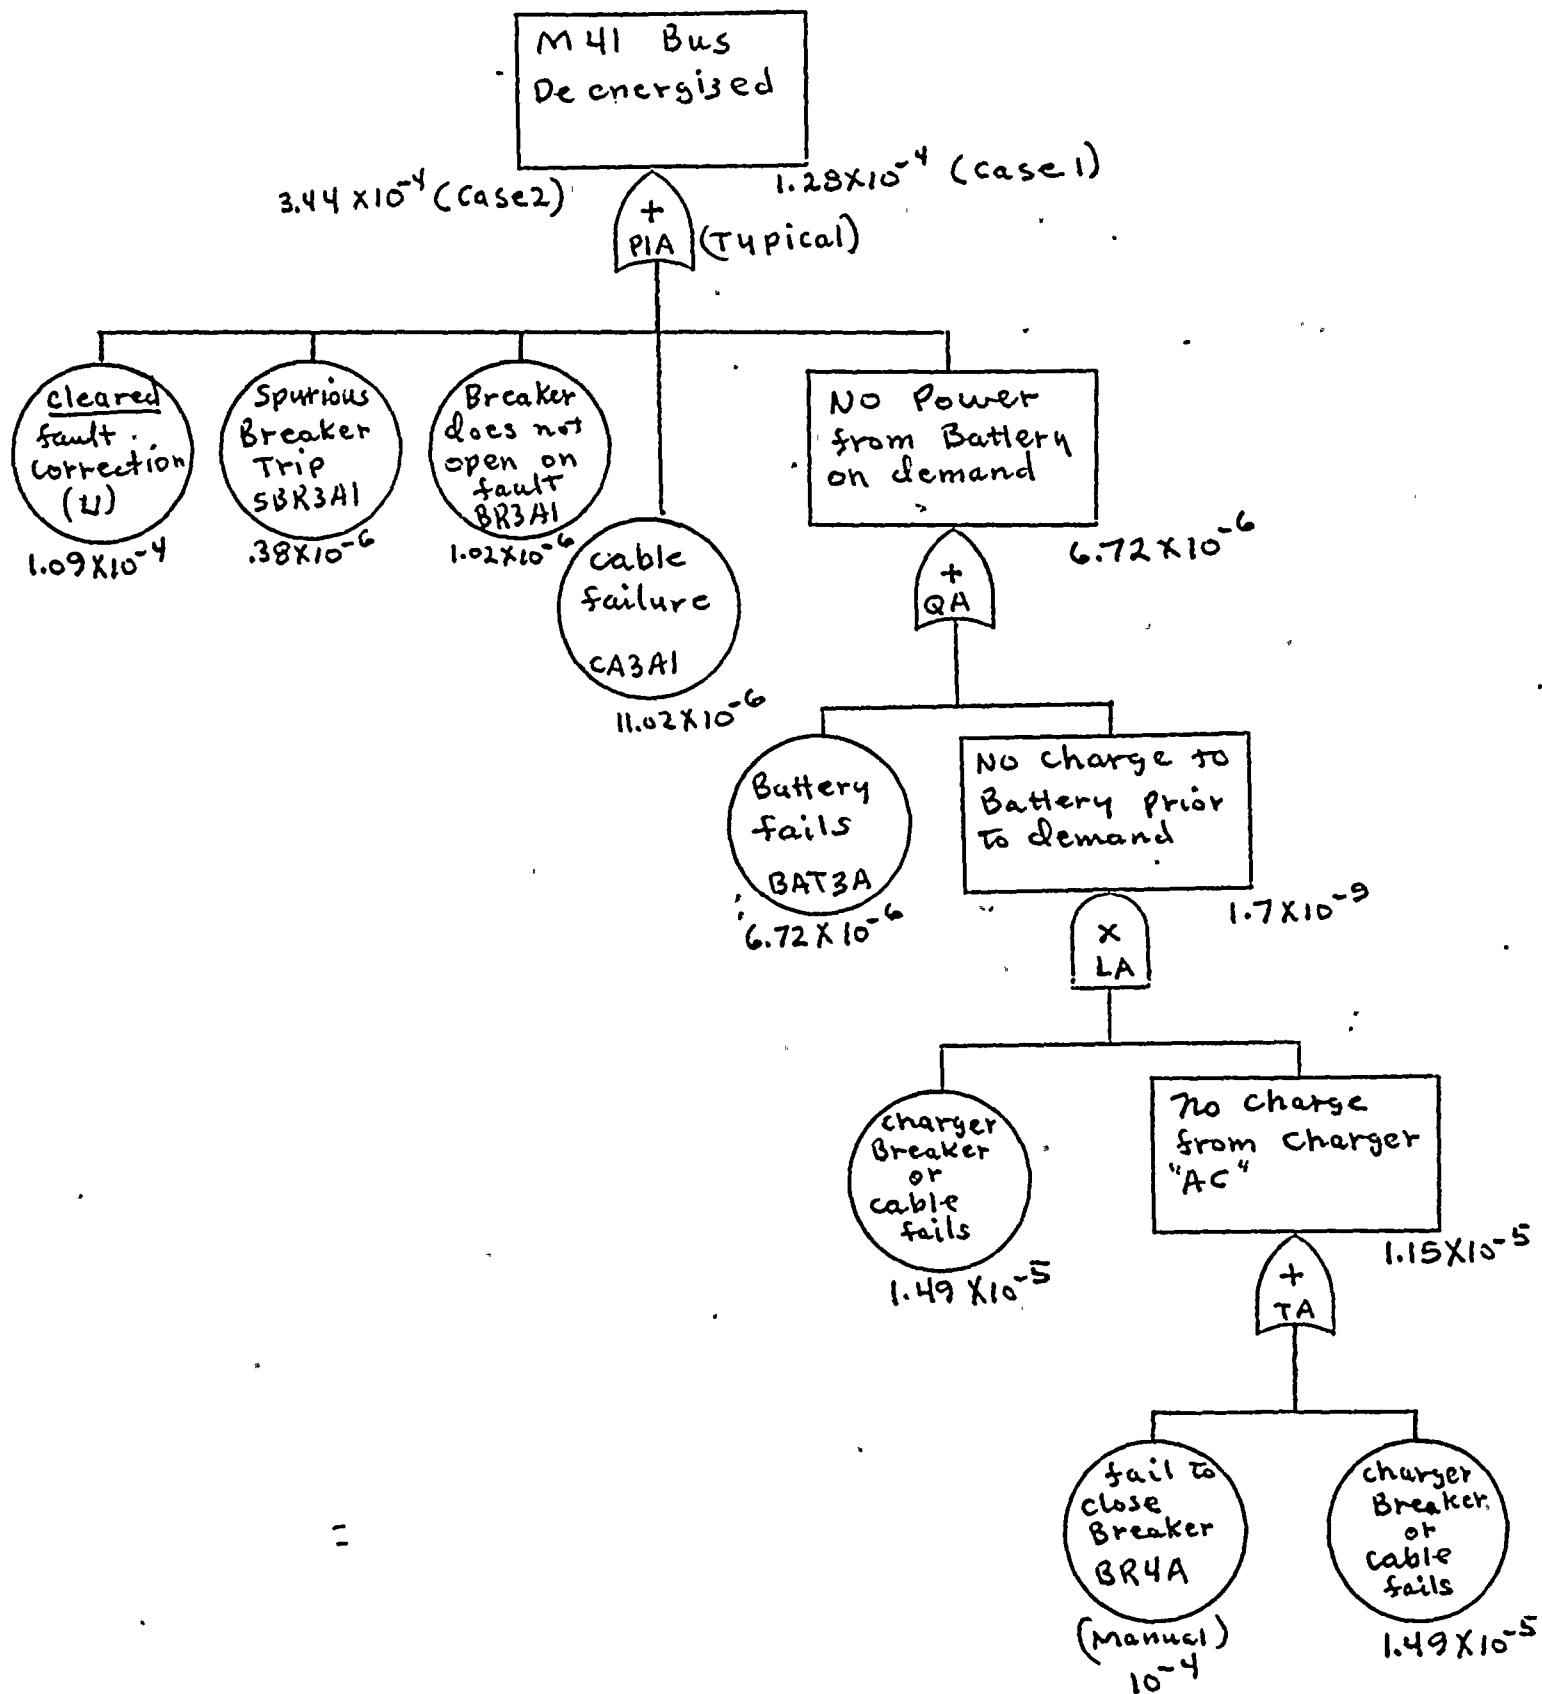
Figure 2 -7-

Note:  $*$  = Common cause spurious Breaker Trip (applies to case 1 only)

$(.38 \times 10^{-6}) (.14) = 5.3 \times 10^{-8}$

$(U) = \text{unavailability} \approx \left[ \begin{array}{l} \text{failure rate} \\ \text{or} \\ \text{fault rate} \\ \text{or} \\ \text{No. of short circuits per unit time} \end{array} \right] \times (\text{repair time})$
