SUBJECT: Interim deficiency rept re inadequate concrete strength
 achieved w/pneumatically placed mortar repairs.Evaluation of
 all repairs will be completed 801201.Final rept will be
 submitted by 801215.

ARIZONA NUCLEAR POWER PROJECT
Post Office Box 21666 Phoenix, Arizona 85036

EVALUATION AND DISPOSITION
OF CONCRETE REPAIRS FOR
DER 79-12

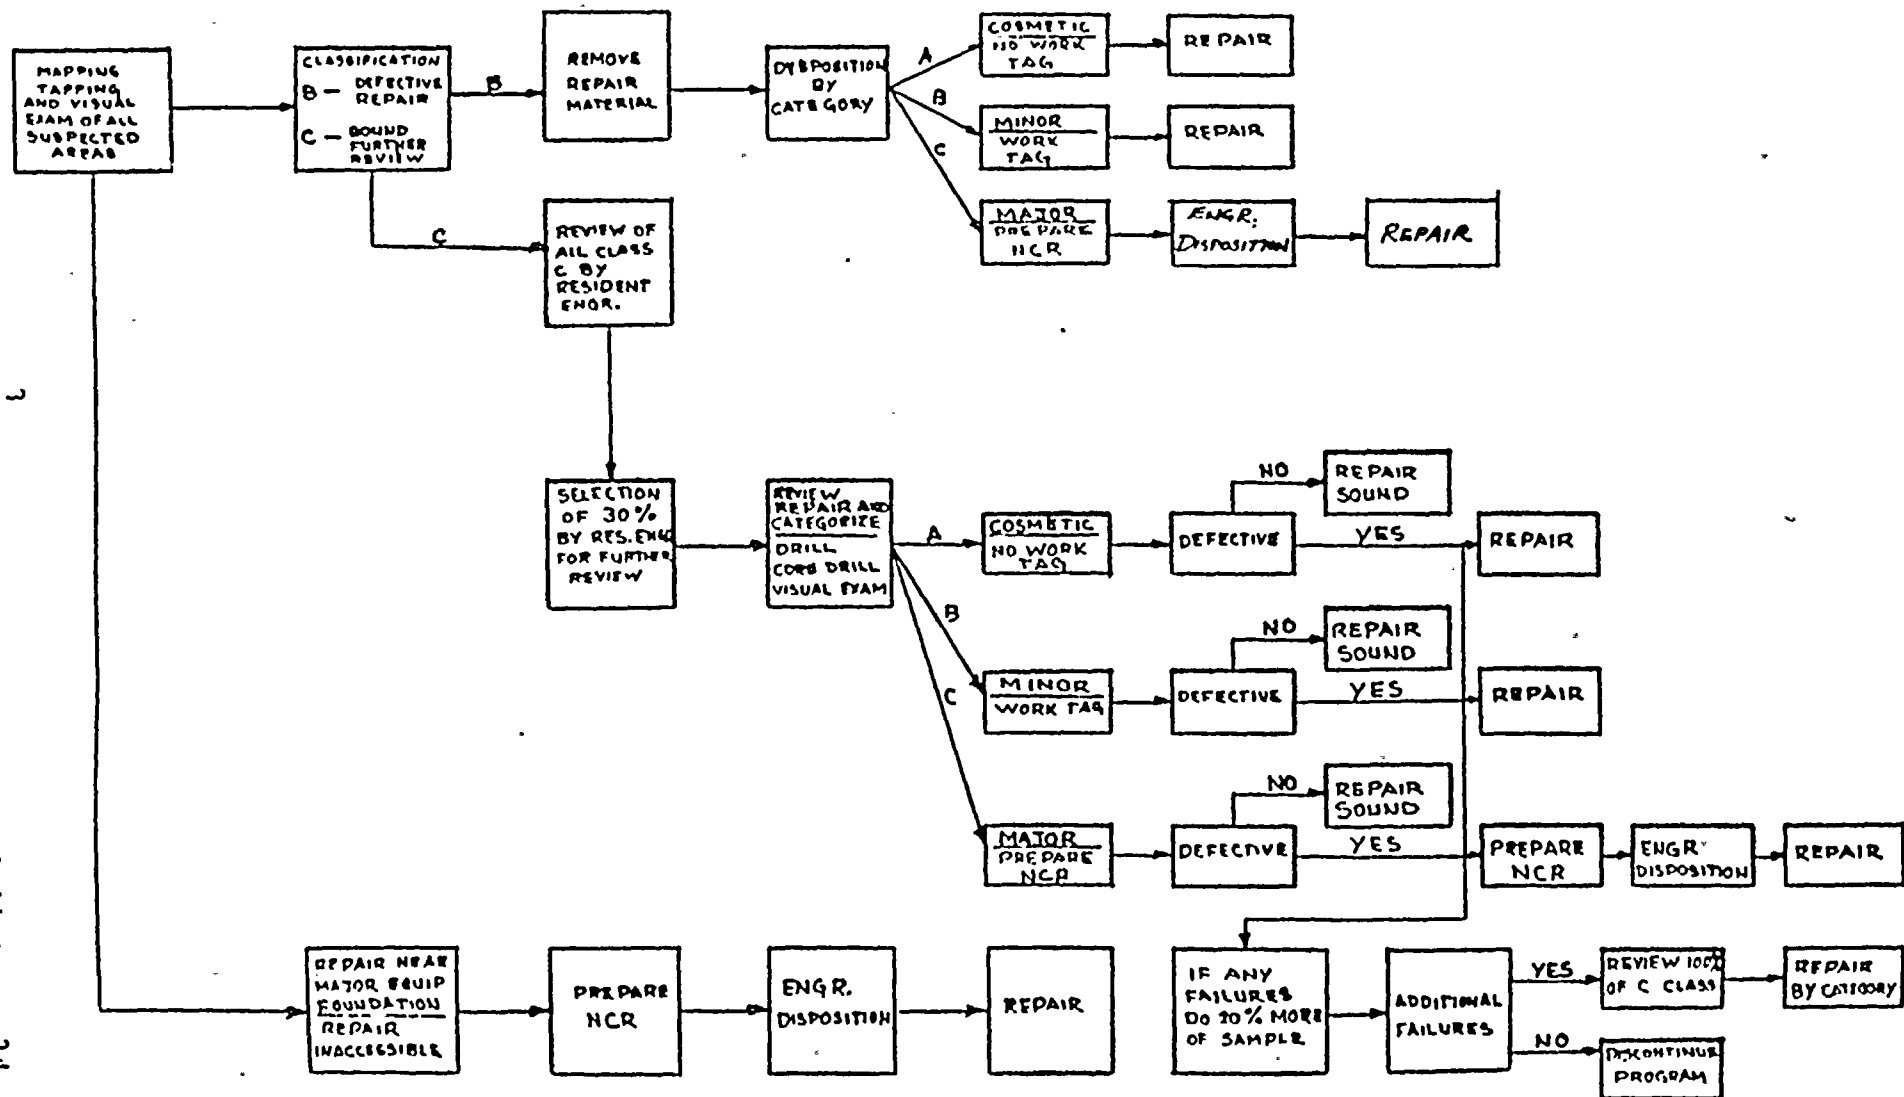
EVALUATION AND DISPOSITION OF
CONCRETE REPAIRS FOR DER 79-12
FLOW DIAGRAM

1. The evaluation and disposition of concrete repairs for DER 79-12 is shown by the flow diagram on page 3. All previously made repairs will be located physically and documented by mapping and sketching. The documentation will be by unit, building, and area.
2. All suspected areas will be identified as acceptable or nonacceptable by tapping or visual examination/engineering judgement. The quality of existing repairs will be investigated using one of the techniques listed below. Those items that are determined to be defective will be dispositioned by category defined in Item 3. Those repairs classified as sound will be reviewed by the Resident Engineer and a sample selected for confirmation of soundness of repair.
