INDIAN POINT 3 HIGH HEAD SAFETY INJECTION PUMP

2003 HHSI Pump Analysis Curves

INDIAN POINT UNIT No. 3

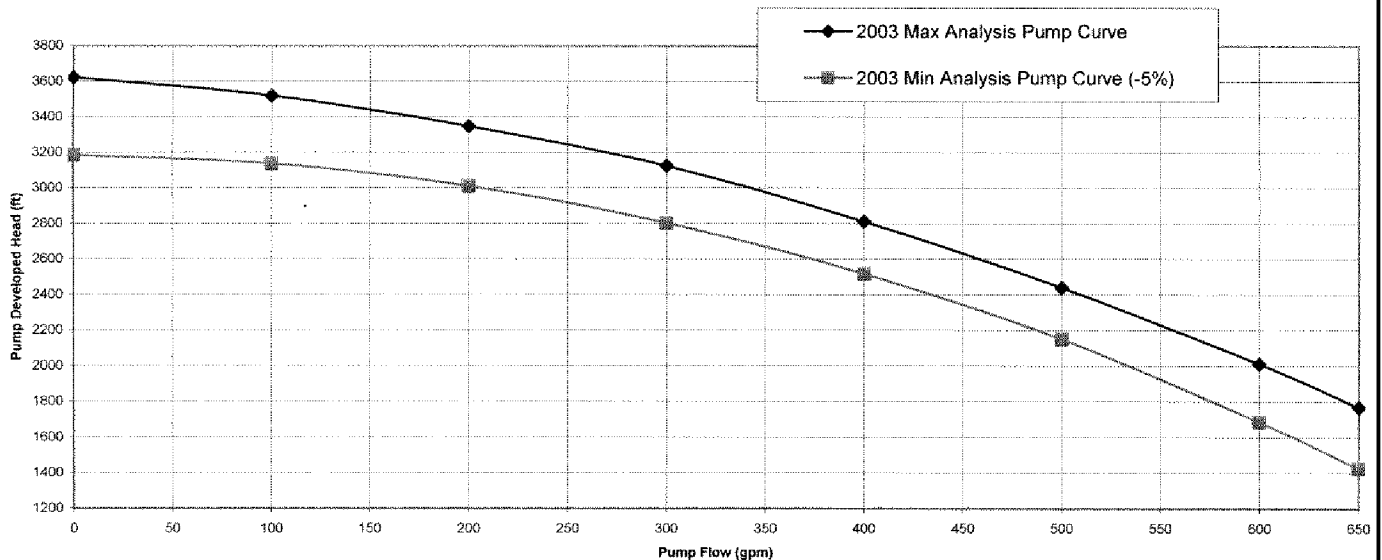
UFSAR FIGURE 6.2-2

NOTE: CURVES SHOWN ARE BASED ON COMPOSITE DATA CONSIDERING VARIATIONS IN THE CERTIFIED PUMP CURVES OR THE AS TESTED PUMP CURVES FOR ALL THREE PUMPS. THE MAXIMUM CURVE IS A COMPOSITE OF THE THREE PUMP CERTIFIED CURVES ENHANCED FROM 1 TO 3 PERCENT AT EACH FLOW POINT. THE MINIMUM CURVE IS BASED ON THE LOWEST CERTIFIED PUMP HEAD DECREASED BY 5% AT EACH FLOW POINT. THE MAXIMUM AND MINIMUM CURVES HAVE BEEN USED IN THE SYSTEM HYDRAULIC FLOW ANALYSIS AND DO NOT INCLUDE MEASUREMENT UNCERTAINTY.

SAFETY INJECTION PUMP PERFORMANCE

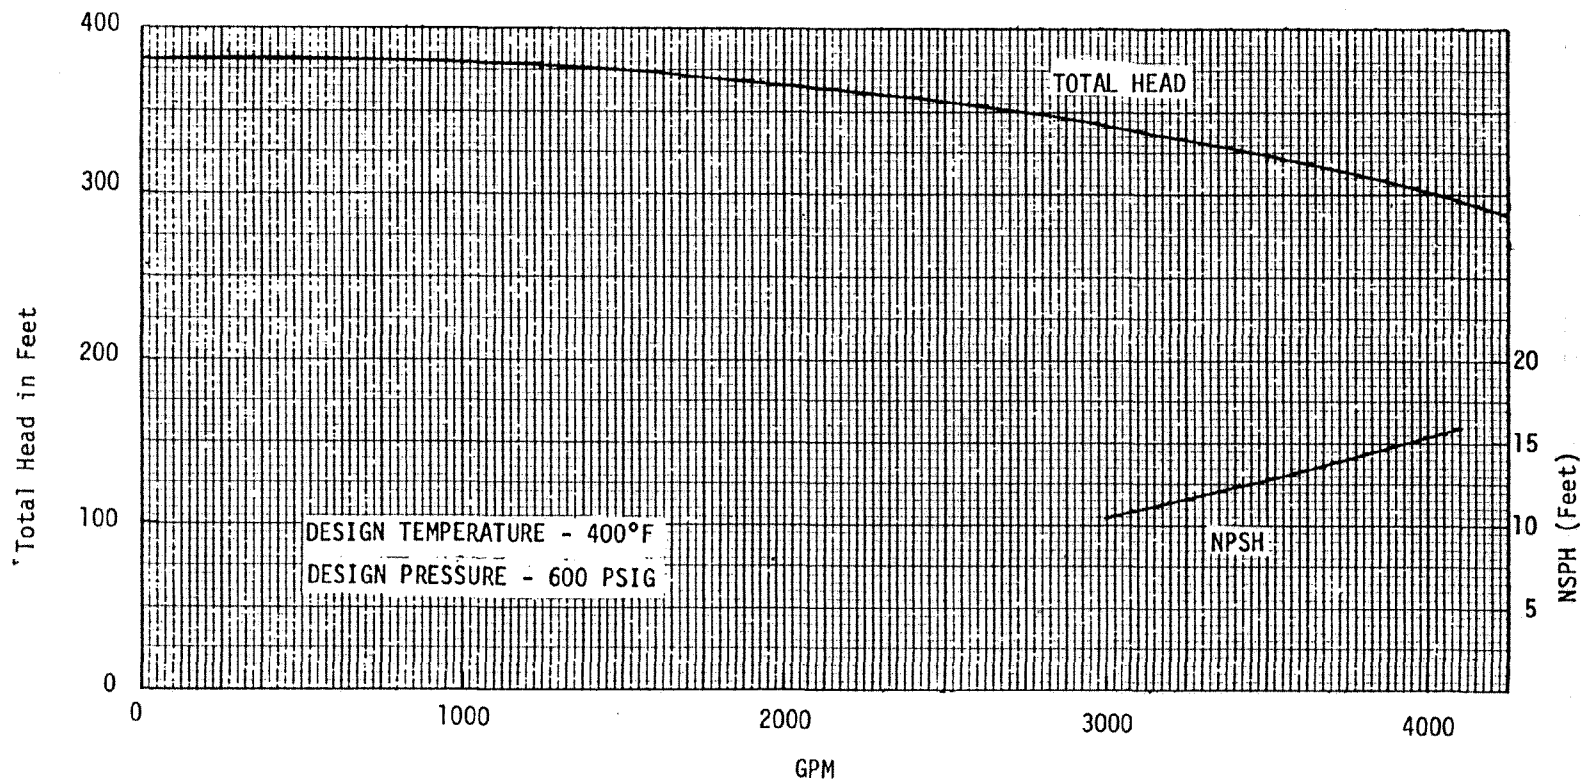
CURVE SHOWN IS CERTIFIED PUMP CURVE REDUCED BY 5% (18 FT.) THIS IS DONE BY TAKING 5% OF THE DEVELOPED HEAD AT THE DESIGN POINT ON THE PUMP CURVE AND APPLYING THIS CORRECTION (18 FT.) UNIFORMLY OVER THE ENTIRE CURVE.

INDIAN POINT 3 FSAR UPDATE
RESIDUAL HEAT
REMOVAL PUMP PERFORMANCE
REV. 1, JULY 1993 FIGURE NO. 6.2-3

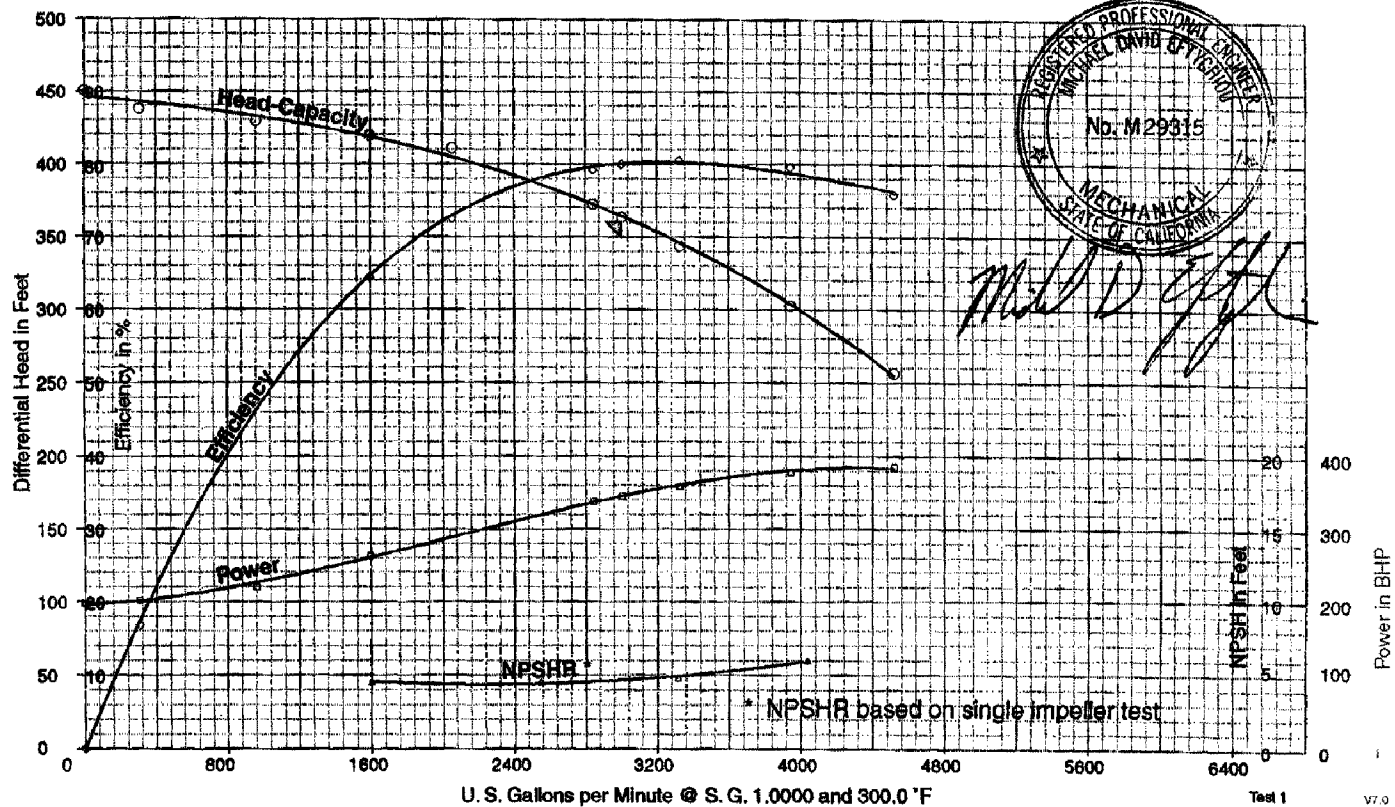
UFSAR FIGURE 6.2-4B REV. NO. 02

RECIRCULATION PUMP
SERIAL #2 - PUMP 32
PERFORMANCE

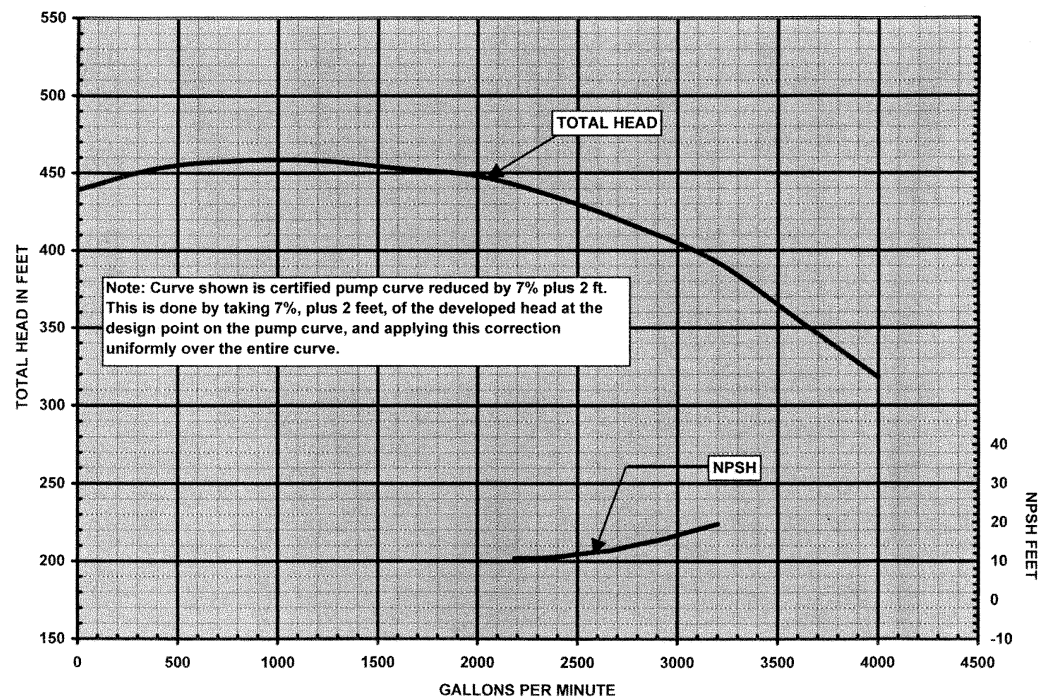
UFSAR FIGURE 6.3-1

CONTAINMENT SPRAY PUMP
PERFORMANCE CHARACTERISTICS

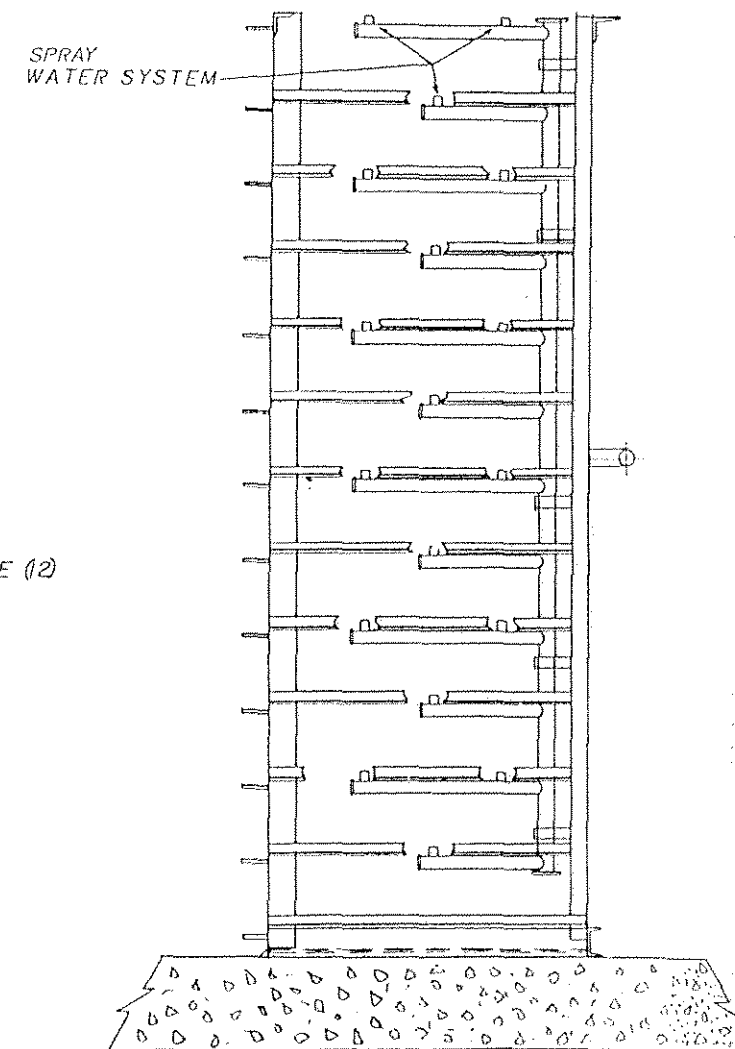
INDIAN POINT 3		FSAR UPDATE	
FIRE DETECTION, SPRAY WATER AND CARBON CELL BANKING ARRANGEMENT			
REV. 0	JULY, 1982	FIGURE NO.	6.4-4

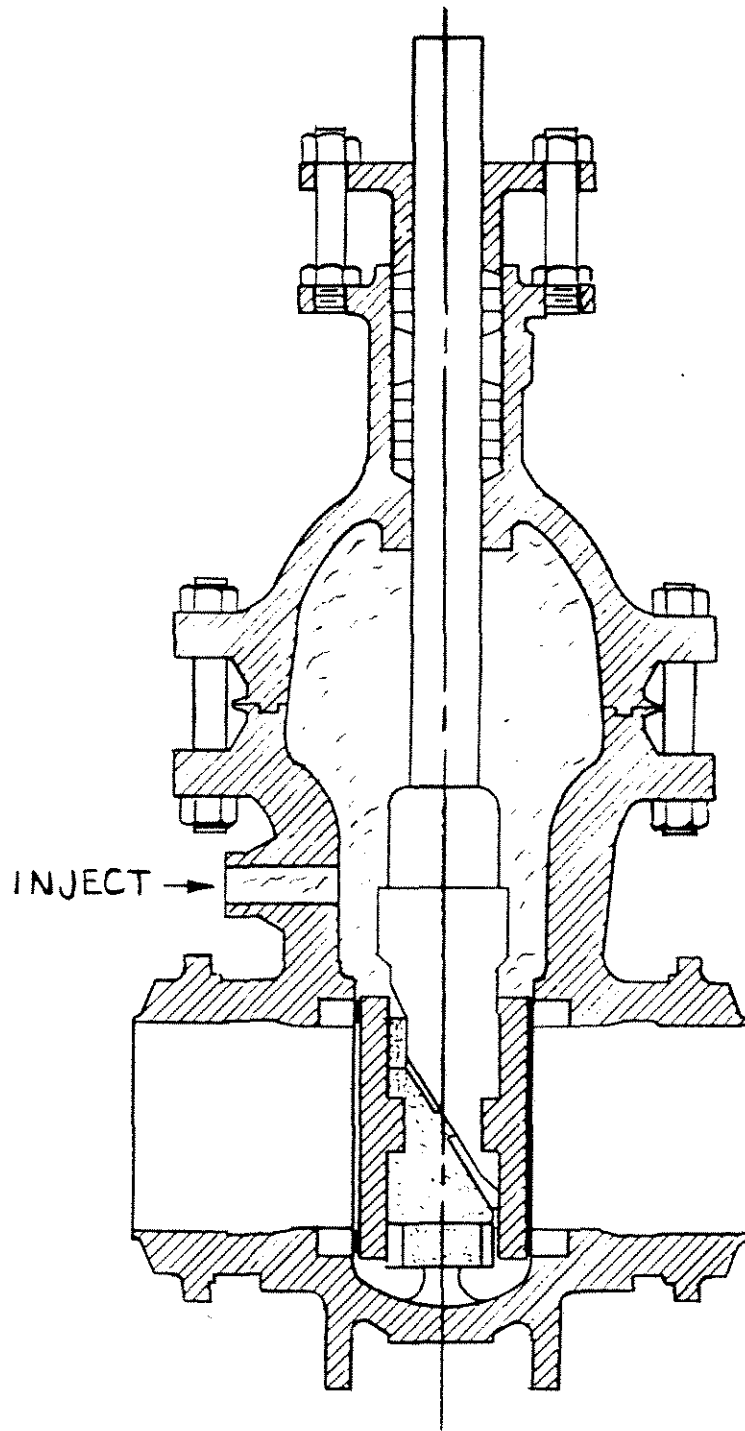
FIGURE NO. 6.5-2

DOUBLE DISK ISOLATION VALVE WITH SEAL WATER
INJECTION

DOUBLE DISK ISOLATION VALVE
WITH SEAL WATER INJECTION

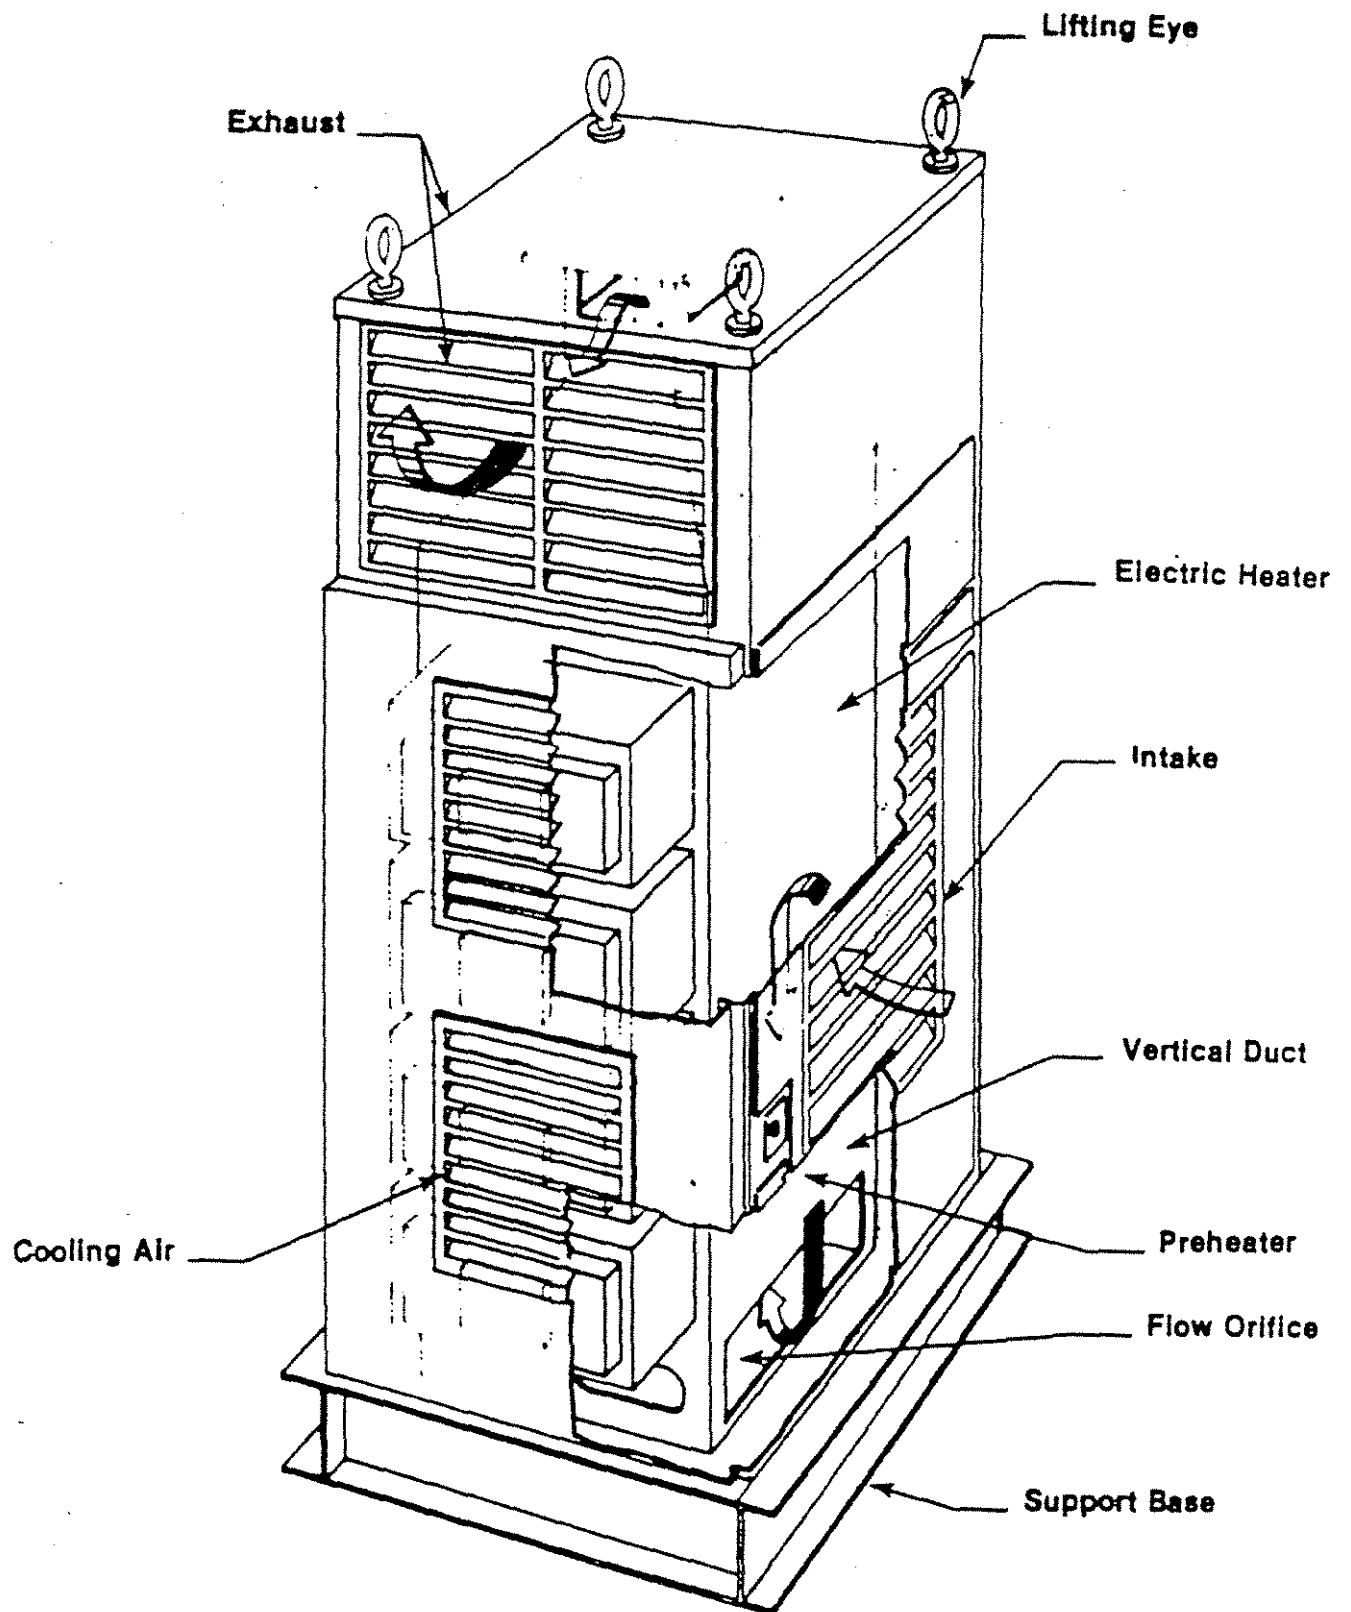
INDIAN POINT 3		FSAR UPDATE	
MODEL B ELECTRIC HYDROGEN RECOMBINER			
REV. 1, JULY 1993		FIGURE NO. 6.8-1

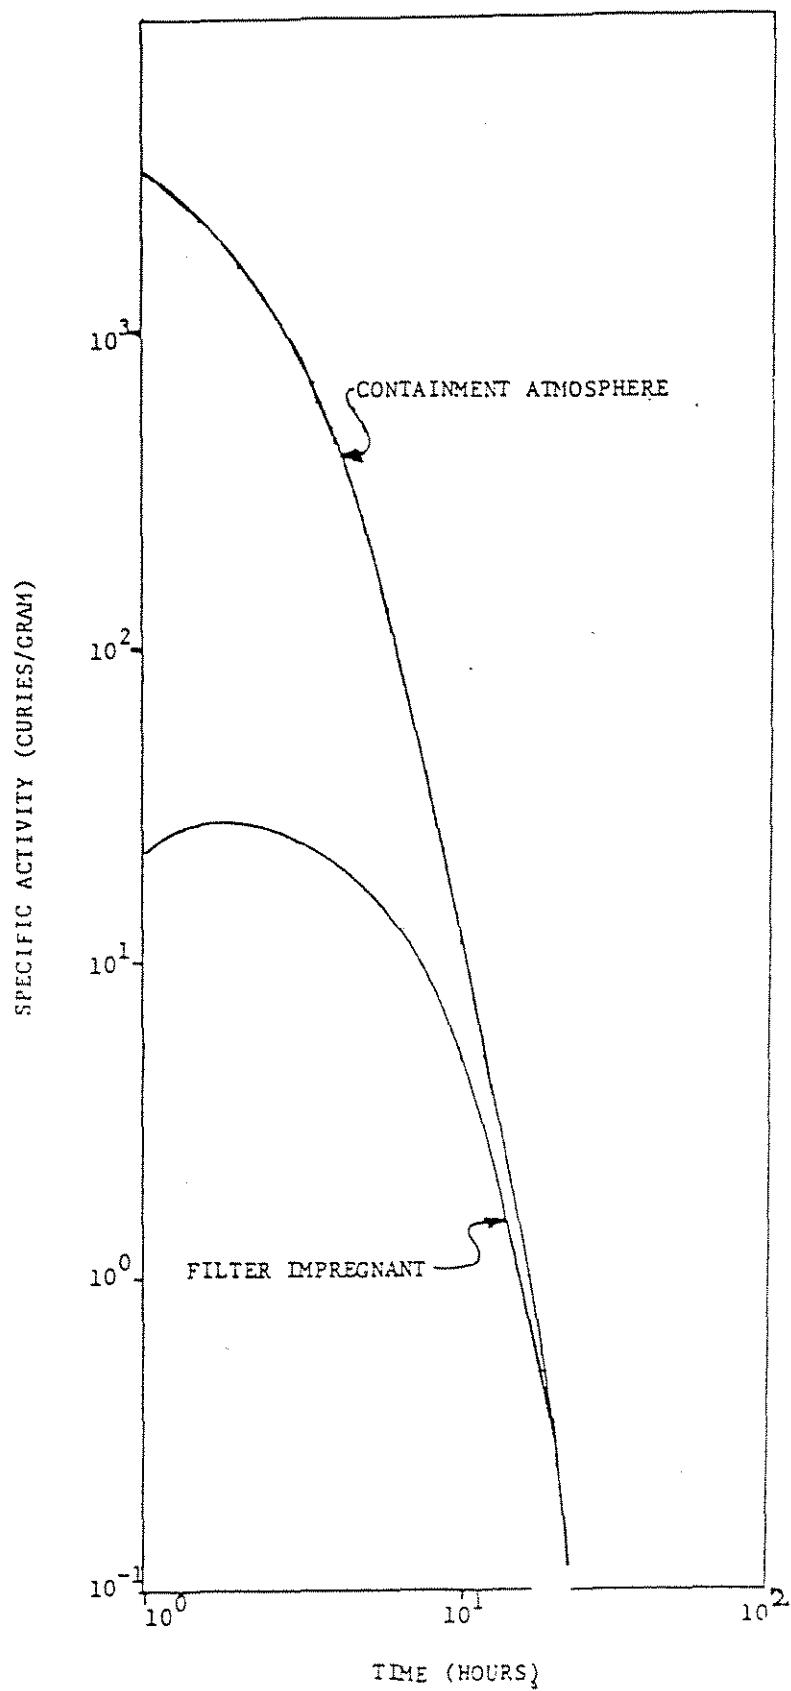
INDIAN POINT 3		FSAR UPDATE
SPECIFIC ACTIVITY OF I-132 - 70% FILTER		
REV. 0	JULY, 1982	FIGURE NO. 6C-2

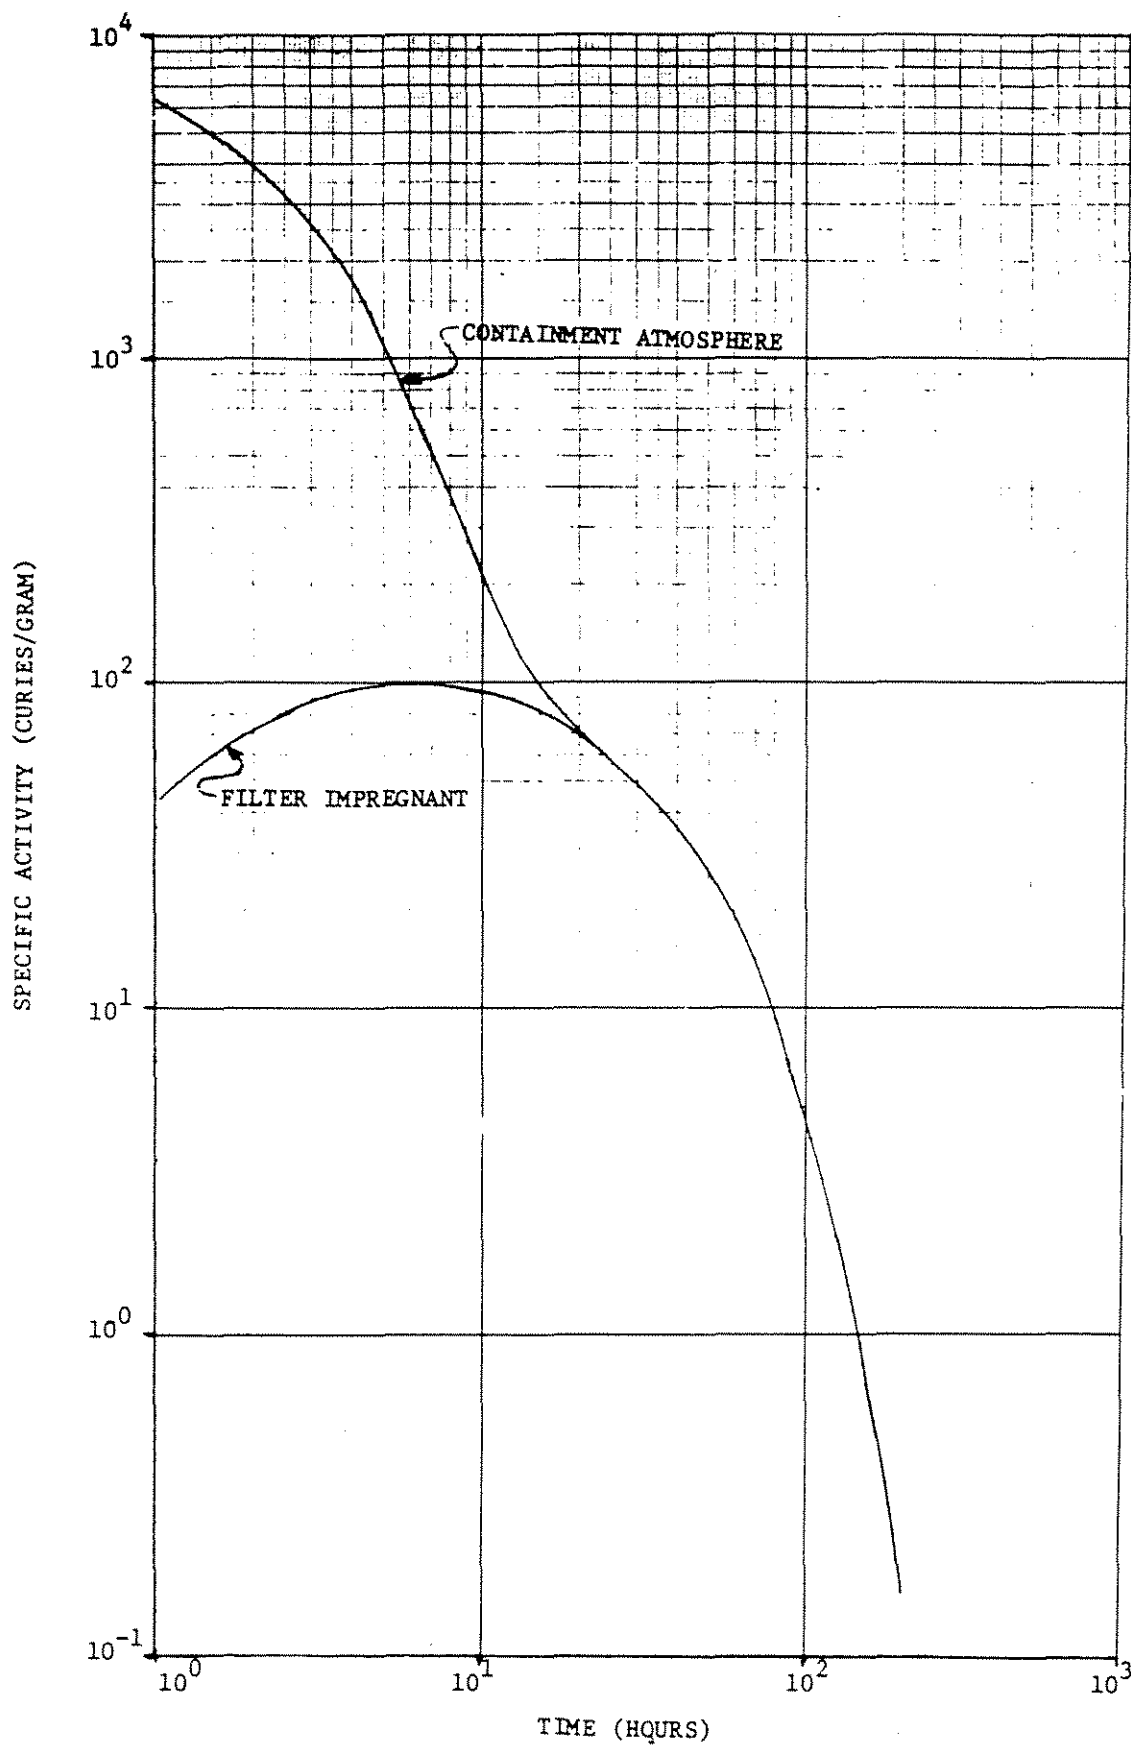
6C-3

SPECIFIC ACTIVITY OF I-133 - 70% FILTER

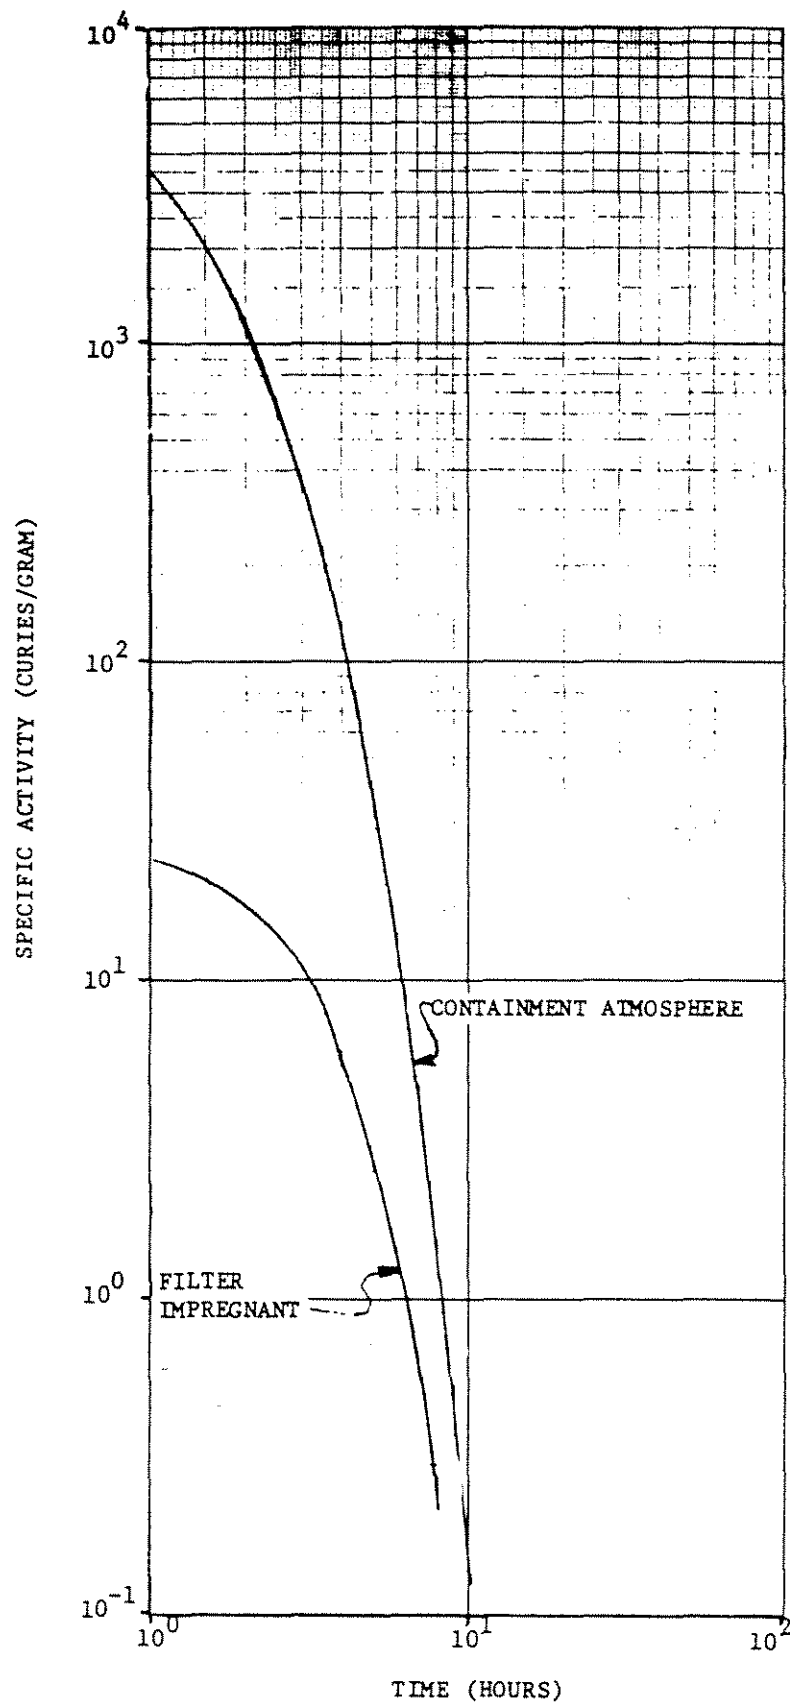
INDIAN POINT 3		FSAR UPDATE	
SPECIFIC ACTIVITY OF I-134 - 70% FILTER			
REV. 0	JULY, 1982	FIGURE NO.	6C-4

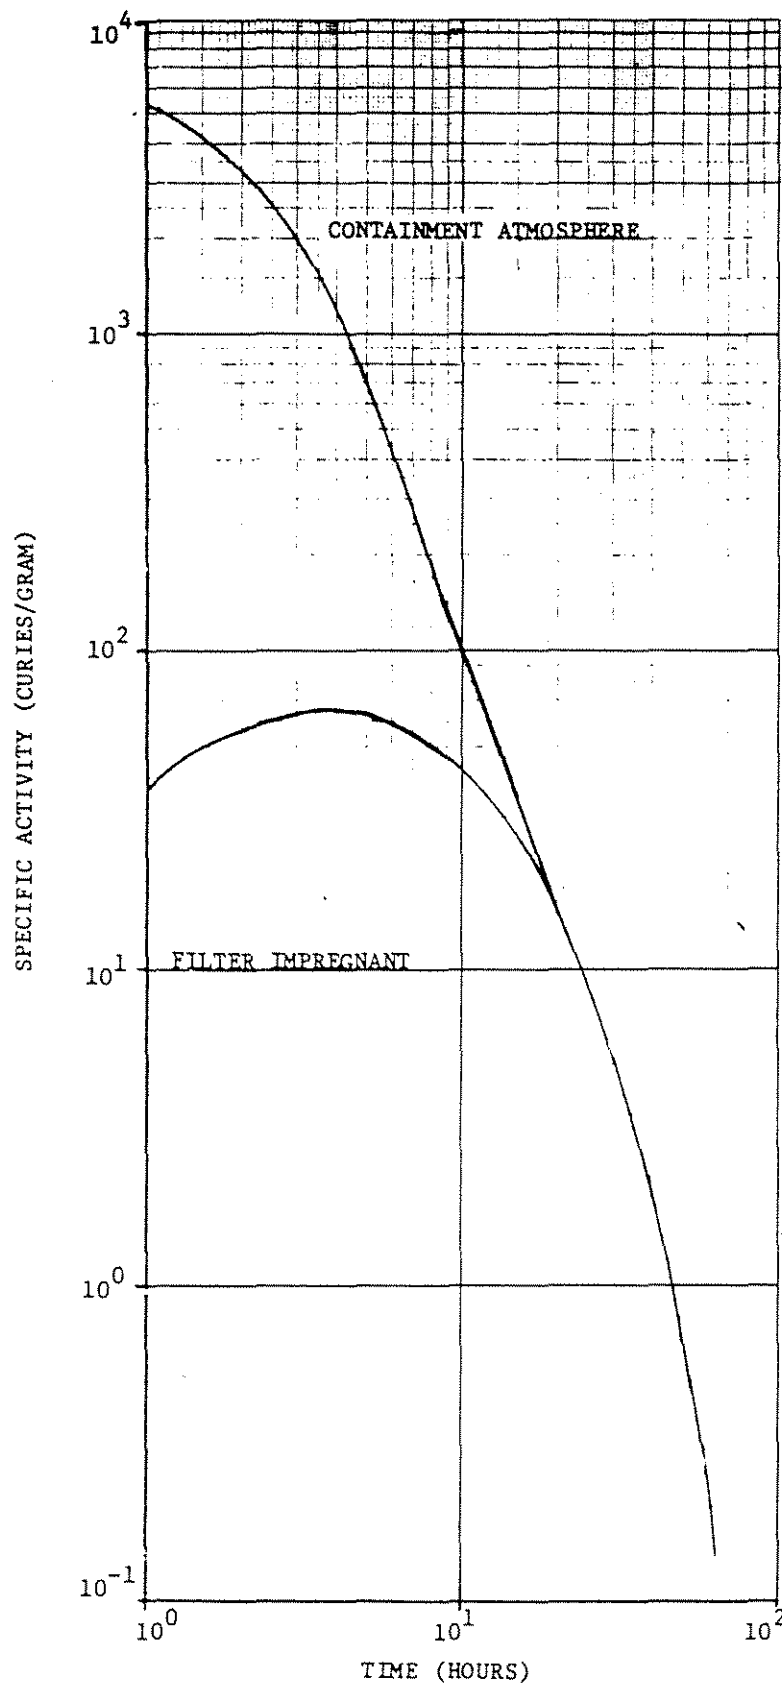
INDIAN POINT 3		FSAR UPDATE	
SPECIFIC ACTIVITY OF I-135 - 70% FILTER			
REV. 0	JULY, 1982	FIGURE NO.	6C-5

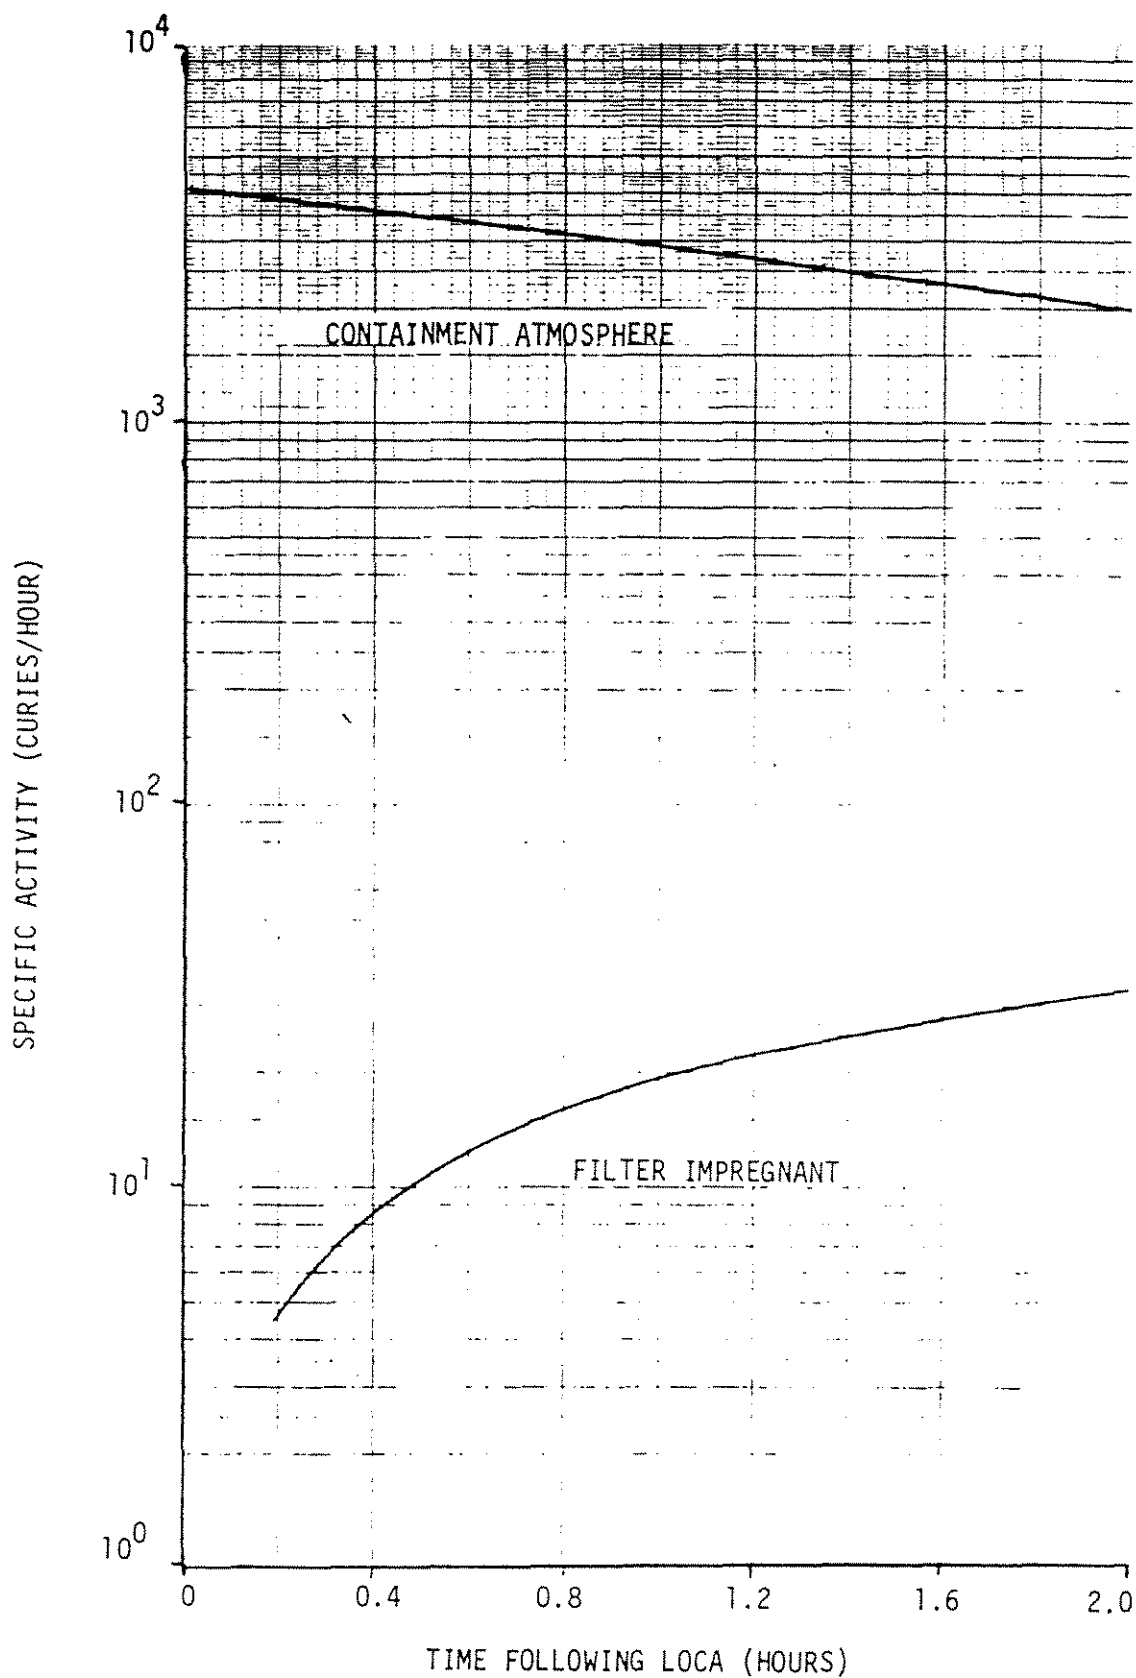
INDIAN POINT 3		FSAR UPDATE
SPECIFIC ACTIVITY OF I-131 - 70% FILTER		
REV. 0	JULY, 1982	FIGURE NO. 6C-6

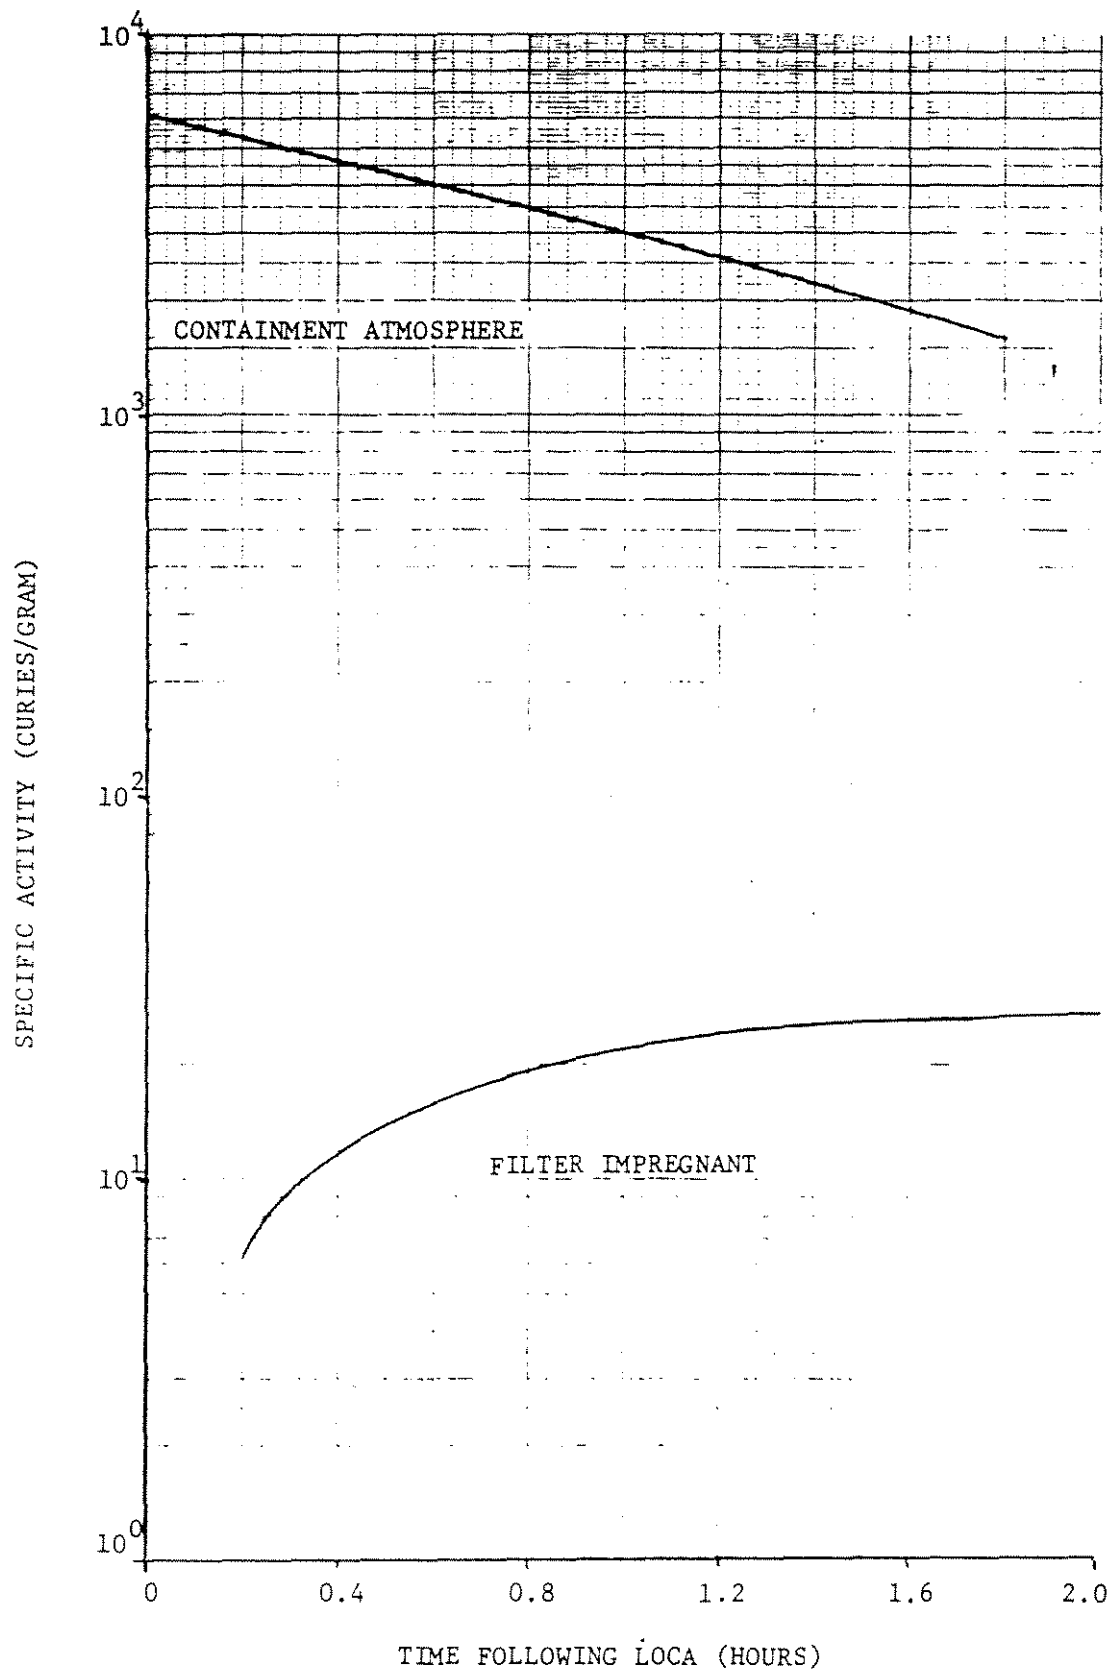
INDIAN POINT 3		FSAR UPDATE	
SPECIFIC ACTIVITY OF I-132 — 70% FILTER			
REV. 0	JULY, 1982	FIGURE NO. 6C-7

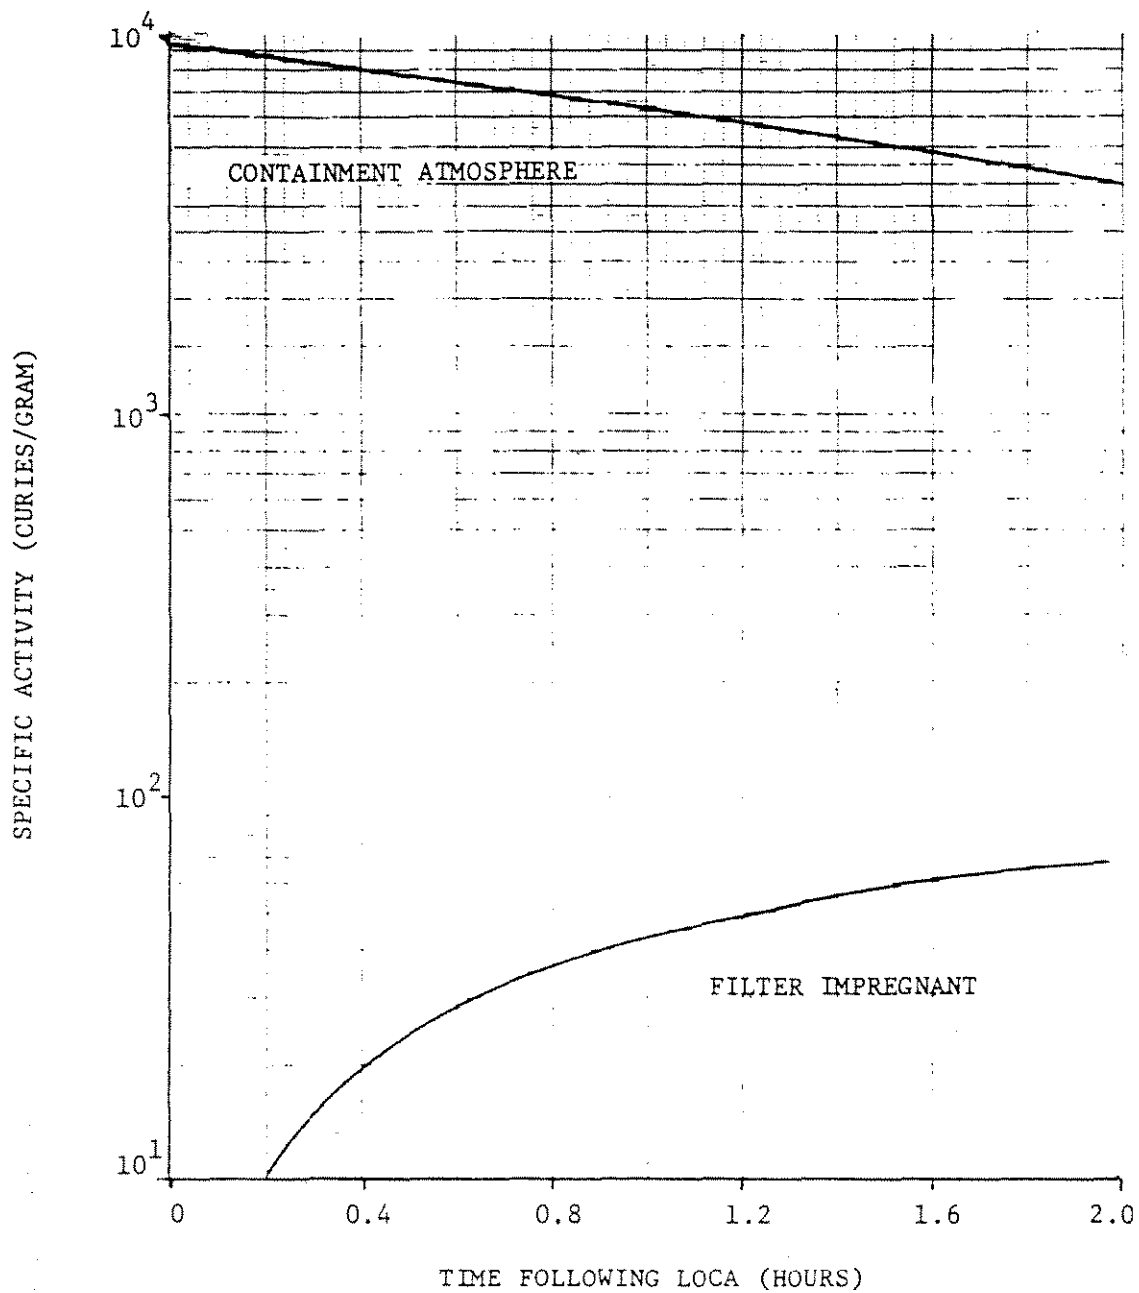
INDIAN POINT 3		FSAR UPDATE
SPECIFIC ACTIVITY OF I-133 - 70% FILTER		
REV. 0	JULY, 1982	FIGURE NO. 6C-8

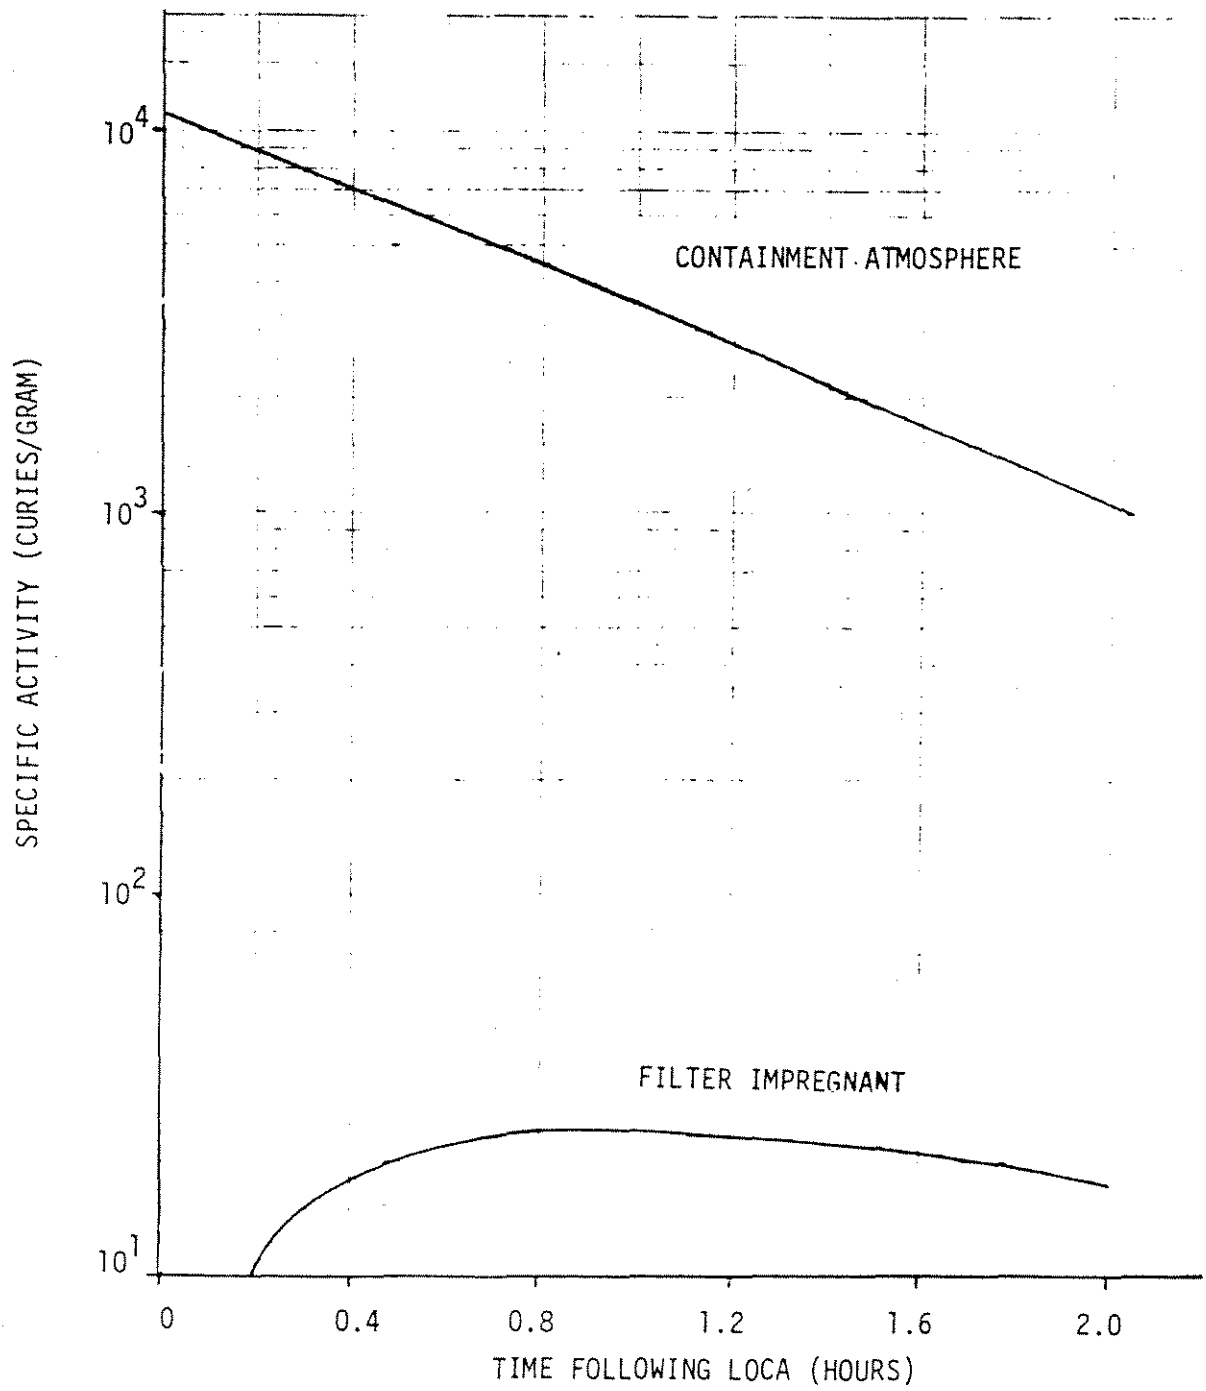
INDIAN POINT 3		FSAR UPDATE
SPECIFIC ACTIVITY OF I-134 - 70% FILTER		
REV. 0	JULY, 1982	FIGURE NO. 6C-9

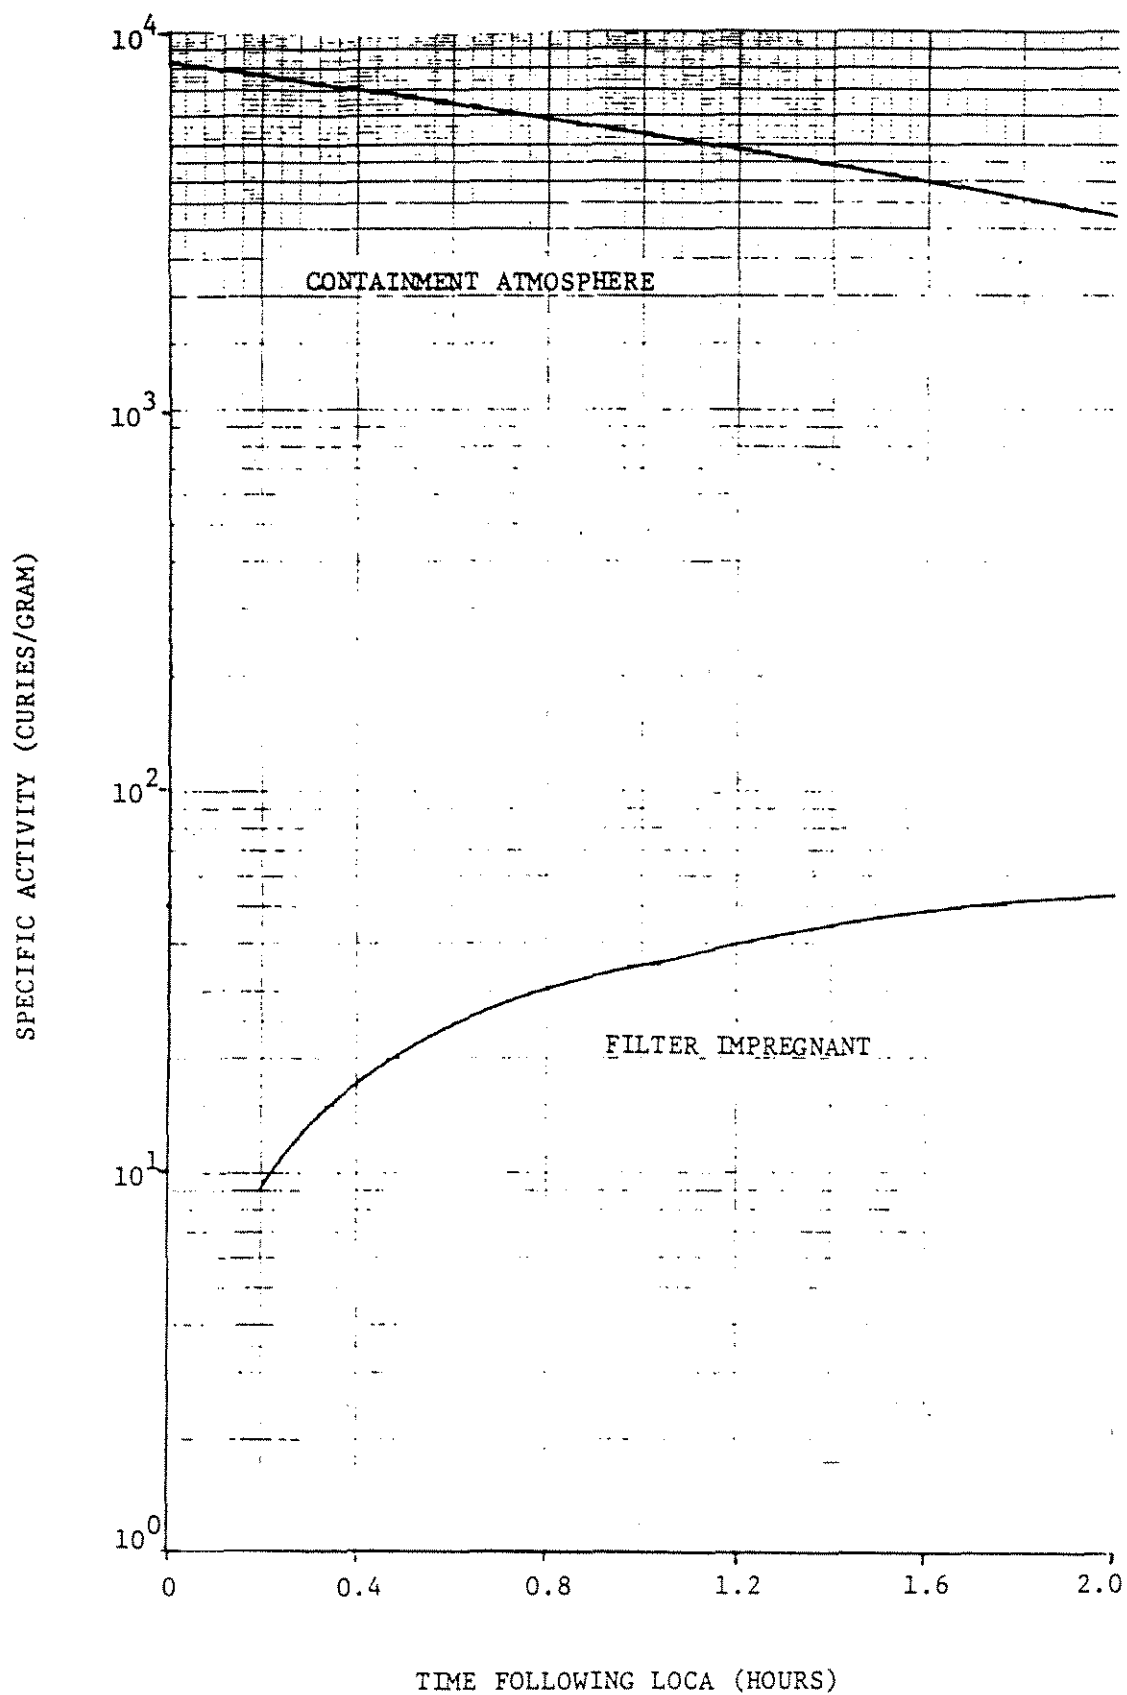
FIGURE NO. 6C-10

SPECIFIC ACTIVITY OF I-135 - 70% FILTER
