INDIAN POINT 3 HIGH HEAD SAFETY INJECTION PUMP

2003 HHSI Pump Analysis Curves

INDIAN POINT UNIT No. 3

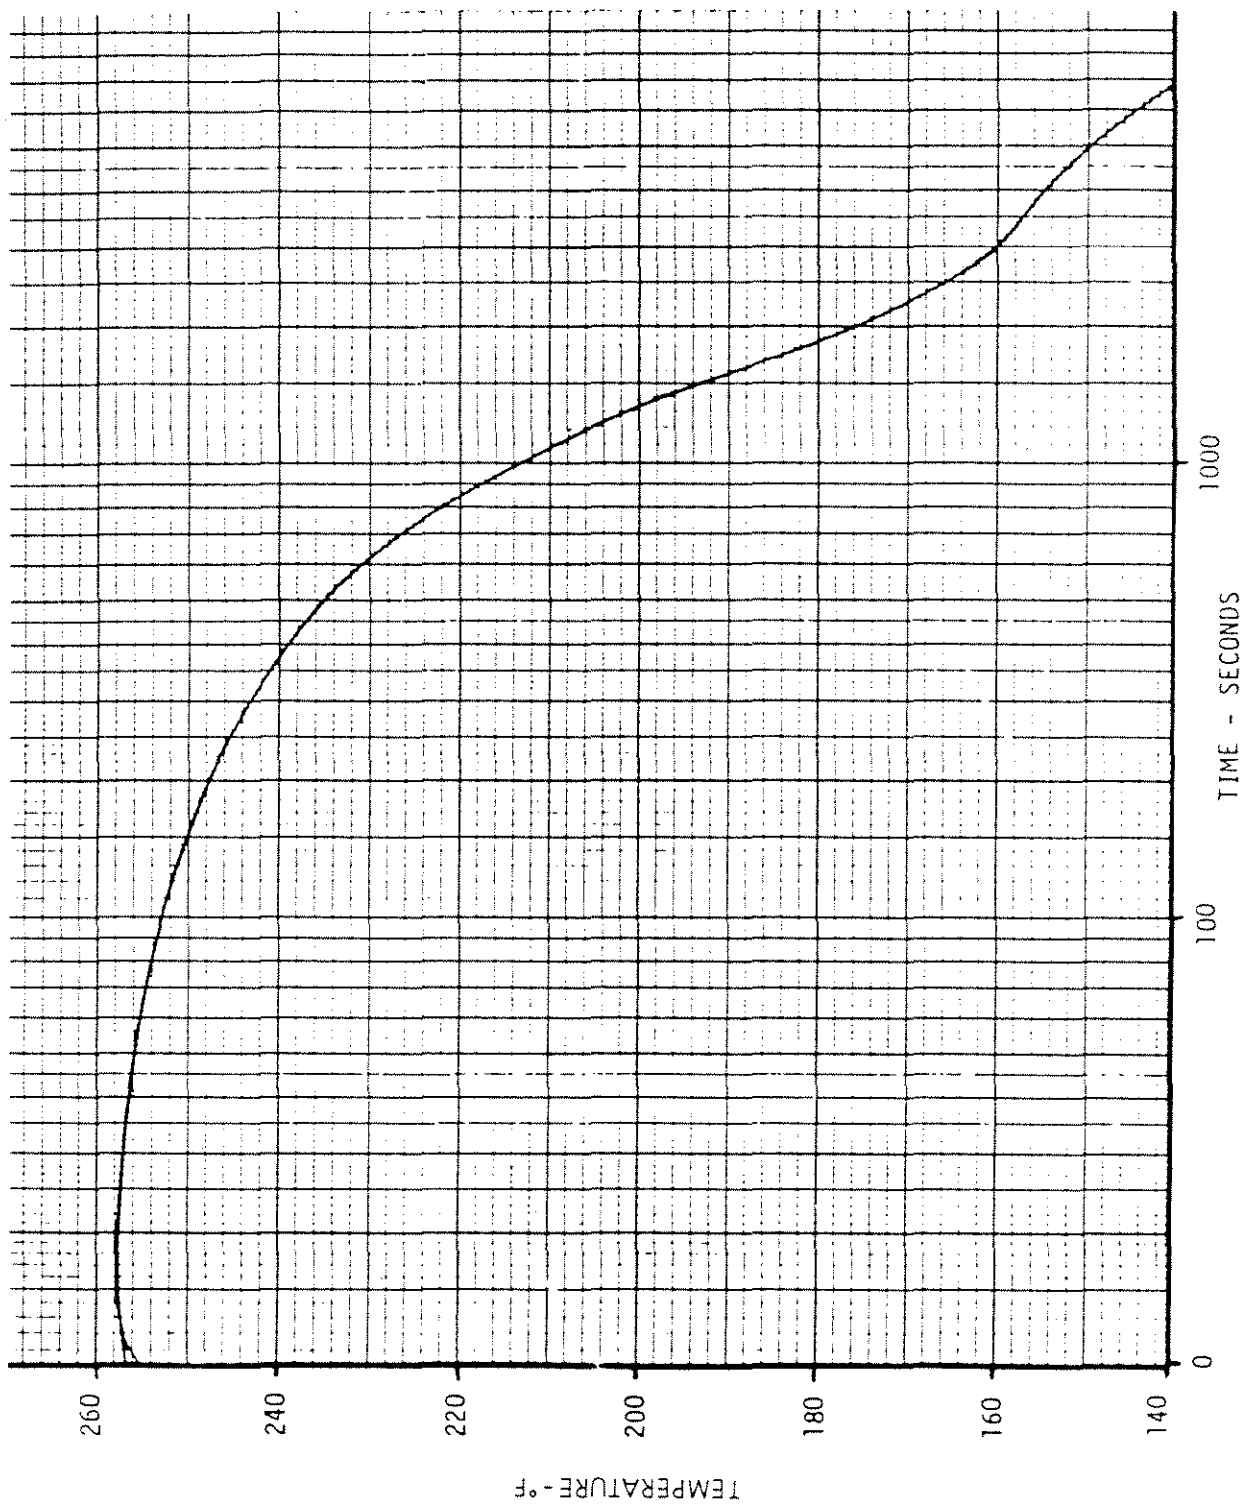
FIGURE NO 6D-1

CONTAINMENT ATMOSPHERE TEMPERATURE
DESIGN BASES SAFETY INJECTION

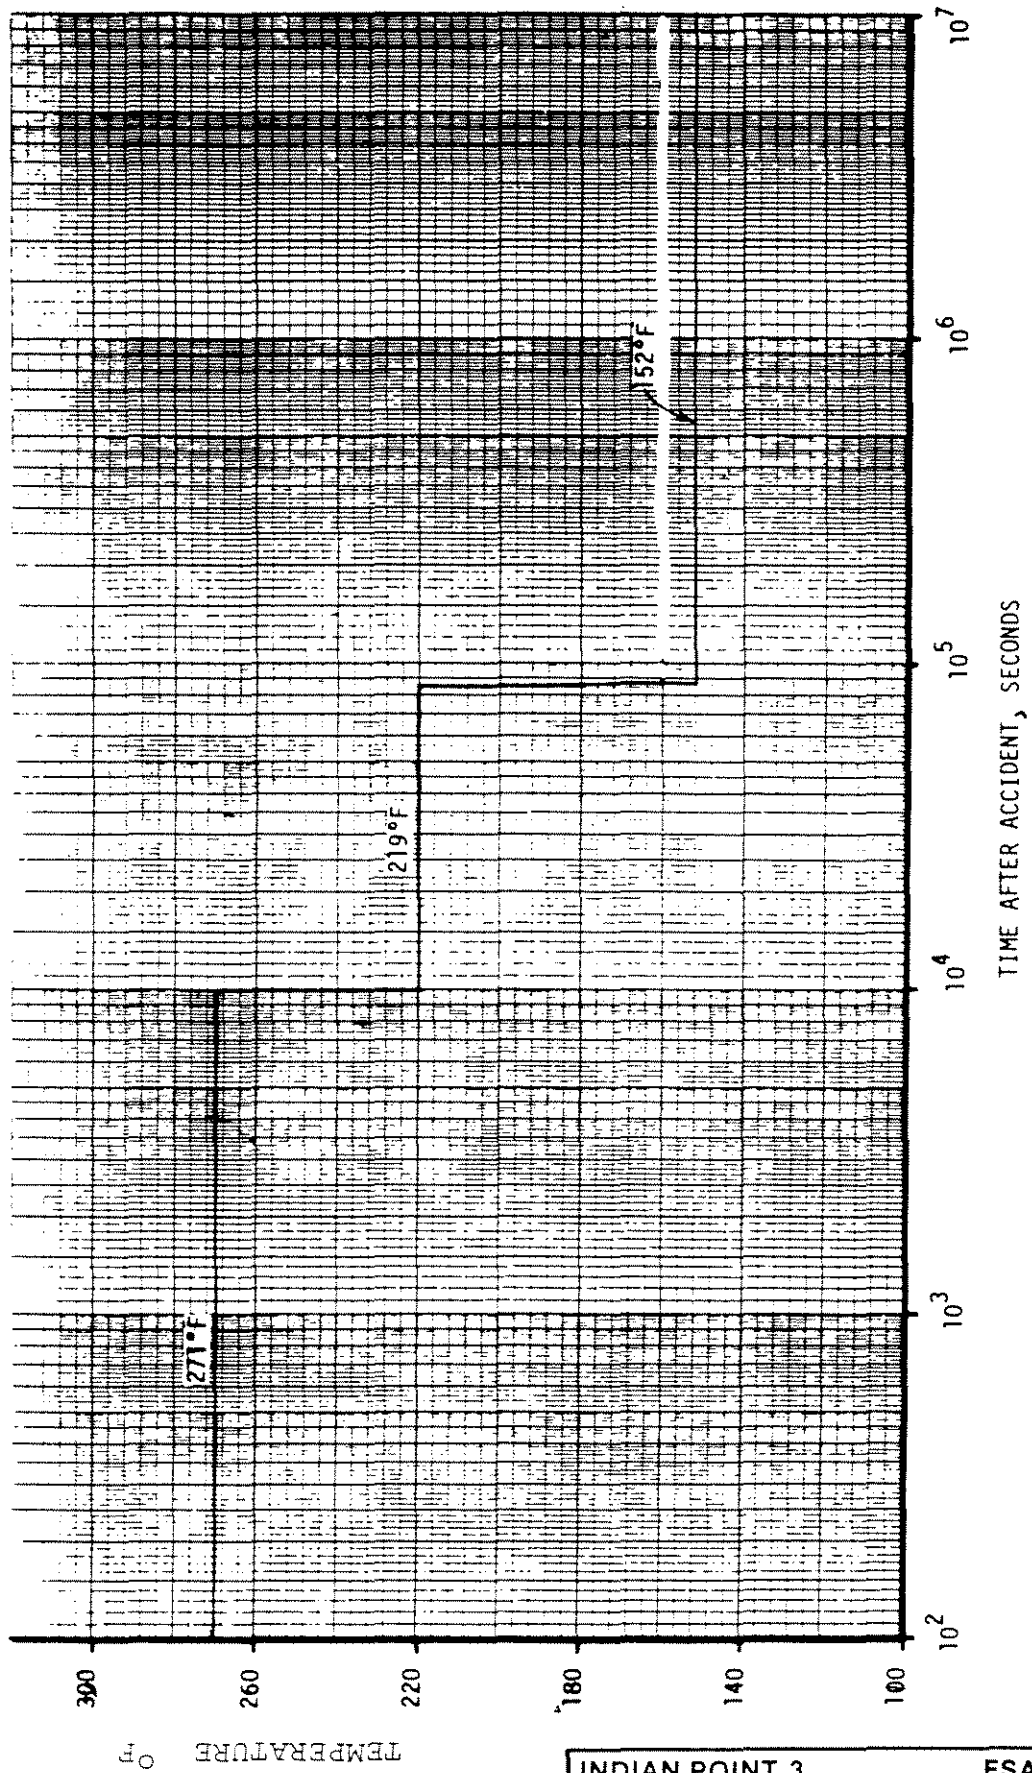
INDIAN POINT 3		FSAR UPDATE	
POST-ACCIDENT CONTAINMENT MATERIALS DESIGN CONDITIONS			
REV 0	JULY, 1982	FIGURE NO	6D-2

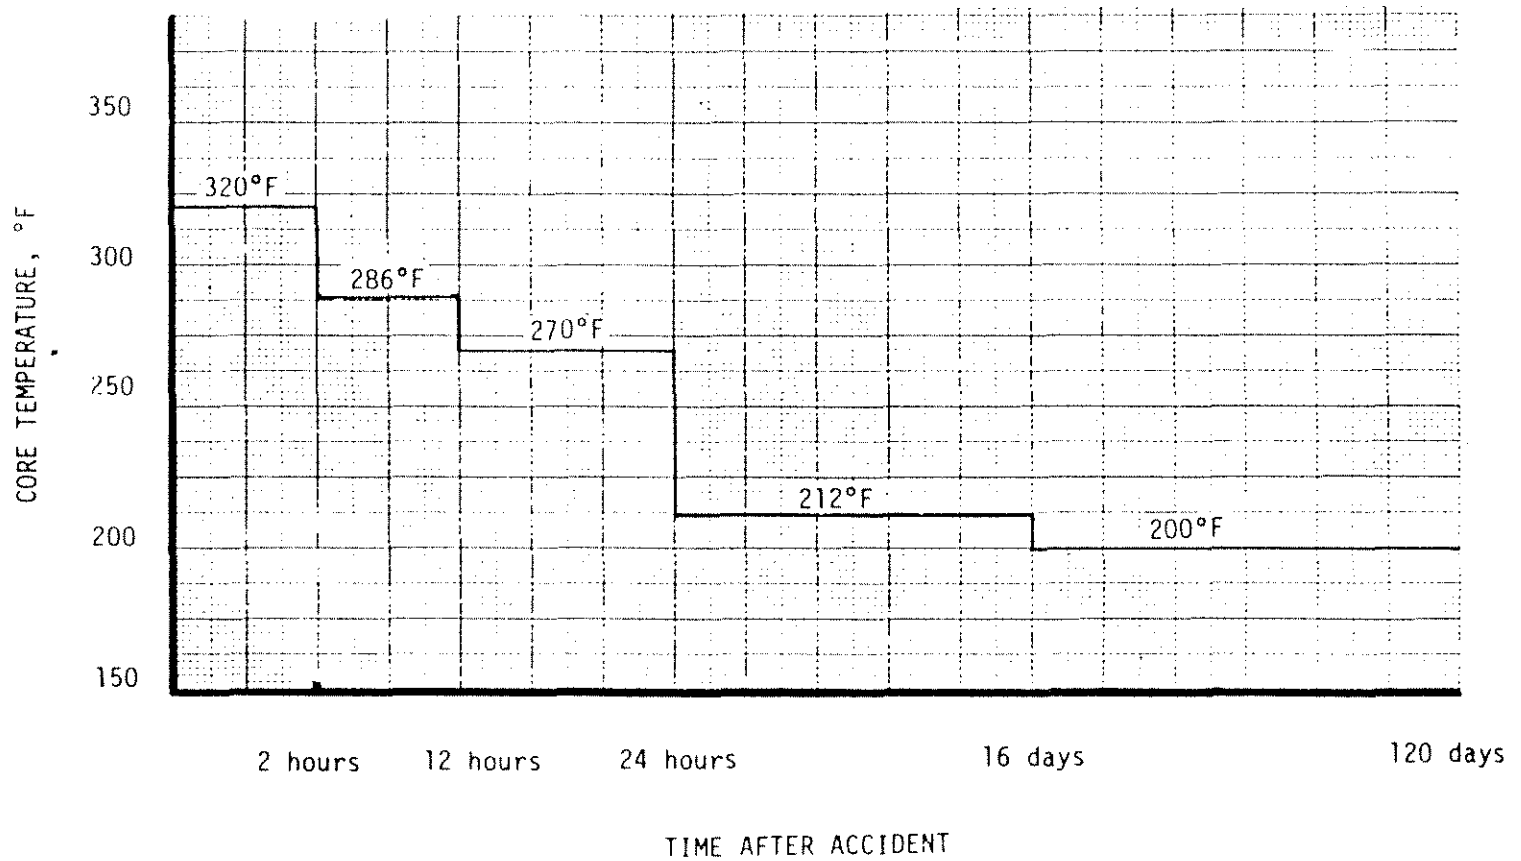
INDIAN POINT 3	FSAR UPDATE
POST-ACCIDENT CORE MATERIALS DESIGN CONDITIONS	
REV. 0	FIGURE NO. 6D-3
JULY, 1982

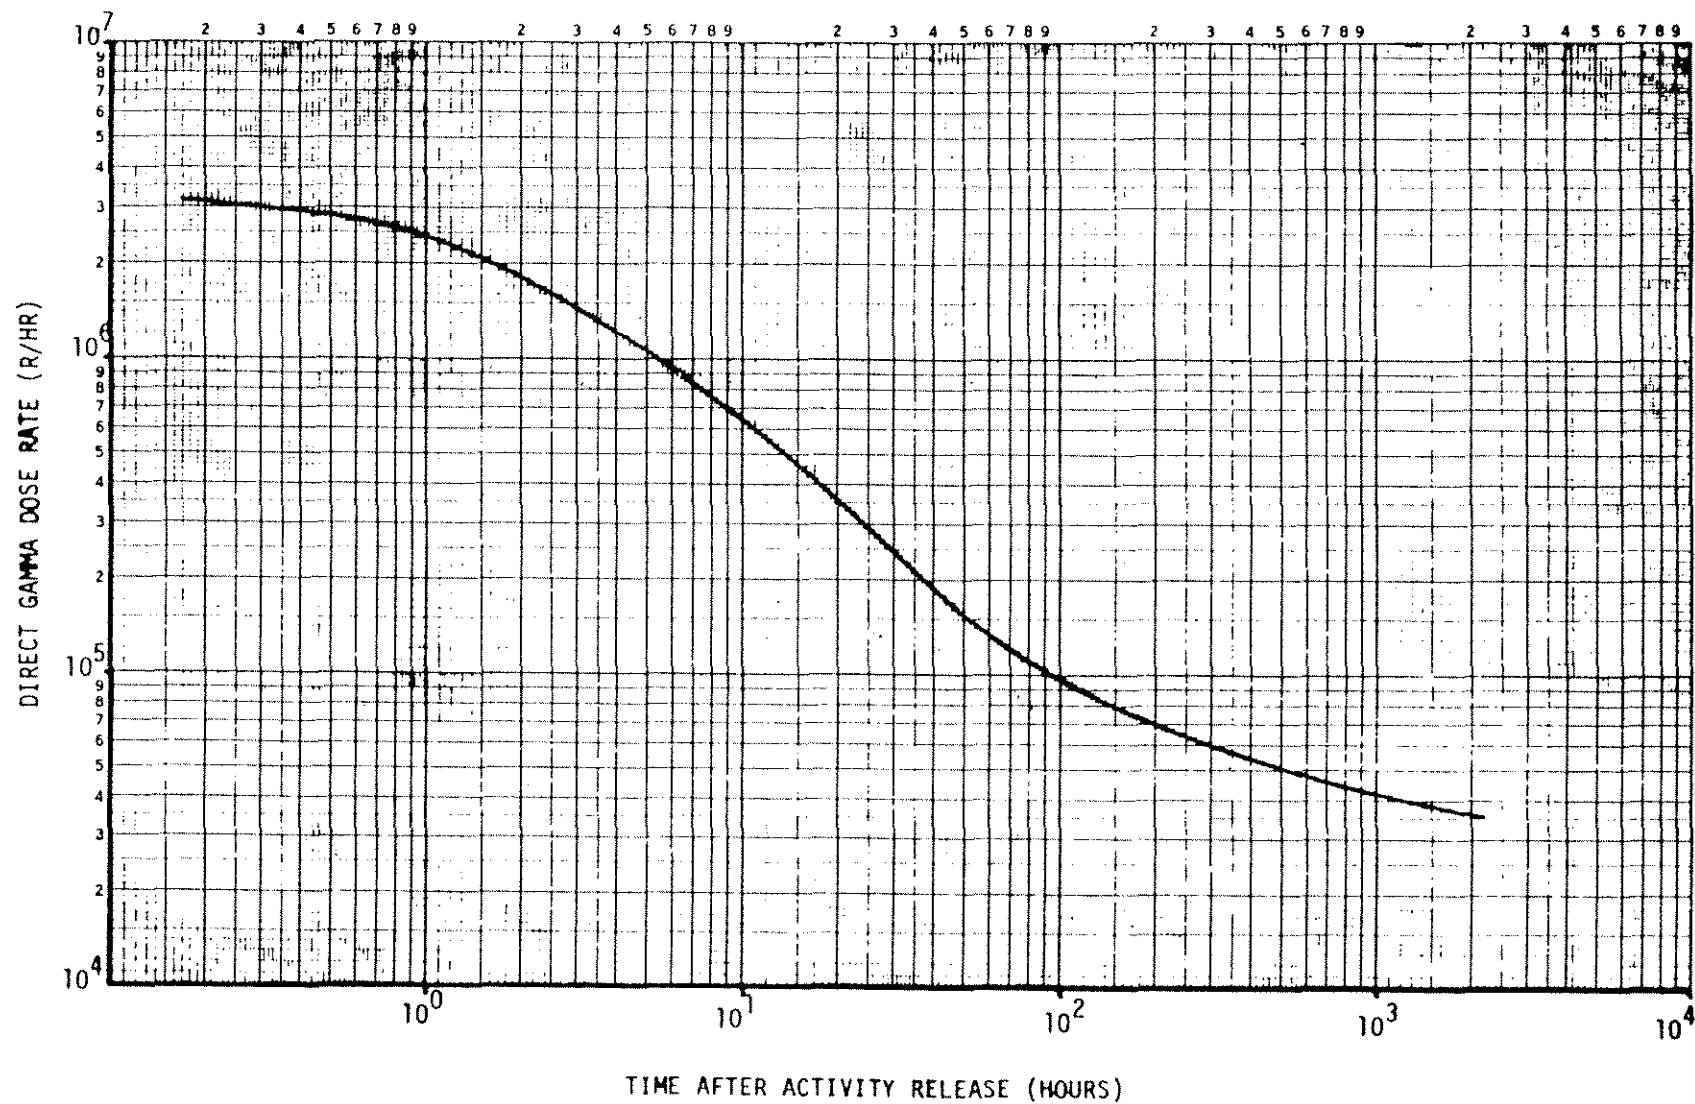
INDIAN POINT 3	FSAR UPDATE
CONTAINMENT ATMOSPHERE DIRECT GAMMA DOSE LEVEL	
REV 0	FIGURE NO. 6D-4
JULY 1982

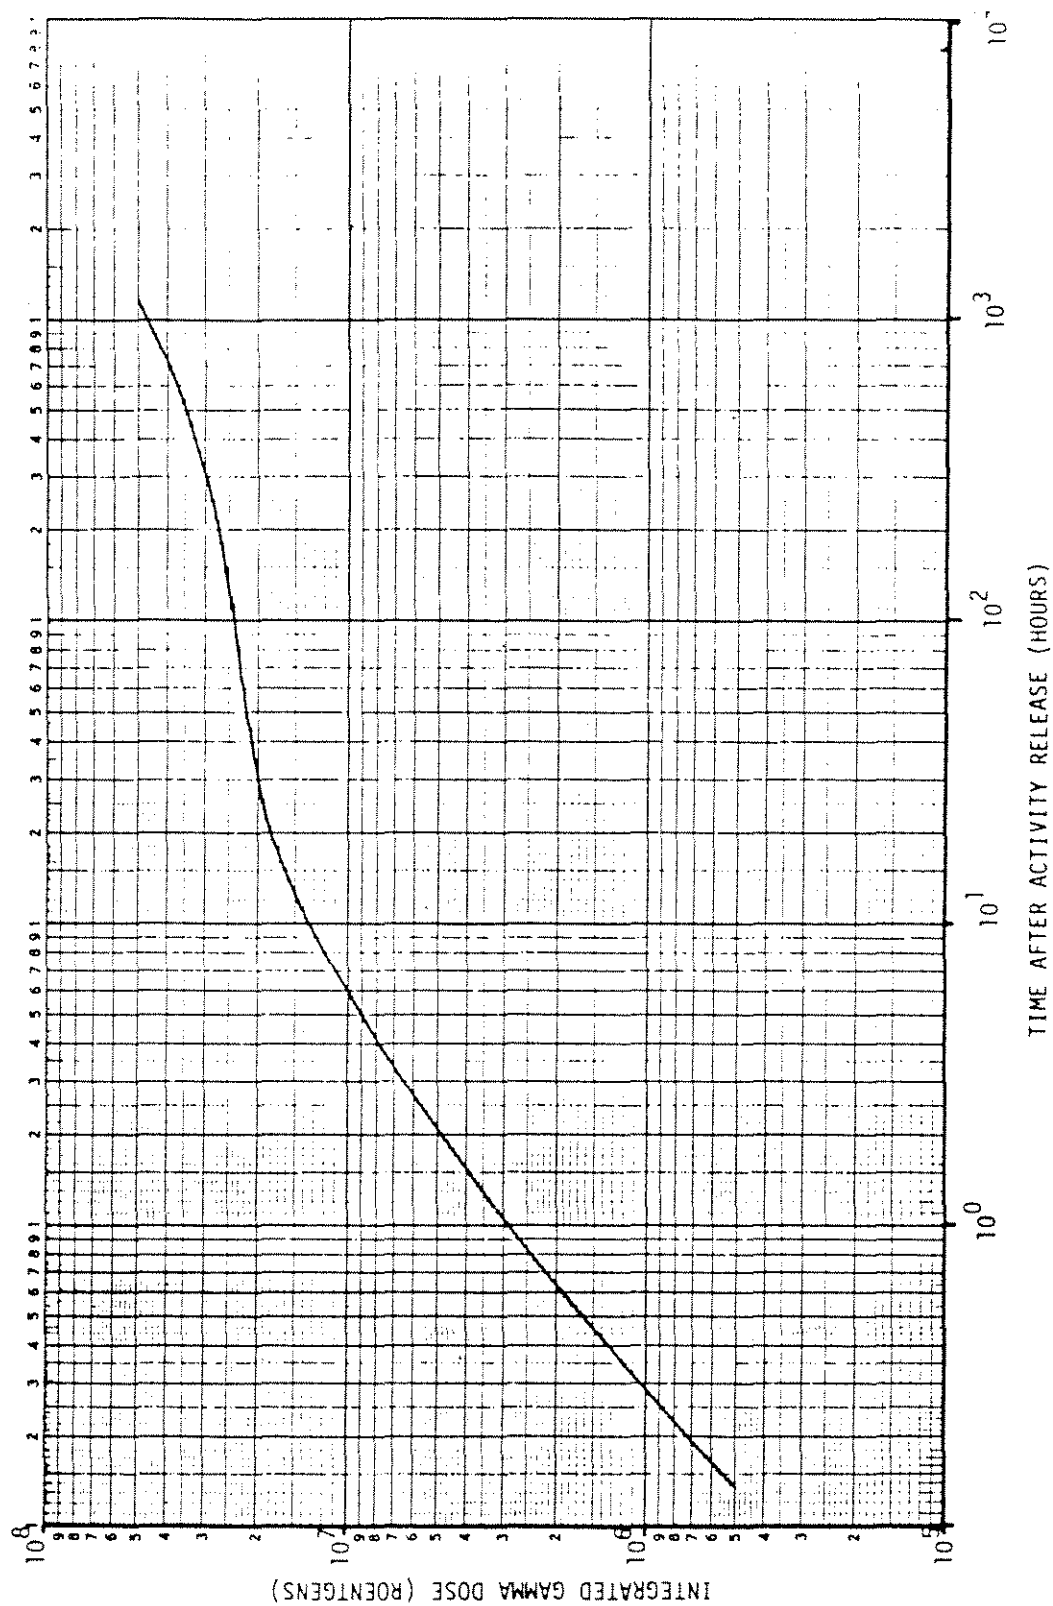
6D-5

CONTAINMENT ATMOSPHERE
INTEGRATED GAMMA DOSE LEVEL

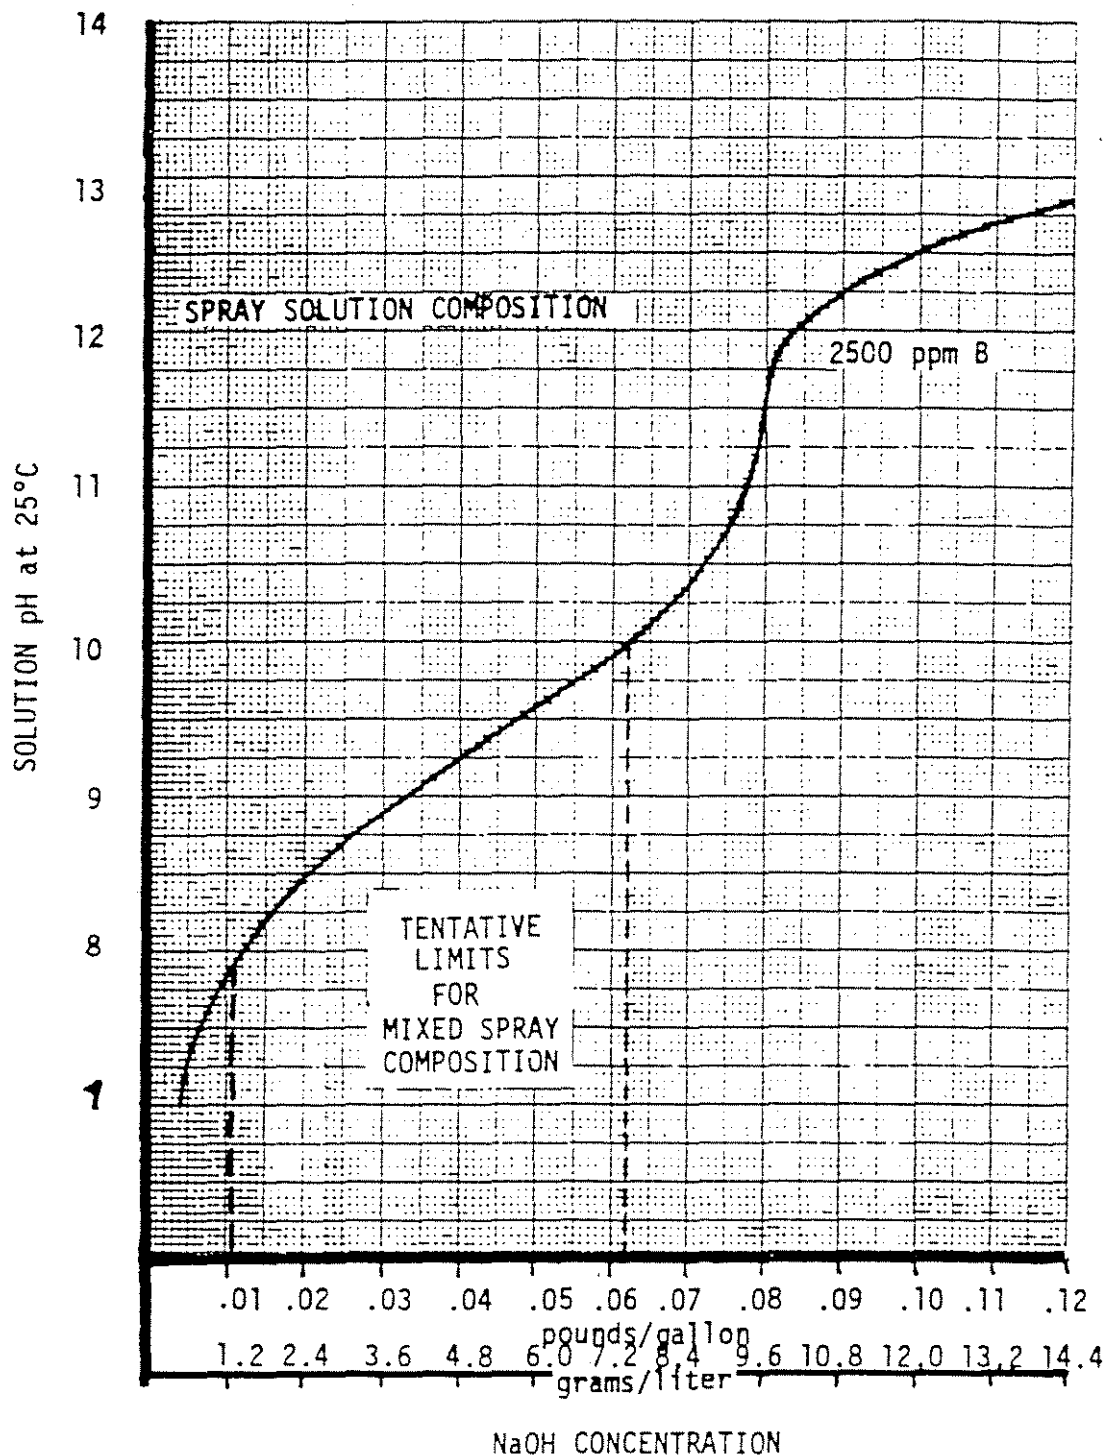
INDIAN POINT 3	FSAR UPDATE
TITRATION CURVE FOR BORIC ACID WITH SODIUM HYDROXIDE	
REV. 1, JULY 1993	FIGURE NO. 6D-6

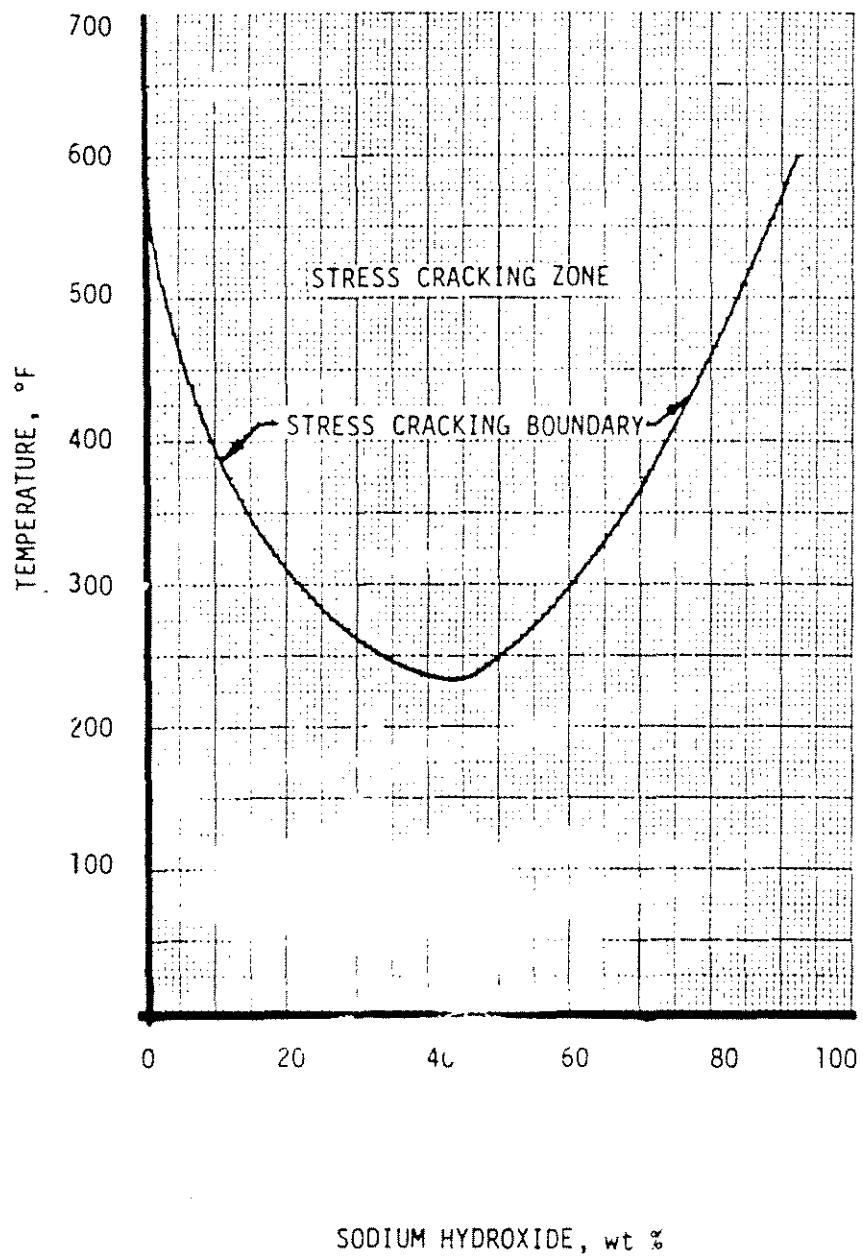
INDIAN POINT 3		FSAR UPDATE	
TEMPERATURE - CONCENTRATION RELATION FOR CAUSTIC CORROSION OF AUSTENITIC STAINLESS STEEL			
REV. 0	JULY, 1982	FIGURE NO.	6D-7

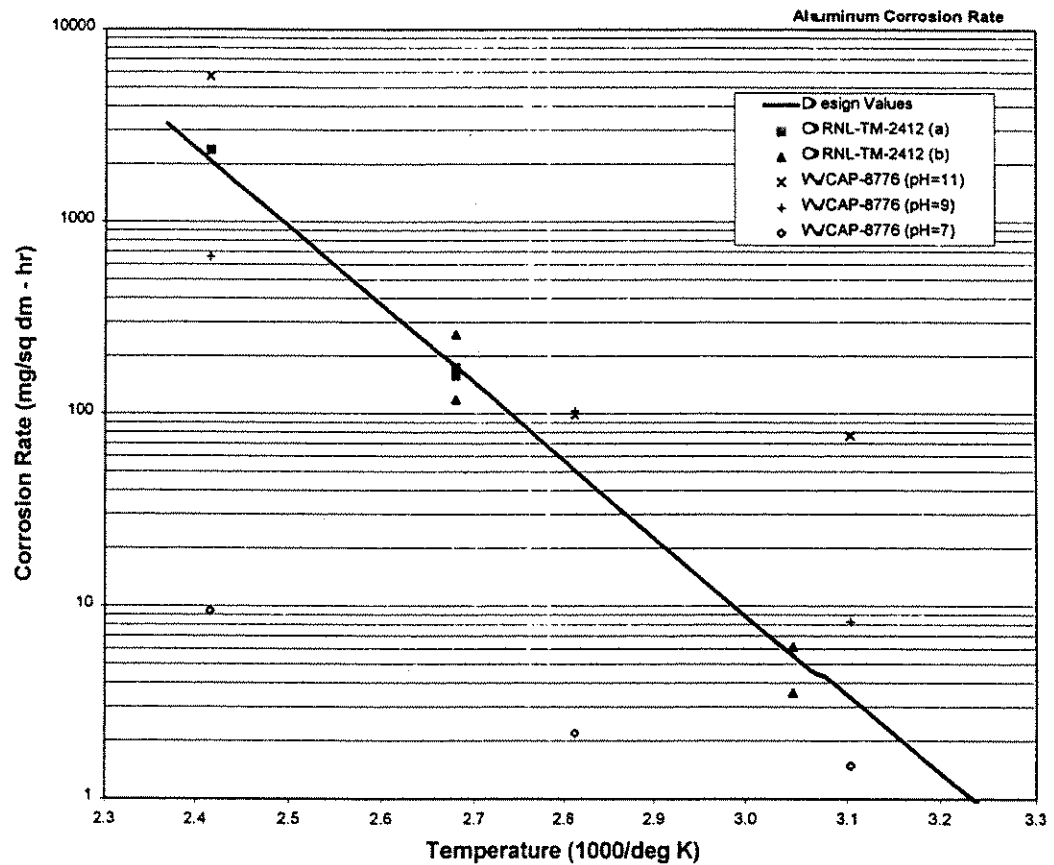
FIG. NO. 6D-8

Aluminum Corrosion Rates In LOCA Environment

ALUMINUM CORROSION
IN DBA ENVIROMENT

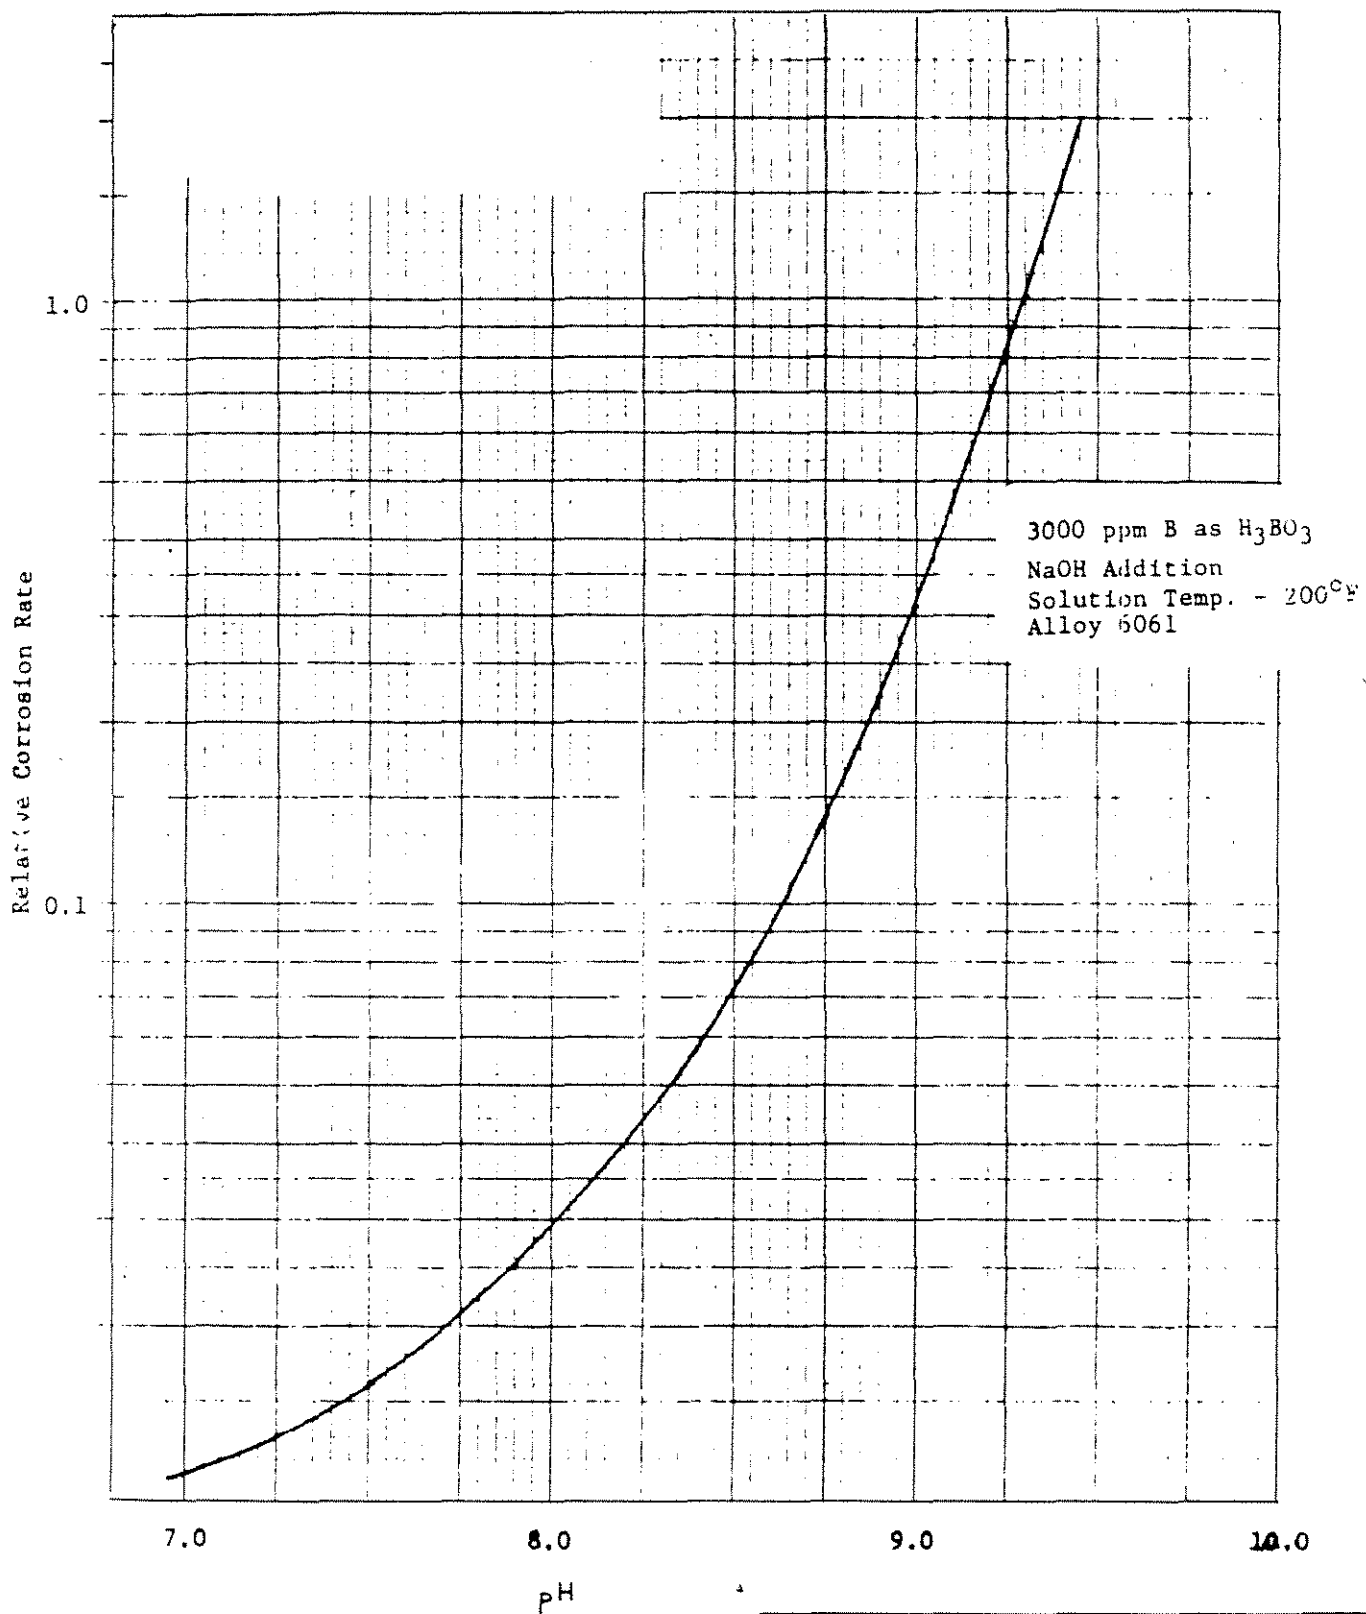
INDIAN POINT 3		FSAR UPDATE	
ALUMINUM CORROSION AS A FUNCTION OF PH			
REV 0	JULY, 1982	FIGURE NO.	6D-9

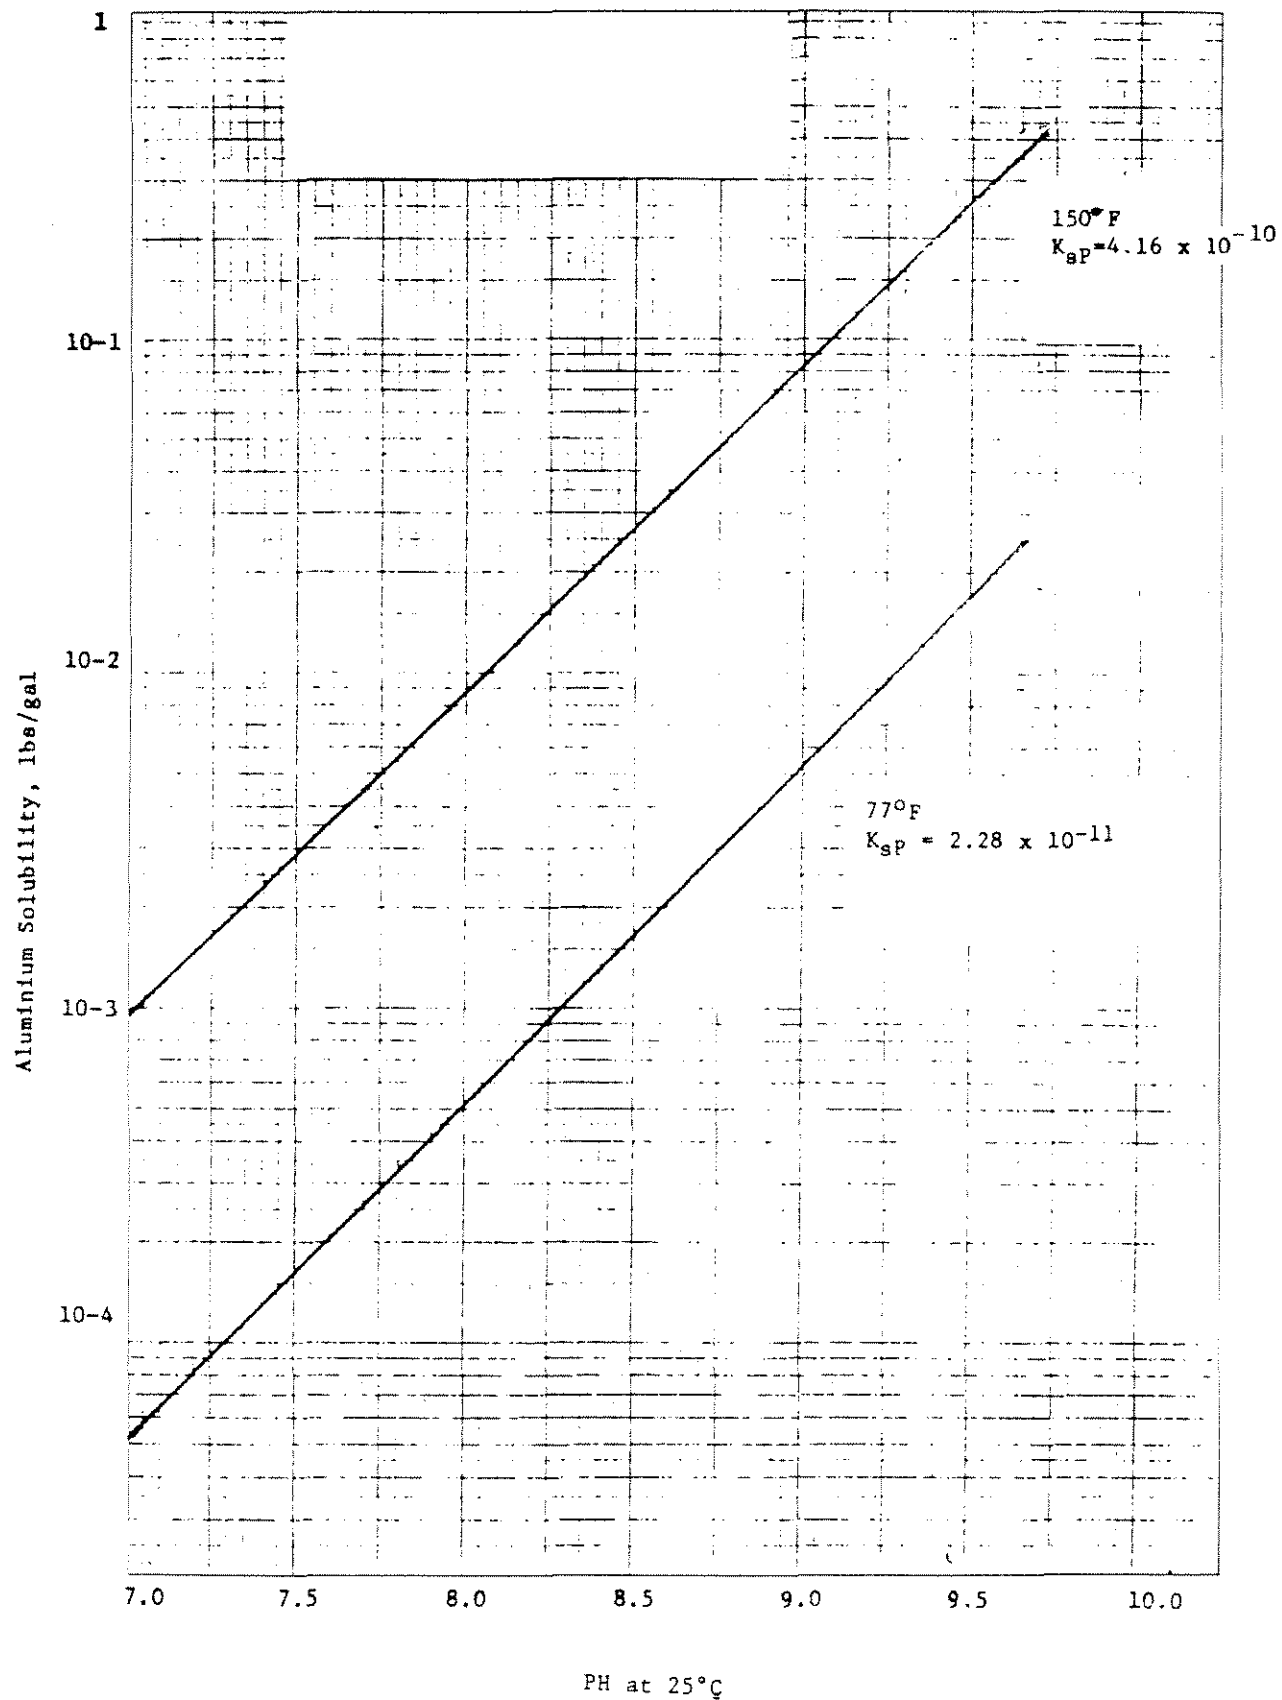
FIGURE NO 6D-10

SOLUBILITY OF ALUMINUM
CORROSION PRODUCTS AS A FUNCTION OF
pH AT 77°F AND 150°F

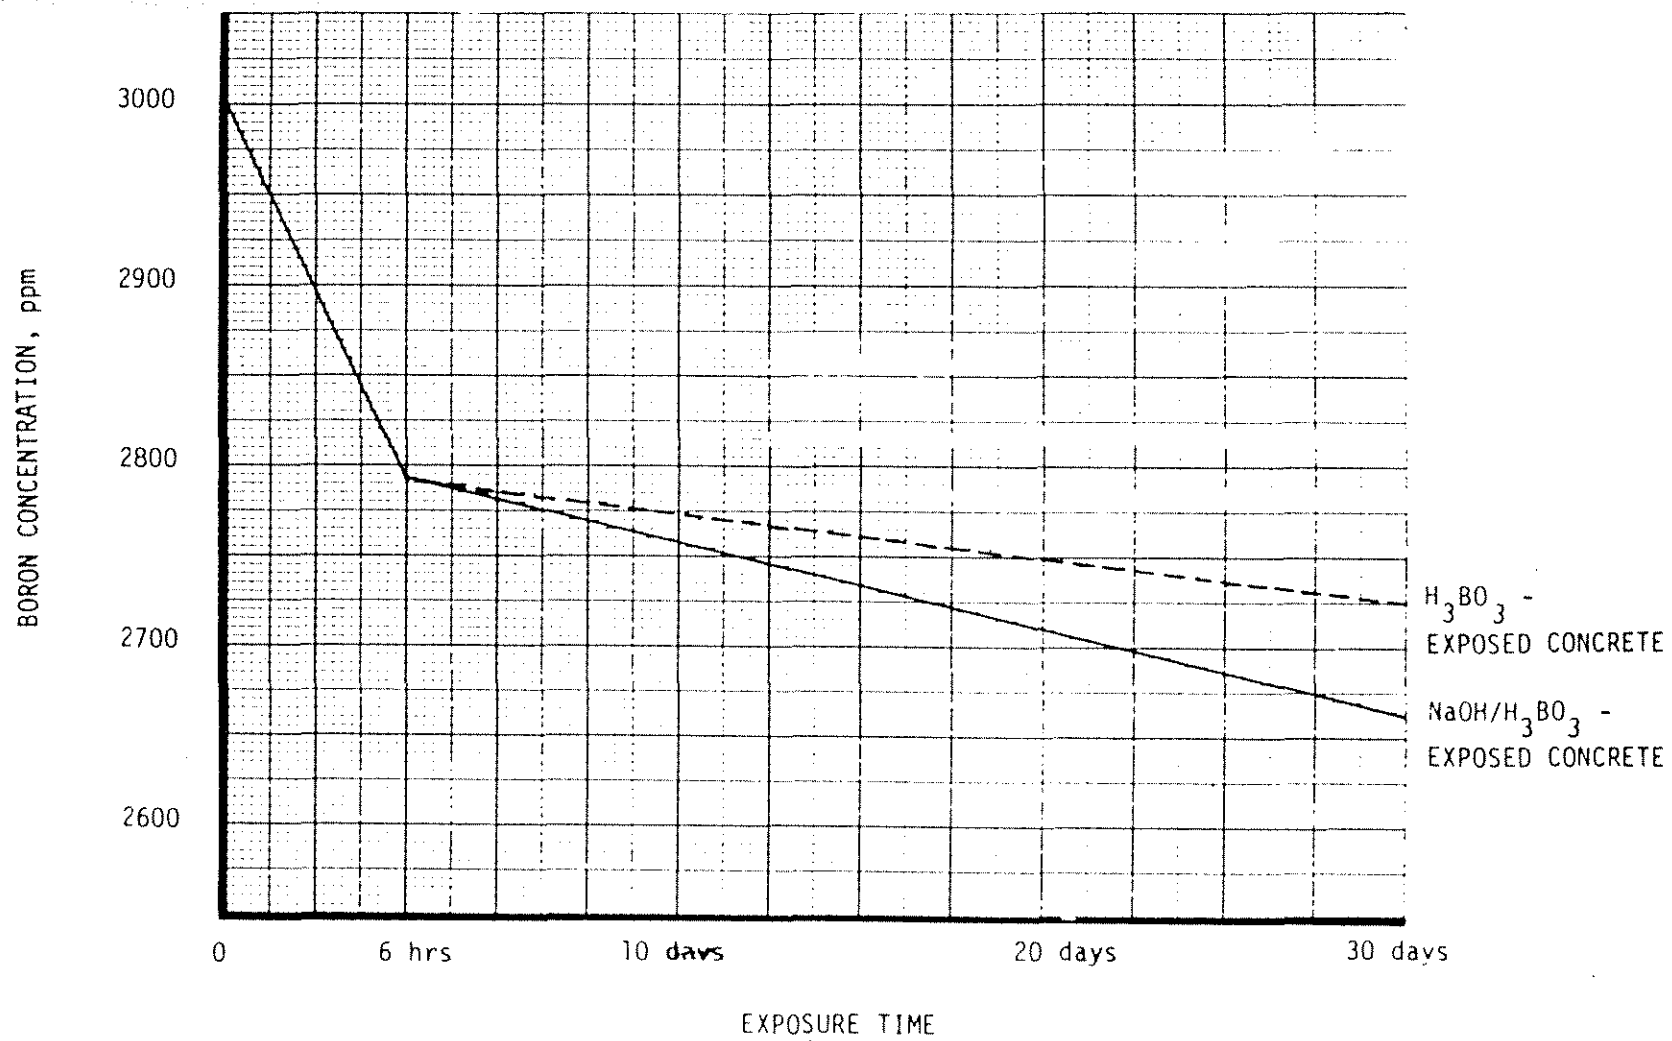
INDIAN POINT 3	FSAR UPDATE
BORON LOSS OF BORON - CONCRETE REACTION FOLLOWING A DBA	
REV. 0	FIGURE NO. 6D-11
JULY 1982

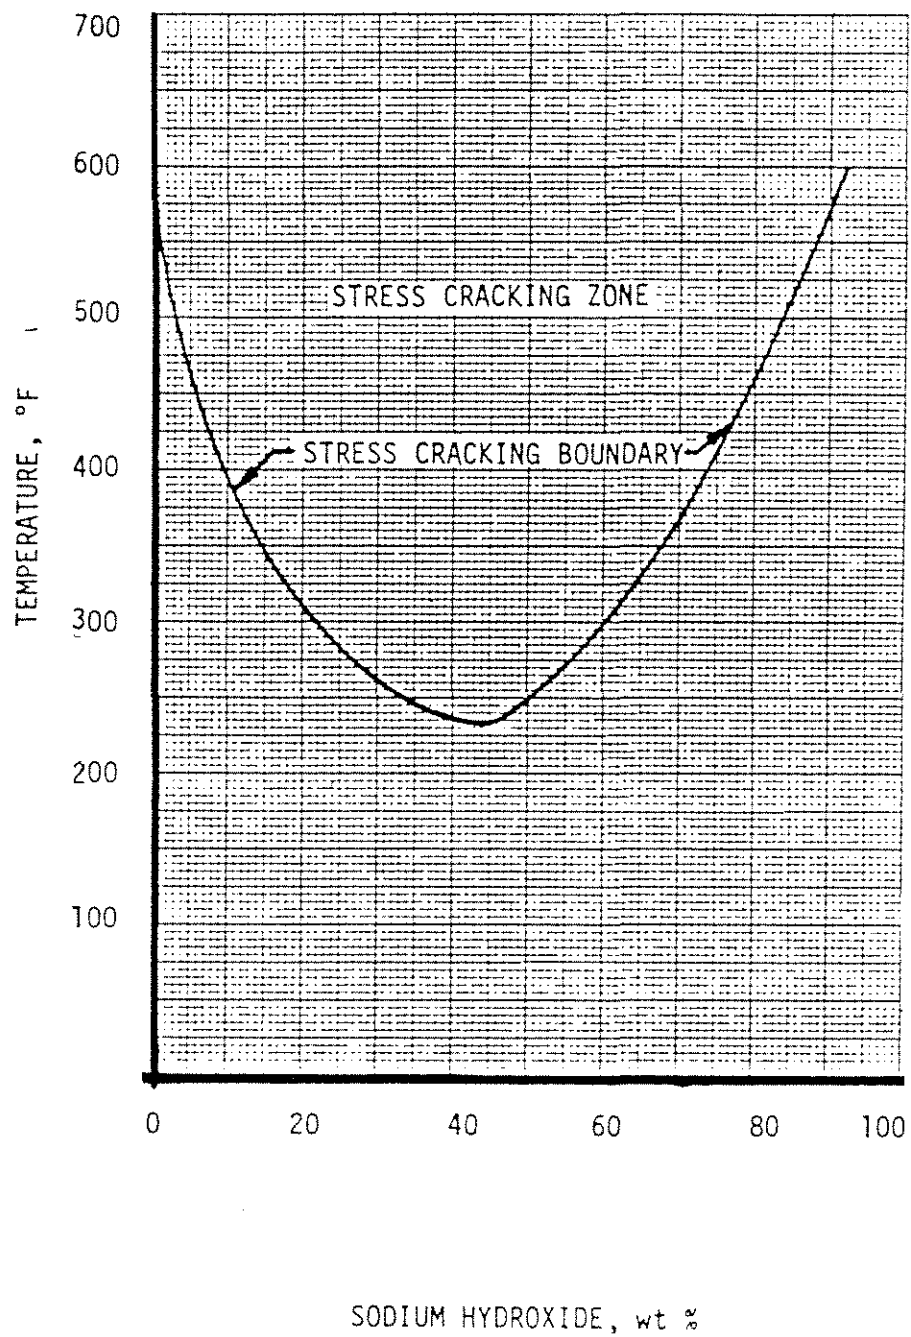
FIGURE NO 6E-1

TEMPERATURE - CONCENTRATION RELATION
FOR CAUSTIC CORROSION OF AUSTENITIC
STAINLESS STEEL

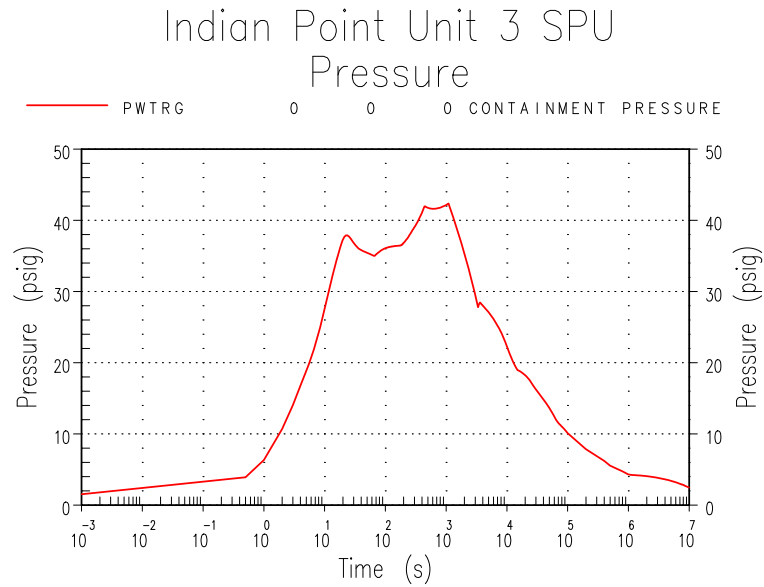
DEPS Minimum Safeguards Pressure Transient

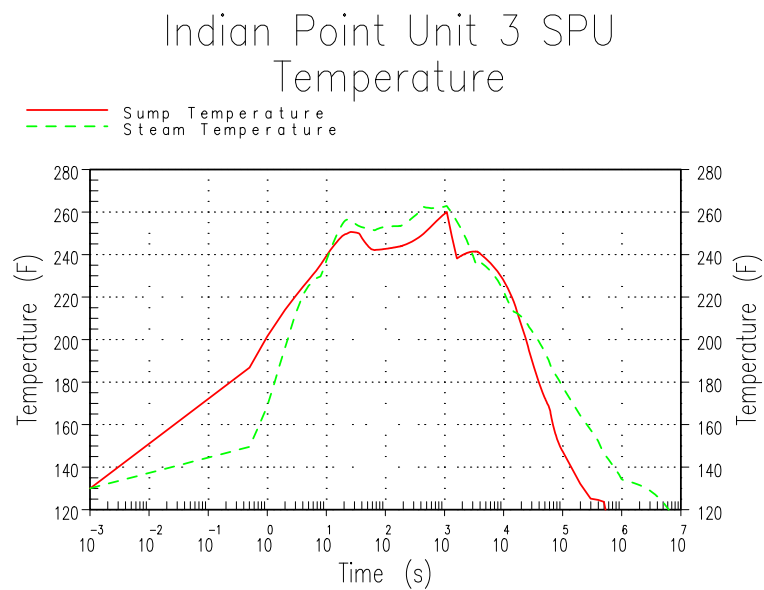
Figure 6F-4

DEPS Minimum Safeguards Temperature Transient

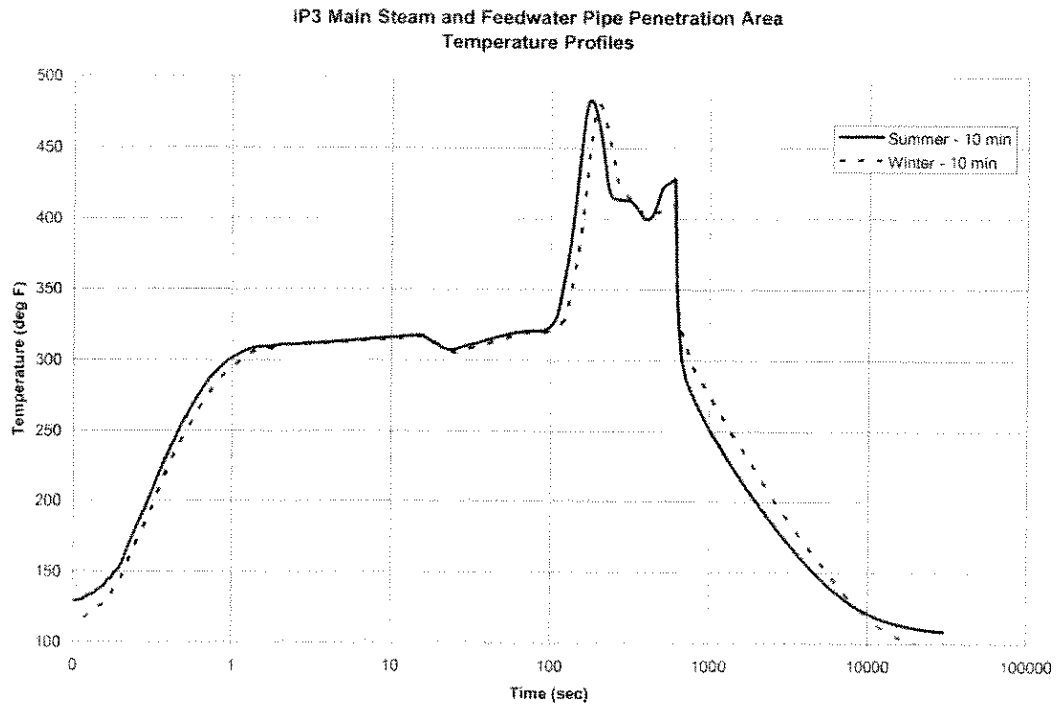
Figure 6F-9B

1. The winter case was generated with the 1.2 ft² header break at 102% initial power.
2. The summer case was generated with the 1.4 ft² header break at 102% initial power.

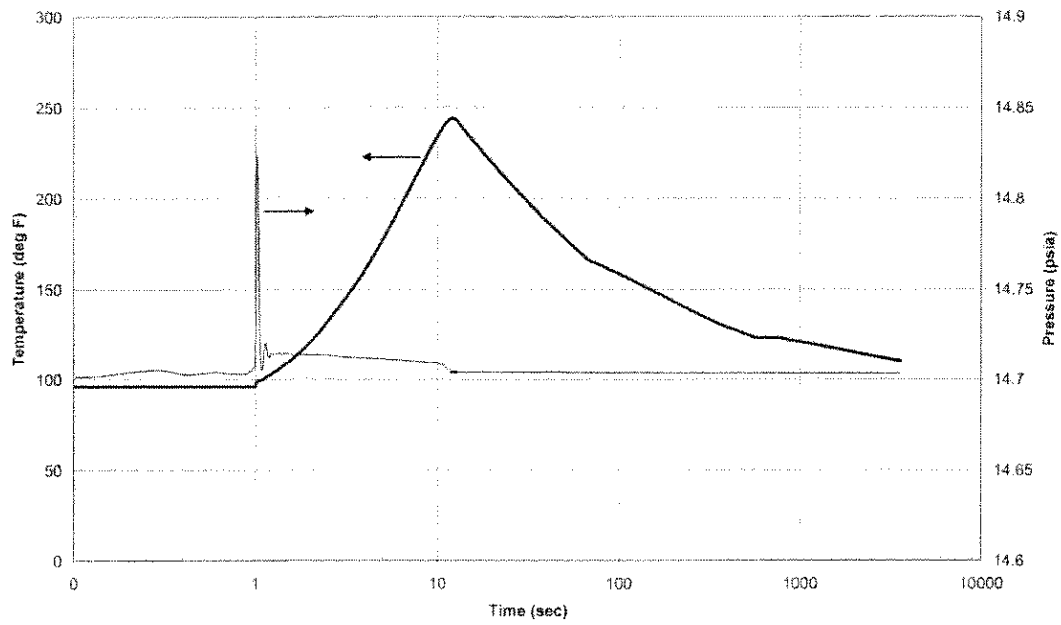
Pressure and Temperature Profile from a 4 inch Steam Line Break
in the Auxiliary Feedwater Pump (AFWP) Room
