Final Report

Anchorage and Seismic Support of
Safety Related Electrical Equipment

RG&E Project Number EWR-2831
12/31/80

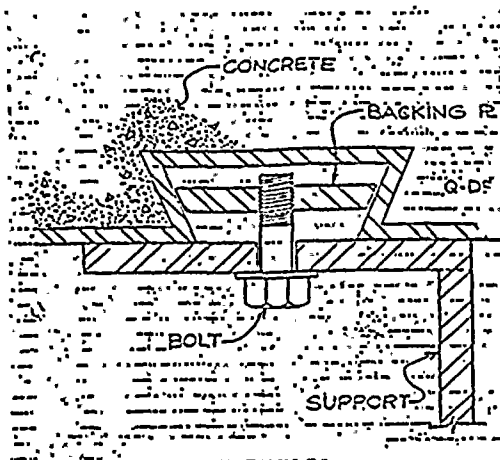
FIGURE 4-1

Q-DECK DETAIL

4.2 Test criteria were established detailing the information necessary to test the anchorage of the supports making up the raceway system. Specific test procedures were prepared, consistent with the test criteria, for each category of anchorage included in this program. The categories of anchorages and specific procedures required to test the following devices were: 1. expansion anchors for both conduit and tray supports in ceiling and/or wall locations, 2. Clips and unistrut hardware that rely on frictional resistance, and 3. Embedded hardware such as Keystone Q deck nuts, embedded unistrut and poured-in-place anchors. Detailed sketches of each of the category 3 type hardware are shown in figures 4-1, 4-2, & 4-3.

4.9.2 A single Q deck wedge was tested using a load cell and a 5/8" rod. The anchor held a 2000 pound tensile load. The zone of influence for a single bolt was maintained at 2 feet. The load cell was also operated at its limit of 5700 pounds to insure confidence in the 2000 pound test loads. No deformation was noted at the higher load. This same test procedure was used to determine the adequacy of the embedded unistrut anchors and the poured in place anchors.

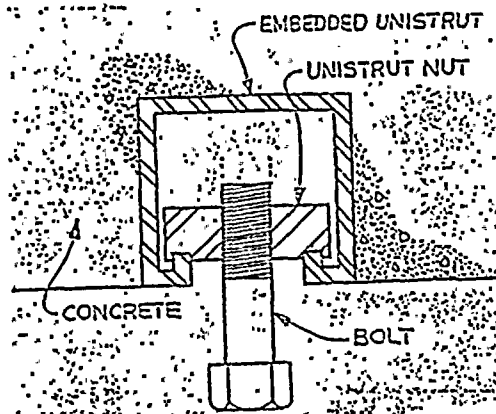
FIGURE 4-2

UNISTRUT DETAIL

4.7.3 The "as-found" torque of all the unistrut stud nuts on a particular support was recorded. All inaccessible bolts were identified and recorded. Torque wrench adapters (i.e., crow's foot) were used to reduce the number of inaccessible nuts or bolts. Those bolts still inaccessible were wrench tightened where possible.

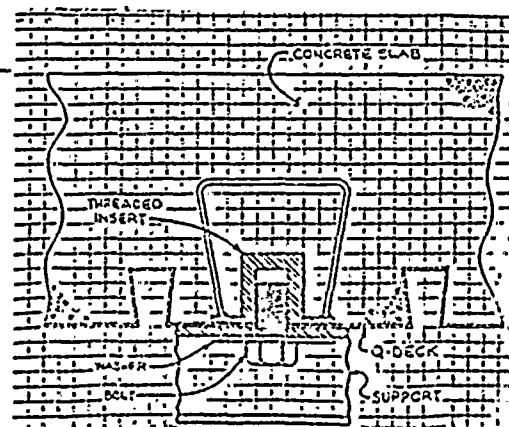
THREADED INSERT DETAIL

POURED IN PLACE ANCHOR
