SUBJECT: Forwards minutes of 830913 meeting w/American Electric Power
 Svc Corp in Bethesda, MD re proposed resolution for numerous
 environ. qualification deficiencies identified by Franklin
 Research Ctr, per 831024 request.

EQUIPMENT QUALIFICATION DEFICIENCIES
IDENTIFIED IN THE FRANKLIN RESEARCH CENTER
TECHNICAL EVALUATION REPORTS DATED OCTOBER 28, 1982

SUMMARY OF DEFICIENCIES IDENTIFIED
IN THE FRANKLIN RESEARCH CENTER TECHNICAL EVALUATION REPORTS
DATED OCTOBER 28, 1982
FOR EQUIPMENT ITEMS IN CATEGORIES I.B. AND II.A.

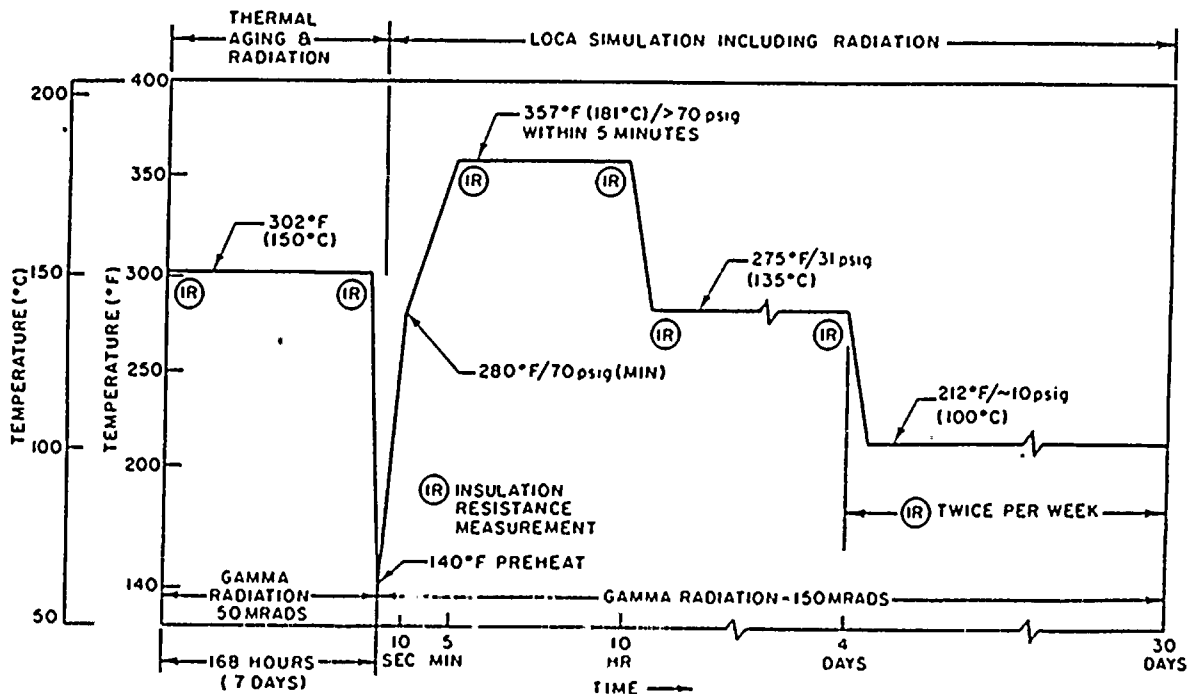
Figure 8. Temperature/pressure profile for simulation of Loss-Of-Coolant Accident environment.

Following the combined radiation-thermal aging exposure, the specimens were simultaneously exposed to steam, chemical-spray and gamma radiation (S/C/R) as illustrated in Figure 8.
