SUBJECT: Forwards inservice insp relief Requests 6 & 7 originally transmitted 790918 & clarified w/addl info, in response to NRC 820316 & 0614 requests.

November 18, 1982
L-82-514

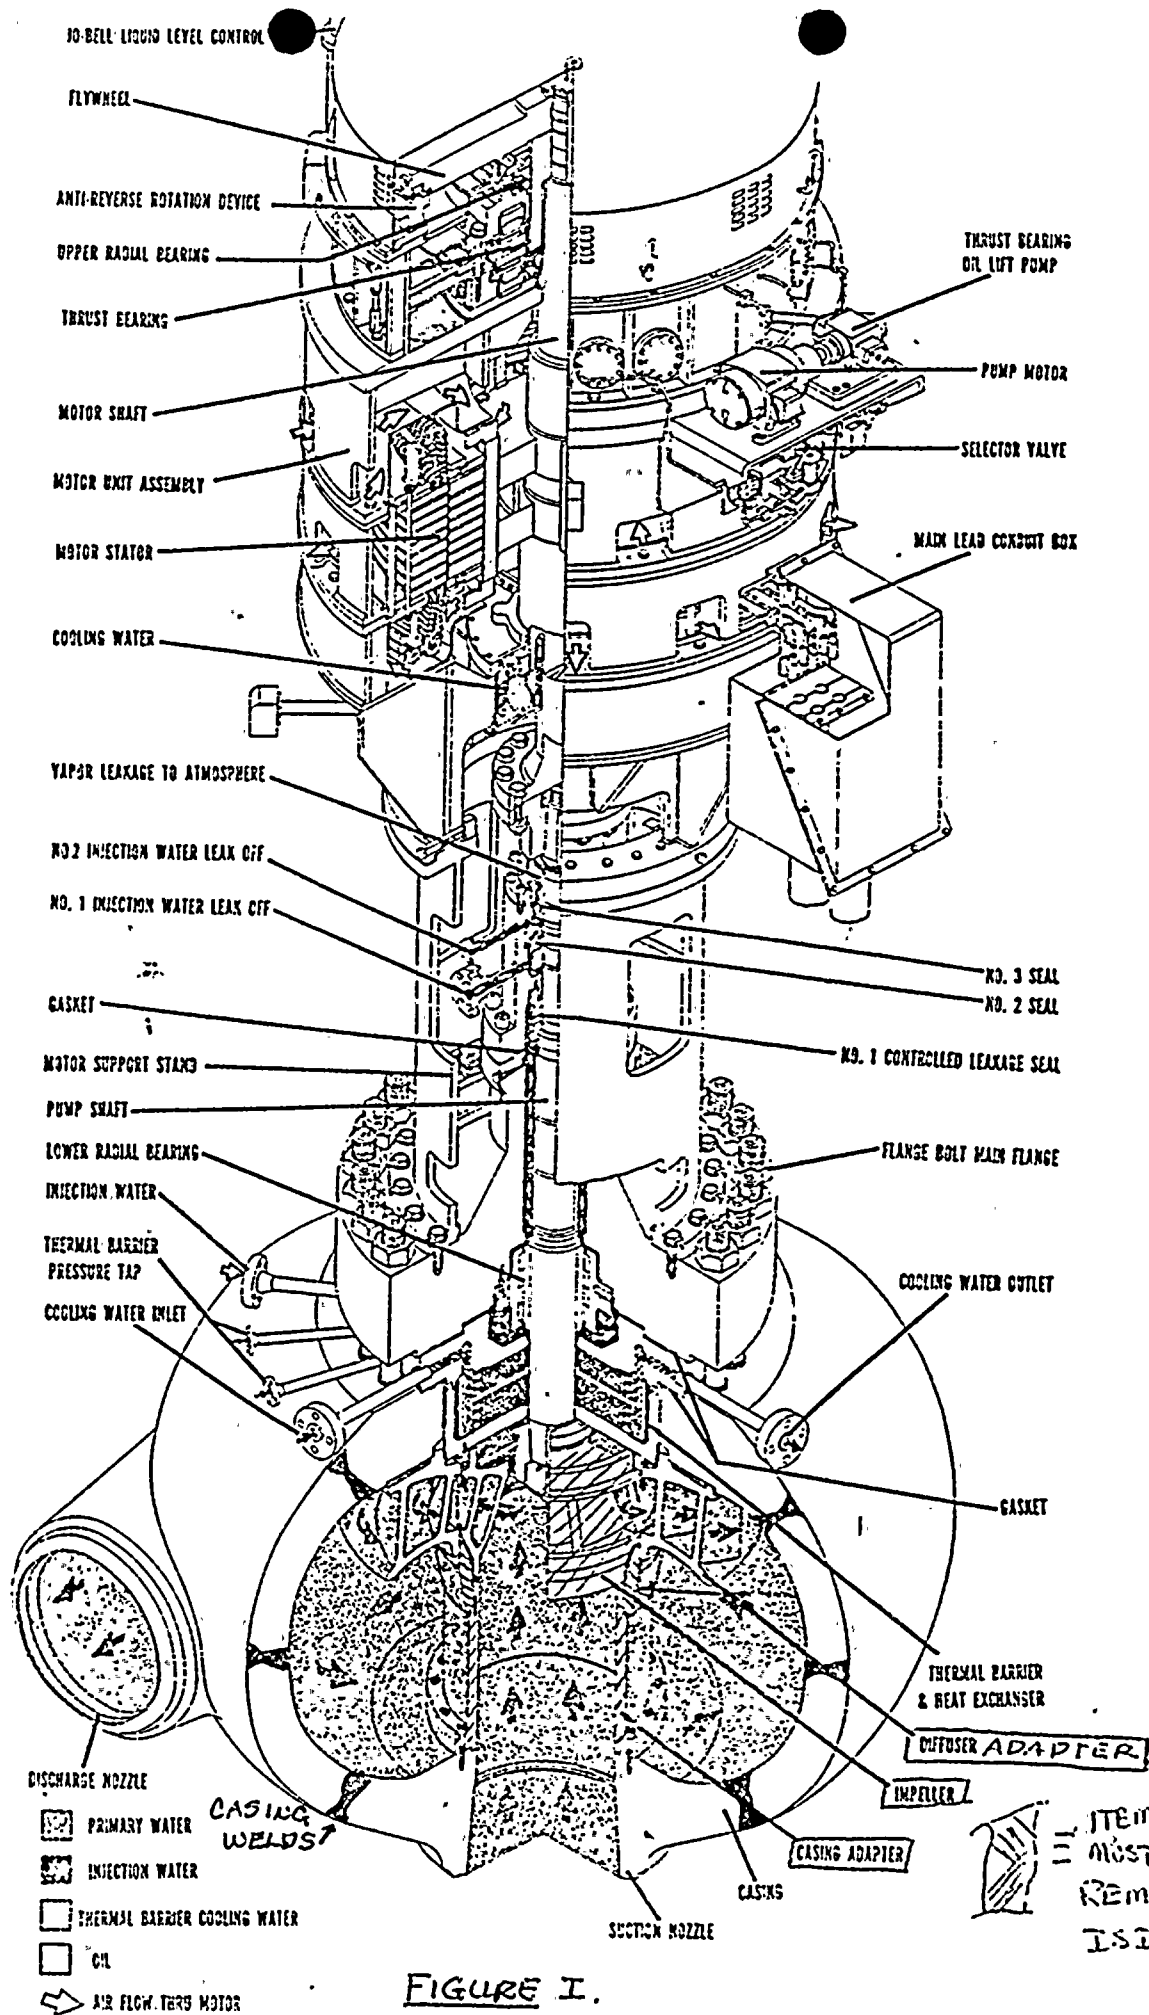
FIGURE I.

FIGURE I-1 Cutaway and Flow Diagram

- 2) Radiographic examination is not possible without the complete disassembly of the pump (see figure I). To perform this examination, large expenditures of manhours and man-rem are required with essentially no compensating increase in plant safety. Based on actual data compiled from the radiographic examination of the Turkey Point Unit No. 3 reactor coolant pump casing welds and visual examination of the internal pressure boundary surfaces on one pump, in excess of 5900 man-hours and 46 man-rem exposure was expended in the disassembly, examinations and reassembly of the pump. These examinations are conducted under somewhat adverse conditions which have far reaching effects as depicted in Figure 2 thru Figure 5.

- 3) There is a very low probability, based upon industry experience, to disassembly pump(s) for maintenance purposes. There is no requirement by the pump manufacture (Westinghouse) to disassemble the pump(s) as part of normal maintenance or inspection. Accordingly, Florida Power & Light Company's procedures do not require disassembly of the pump(s) for maintenance or inspection purposes. There are no reported failures within the pump casings with these model pump(s). It's note worthy to mention that removal of the pump impeller does not provide access to the casing internal surfaces which would still prohibit the inspection (visual and volumetric) of the pump to Code requirements. See Figure I for items to be removed for Code ISI examination compliance.

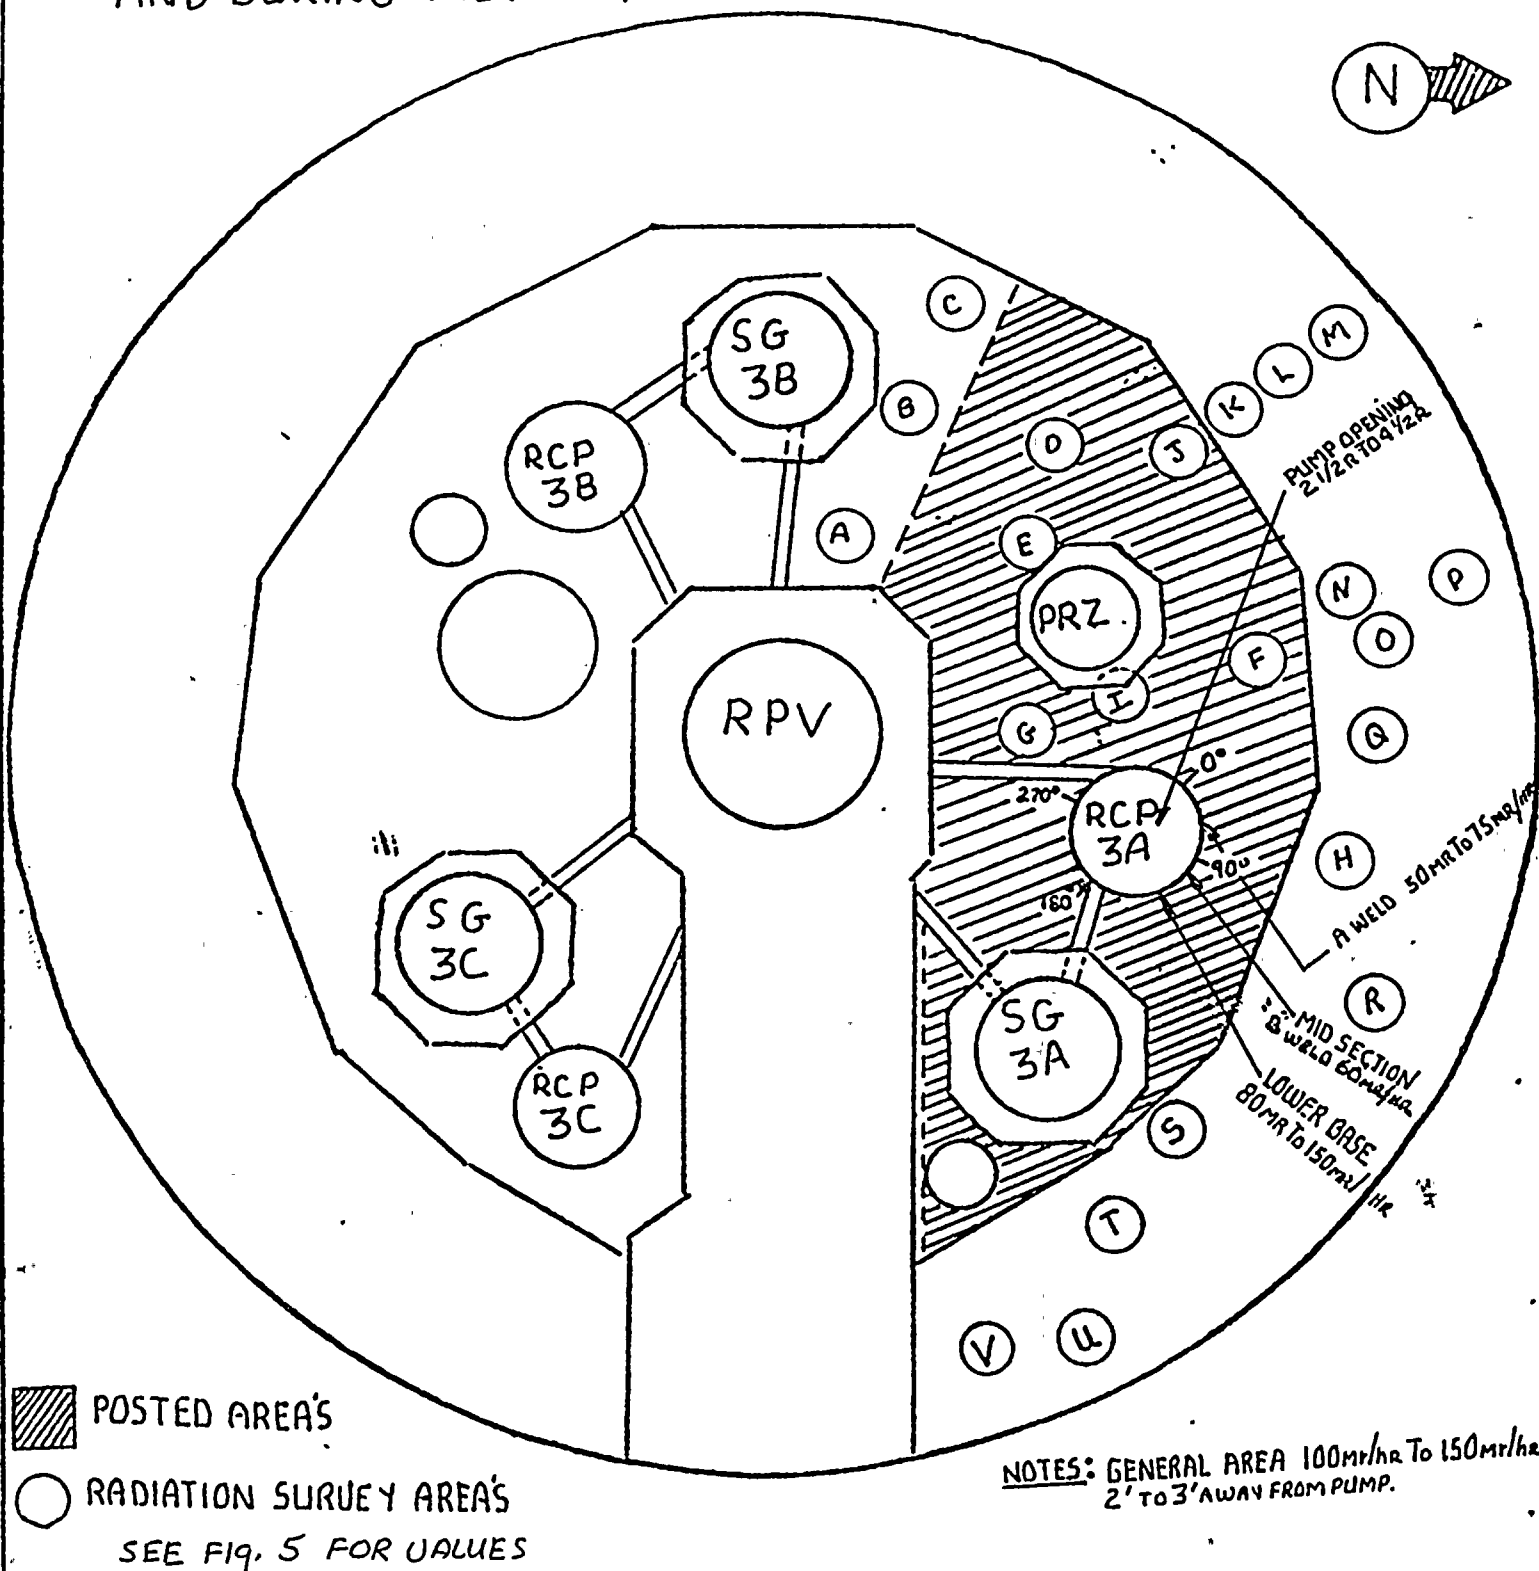
FIGURE NO. 2

GENERAL SURVEY OF RCP AREA PRIOR TO RT(MINAC)
AND DURING THE (MINAC) EXAMINATION. 30' 6" ELEVATION

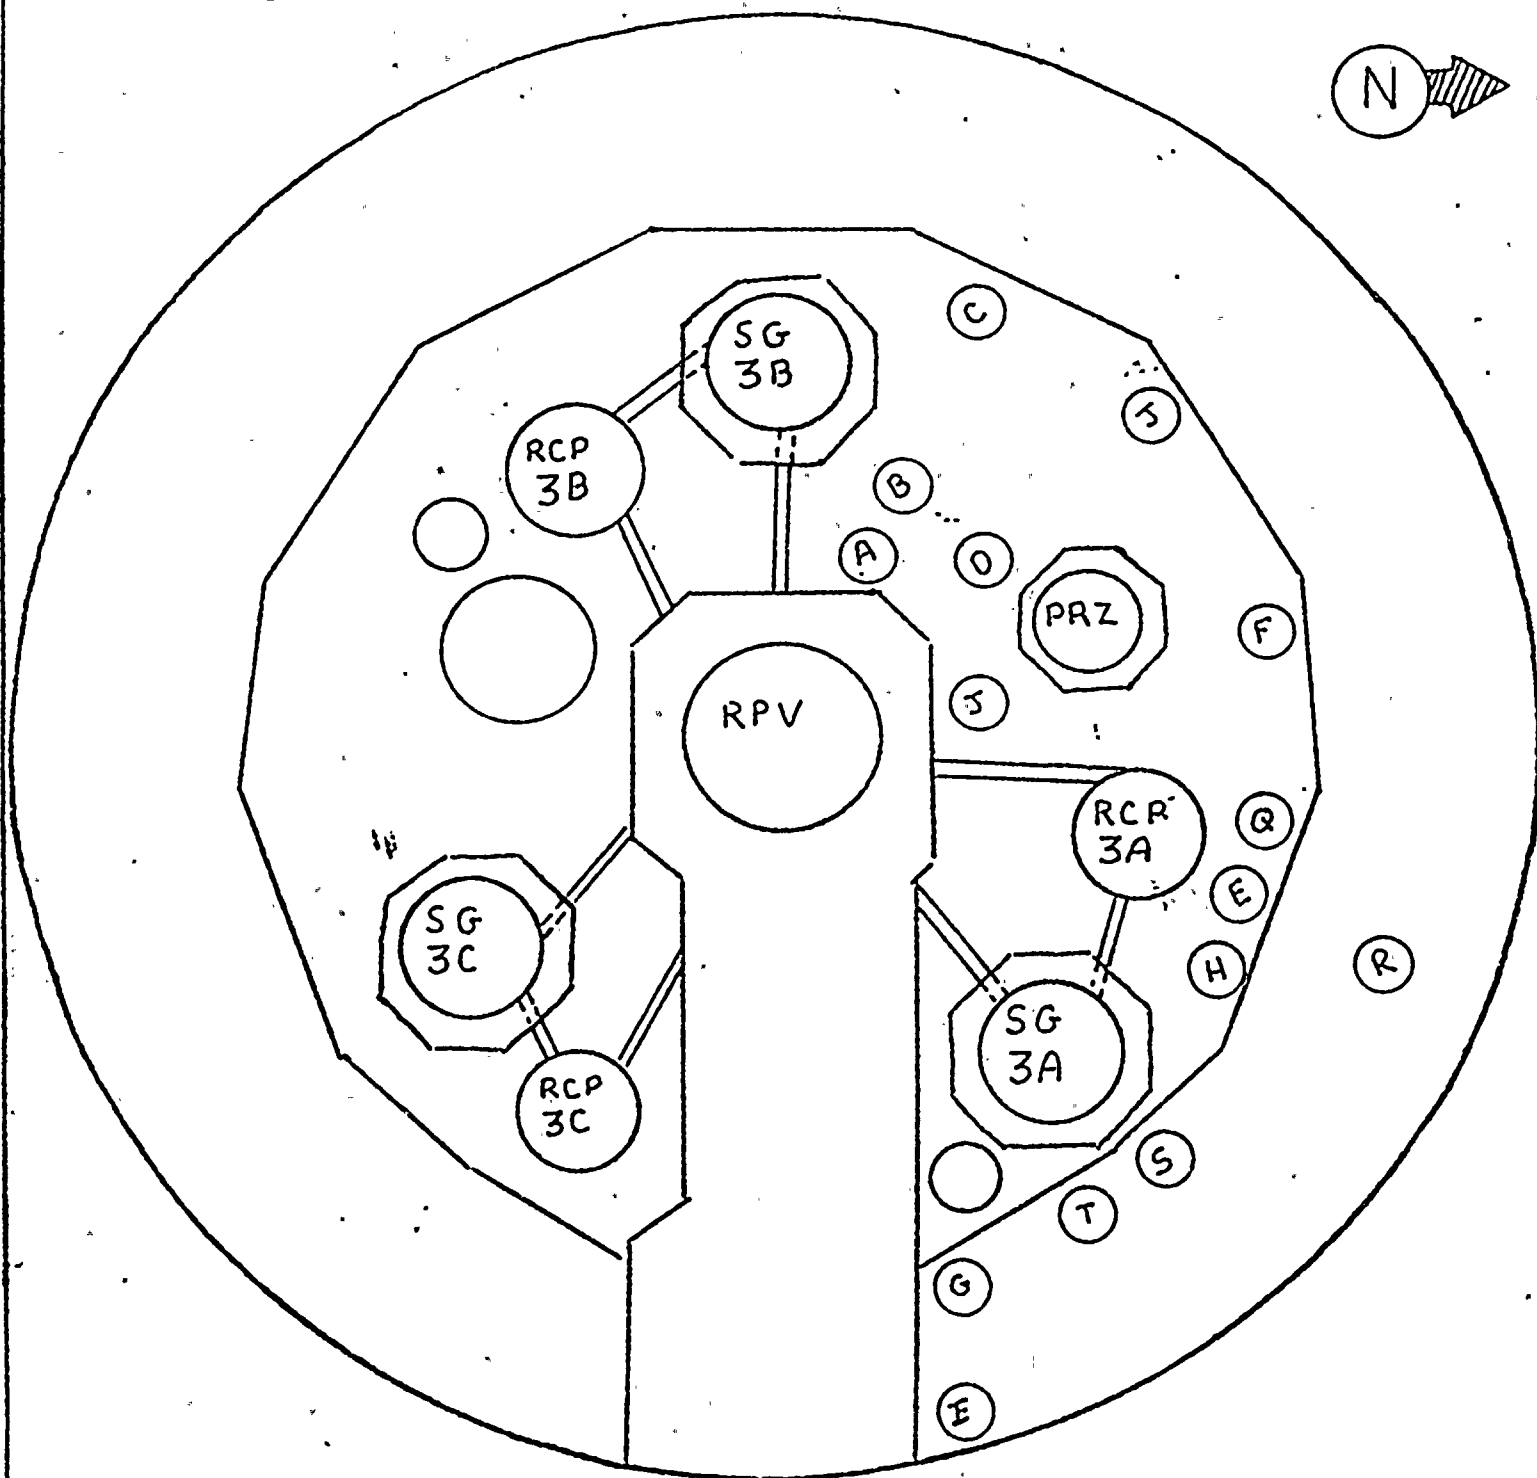
FIGURE NO. 3

○ RADIATION SURVEY AREA'S
SEE FIG. 5 FOR VALUES

GENERAL SURVEY OF RCP AREA PRIOR TO RT (MINAC)
AND DURING THE (MINAC) EXAMINATION 58' ELEVATION
