ACCESSION NBR: 8308150225 DOC. DATE: 83/08/09 NOTARIZED: NO DOCKET #
 FACIL: 50-250 Turkey Point Plant, Unit 3, Florida Power and Light C 05000250
 50-251 Turkey Point Plant, Unit 4, Florida Power and Light C 05000251
 AUTH. NAME AUTHOR AFFILIATION
 URRIG, R. E. Florida Power & Light Co.
 RECIP. NAME RECIPIENT AFFILIATION
 VARGA, S. A. Operating Reactors Branch 1

SUBJECT: Forwards addl info re NUREG-0737, Item III.D.3.4, "Control Room Habitability Requirements," per 830106 request. Design changes made & justification provided for unsubstantial backfit items, per 830307 ltr.

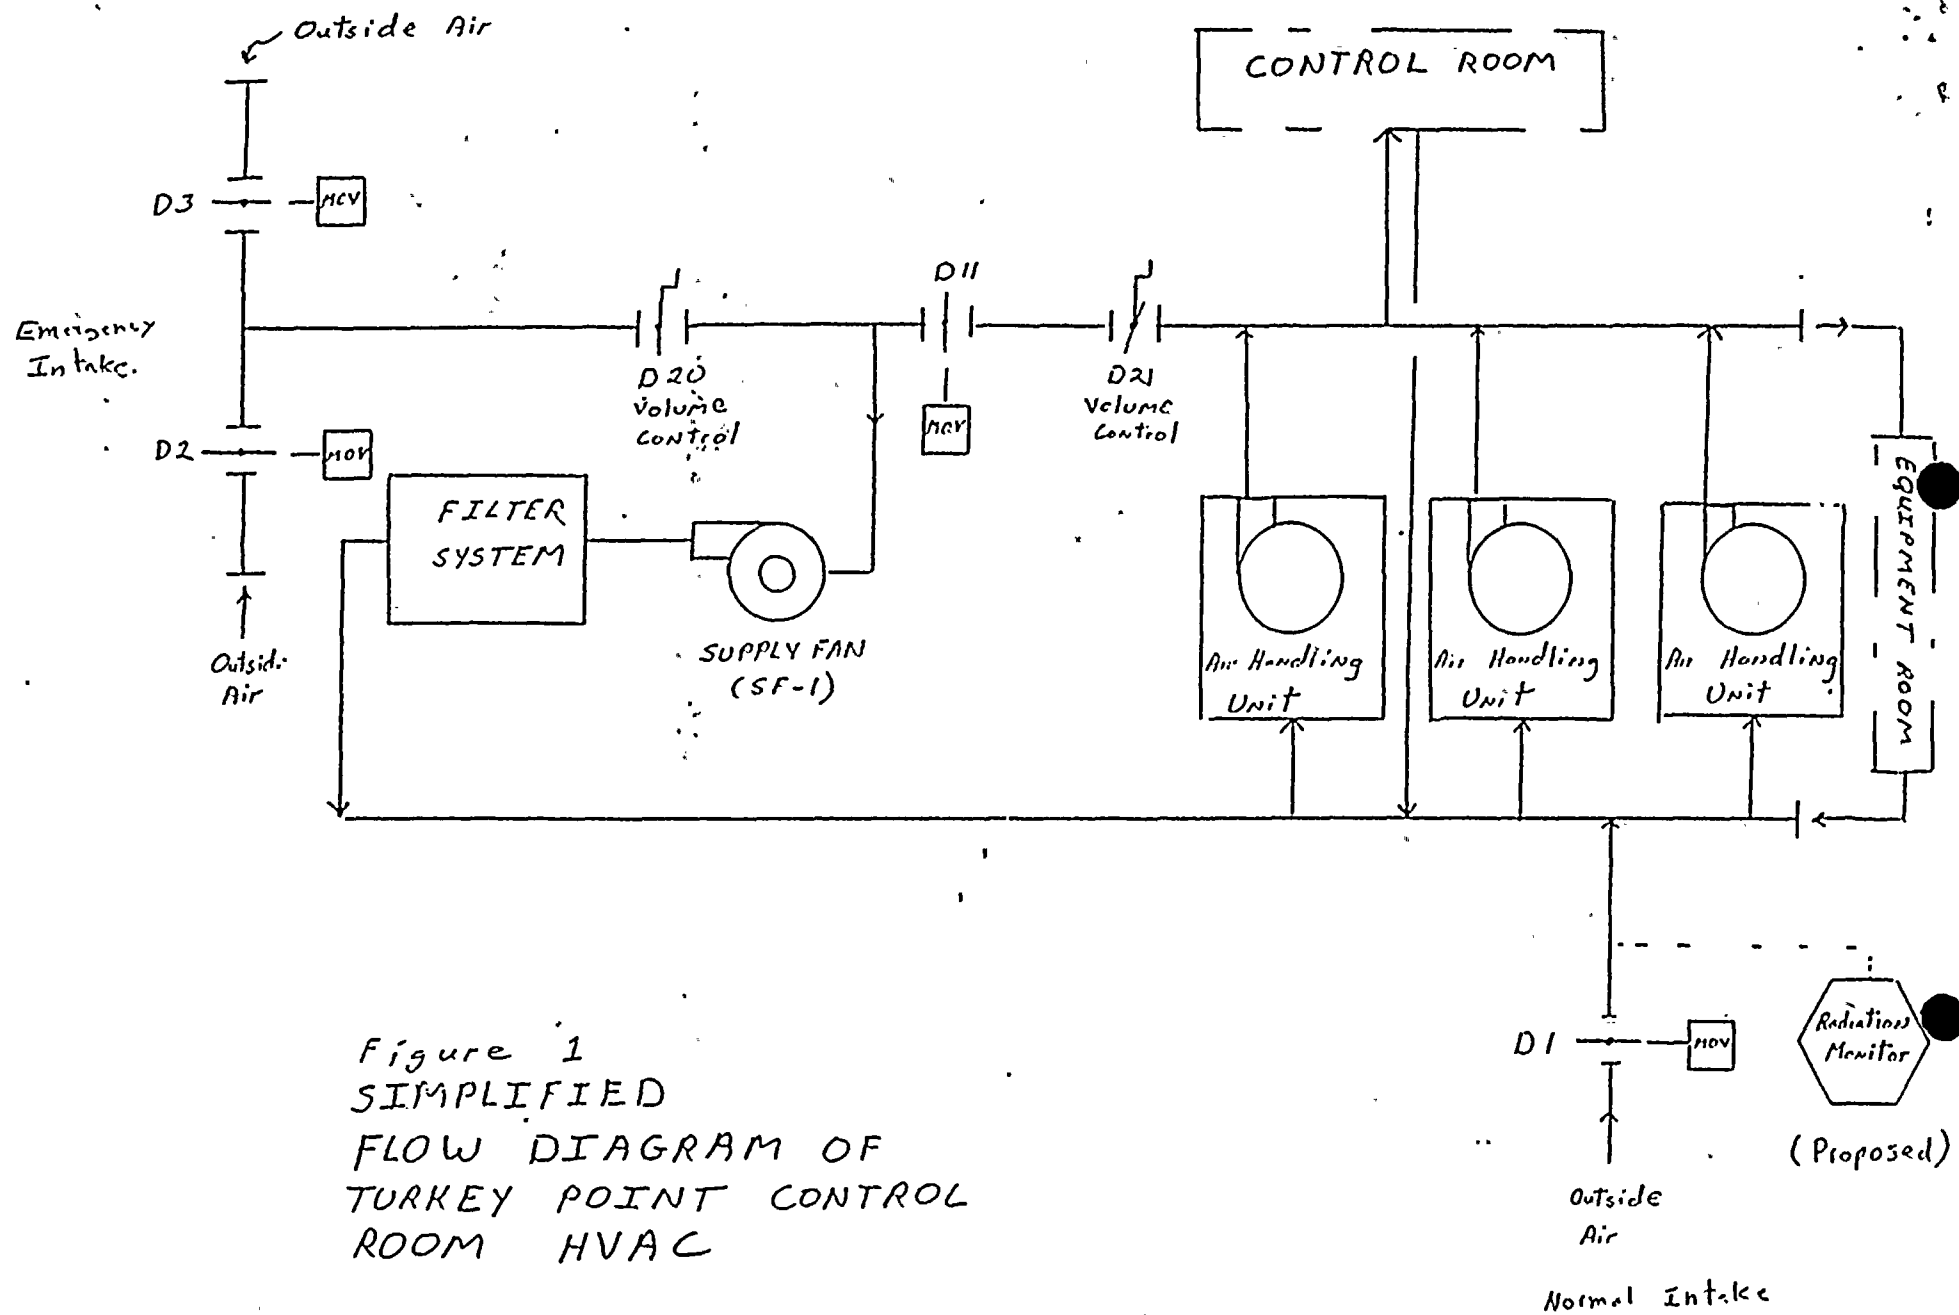
Figure 1
SIMPLIFIED
FLOW DIAGRAM OF
TURKEY POINT CONTROL
ROOM HVAC

Ref: Dwg. 5177-181-M-1 Rev 4

Damper D-20 is a fixed position, volume control damper that performs no active function once it is positioned during initial HVAC balance. In order to maintain operator exposures below the requirements of GDC-19 this damper is adjusted to provide a predetermined filtered emergency air intake following an accident. It does not serve an isolation function since filtered intake is provided to remain within the dose limits of GDC-19. On an isolation signal dampers D-2 and D-3 open to provide emergency intake air and thus D-20 is not needed as a redundant isolation damper. See Figure 1.

This statement implies a misunderstanding of the operation of the control room HVAC system. The following is a description of the operation of this equipment. (See Figure 1 for details).

Damper D-20 is a fixed volume control damper adjusted to provide a predetermined flow (250 cfm) of outside air to the filter. This flow is required to maintain control room pressure to prevent infiltration of unfiltered air. Damper D-21 is also a fixed volume control damper adjusted to provide a constant recirculated purification flow (750 cfm). Neither of these dampers is positioned after the initial ventilation system balance.

The operation of the emergency air intake during the Maximum Hypothetical Accidental (MHA) is not optional. The control room atmosphere is maintained in a safe condition by operation of a filtered intake. If the emergency air intake is not utilized, then unfiltered bypass leakage will occur which may create a potentially hazardous condition. Our radiation analysis performed for the Control Room Habitability Study based on the MHA showed that doses would be within GDC-19 limits only through the use of the emergency air intake and it is our position that the emergency intake be used. There is no total recirculation mode for Turkey Point.
