ACCESSION NBR:9004090145 DOC.DATE: 90/03/29 NOTARIZED: NO DOCKET #  
 FACIL:50-250 Turkey Point Plant, Unit 3, Florida Power and Light C 05000250  
 50-251 Turkey Point Plant, Unit 4, Florida Power and Light C 05000251

SUBJECT: Forwards licensee response to questions discussed during  
 891017-19 audit re resolution of station blackout issue.

DISTRIBUTION CODE: A050D COPIES RECEIVED:LTR 1 ENCL 1 SIZE: 53 + 39  
 TITLE: OR Submittal: Station Blackout (USI A-44) 10CFR50.63, MPA A-22

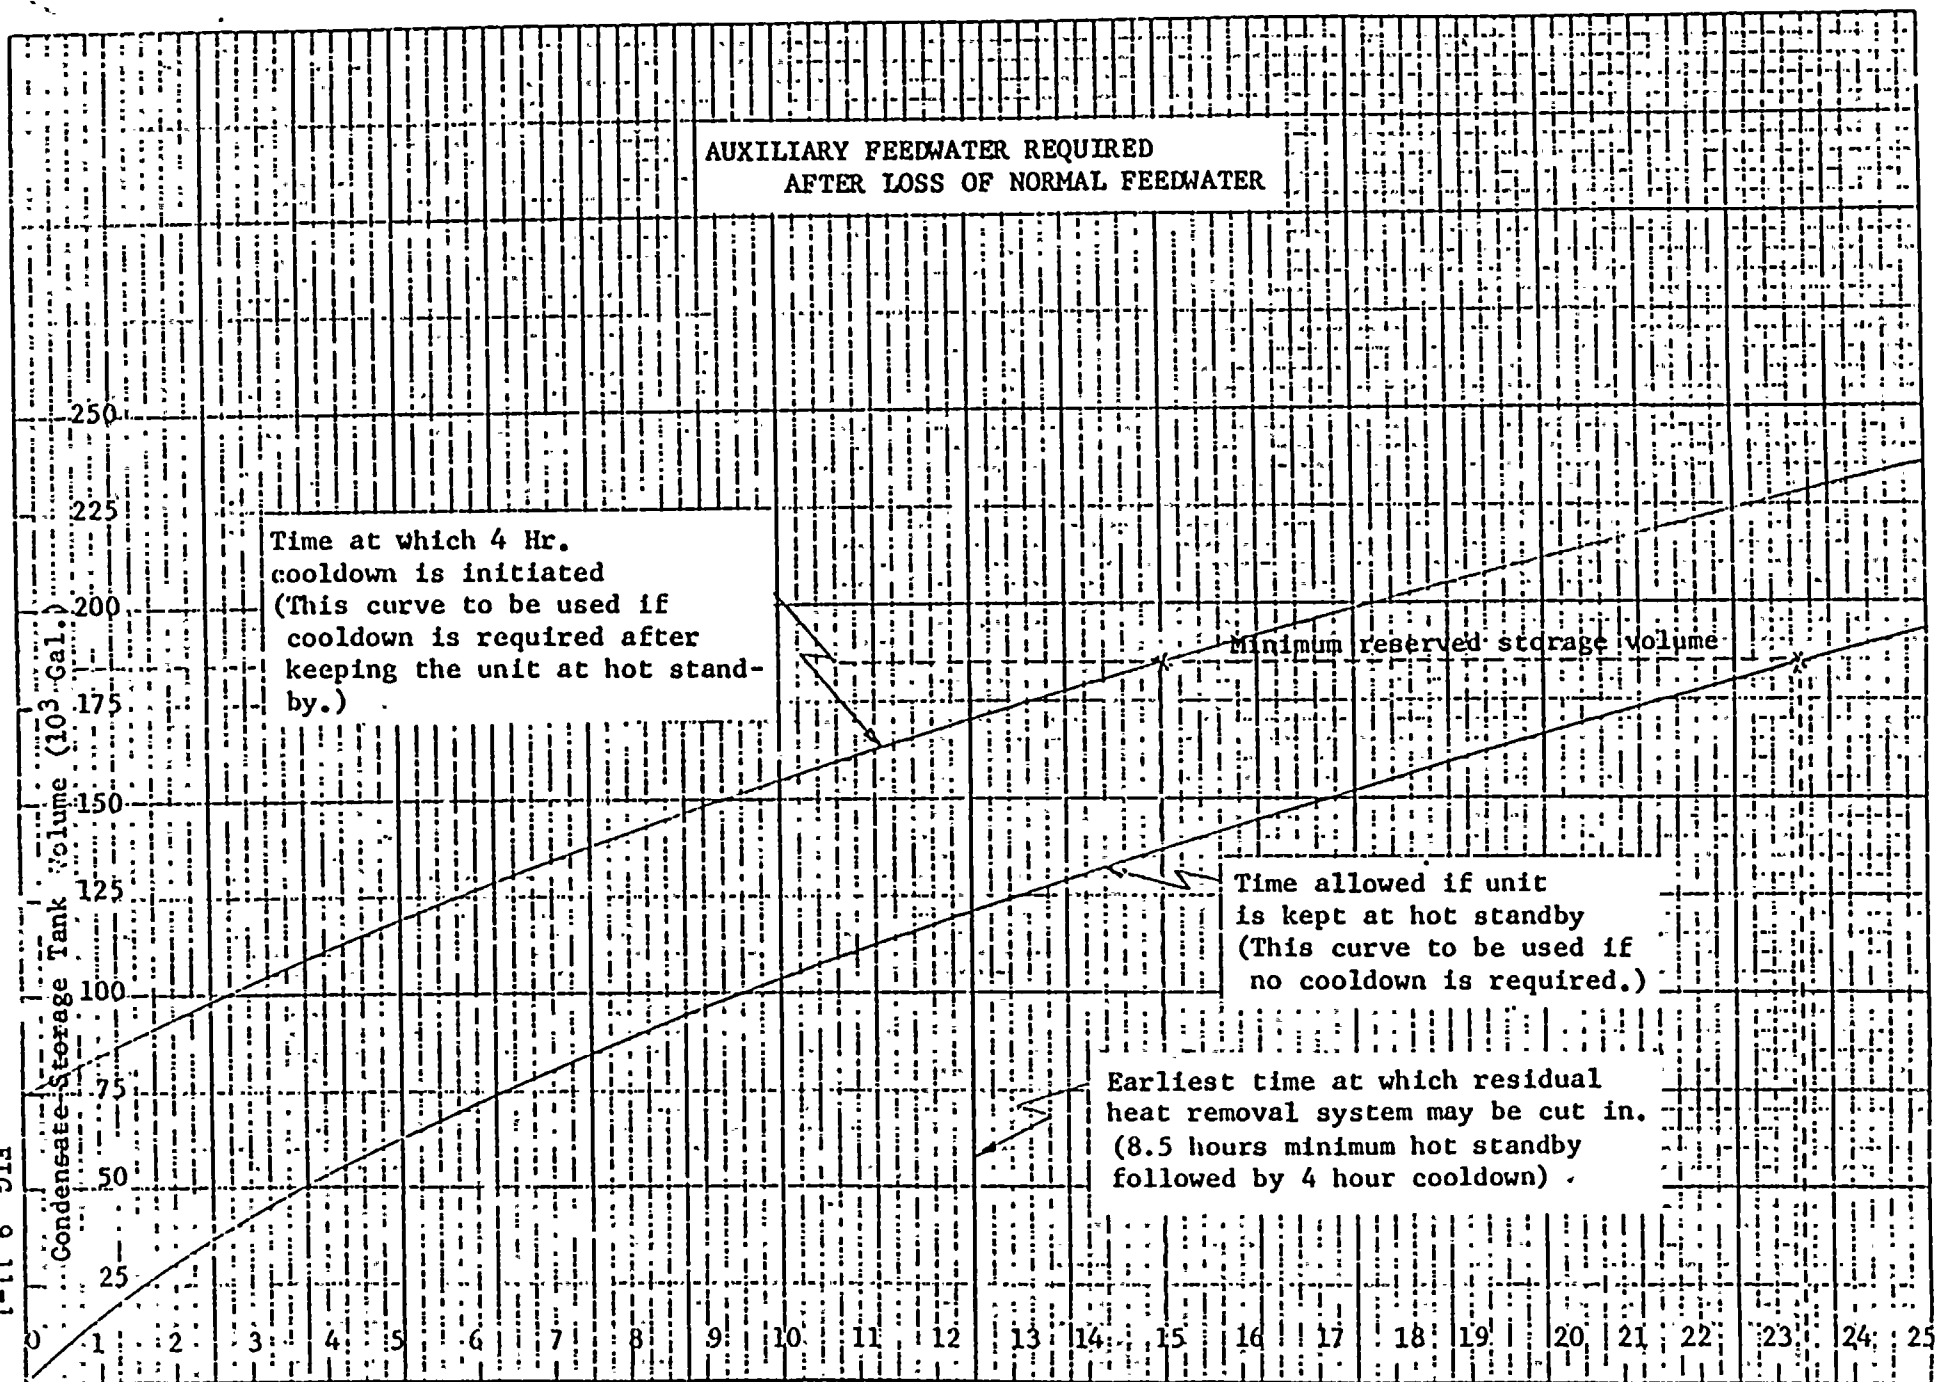
FIG. 9.11-1

# AUXILIARY FEEDWATER REQUIRED AFTER LOSS OF NORMAL FEEDWATER

Time (Hrs.)

This is shown graphically in Figure 9.11-1.
