TECHNICAL EVALUATION REPORT ON THE  
"SUBMITTAL-ONLY" REVIEW OF THE  
INDIVIDUAL PLANT EXAMINATION OF EXTERNAL EVENTS  
AT TURKEY POINT NUCLEAR PLANT, UNITS 3 AND 4

FINAL REPORT

Completed: January 1997  
Final: January 1998

Energy Research, Inc.  
P.O. Box 2034  
Rockville, Maryland 20847-2034

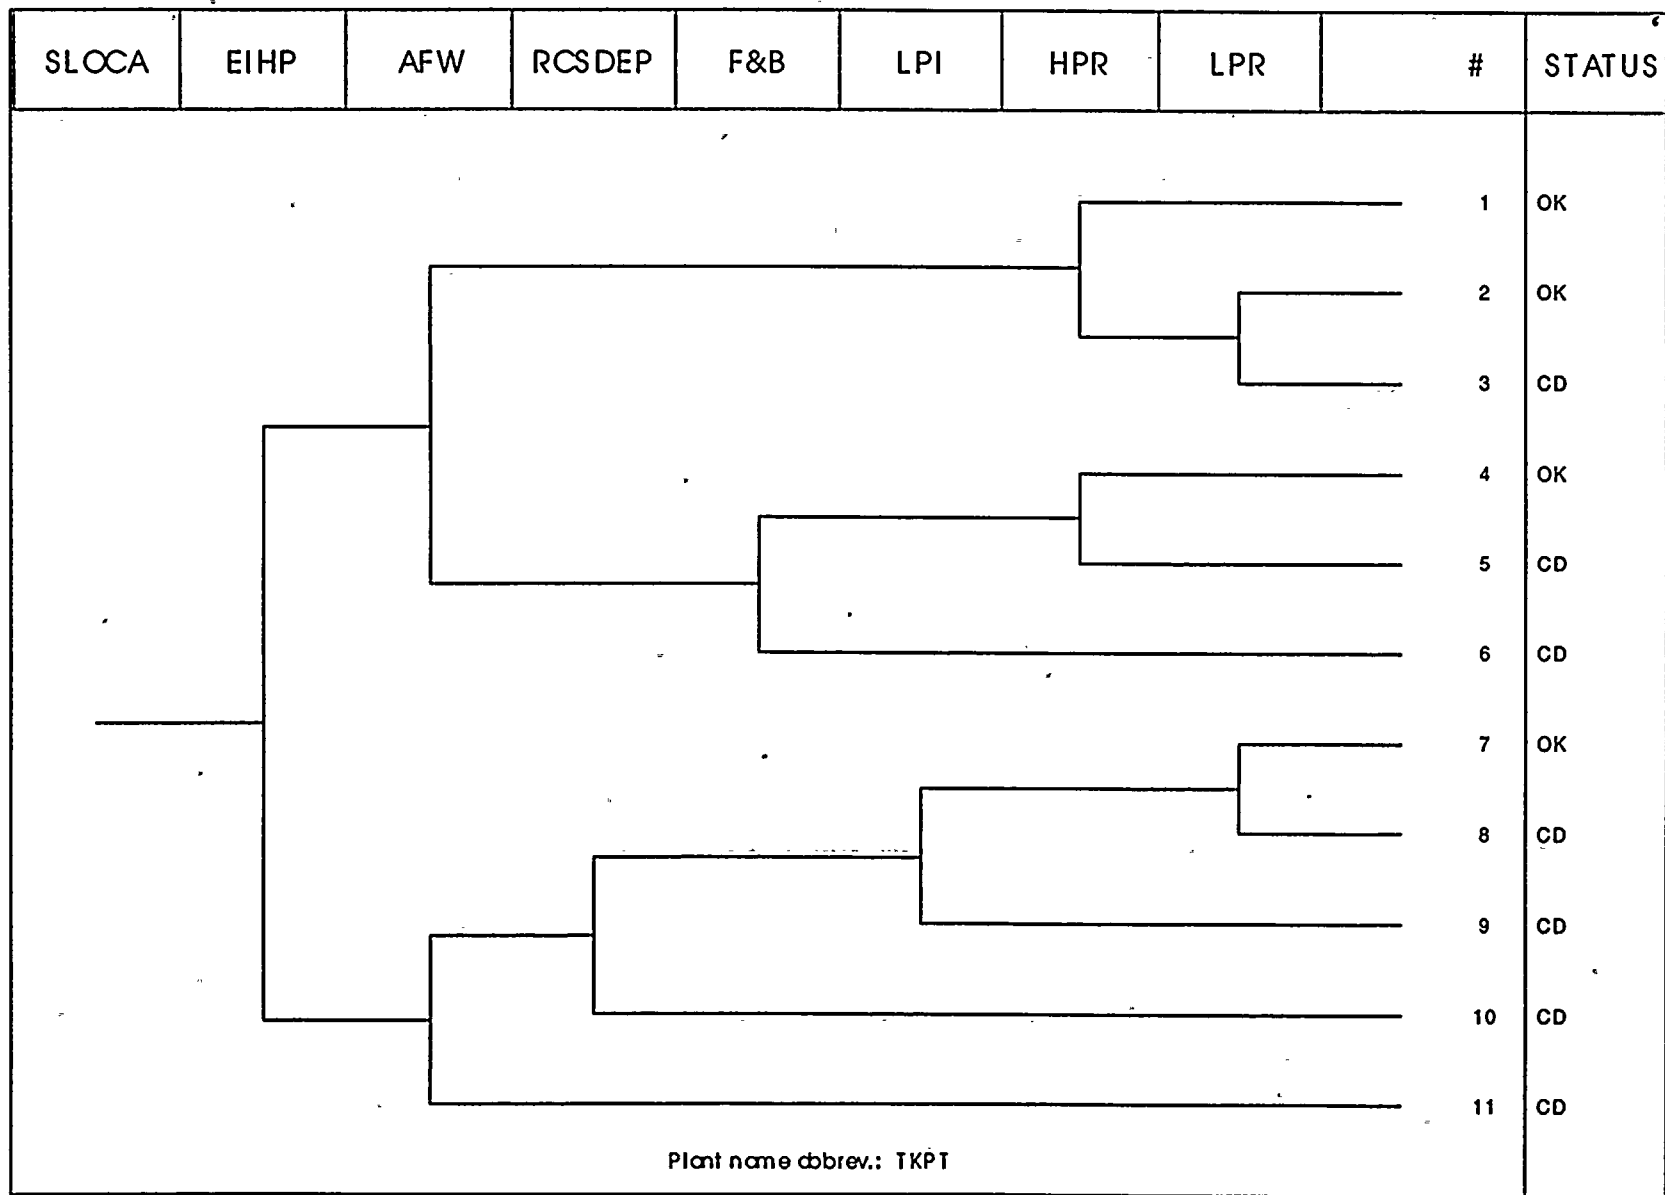
SLOCA	EIHP	AFW	RCSDEP	F&B	LPI	HPR	LPR	#	STATUS

1	OK
								2	OK
								3	CD
								4	OK
								5	CD
								6	CD
								7	OK
								8	CD
								9	CD
								10	CD
								11	CD

Page
SDP Event Tree — Transients .....	25
SDP Event Tree — Small LOCA .....	26
SDP Event Tree — Medium LOCA .....	27
SDP Event Tree — Large LOCA .....	28
SDP Event Tree — LOOP .....	29
SDP Event Tree — Steam Generator Tube Rupture (SGTR) .....	30
SDP Event Tree — Anticipated Transients Without Scram (ATWS) .....	31

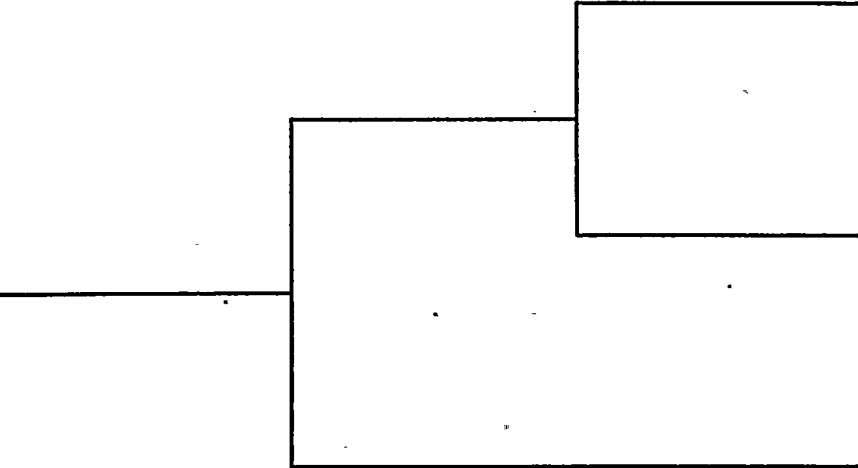
MLOCA	EIHP	LPR	#	STATUS

OK
					CD
					CD
Plant name abbrev.: TKPT

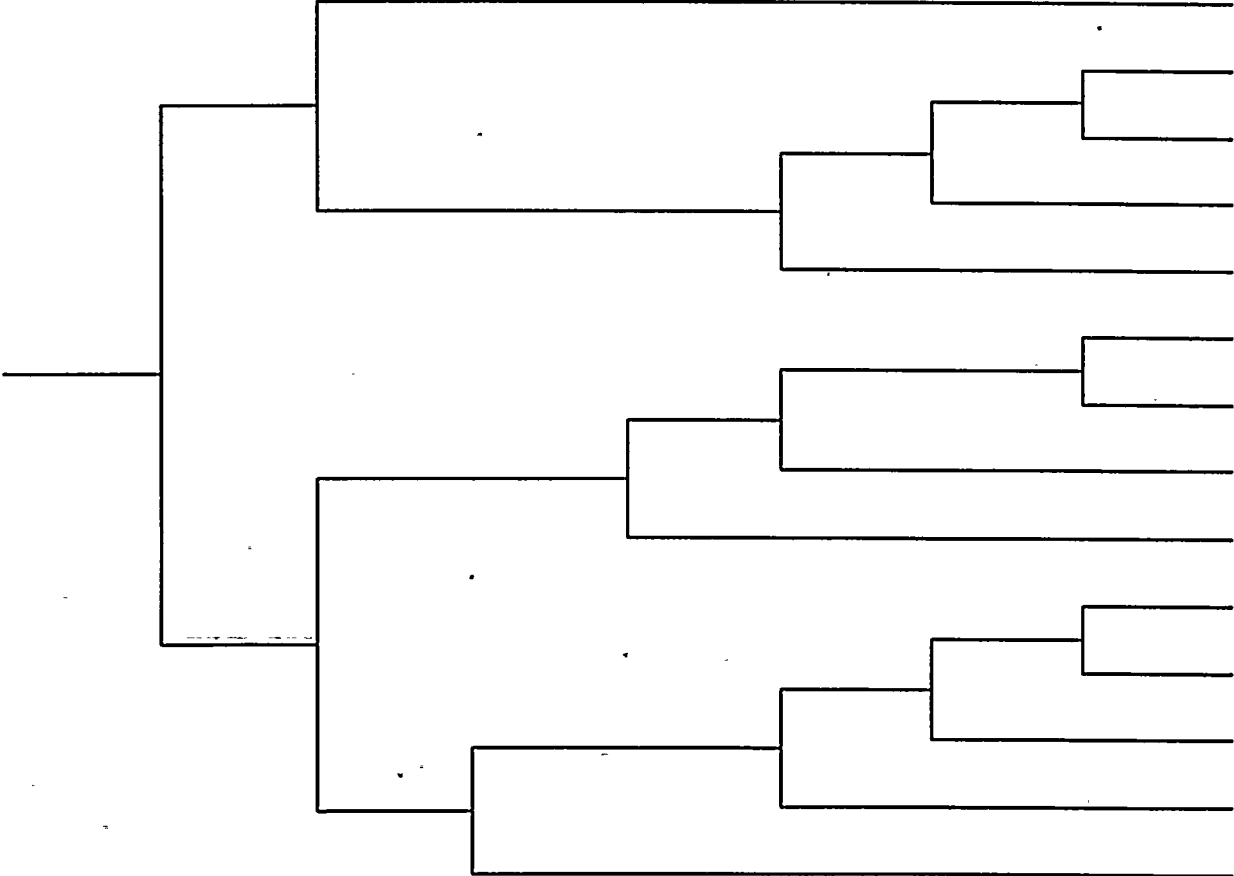
LOOP	EAC	TDAFW	REC2	REC5	EIHP	FB	HPR	#	STATUS

1	OK
									2	OK
									3	CD
									4	CD
									5	CD
									6	OK
									7	CD
									8	CD
									9	CD
									10	OK
									11	CD
									12	CD
									13	CD
									14	CD
