SUBJECT: Request relief from certain requirements of ASME Section XI,  
1992 Edition.Relief request 20 re exemption of tendon insp,  
encl.

L-99-075  
10 CFR 50.55a

Effective September 9, 1996, the NRC amended 10 CFR 50.55a to incorporate by reference the 1992 Edition with the 1992 Addenda of Subsection IWL, "Requirements for Class CC Concrete Components of Light-Water Cooled Power Plants," of Section XI, Division 1, of the American Society of Mechanical Engineers Boiler and Pressure Vessel Code (ASME Code). The revisions to 10 CFR 50.55a were designed to assure that the critical areas of containments are routinely inspected to detect and take corrective action for defects that could compromise a containment's structural integrity. Implementation of the revised requirements for containment examination is required by September 9, 2001, five years from the effective date of the rule.

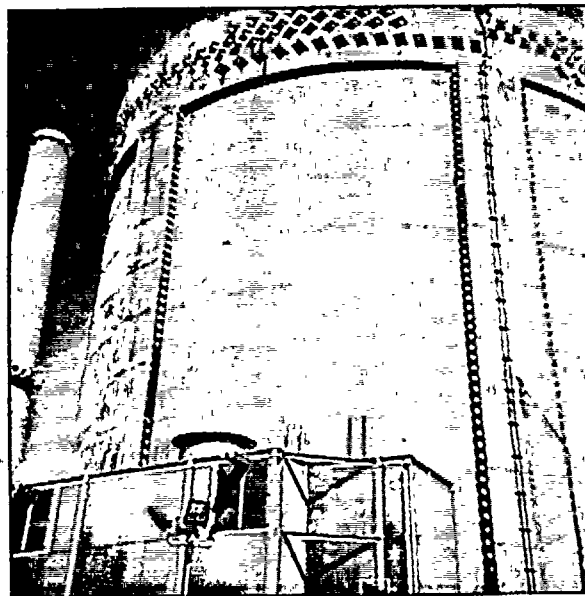
**Photos of Units 3 and 4 Containment Buildings and main steam safety  
and atmospheric dump pipes.**

UNIT 3  
VIEW LOOKING EAST

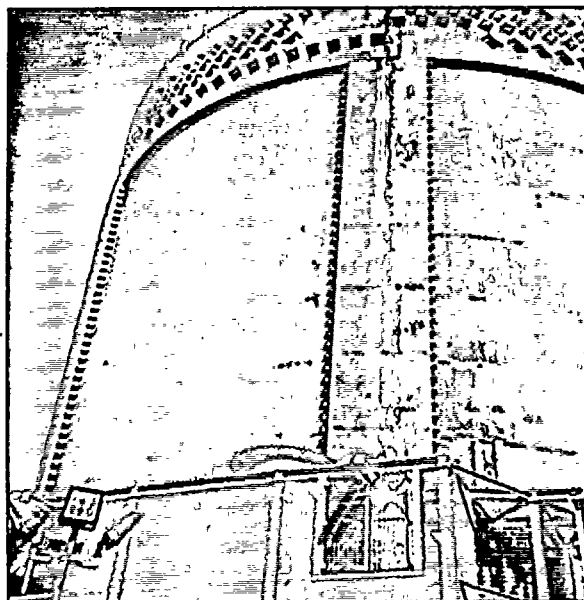
UNIT 4  
VIEW LOOKING EAST

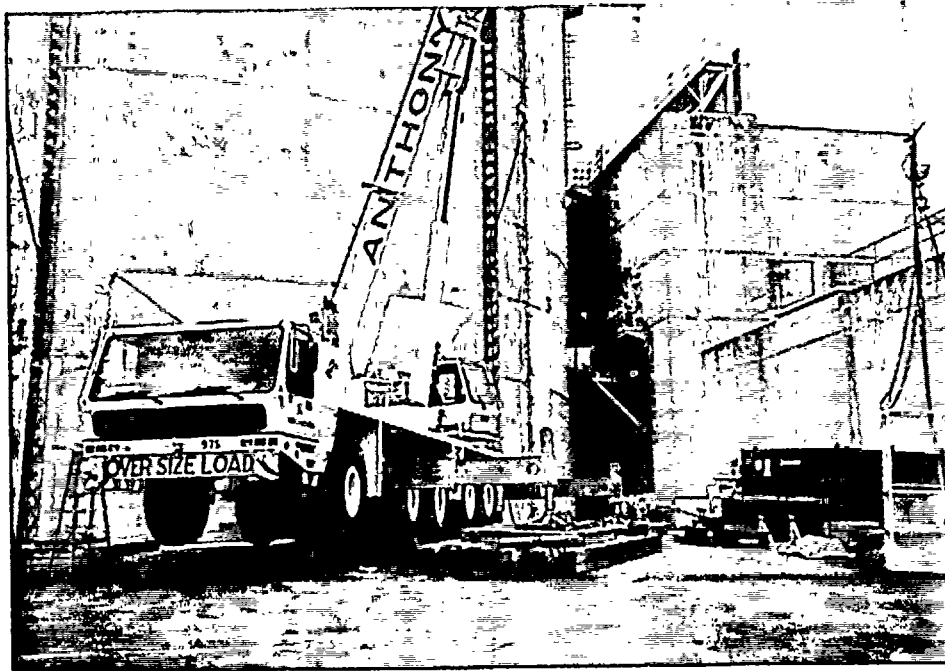
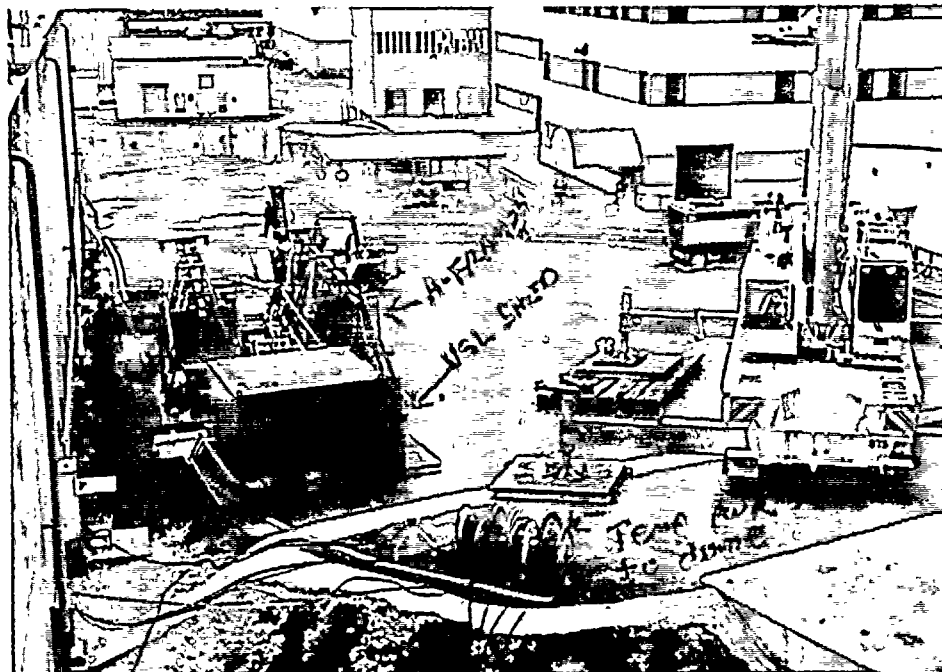
Photos of crane and/inspection equipment on Unit 4 ramp during 25<sup>th</sup>  
year tendon inspection.

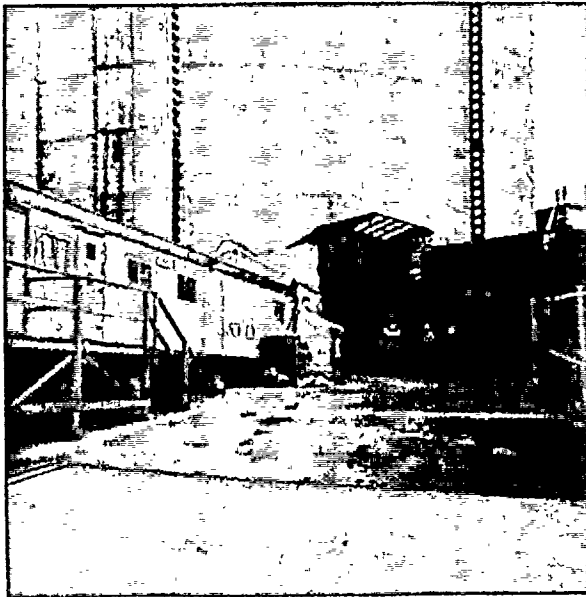
- Photos of security and health physics facilities, and tool containers on Unit 3 ramp during Cycle 17 refueling outage.
