SUBJECT: Forwards revised relief request 20 re requirement to perform exams as required by IWL-2524 & IWL-2525, Table IWL-2500-1 re tendons. Rev submitted per recent discussions with NRC.

L-99-187
10 CFR 50.55a

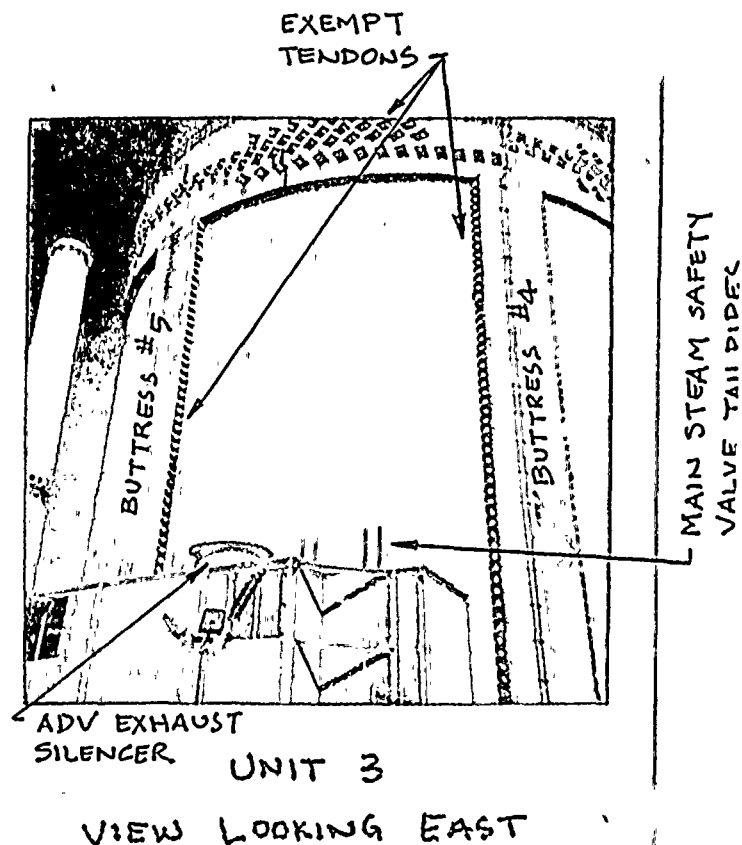
**Photos of Units 3 and 4 Containment Buildings and main steam safety
and atmospheric dump pipes.**

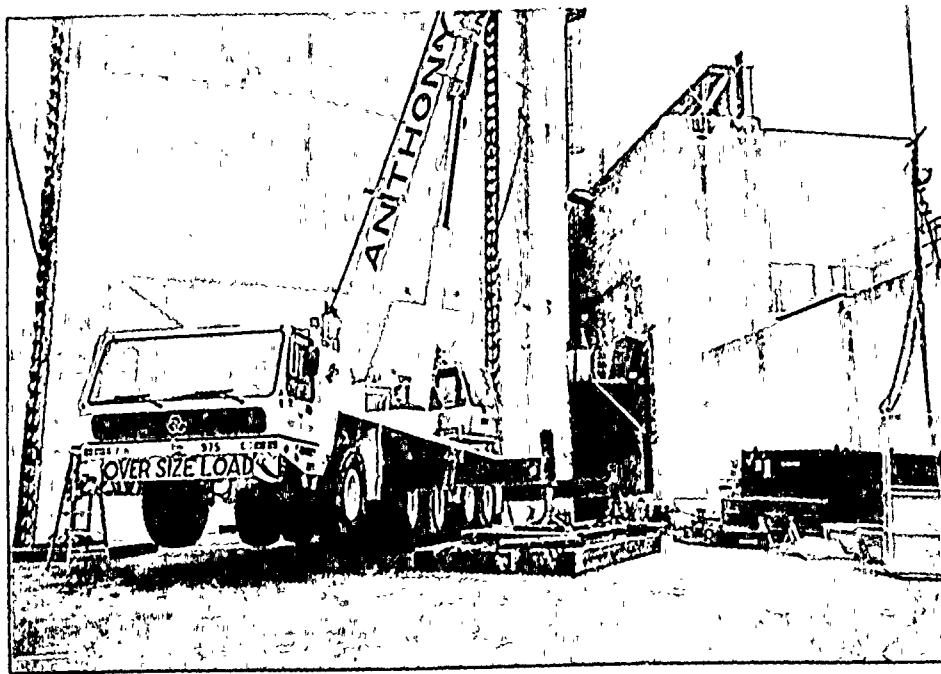
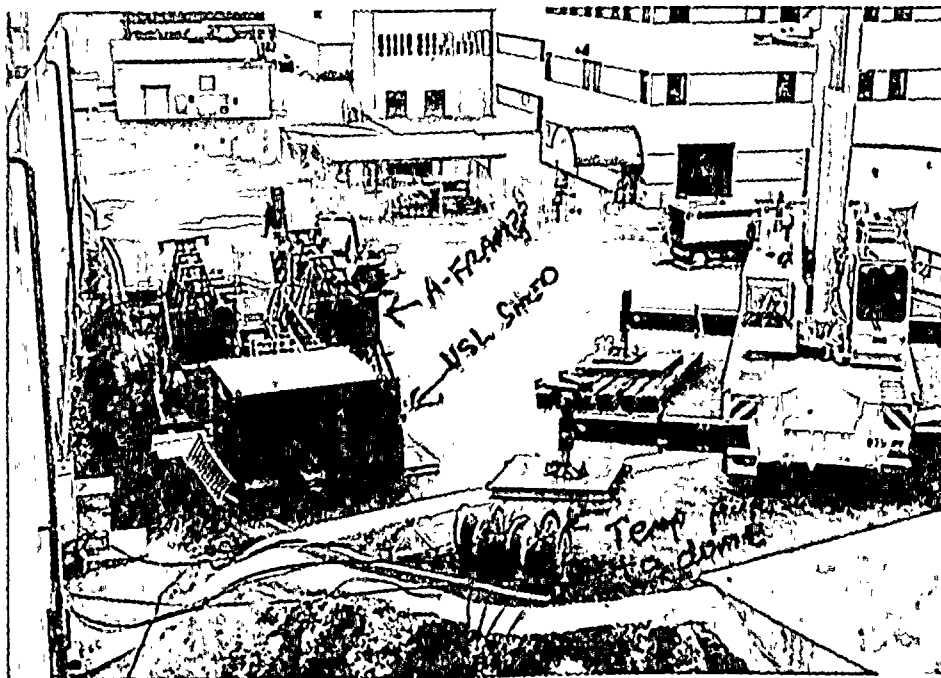
Photos of crane and inspection equipment on Unit 4 ramp during 25th
year tendon inspection.
